MONTANA DEPARTMENT OF TRANSPORTATION STREAM MITIGATION MONITORING REPORT

*Foy's Bend Fisheries Conservation Area
Flathead County, Montana*

YEAR 2013

MDT Project Number: NH-MT 5-3(50) 109F
Control Number: 20380013

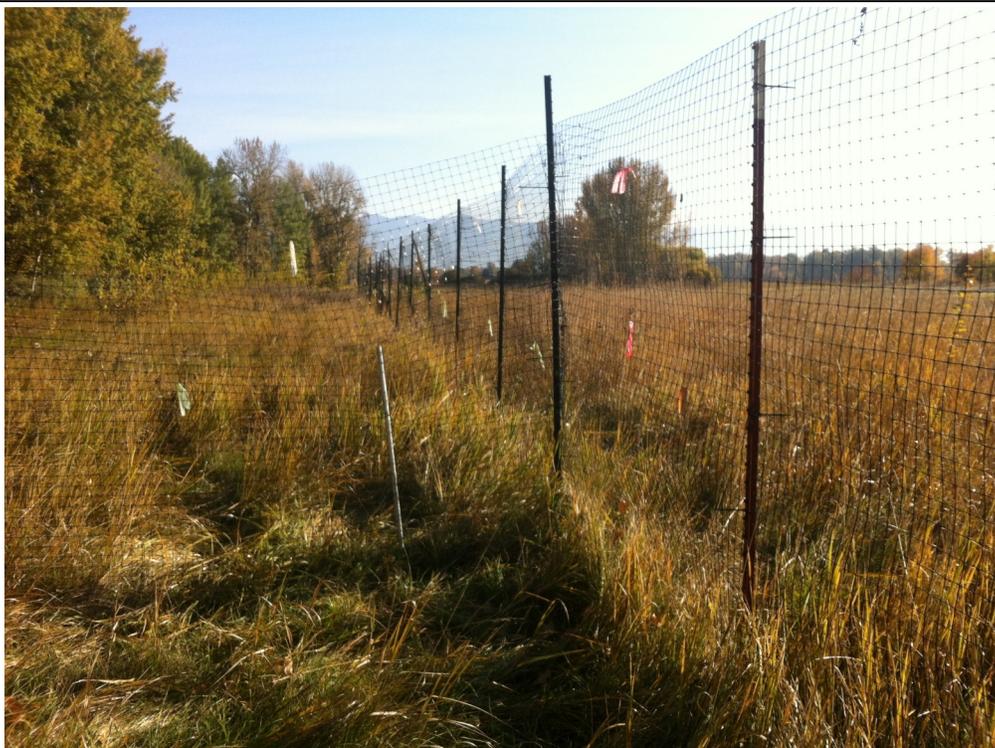
One minor fencing issue was identified during the monitoring event. The fence installed around exclosure #9 had a small tear on the north side and has already been repaired. Photographs were taken and the location was recorded using a GPS to allow for follow up inspections.

Fencing around the riparian exclosures was installed very well, with only one minor issue noted. A small gap in the fence was noted on the north side of exclosure #9. Photo documentation by surveying crews indicated this fencing issue has already been repaired. Otherwise, all fencing was in excellent condition.

Broken Fence
D-6
