MONTANA DEPARTMENT OF TRANSPORTATION STREAM MITIGATION MONITORING REPORT

*Clark Fork River
Granite County, Montana*

STREAM MITIGATION MONITORING REPORT:

YEAR 2013

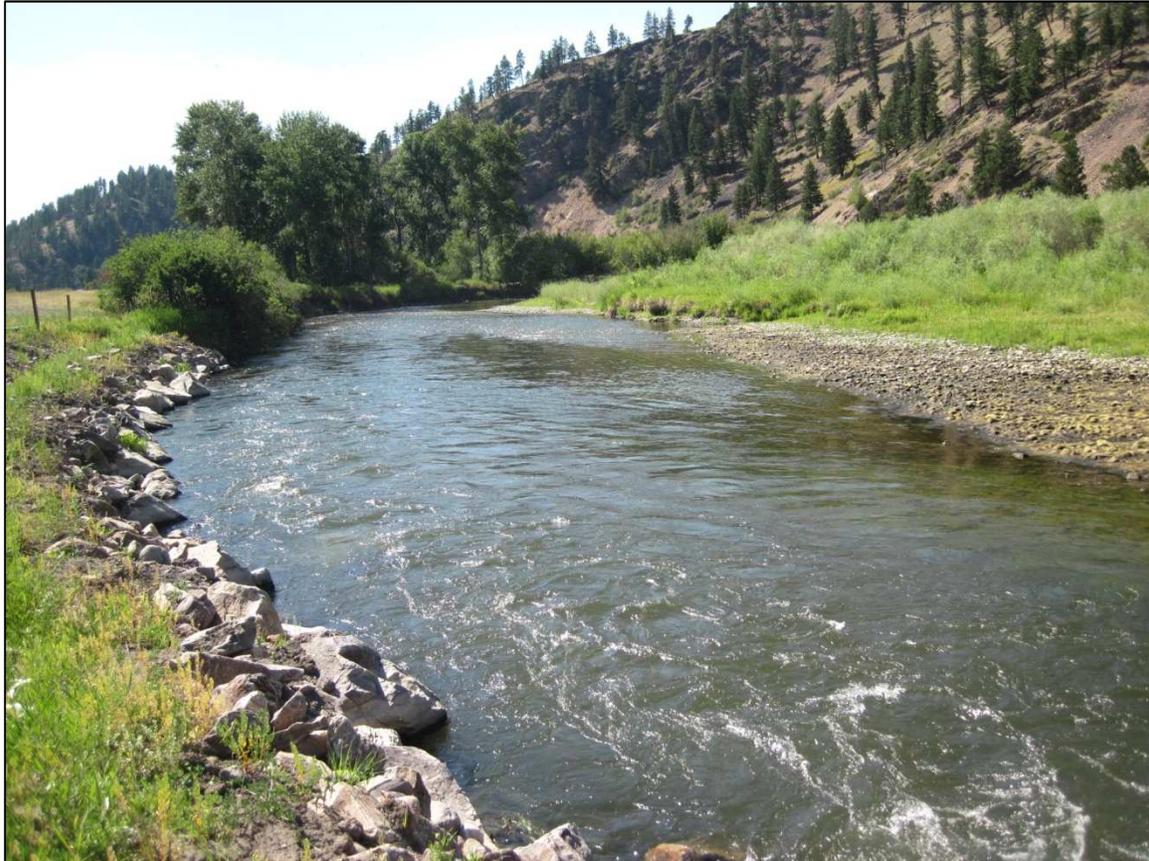
Cover. View of Clark Fork River with rip rap and willow plantings looking West (downstream).

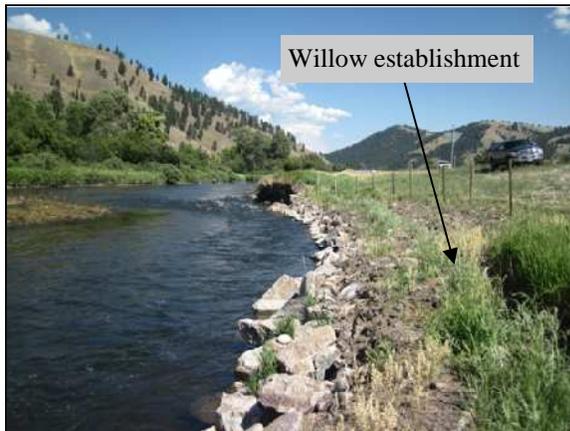
Photo 1
Description: View upstream looking at revetment.
Taken in 2013

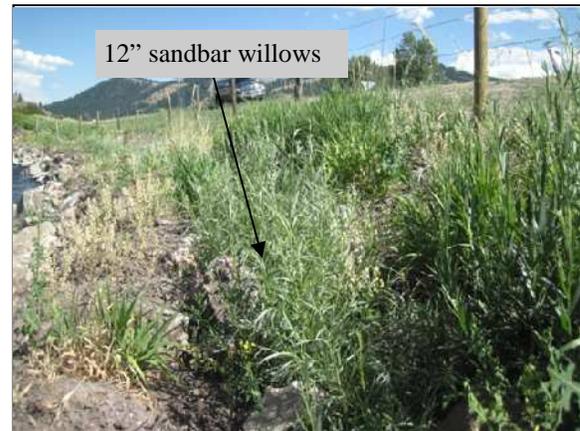
Photo 4
Description: Willow growth at top of revetment.
Taken in 2013

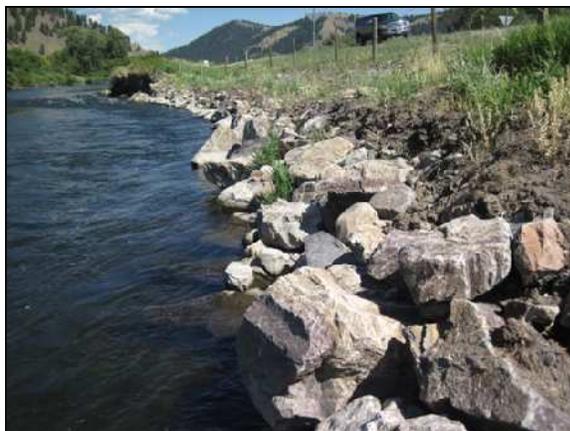
Photo 2
Description: Toe of revetment looking upstream.
Taken in 2013

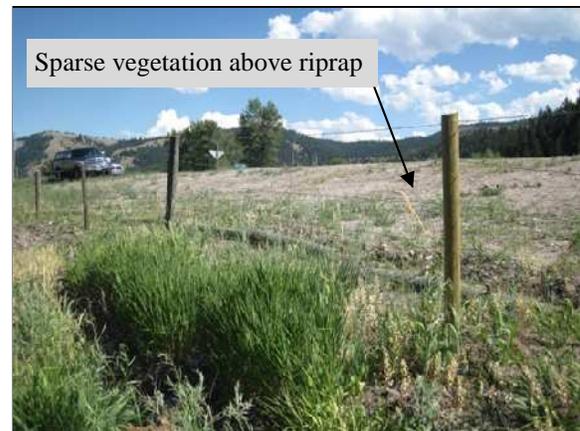
Photo 5
Description: Weedy streambank/work area.
Taken in 2013

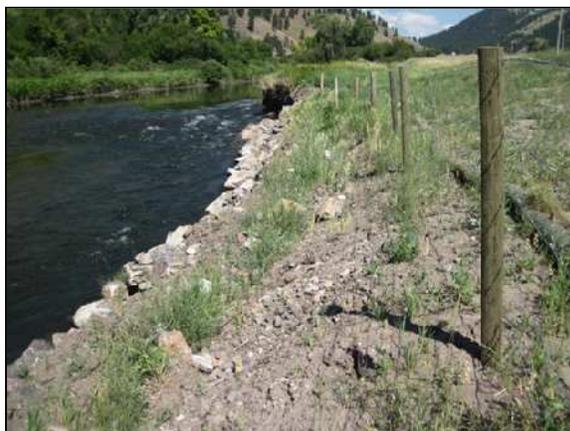
Photo 3
Description: Middle of revetment looking upstream.
Taken in 2013

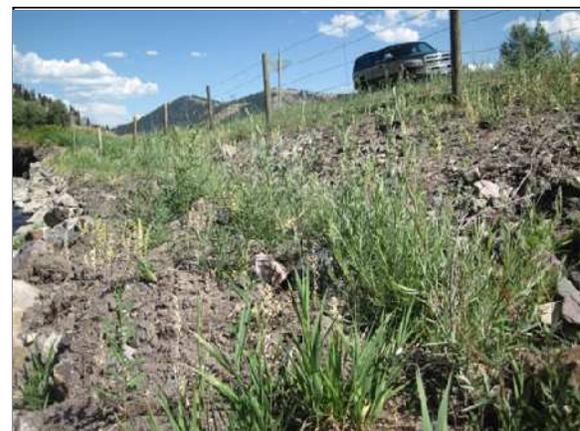
Photo 6
Description: Sandbar willow growth and bare ground.
Taken in 2013

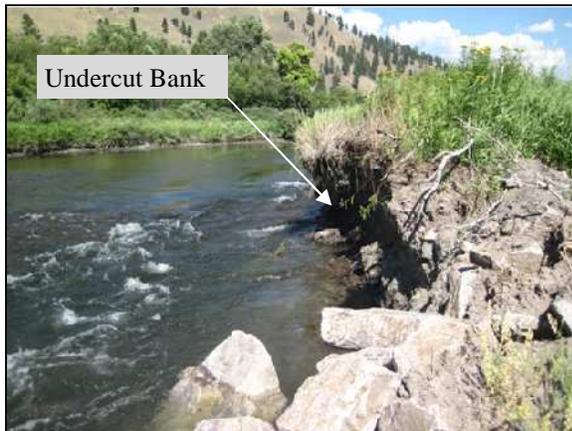
Upstream of the project area is an eroding bank approximately ten to fifteen feet in length (Photo 7, Appendix A). This bank does not currently appear to threaten the project area; however the eroding streambank should continued to be monitored to determine if it is a threat to the stabilized streambank or the Interstate. If the bank continues to erode, placement of additional riprap is recommended to maintain protection of the highway. If necessary, the extent of additional riprap installation should be evaluated based on anticipated erosive activity, flow direction, bar formation, existing bank materials, and vegetative composition.

Photo 7
Description: Eroding streambank at upstream extent.
Taken in 2013

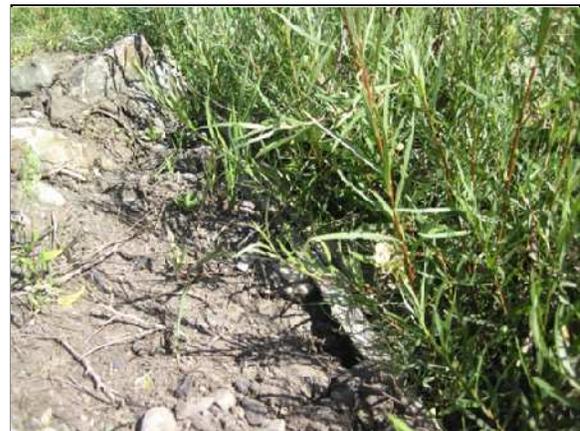
Photo 10
Description: Close-up of sandbar willow growth.
Taken in 2013

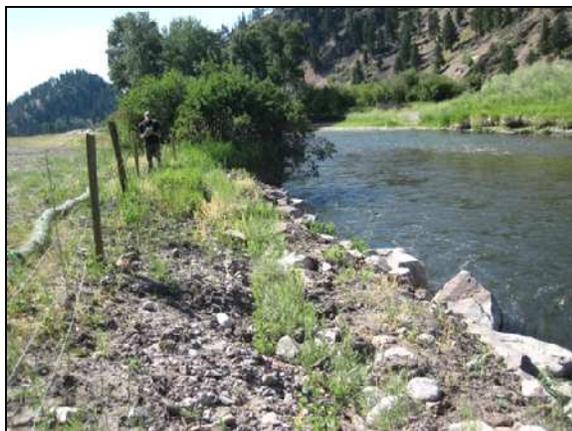
Photo 8
Description: Middle of revetment looking downstream.
Taken in 2013

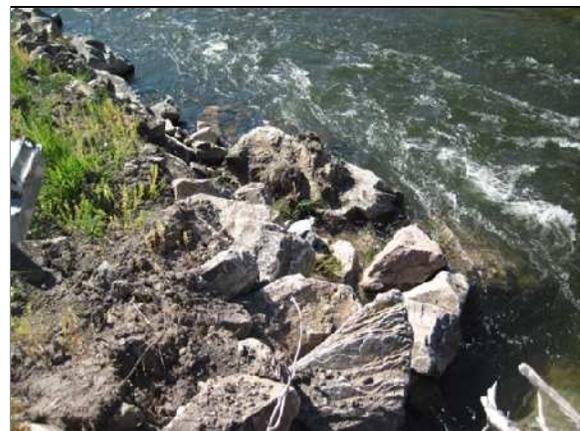
Photo 11
Description: Upstream extent of rip-raped streambank.
Taken in 2013

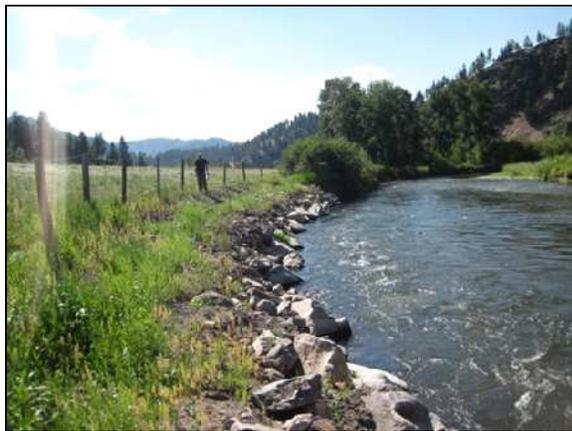
Photo 9
Description: Looking downstream at revetment.
Taken in 2013

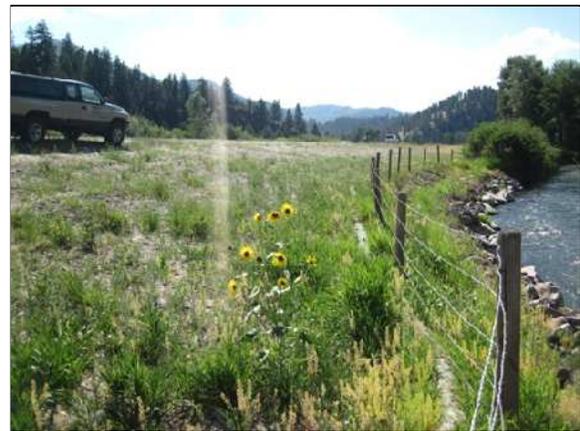
The upper streambank area and project staging area contained a large amount of weedy and undesirable species and approximately 60% bare ground (Photo 12, Appendix A). Additional seeding of the site is suggested as soon as possible to prevent additional weed colonization.

Photo 12
Description: Weedy and bare re-sloped work area.
Taken in 2013

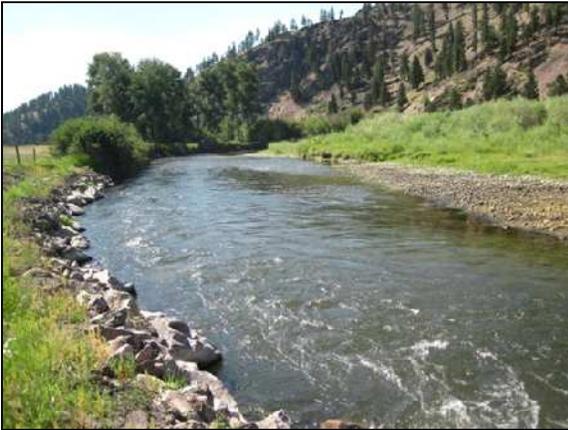
Photo 13
Description: Looking downstream at revetment.
Taken in 2013

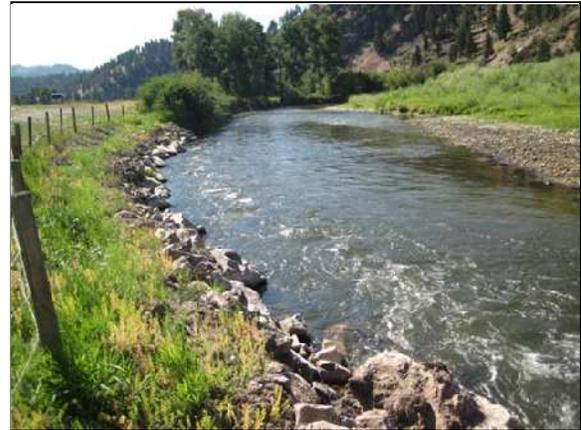
Photo 14
Description: Looking downstream at revetment.
Taken in 2013
