MONTANA DEPARTMENT OF TRANSPORTATION STREAM MITIGATION MONITORING REPORT

*Ashley Creek
Flathead County, Montana*

*Project Completed: 2010
Monitoring Report #2: December, 2014*

MDT Project Number: NH-MT 5-3(59) FST
Control Number: 2038

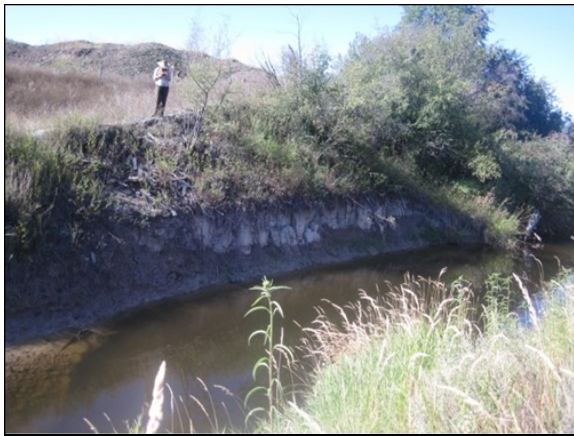
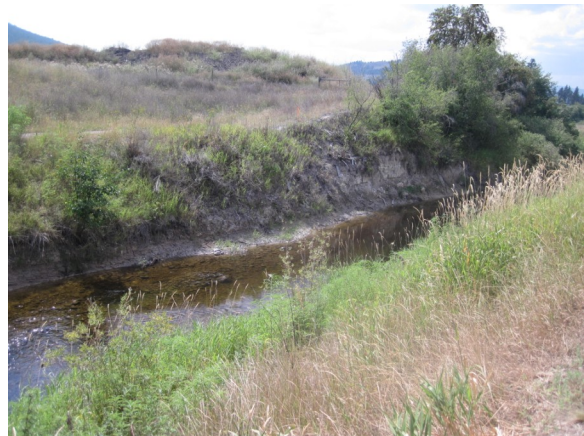
Photo 6—2013

Eroding bank EBR1 occurs against a high terrace with a steep bank angle, which prevents vegetation from establishing. A clay lens was observed along the toe of the slope, which may provide resistance to additional lateral or vertical erosion. The 53-foot segment of eroding bank did not appear to migrate laterally following the first monitoring event in 2013. Erosion severity along this bank is considered moderate due to lack of vegetation, steep bank angle, and presence of fine grained soils.

Description: View of EBR1 on south side of channel.
Compass: 225 (South-Southwest)

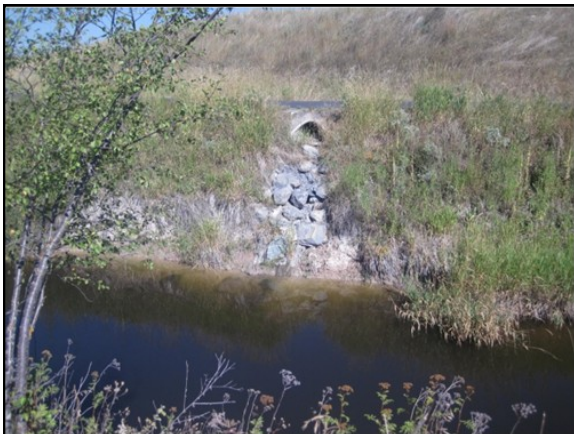
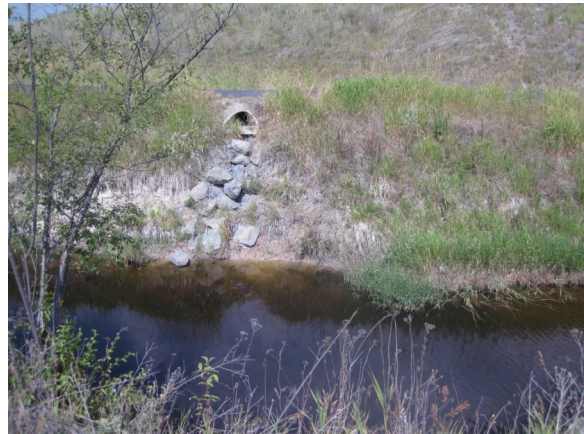
Photo 7—2013

Erosion of a 40-foot bank segment at EBL1 is occurring both upstream and downstream of a stormwater culvert. During construction of the project, riprap was placed below the culvert outlet to protect the bank from erosion. Portions of the riprap placed below the culvert had sloughed into the channel. Erosion at this bank was also noted in 2013, and appears to have become more degraded in 2014. A separate inspection (RESPEC,

2014) provided additional details, causes of erosion, and recommended actions to stabilize this bank. This report cited the lack of riprap placement in a key trench at the toe of the slope, poorly graded riprap, and disturbance of fine grained soils during construction as causes for riprap failure and bank instability at this location. Stream bank vegetation consists of reed canary grass, which has an excellent root system capable of withstanding erosion (root stability index score of 9); therefore, lack of vegetation along the bank is not a contributing factor. Erosion severity at this location is considered moderate.

Description: View of EBL1 beneath culvert outlet on north streambank upstream of bridge.
Compass: 0 (North)

The stream bank inventory identified four eroding stream banks, totaling 189 feet, or 18% of the total project bank length of 860 feet. Eroding bank EBL1 is currently being evaluated by MDT to repair and stabilize as part of a bridge expansion project over Ashley Creek, which is currently scheduled for 2015-2016.

Stone materials placed along the toe of the bank beneath a culvert upstream from the new bridge have continued to slough into the stream channel. These materials appear to be sloughing due to the steep bank angle (steeper than 1H:1V), saturation of the bank when the culvert discharges water on the bank, and improper placement of riprap beneath the culvert outlet. Stone toe protection beneath this culvert will need to be replaced to maintain bank and culvert protection if additional material continues to slough. MDT is currently evaluating stabilization alternatives at the outlet of this culvert as part of a bridge expansion project over Ashley Creek.

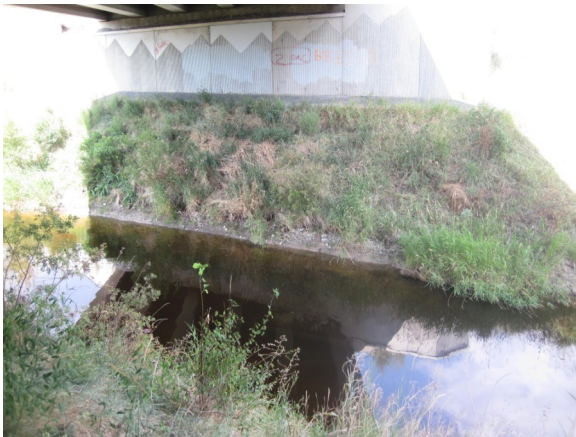
Photo 8—2104

Description: EBL2; Low water with no vegetation.
Compass: 315 (Northwest)

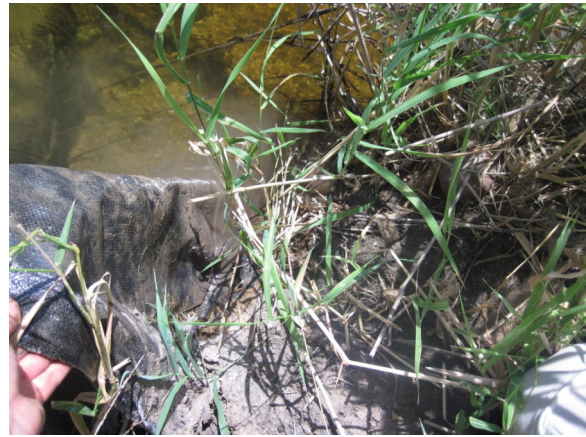
Photo 9—2014

Description: EBL2; Loose geo-tech fabric at the up-stream end of eroding streambank.

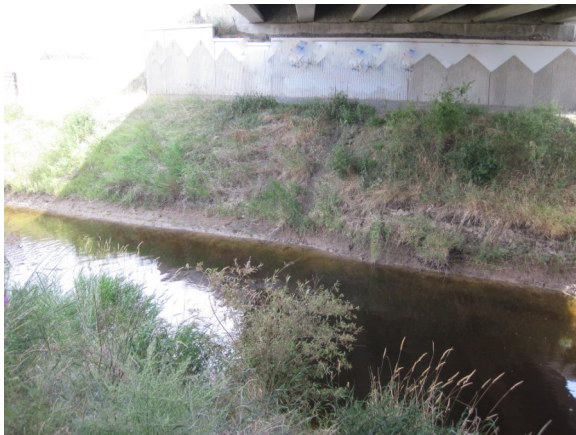
Photo 10—2014

Description: EBR2; Erosion caused by high flow events,. Streambank actively eroding and sloughing. Note: Photo has been altered due to explicit language on background wall.
