# MONTANA DEPARTMENT OF TRANSPORTATION STREAM MITIGATION MONITORING REPORT

*Bowser Creek  
Flathead County, Montana*

*Project Completed: 2010  
Monitoring Report #2: December, 2014*

MDT Project Number: NH 15(93)  
Control Number: 2038-011

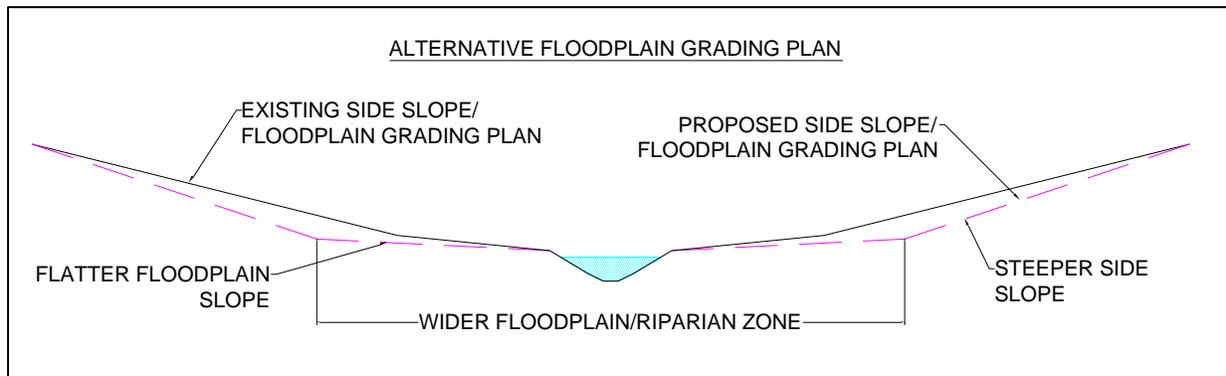
Figure 2. Alternative grading plan to increase floodplain and riparian areas.

Side slope designs along Bowser Creek provide room for a very narrow, 14 foot wide riparian and floodplain zone. Perpendicular transect survey results (Appendix B) illustrate a narrow bankfull bench adjacent to the creek has been constructed for flood inundation and wetland/riparian vegetation establishment. Integrating a slightly steeper upland side slope design would provide for a wider, more functional floodplain and

riparian zone by allowing the stream to access a larger, flat zone adjacent to the active channel (Figure 2). Constructing steeper side slopes and a wider floodplain area requires additional excavation; therefore a cost/benefit analysis of creating additional floodplain and wetland features, and the associated mitigation credits, is potentially worth consideration for future stream and riparian mitigation designs. Design of steeper side slopes also must take into consideration highway safety, and allow for vehicles to exit the roadway safely; therefore this design parameter may not allow for maximizing floodplain area adjacent to the channel.

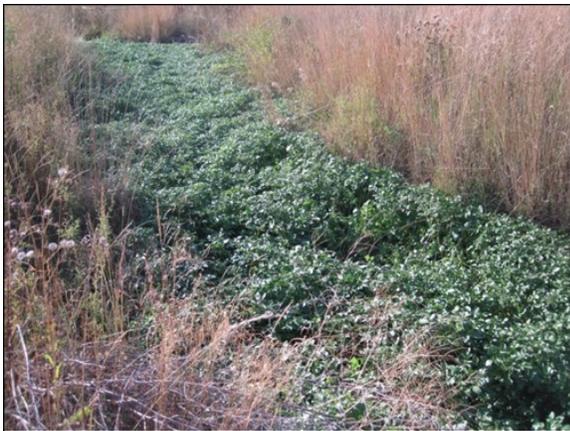
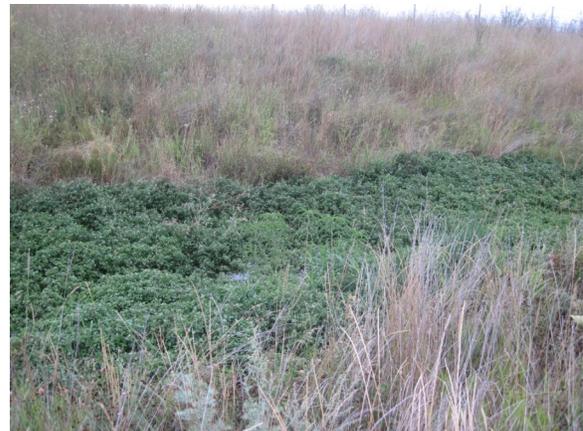
**Photo 1—2013**  
**Description:** Instream vegetation on Bowser Creek. **Compass:** 90 (East)

**Photo 1—2014**  
**Description:** Instream vegetation on Bowser Creek. **Compass:** 90 (East)

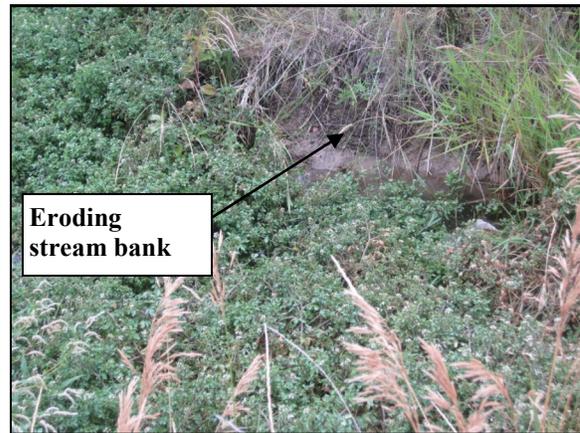
**Photo 4**  
**EBL2**– Downstream of culvert, stream bank eroding for approximately 36 feet.

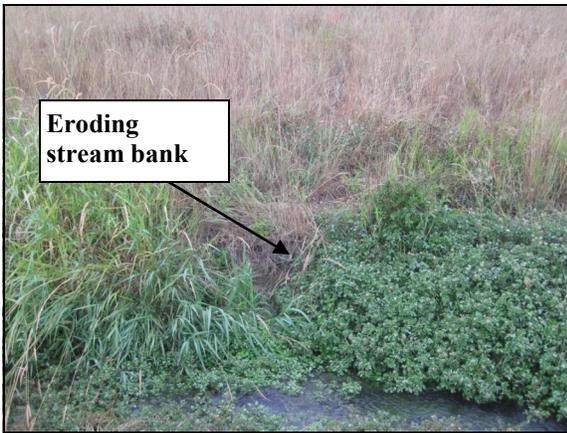
**Photo 5**  
**EBL2**– Downstream of culvert, stream bank eroding for approximately 36 feet.

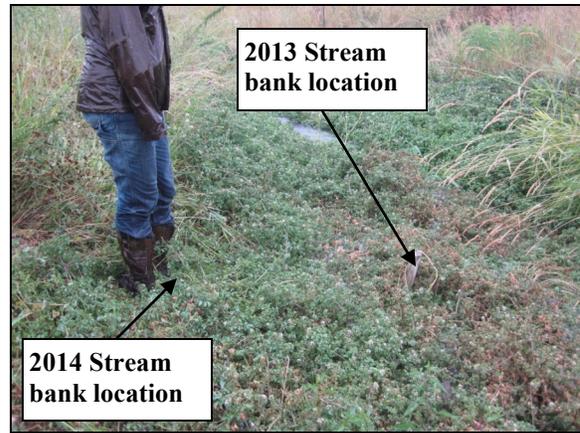
**Photo 6**  
**EBR1**– Across from inflow culvert. Stream bank length is approximately 48 feet long, receding 2-3 feet.

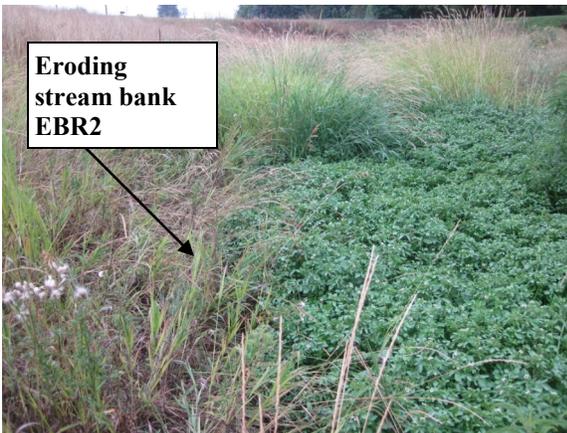
**Photo 8**  
**EBR2**– Downstream of culvert, stream bank eroding for approximately 36 feet.
