MONTANA DEPARTMENT OF TRANSPORTATION STREAM MITIGATION MONITORING REPORT

*Foy's Bend Fisheries Conservation Area
Flathead County, Montana*

*Project Completed: 2013
Monitoring Report #2: December 2014*

MDT Project Number: NH-MT 5-3(50) 109F
Control Number: 20380013

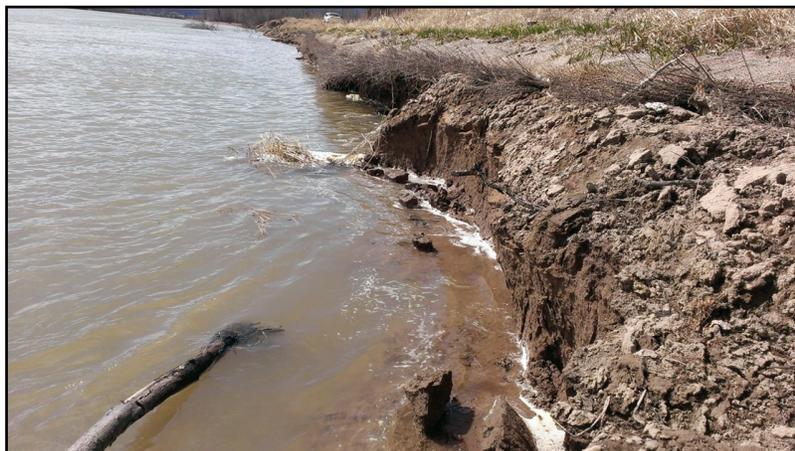
- b. Significant soil loss was observed on the bank slope below the bioengineered bank treatment.
- c. Soil loss had undermined approximately 50 feet of the bank treatment near the upstream end of the project (near survey transect #5 in Appendix A). This undercut was extended up to 2 feet beneath the soil lift and had a vertical, eroding scarp 1.5 to 2.0 feet high. Most of the conifer fascine was still suspended by the soil lift, but some of the fascine had collapsed onto the eroding bank slope below. This 50-foot section contained the lowest point of the soil lift. Since the time of construction, we estimate the unvegetated bank edge has moved a minimum of 6 feet toward the constructed bank treatment.

Photo 14– Failure of bank slope beneath bioengineered bank treatment. Note undermining of soil lift a fascine

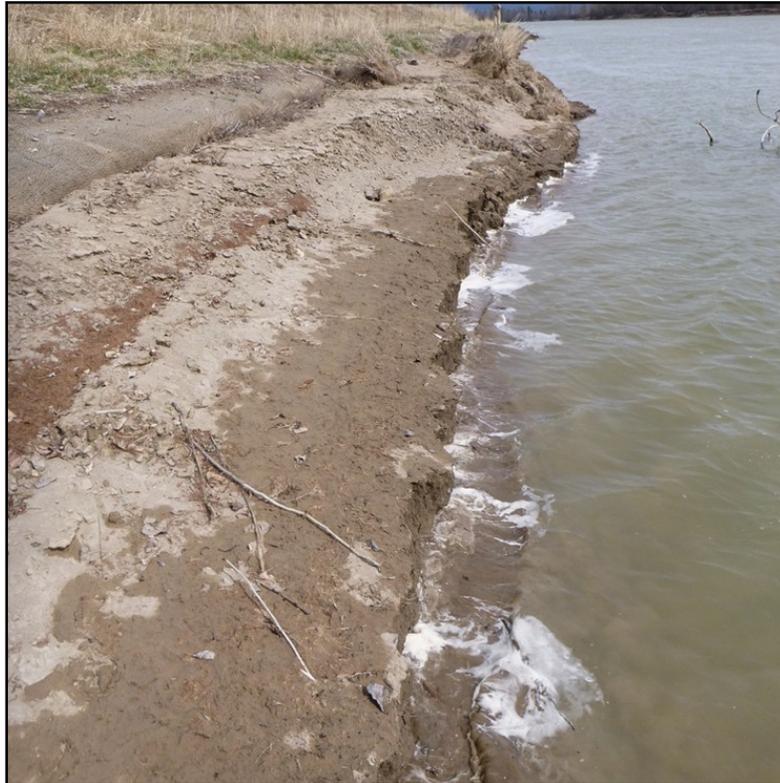
- c. Wave Erosion: Waves were actively eroding the bank slope at the water surface. A small vertical scarp was observed at the erosional face. Height of the scarp ranged from a couple inches to a couple feet. Wave erosion was observed whenever wind speed increased above approximately 10 knots for more than a few minutes. Wind-caused wave erosion is expected to be significant during prolonged southwesterly winds, as the fetch is approximately 1 mile in length. Bank erosion was also observed when wakes from passing boats reached the shore. 3 boats were observed traveling in the middle of the river that each caused collapse of the vertical erosion scarp during the site visit.

Photo 15 – Scarp caused by wave erosion along the bank (Photo taken in April, 2014).

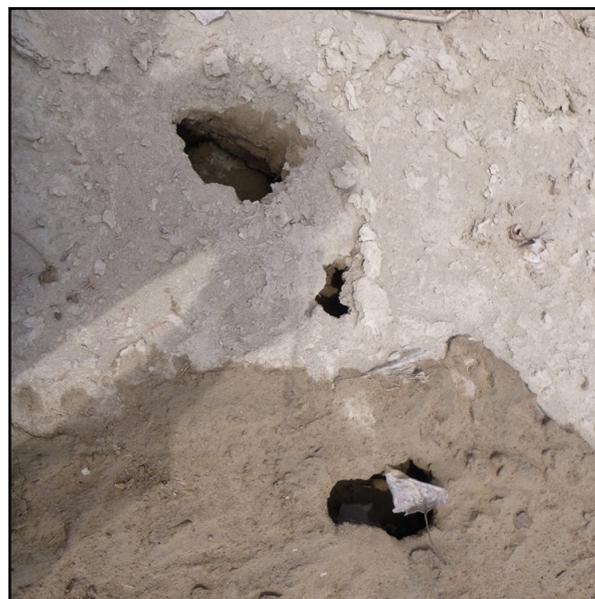
- a. Internal Erosion: Piping losses of soil were observed in numerous locations. Piping was evidenced by large voids and tunnels (pipes) within the bank soils. These pipes were oriented generally perpendicular to the slope but were somewhat serpentine.

Piping was observed in the restoration area at a greater frequency than in the unaltered, eroding bank upstream. This may have been caused by subtle differences in the soils along the treatment section, but more likely was the result of the upper treated bank being more stable and preventing collapse and covering up the pipes.

Photo 16– Holes created by collapsing pipe from internal erosion of the bank
