MONTANA DEPARTMENT OF TRANSPORTATION STREAM MITIGATION MONITORING REPORT

*Mill Creek
Ravalli County, Montana*

*Project Constructed: 2011
Monitoring Report #2: December, 2014*

STREAM MITIGATION MONITORING REPORT #2

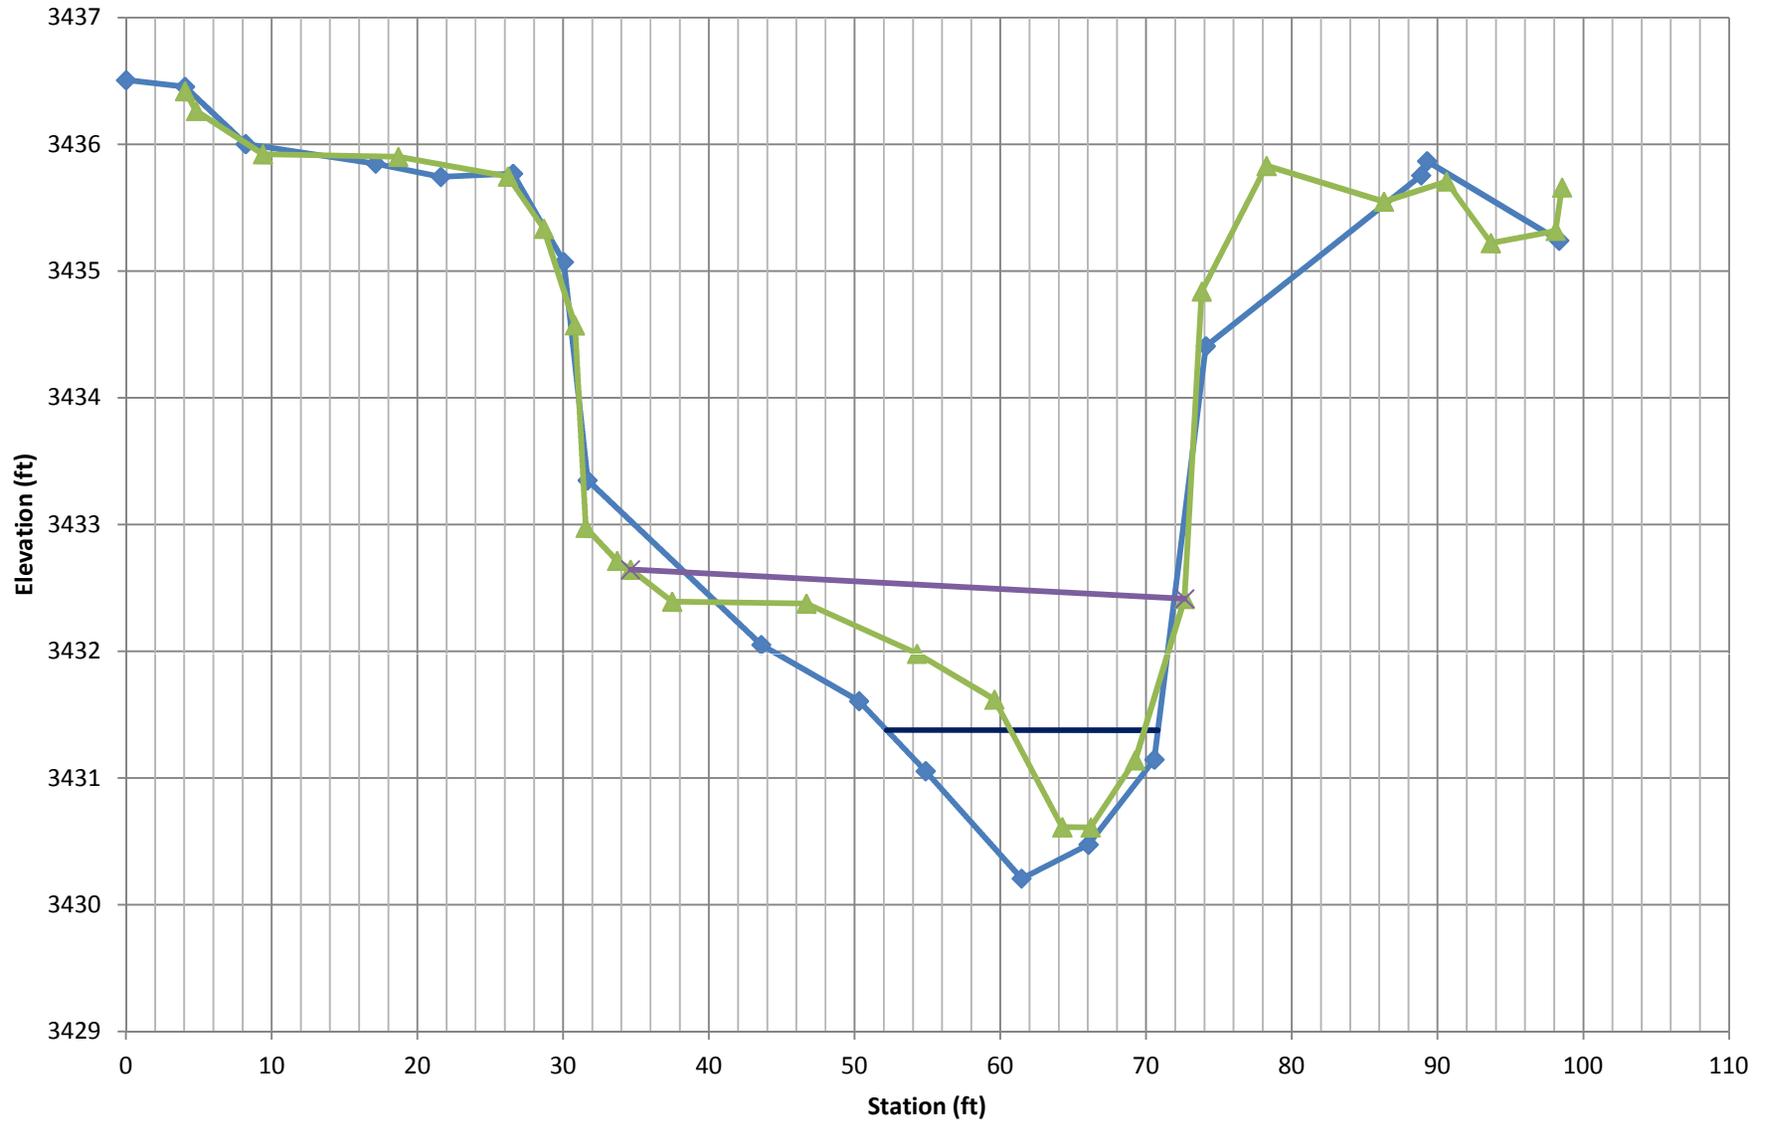
Mill Creek Transect #1 - Riffle

The channel at riffle transect #1 appears to be more indicative of a pool, with development of an adjacent point bar and thalweg along the right bank. Bank erosion was noted along this bank during the 2014 monitoring event, although the re-survey does not indicate significant lateral migration toward the south. Upstream of this transect, the channel has migrated northward (Eroding Bank 1-2), and the channel now appears to be creating a shallow pool along the right bank through transect #1. Inspection of the longitudinal profile indicates the bed at this transect occurs at a shallow pool (STA 140+00).

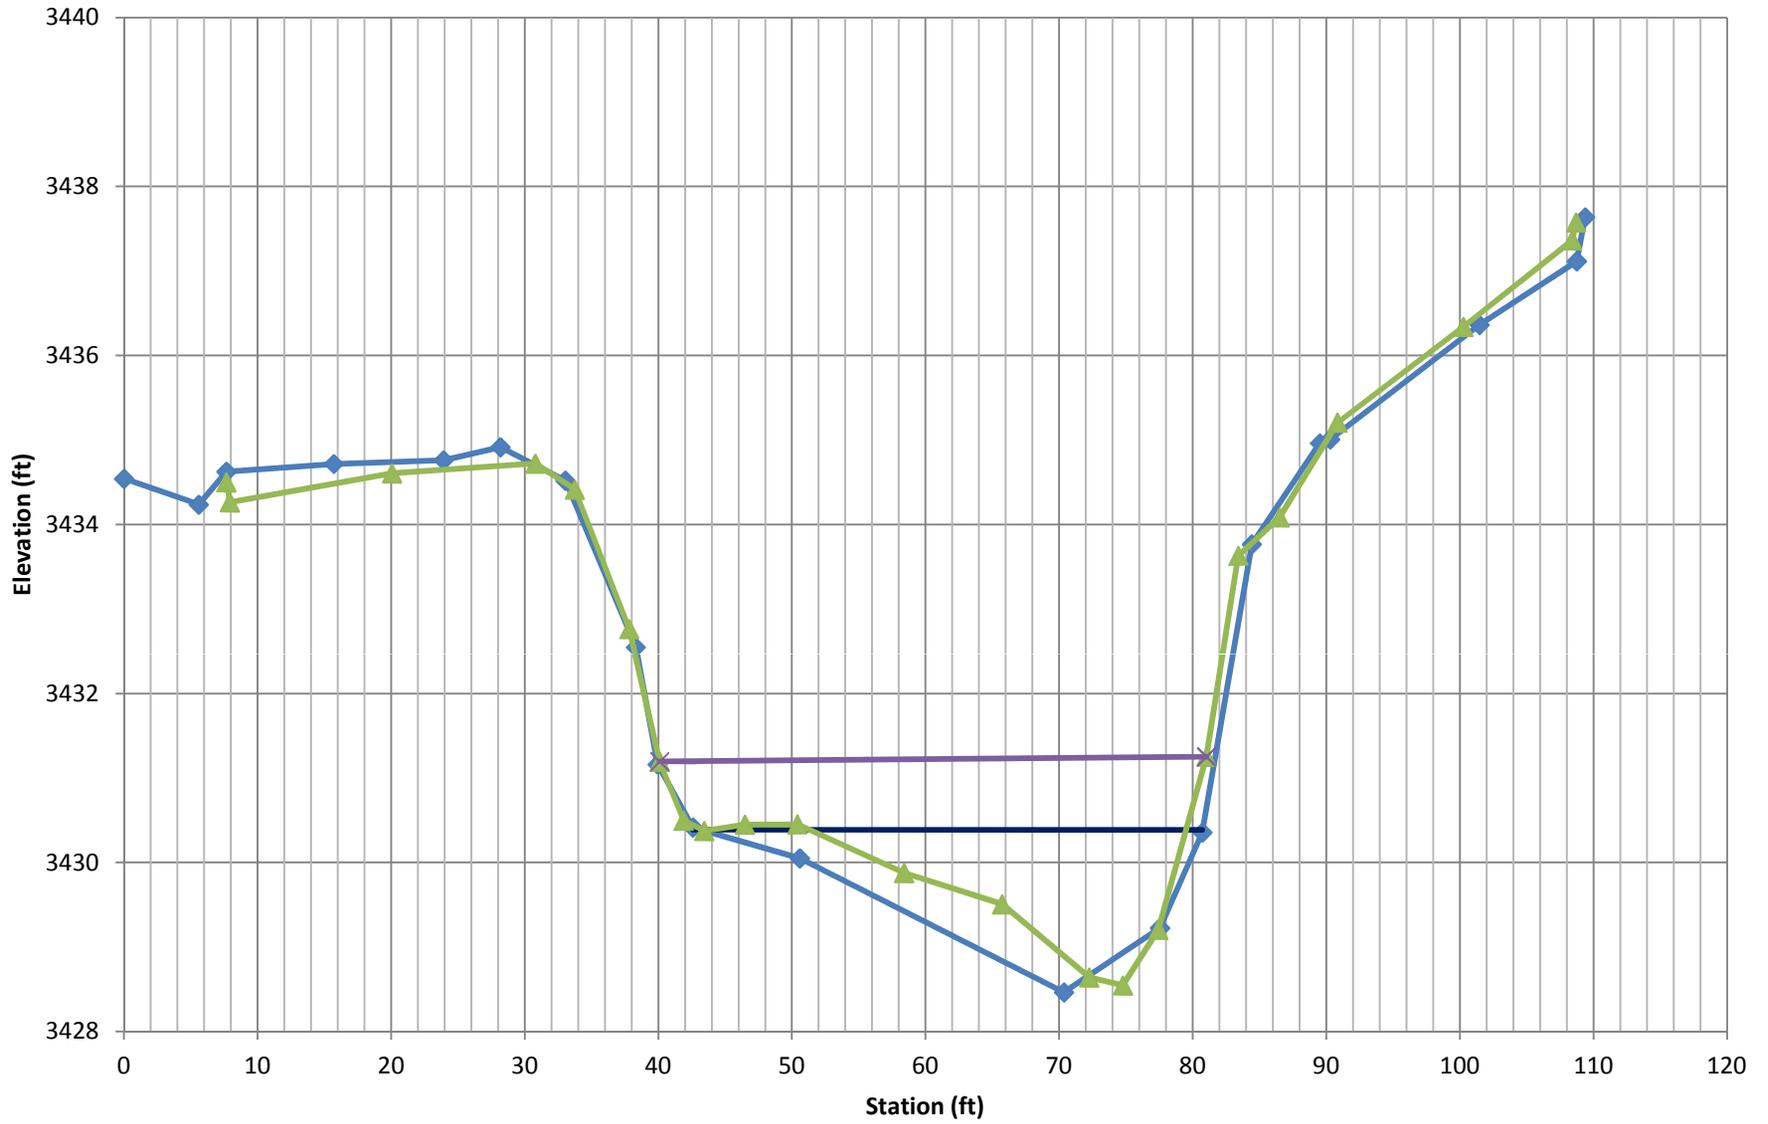
Mill Creek Transect #4 - Riffle

Riffle transect #4 occurs just above the last bend upstream of the U.S. Highway 93 Bridge. The re-survey at this transect indicated some deposition along the left (north) side of the channel with the thalweg along the right (south) bank. The stream bed does not appear to be aggrading, degrading, or laterally moving. Inspection of the longitudinal profile indicates the bed at this transect occurs at the downstream tail end of a pool (STA 500+00).

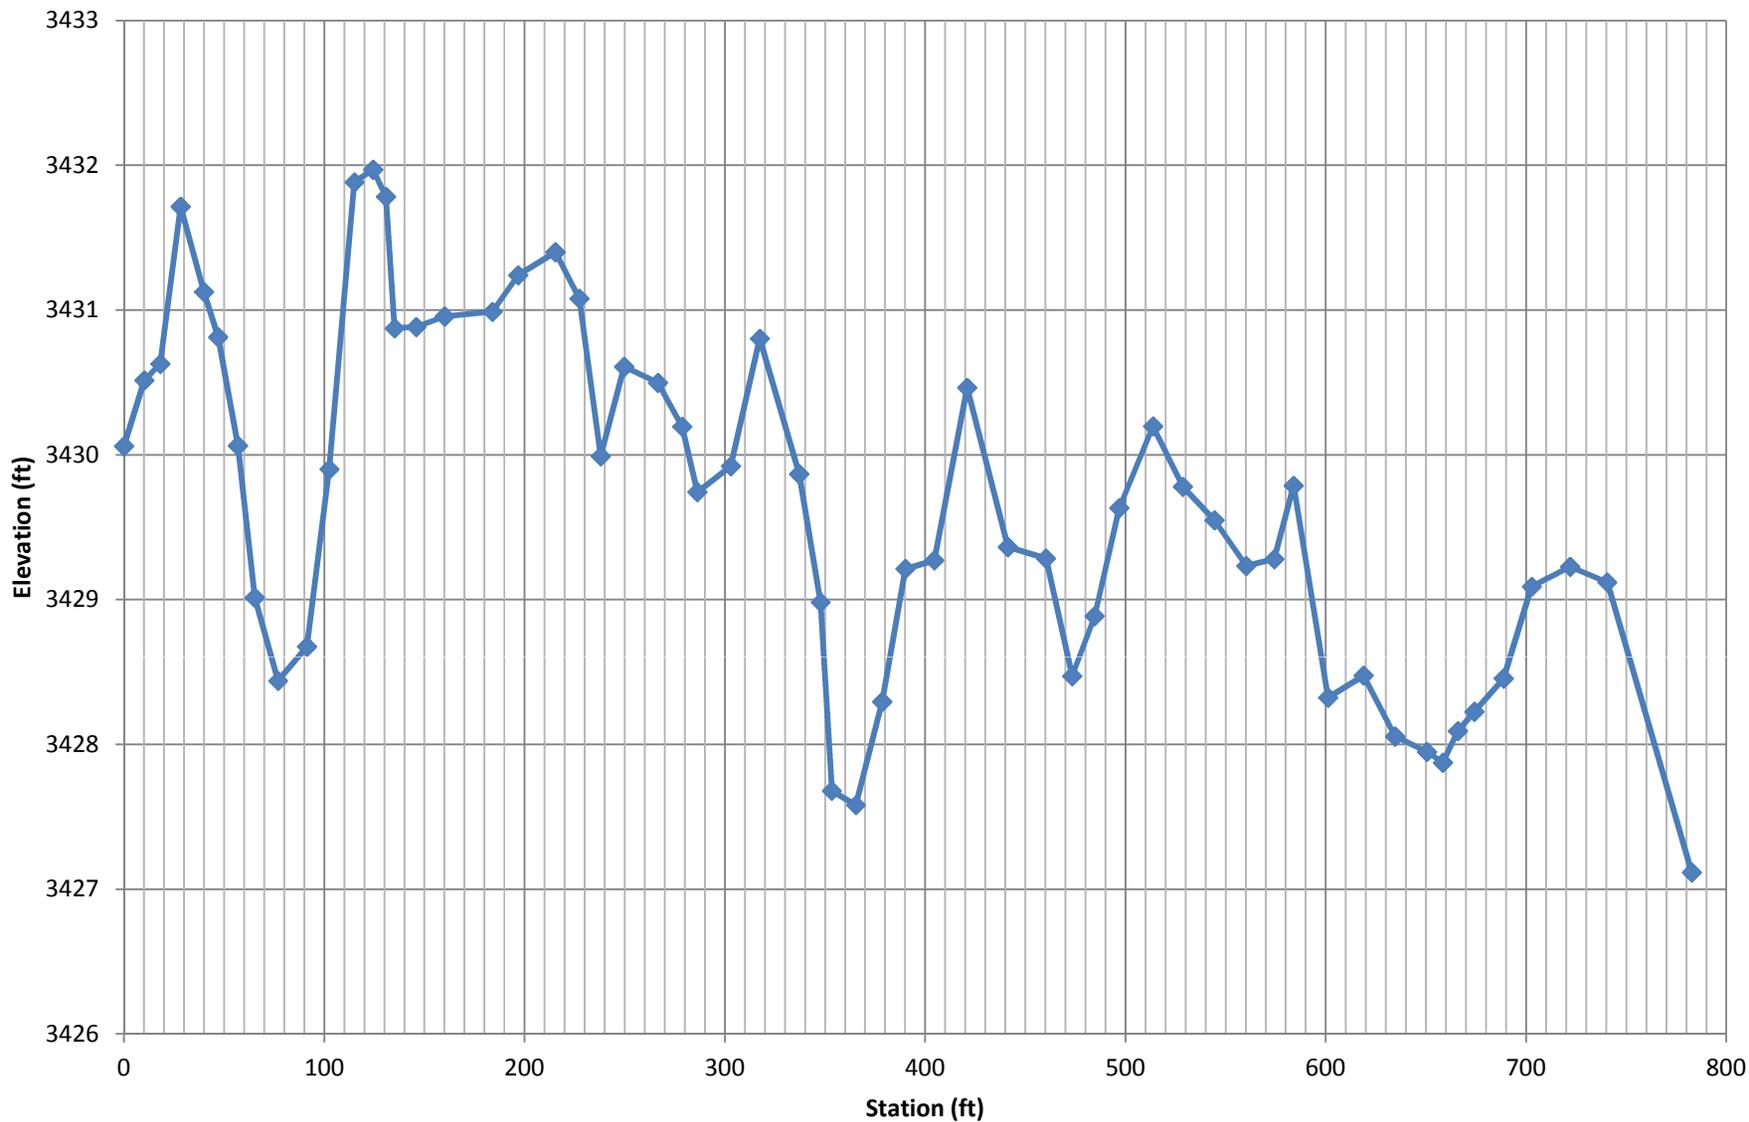
Mill Creek Longitudinal Profile

A longitudinal profile of the stream bed along the thalweg was surveyed to document bedform complexity and aquatic habitat conditions (Appendix B). The bed profile indicates the presence of two deep and multiple shallow pools separated by very short riffles. Shorter, shallower pools exist primarily between meander bends where woody debris is generating localized pool development. Two longer, deeper pools exist (from STA 30+00 to 120+00; and from 320+00 to 420+00) where the channel is scouring against the outside bank of the meander bends. The short riffle features are likely to move as subsequent high flow events continue to deposit and erode the channel, woody debris features migrate, and the channel shifts within its floodplain.

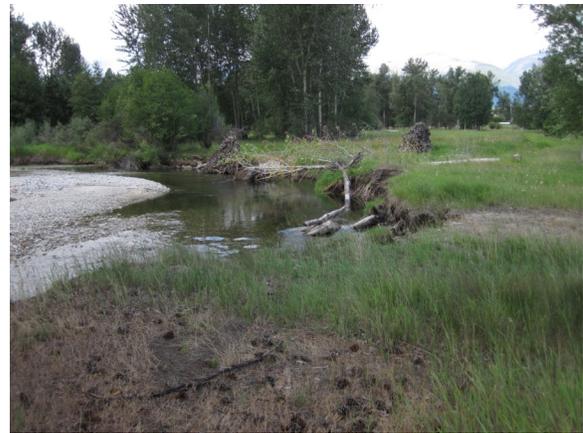
Photo Point 4.3—2014

Description: View of point bar formation from Photo Point 4. **Compass:** 225 (Southwest)

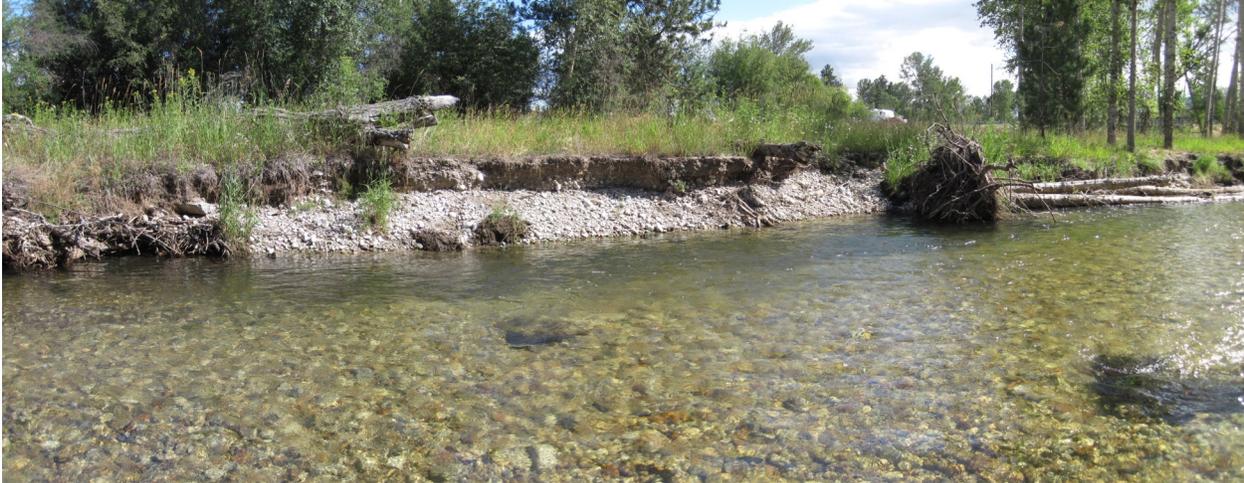
Erosion at EBL3 is occurring at the head of the former channel alignment, and extends downstream approximately 90 feet to beyond a newly fallen tree. Erosion is occurring along lower stream bank causing bank failure and retreat. The vegetation community consists of meadow foxtail, white and red clover, Kentucky blue-grass, common tansy, and ox-eye daisy. The bank has retreated approximately 1 to 2 feet since 2013. Based on the combination of erosion factors, severity of erosion along EBL3 is considered low.

Description: Upper section of Eroding Streambank L3 in 2014

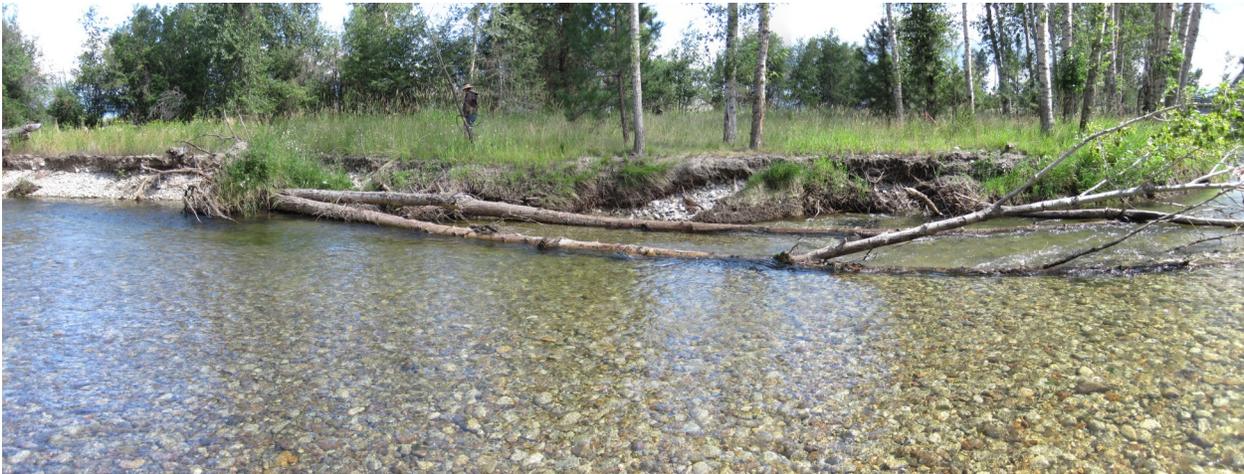
Description: Lower section of Eroding Streambank L3 in 2014

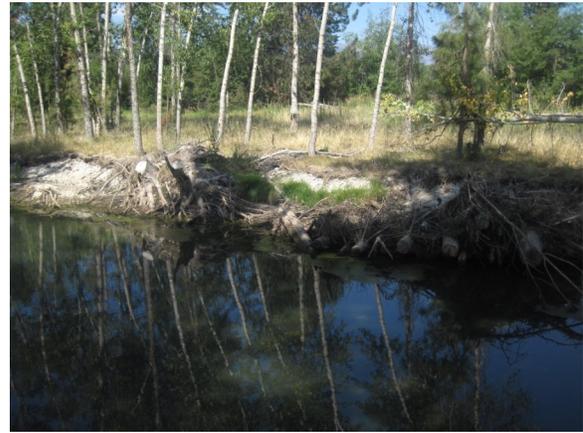
At eroding bank EBL4, bank sloughing has continued to occur upstream and downstream of root balls that have fallen into the channel. The 64-foot long eroding bank has several root balls from cut trees along the toe, which may have been used to construct the log revetment just downstream. Bank instability at this location is potentially caused by removal of the trees for use in log revetment construction, or from natural channel adjustments following construction. The dominant vegetation along the bank includes reed canary grass and smooth brome. The bank has retreated approximately 1 to 2 feet since 2013, and is considered low to moderate in severity.

Description: Eroding streambank L4 in 2013.

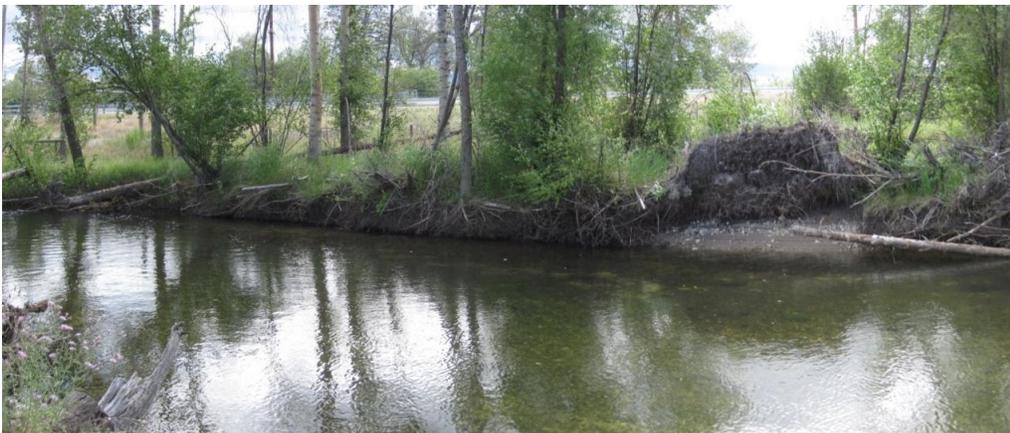
At eroding bank EBR1, several trees have fallen into the channel due to undercutting directly across the channel from EBL4. Trees have also fallen away from the channel, providing evidence of undercutting and block failure, or blow down. The bank appeared more stable during the 2014 monitoring event than in 2013. The vegetation community along this bank consists of cottonwood, alder, smooth brome, and birch. Bank erosion severity along this 58-foot segment is considered low.

Description: Eroding streambank R1 in 2014.

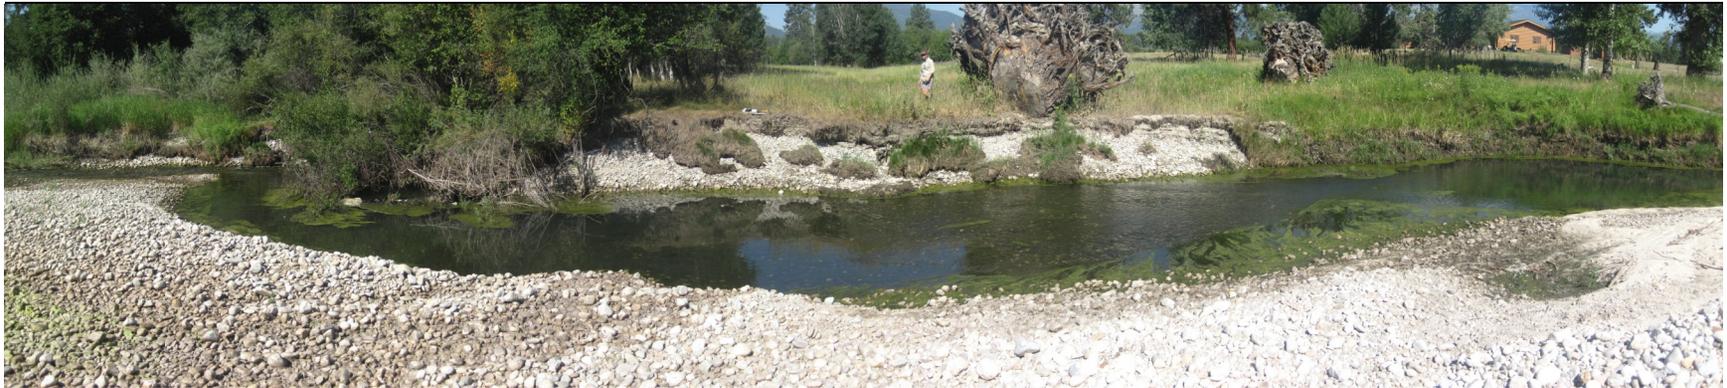
Description: Eroding Streambank L1 in 2013.

Two eroding banks identified during the 2013 monitoring event have combined into one long, eroding bank immediately upstream of the project reach (EBL1 and EBL2). Although these banks lie outside of the relocated channel segment, they were noted

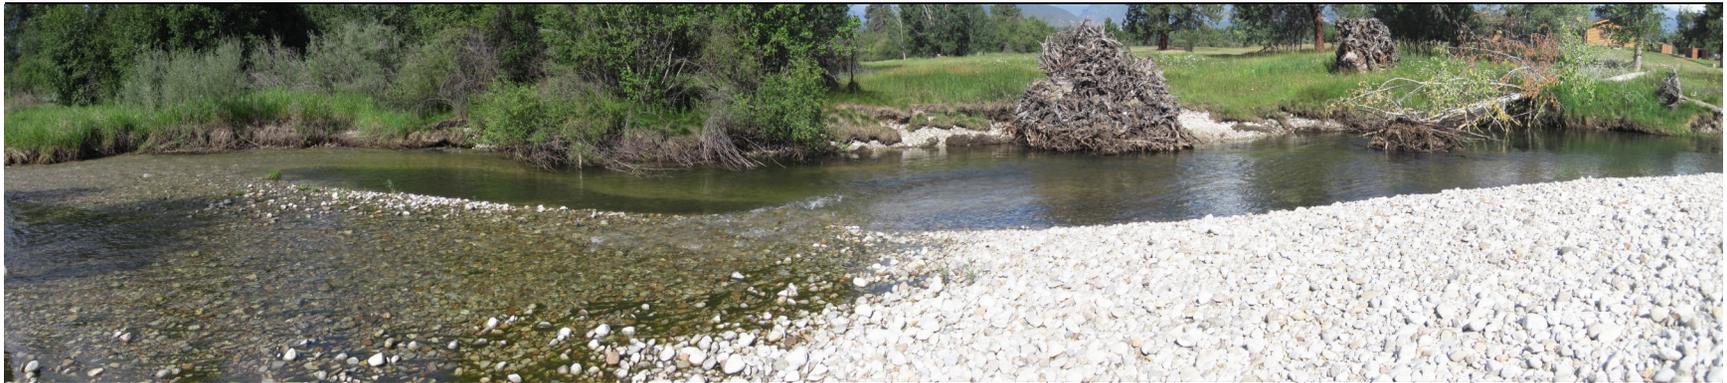
Description: Eroding streambank L1 in 2014.

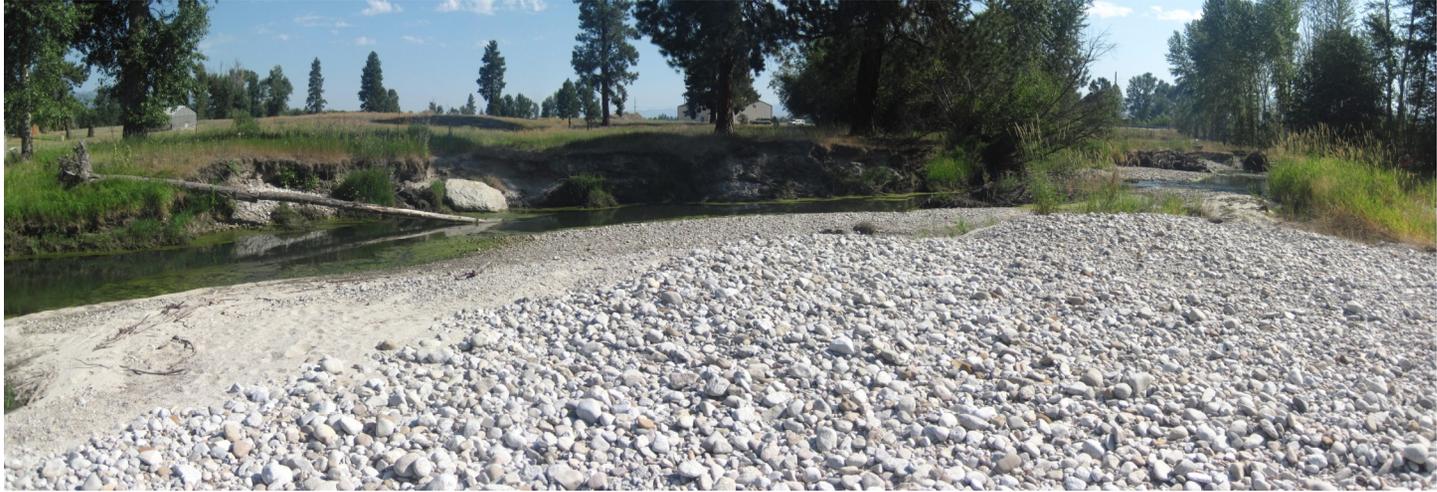
Description: Eroding Streambank L2 in 2013.

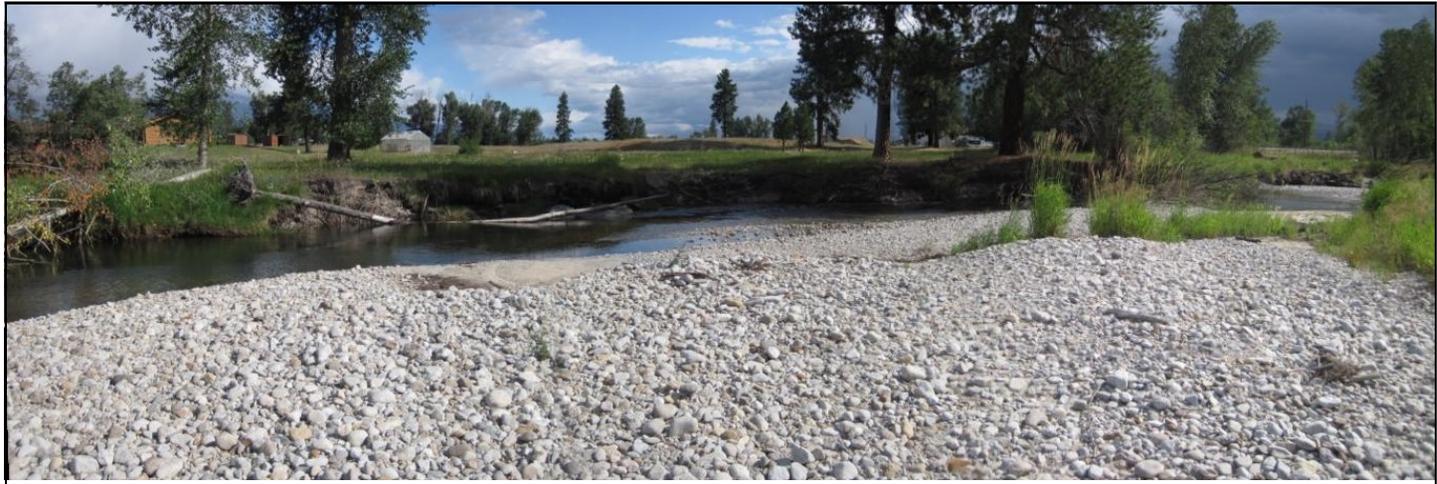
Description: Eroding Streambank L2 in 2014.
