MONTANA DEPARTMENT OF TRANSPORTATION STREAM MITIGATION MONITORING REPORT

STREAM MITIGATION MONITORING REPORT #3

*Spring Creek
Flathead County, Montana*

MDT Project Number: NH-MT 5-3(59) 109
Control Number: 2038

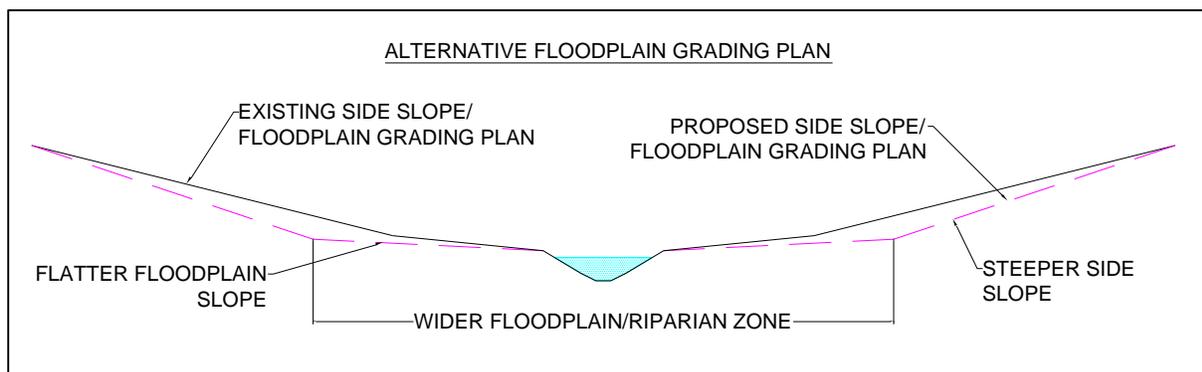
Figure 2. Alternative grading plan to increase floodplain and riparian areas.

The reconstructed channel segment of Spring Creek is designed with upland side slopes that transition to a narrow, 17.5-foot wide floodplain bench. Perpendicular transect survey results (Appendix B) illustrate floodplain slopes down to the channel which reduces the area available for overbank flooding to a narrow zone adjacent to the channel. This design configuration results in a relatively limited riparian/floodplain zone approximately three times wider than the active channel. Integrating a slightly steeper upland side slope design would provide for a wider, more functional floodplain and riparian zone by allowing the stream to access a larger, flat floodplain adjacent to the active channel (Figure 2). Constructing steeper side slopes and a wider floodplain area requires additional excavation; therefore a cost/benefit analysis of creating additional floodplain and wetland features, and the associated mitigation credits, is potentially worth consideration for future stream and riparian mitigation designs.

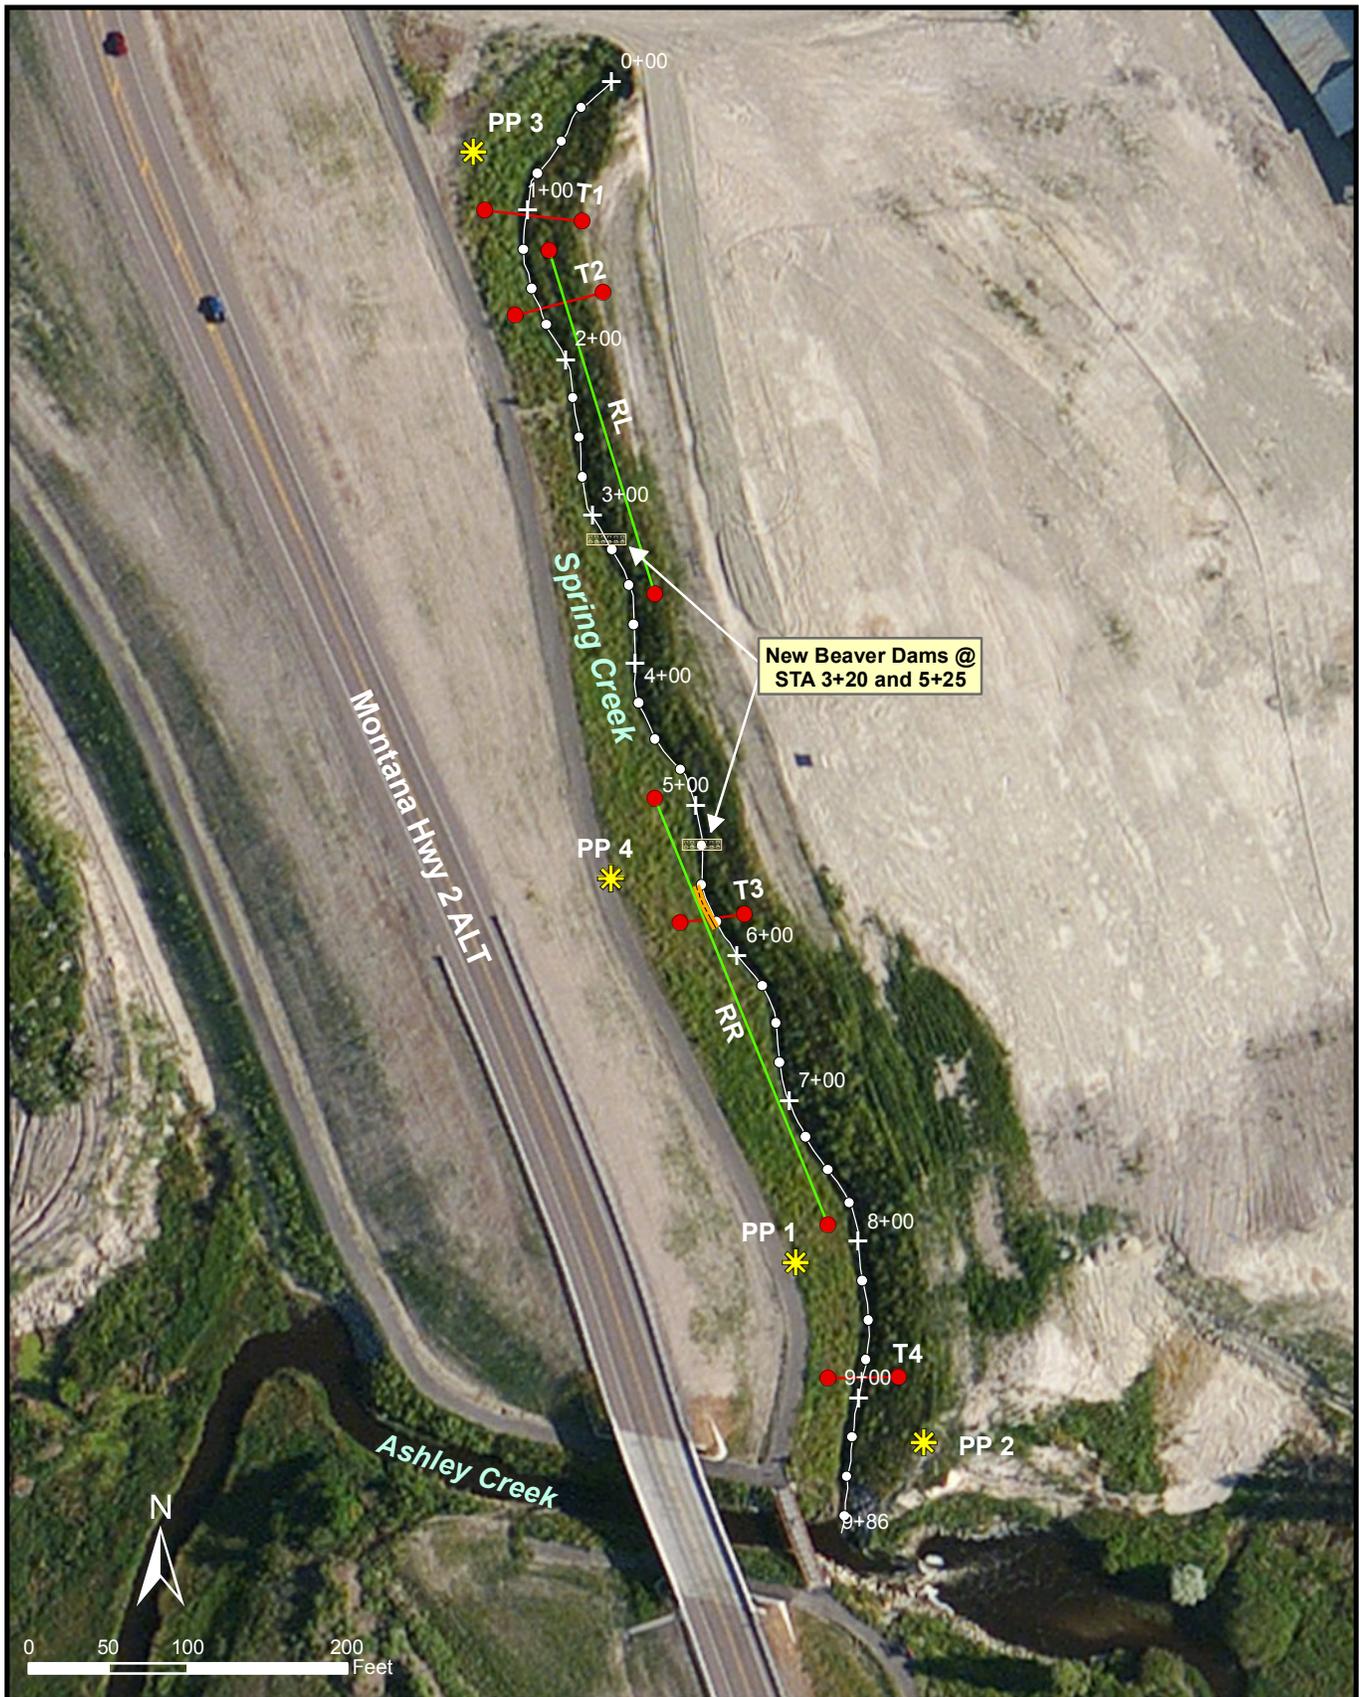
Spring Creek - 2015 Monitoring Features
Figure 3
Date: 10/12/2015
<i>Spring_features2015.mxd</i>

Bank erosion was observed along one 30-foot long segment of the constructed channel (Figure 3, Appendix A). The bank has retreated approximately 1-2 feet since it was constructed. Wooden stakes used to pin coir logs remain in the channel, indicating the original extent of the bank at this location. The channel along this bank segment remains relatively densely vegetated with reed canary grass (*Phalaris arundinacea*), with lesser cover provided by Maximilian sunflower (*Helianthus maximiliani*) and Canadian thistle (*Cirsium arvense*). No floodplain exists to the west of the channel, and the adjacent area is a sloped embankment that extends upward to the bike path to the west of the creek. The erosion occurred approximately 30 feet downstream from one of the two beaver dams; however, the dam did not appear to be the primary cause of erosion. The bio-degradation of coir logs installed along the banks appears to have left a void in the bank at this location.

New Beaver Dams @ STA 3+20 and 5+25

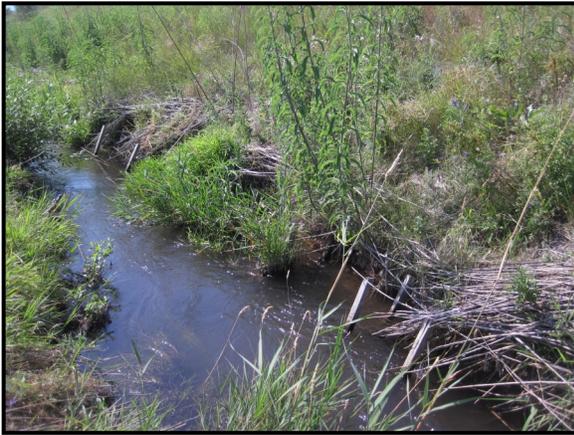
The stream bank inventory identified one 30-foot long eroding bank segment that has retreated approximately 1-2 feet since the project was constructed. This bank segment represents less than 2% of the overall bank length of 1,990 feet. Erosion at this location appears as a result of decay of the coir logs used to construct the channel, and the lack of a stable bank forming in its absence. Due to the relatively short eroding bank segment and the establishment of stable vegetation along the bank, corrective actions are not warranted. Performance criteria for the site allow for up to 25% of the stream banks to indicate signs of erosion or instability; as a result, the performance criterion for stream bank stability is currently being met.

Additional Photo 2 - 2015
Description: Eroding Bank EBR1
Compass: 180 (South)

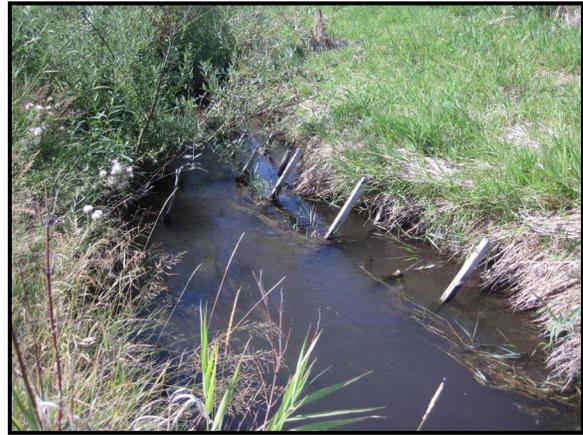
Additional Photo 3 - 2015
Description: Evidence of bank retreat
Compass: 225 (Southwest)

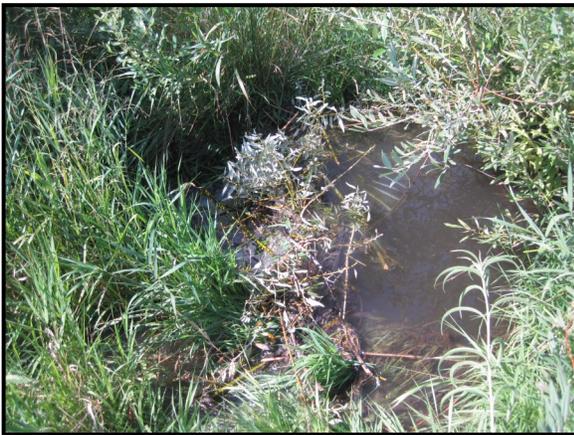
Habitat variability appears to be improving over time as the stands of willows provide habitat for beavers. Two small beaver dams were observed in the creek during the 2015 monitoring event, which are generating small backwater pools. These pools may expand depending on continued use of the Spring Creek channel by beavers.

Additional Photo 4 - 2015
Description: Small beaver dam observed in Spring Creek

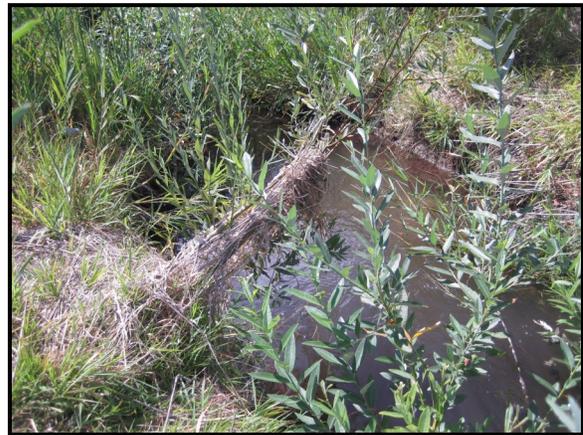
Additional Photo 5 - 2015
Description: Evidence of high flows - flood debris above banks
