MONTANA DEPARTMENT OF TRANSPORTATION STREAM MONITORING REPORT

*Little Rock Creek at Judith Slide Repair
Fergus County, Montana*

*Project Completed: 2013
Monitoring Report #4: December, 2017*

MDT Project Number: STPS 426-2(12) 15
Control Number: 7726000

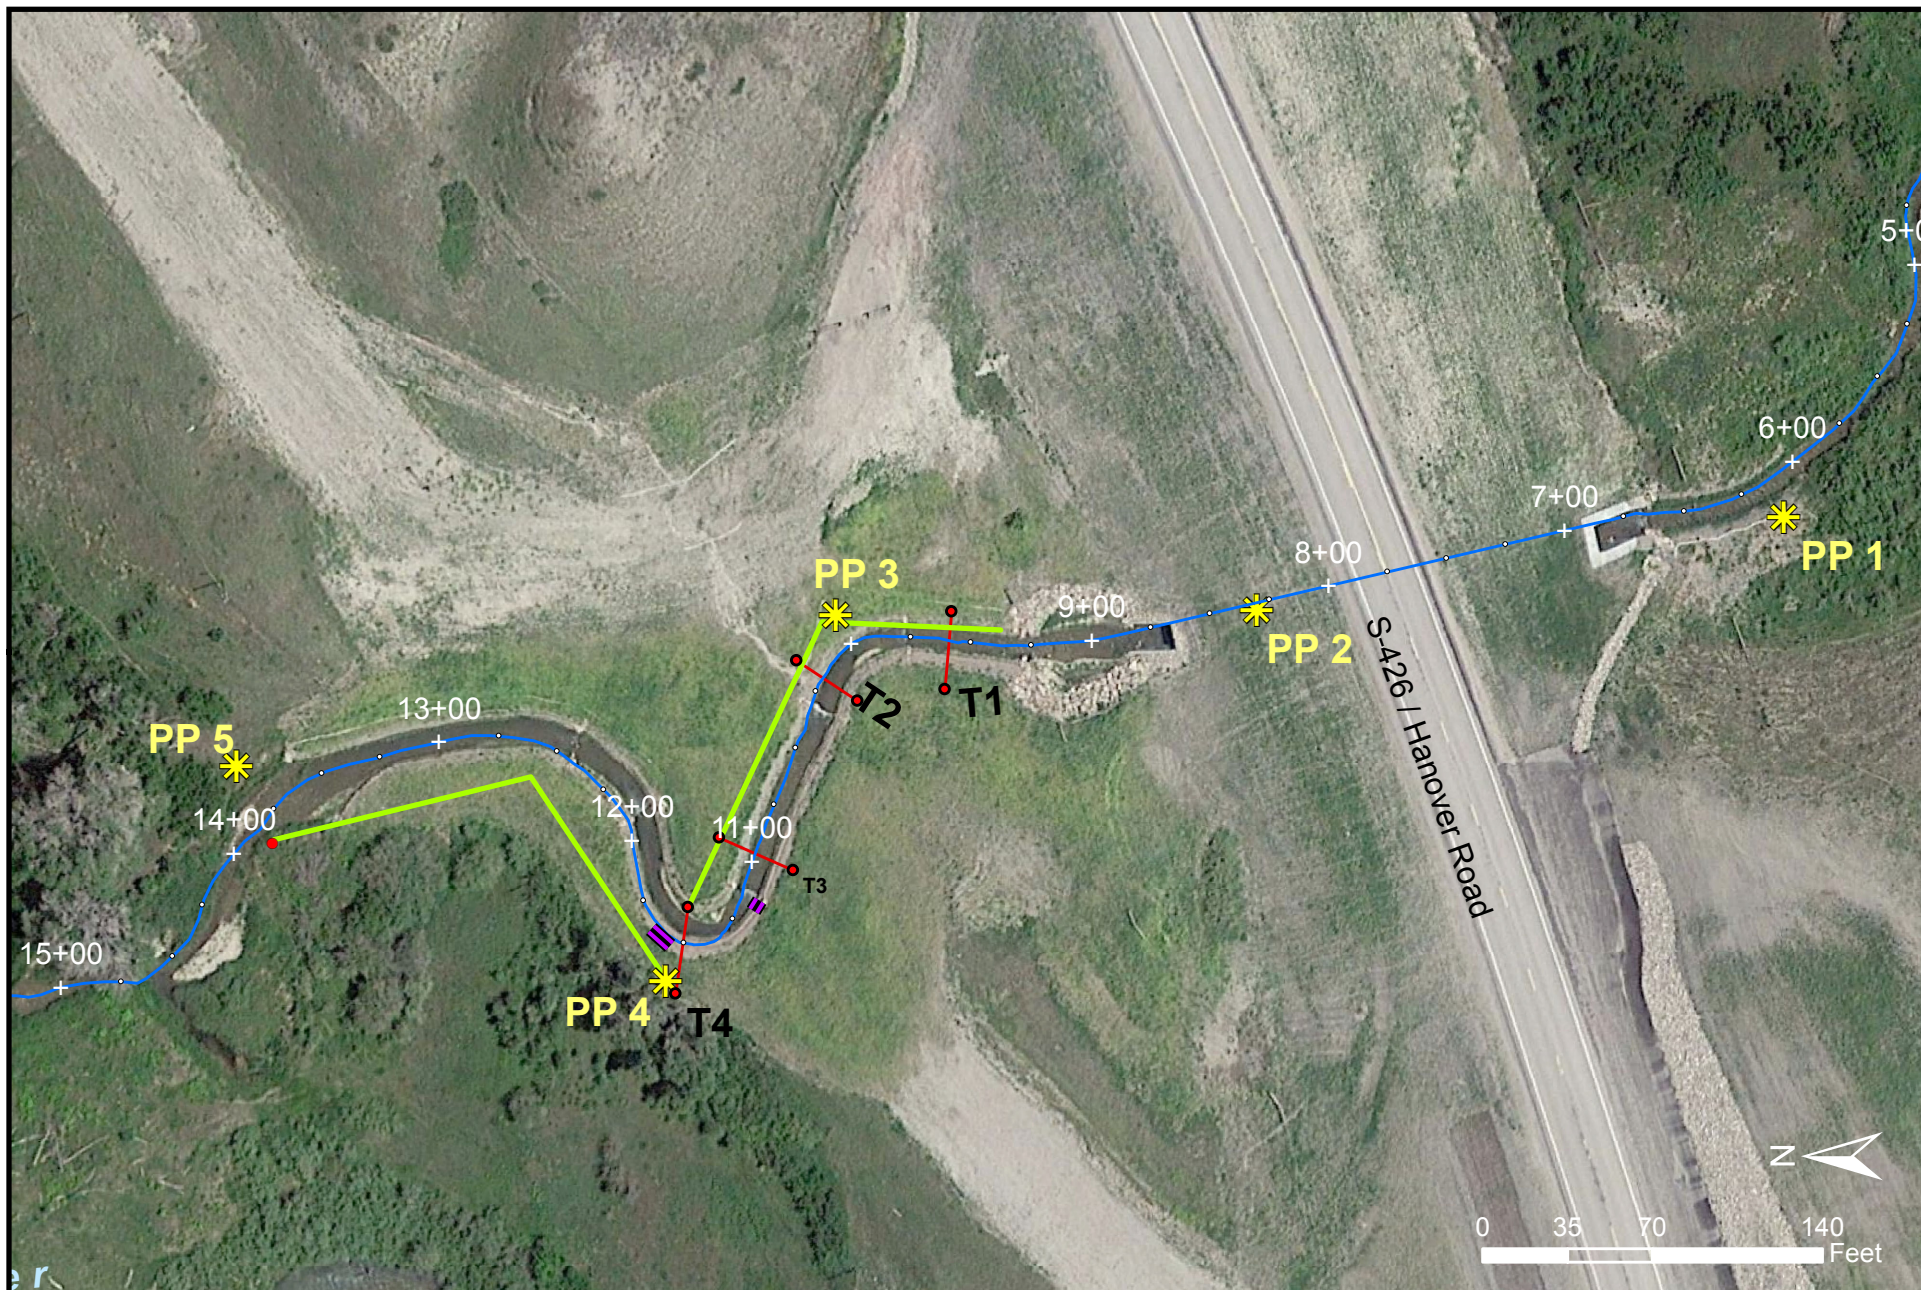
In 2017, two eroding banks totaling 26 feet were observed along Little Rock Creek (See Figure 3 in Appendix A). A 20-foot segment along the left bank between Station 11+60 and 11+80 was originally observed in 2015, and has continued to undercut and erode beneath the coir fabric lifts (see additional photo 2 in Appendix C). The coir logs installed along this bank have slumped and fallen into the void created by this undercutting formation while the lower bank has become established with vegetation. Erosion along this bank segment has been consistently observed for the past three years and does not appear to be lengthening or causing damage to downstream reaches of the reconstructed stream channel. The undercutting beneath the coir lifts is caused by the relatively sharp bend and scour forces acting upon the stream bed. While this bank has exhibited signs of instability for the past three years, it provides good aquatic habitat and cover for fish which are likely utilizing this undercut bank. No corrective actions are warranted along the eroding bank.

A short, 6-foot eroding bank segment was observed in 2017 just downstream from one of the rock plunge pool structures installed at Station 11+20 (see additional photo 3 in Appendix C). Erosion along this bank appears due to the dynamic hydraulics at play in the vicinity of the rock plunge pool structure, which has resulted in a short segment of coir lift separating from the bank. The eroding bank segment remains relatively short and as a result, no corrective actions are necessary at this time.

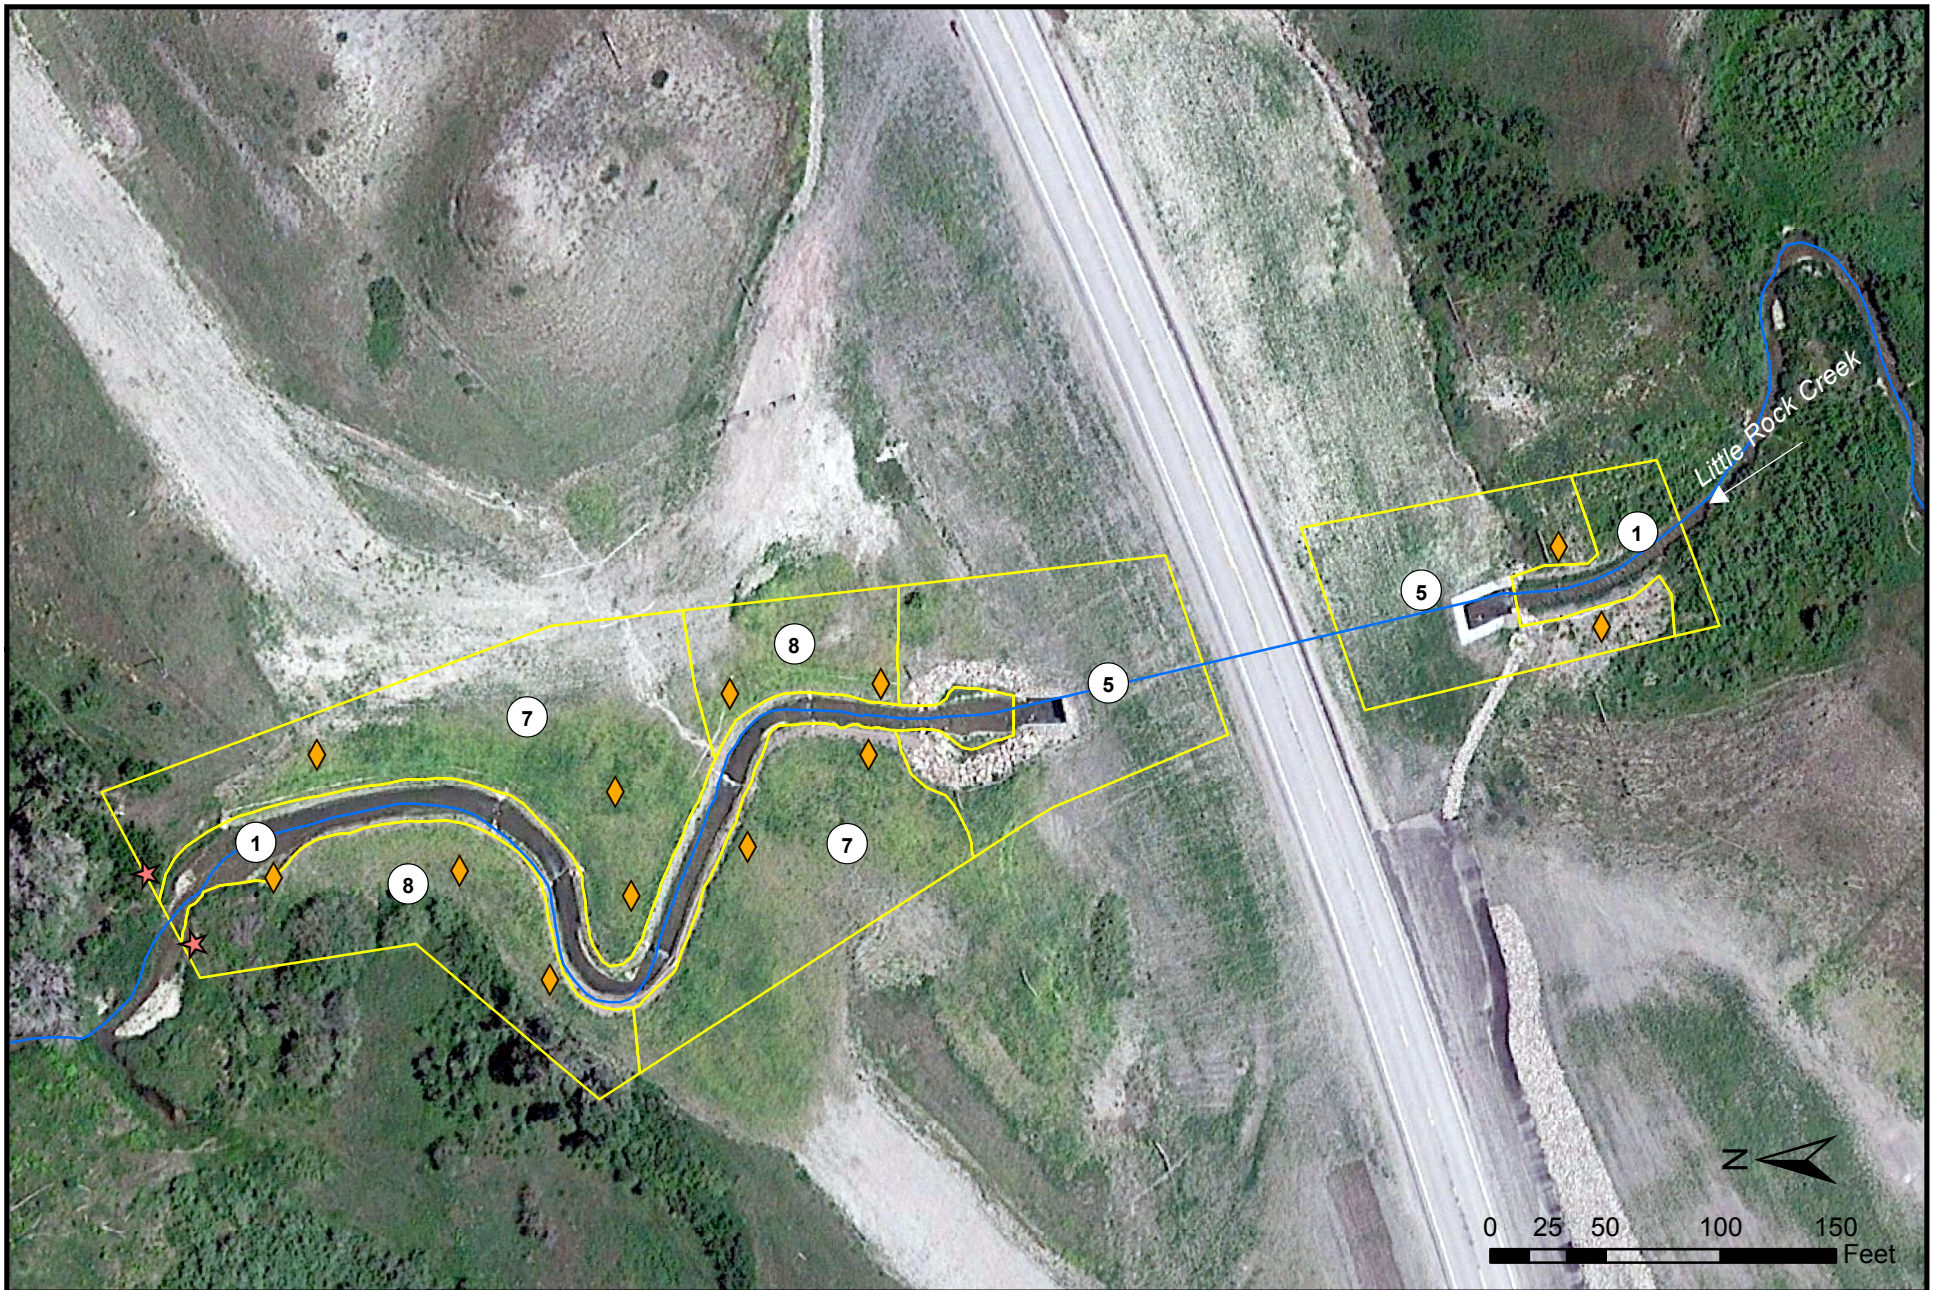
Four Montana State-listed noxious weeds were observed within the reconstructed segment of Little Rock Creek in 2017 (Table 7). Canada thistle (*Cirsium arvense*) and leafy spurge (*Euphorbia esula*) infestations, identified as trace to low cover classes on site, are shown on Figure 4 in Appendix A. Houndstongue (*Cynoglossum officinale*)

and field bindweed were observed as isolated occurrences, and were therefore not mapped on Figure 4. The combined areal cover of all four noxious weed species identified in 2017 was estimated at 5%. The increase in noxious weeds was observed in both riparian and stream bank areas. Infestations of noxious weeds were observed just outside of the project site during the 2013 monitoring event, which may have offered a seed source for establishment of weeds within the site. The percent cover estimates recorded for all vegetation categories, including noxious weeds, may have been influenced by a combination of factors, including, but not limited to, adjacent land management, previous herbicide applications, differences in annual precipitation and temperature, calibration training completed by field staff, and other unknown factors that make it difficult to determine the exact cause(s) for increases or decreases in coverage.

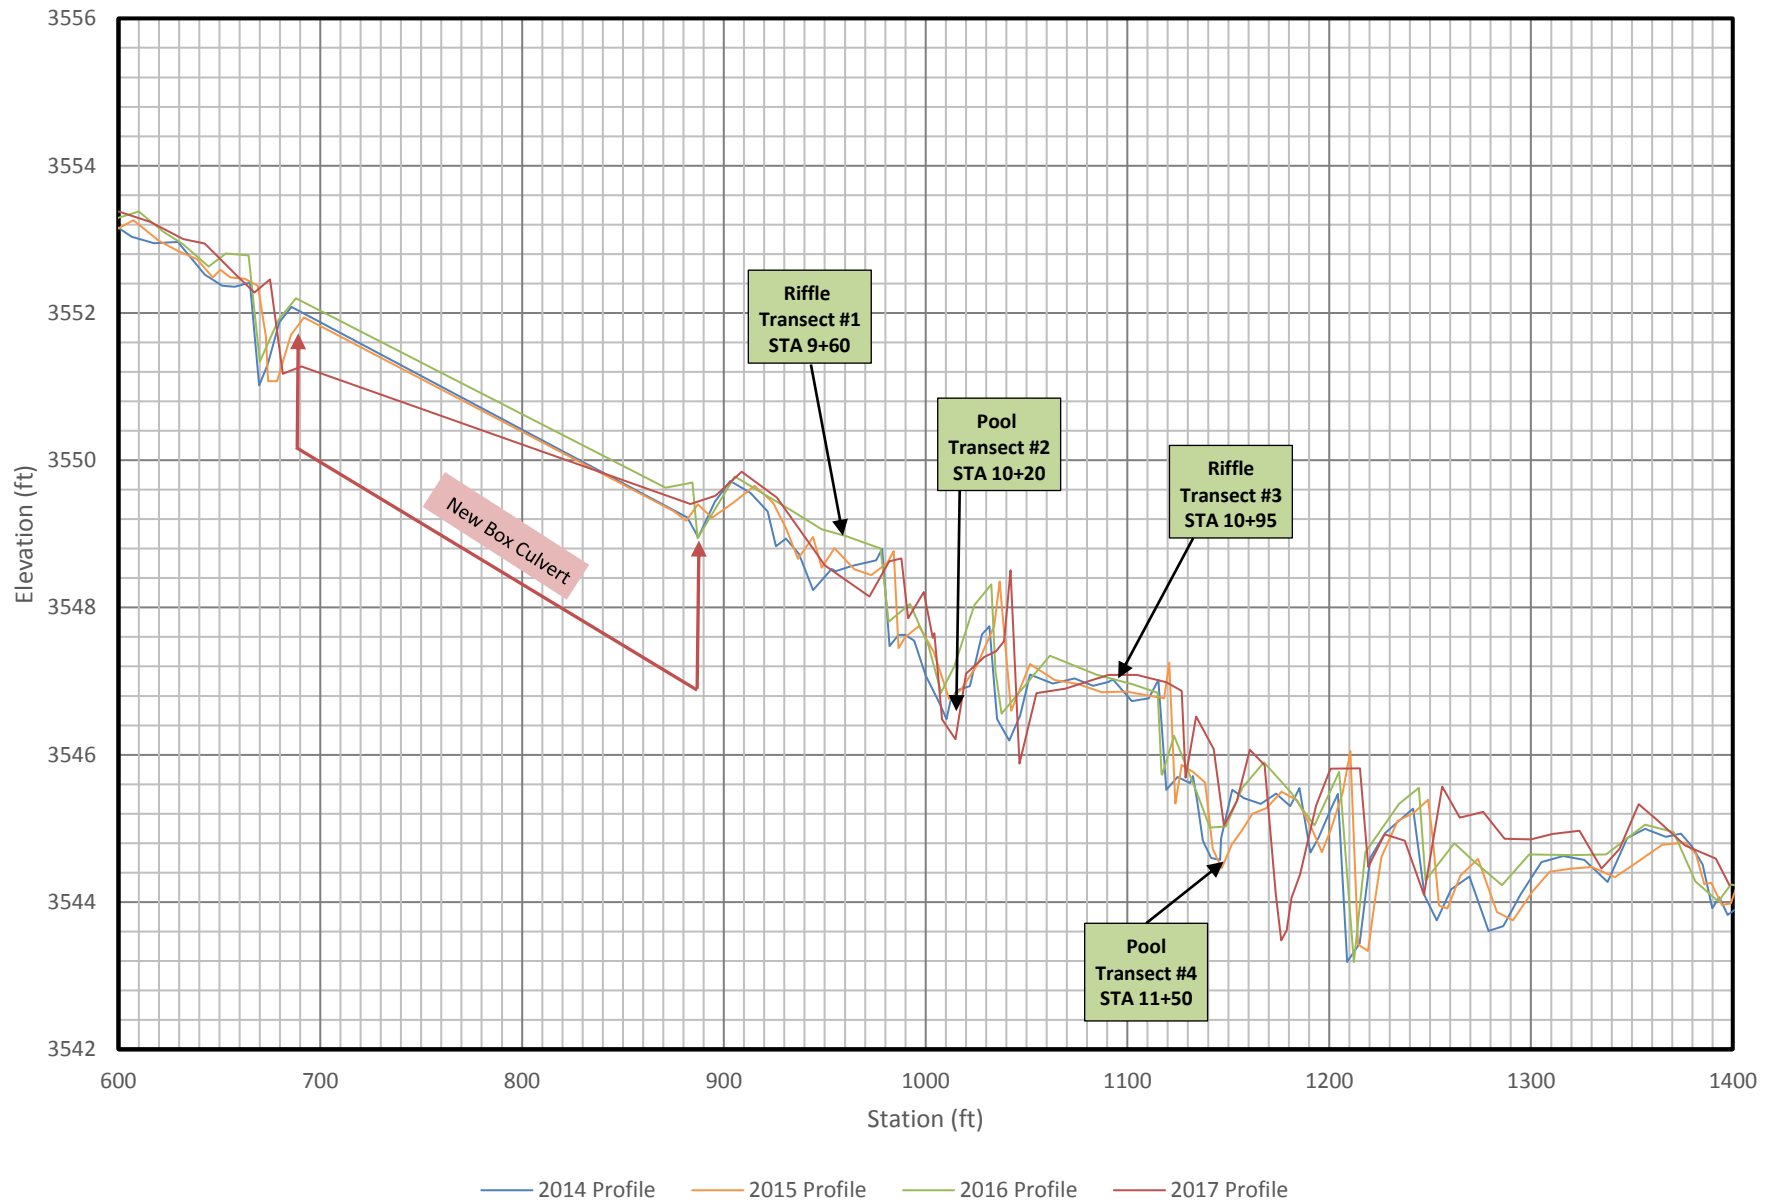
Judith Slide Longitudinal Profile of Reconstructed Channel Segment: 2014 - 2017

not indicate signs of widespread aggradation or degradation, and the channel appears vertically stable four years after its construction.

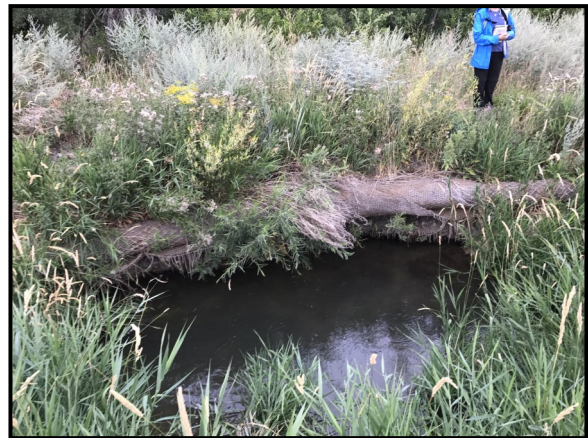
Additional Photo 2: 2017

Description: Undercut beneath coir fabric stretching along eroding bank.

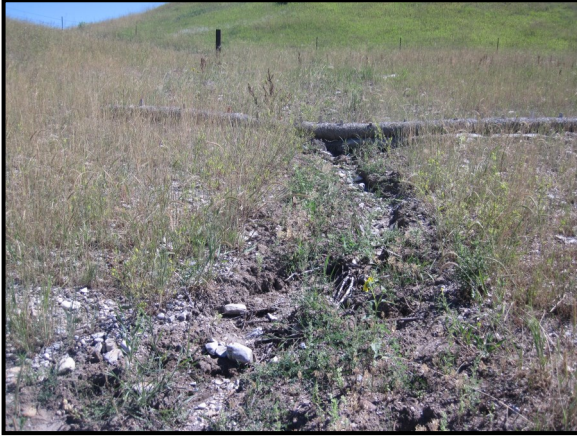
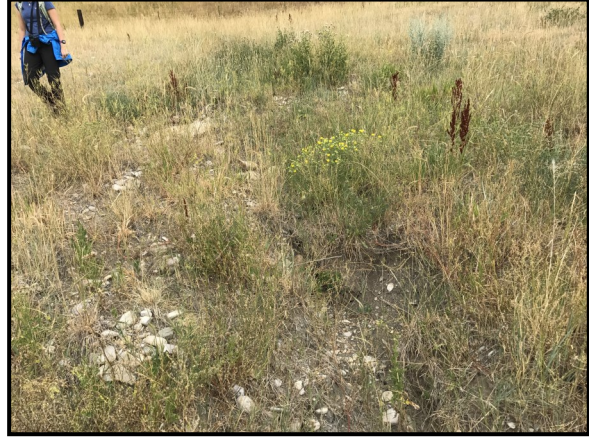
10. Formation of a small gully to the east of the newly constructed channel was noted in 2015. This gully formation appeared to be the result of a seep and surface water runoff flowing across the eastern side of the project reach. Vegetation has matured along the length of the gully, and appears to have stabilized the small gully formation noted during earlier monitoring events.

Additional Photo 5: Gully identified along east site of reconstructed channel
