# MONTANA DEPARTMENT OF TRANSPORTATION STREAM MITIGATION MONITORING REPORT

*Year Project Completed: 2011  
Monitoring Report #5: December, 2017*

## **STREAM MITIGATION MONITORING REPORT #5**

MDT Project Number: NH 7-1(114)59  
Control Number: CN 2015004

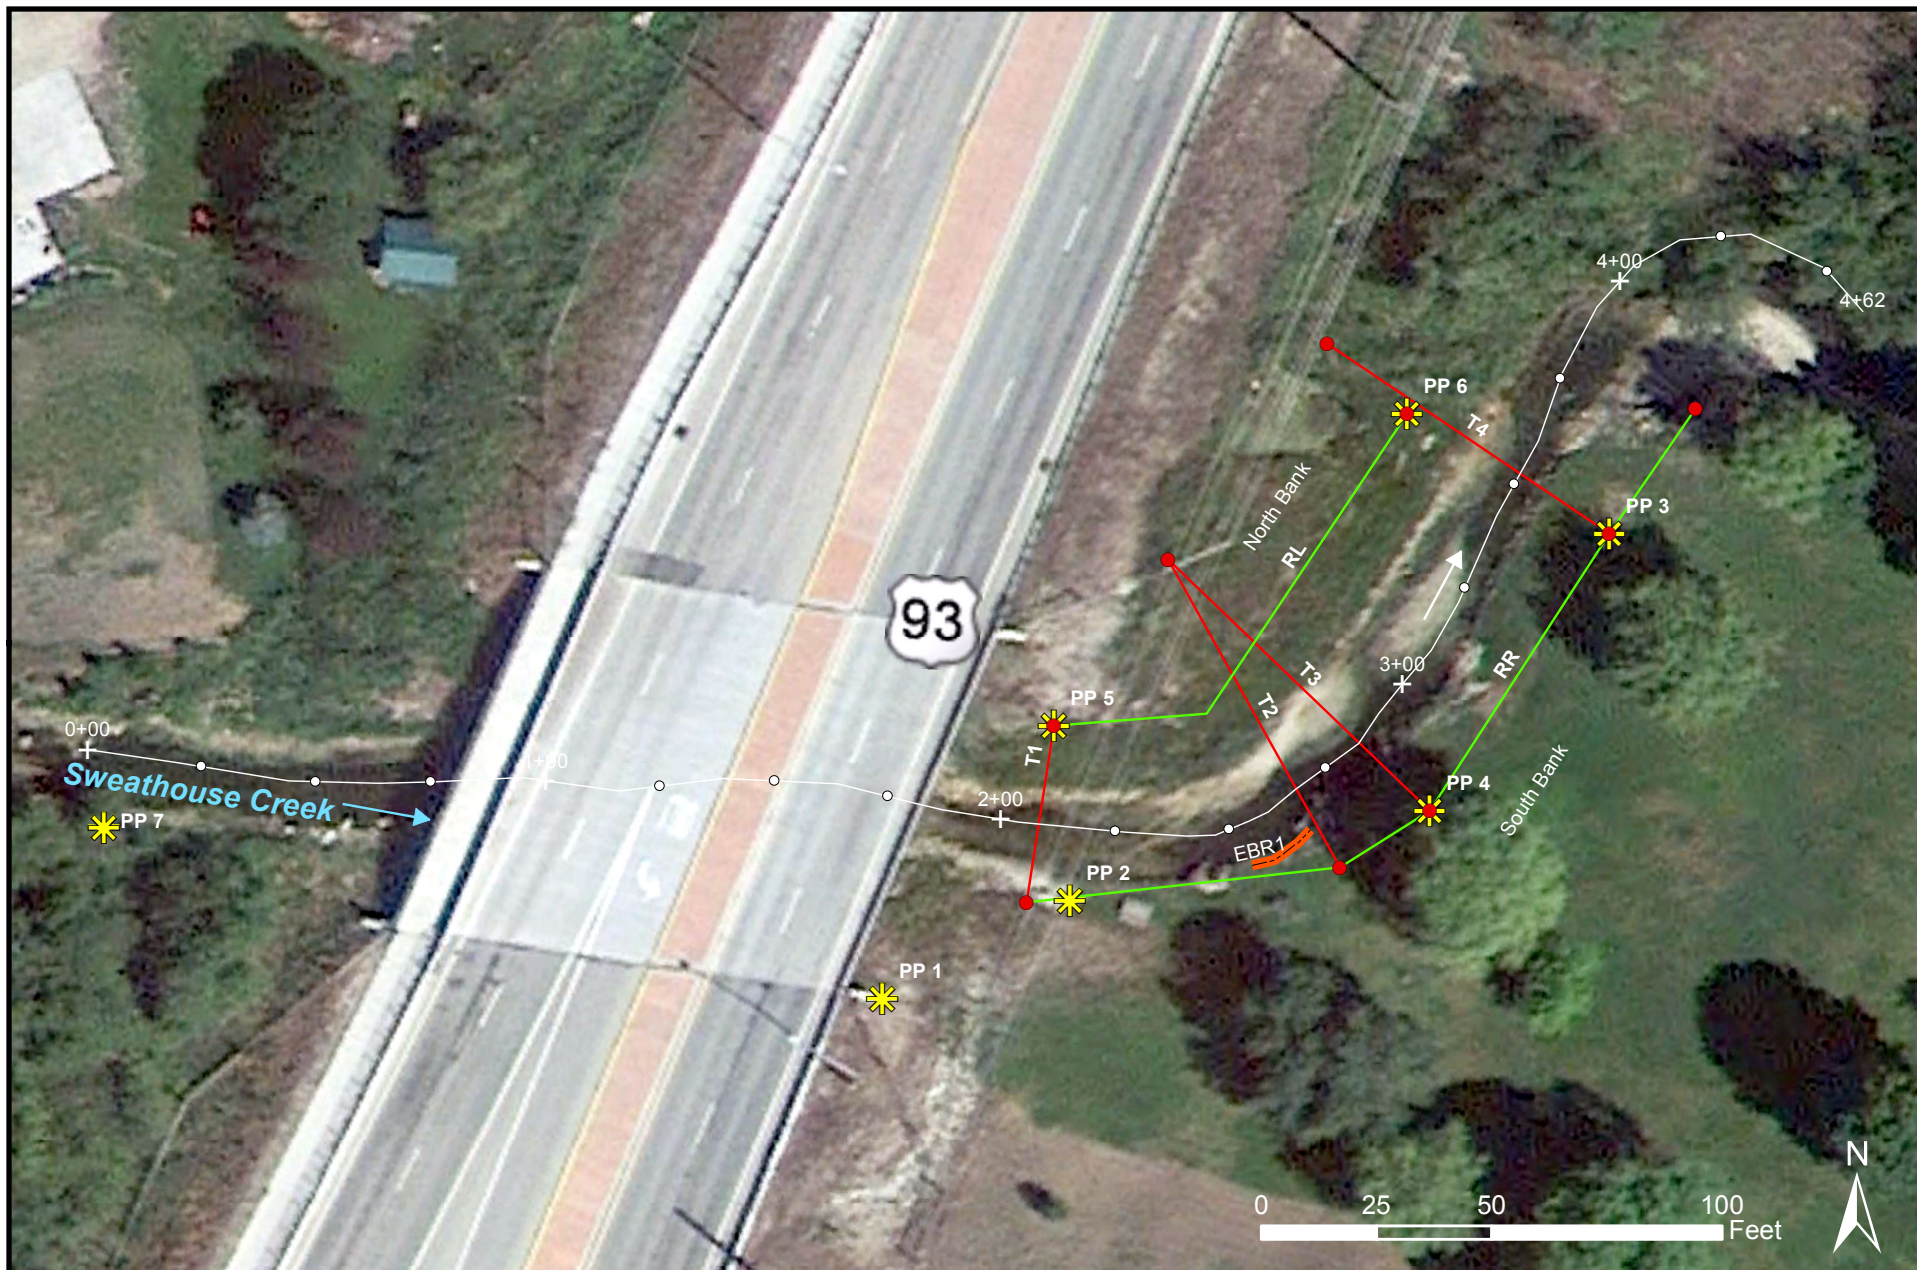
Figure 2

## 2017 Monitoring Features Sweathouse Creek

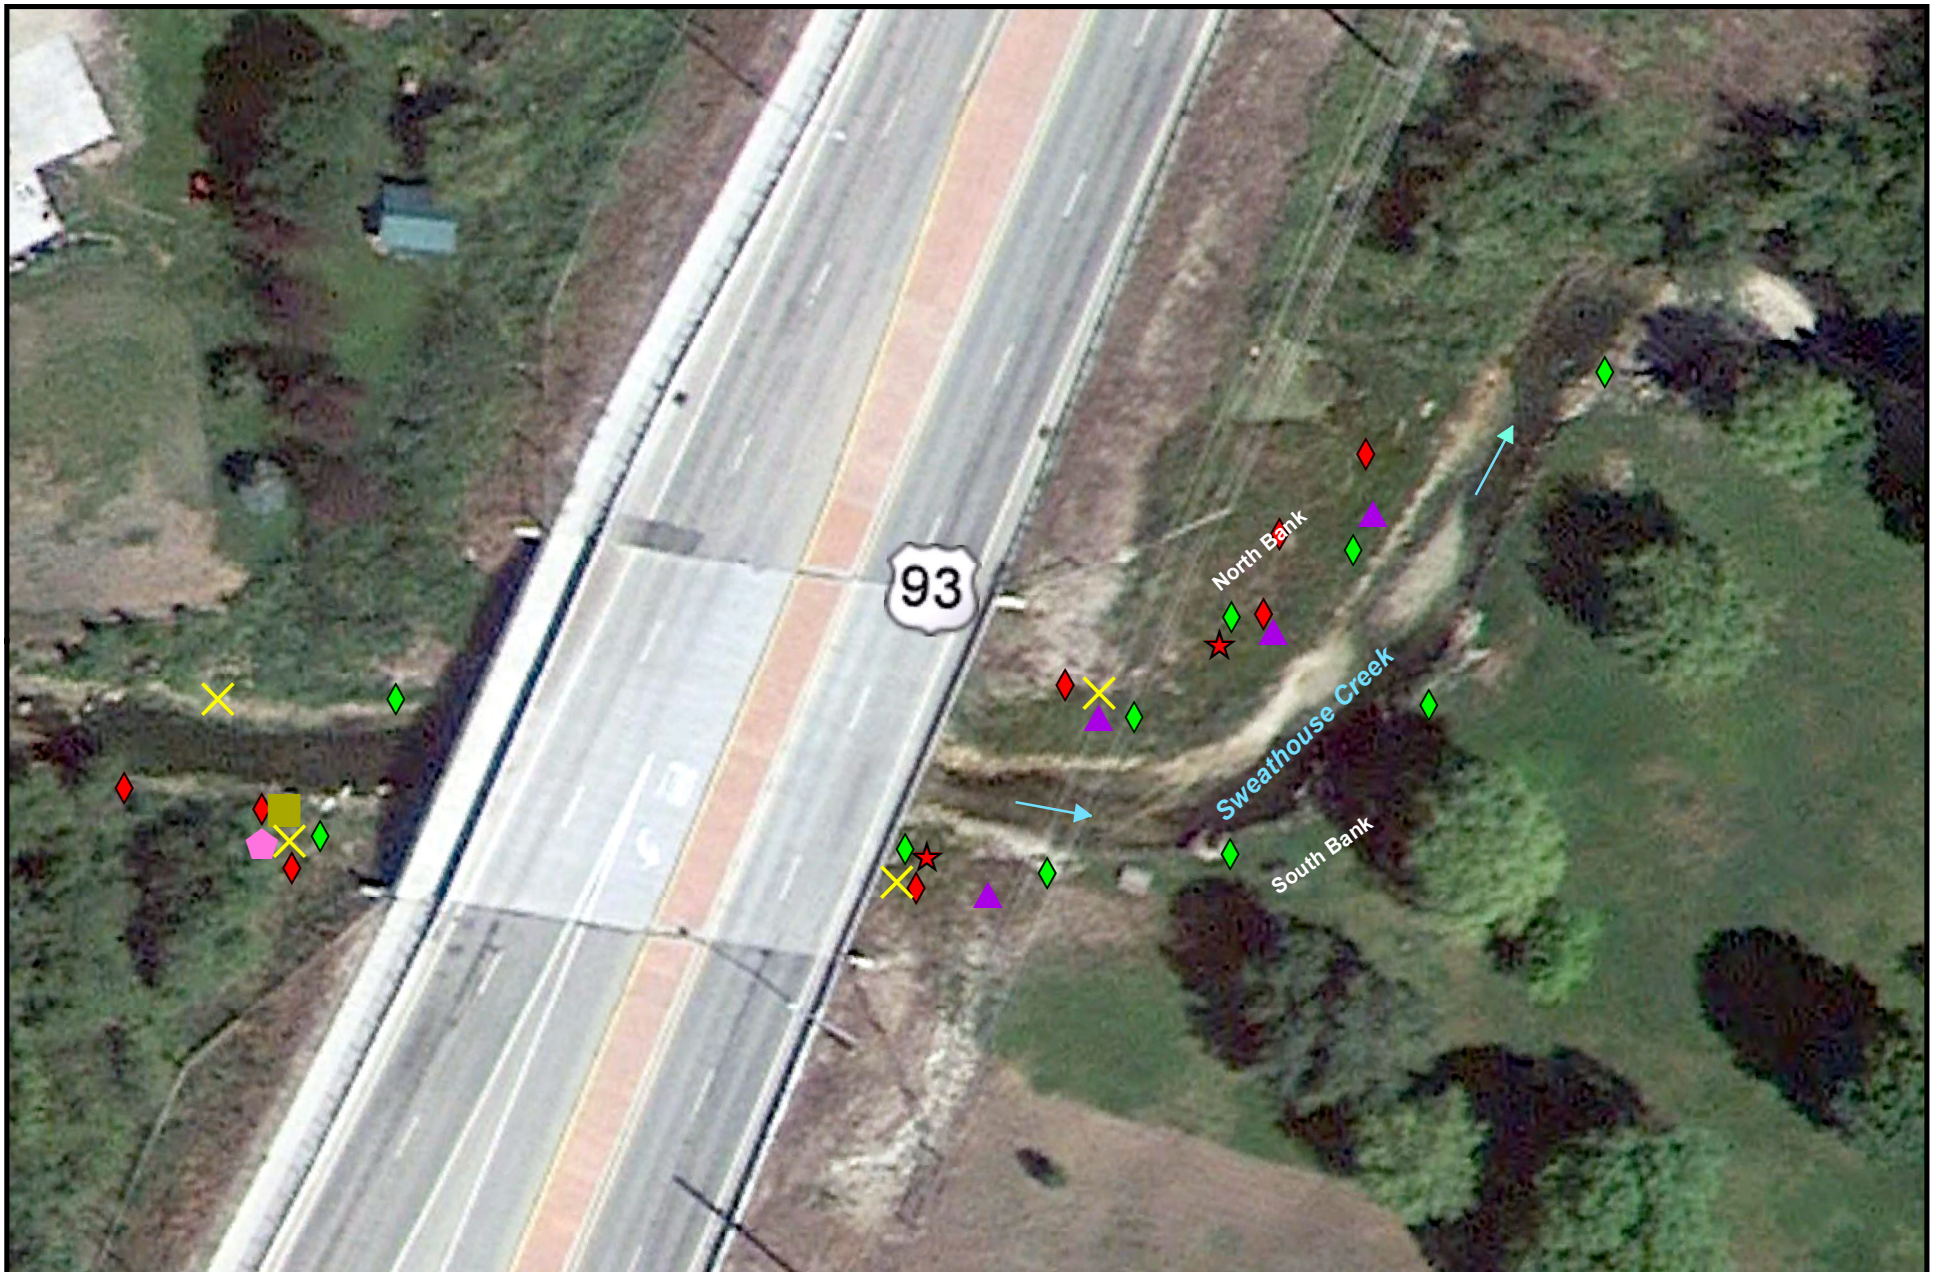
One infestation of tall buttercup (*Ranunculus acris*), a Montana Listed Priority 2A noxious weed, and twenty-nine infestations of Montana Listed Priority 2B noxious weeds, including spotted knapweed (*Centaurea stoebe*), Canada thistle (*Cirsium arvense*), St. Johnswort (*Hypericum perforatum*), oxeye daisy (*Leucanthemum vulgare*), yellow toadflax (*Linaria vulgaris*), and common tansy (*Tanacetum vulgare*) were identified along the riparian corridor and are listed in Table 4. Cheatgrass (*Bromus tectorum*), a Montana Priority 3 regulated weed species was also identified in several locations across the site. Canada thistle, spotted knapweed, and oxeye daisy comprised the majority of noxious weed infestations observed across the site.

Each noxious weed occurrence was identified with cover classes ranging from trace (less than 1 percent) to low (1 to 5 percent). An estimated 6% of the riparian belt transects have been colonized by noxious weeds, which occur primarily outside of the MDT right-of-way, downstream of the Highway 93 Bridge (see Figure 3 in Appendix A).

## 2017 Monitoring Noxious Weeds Sweathouse Creek

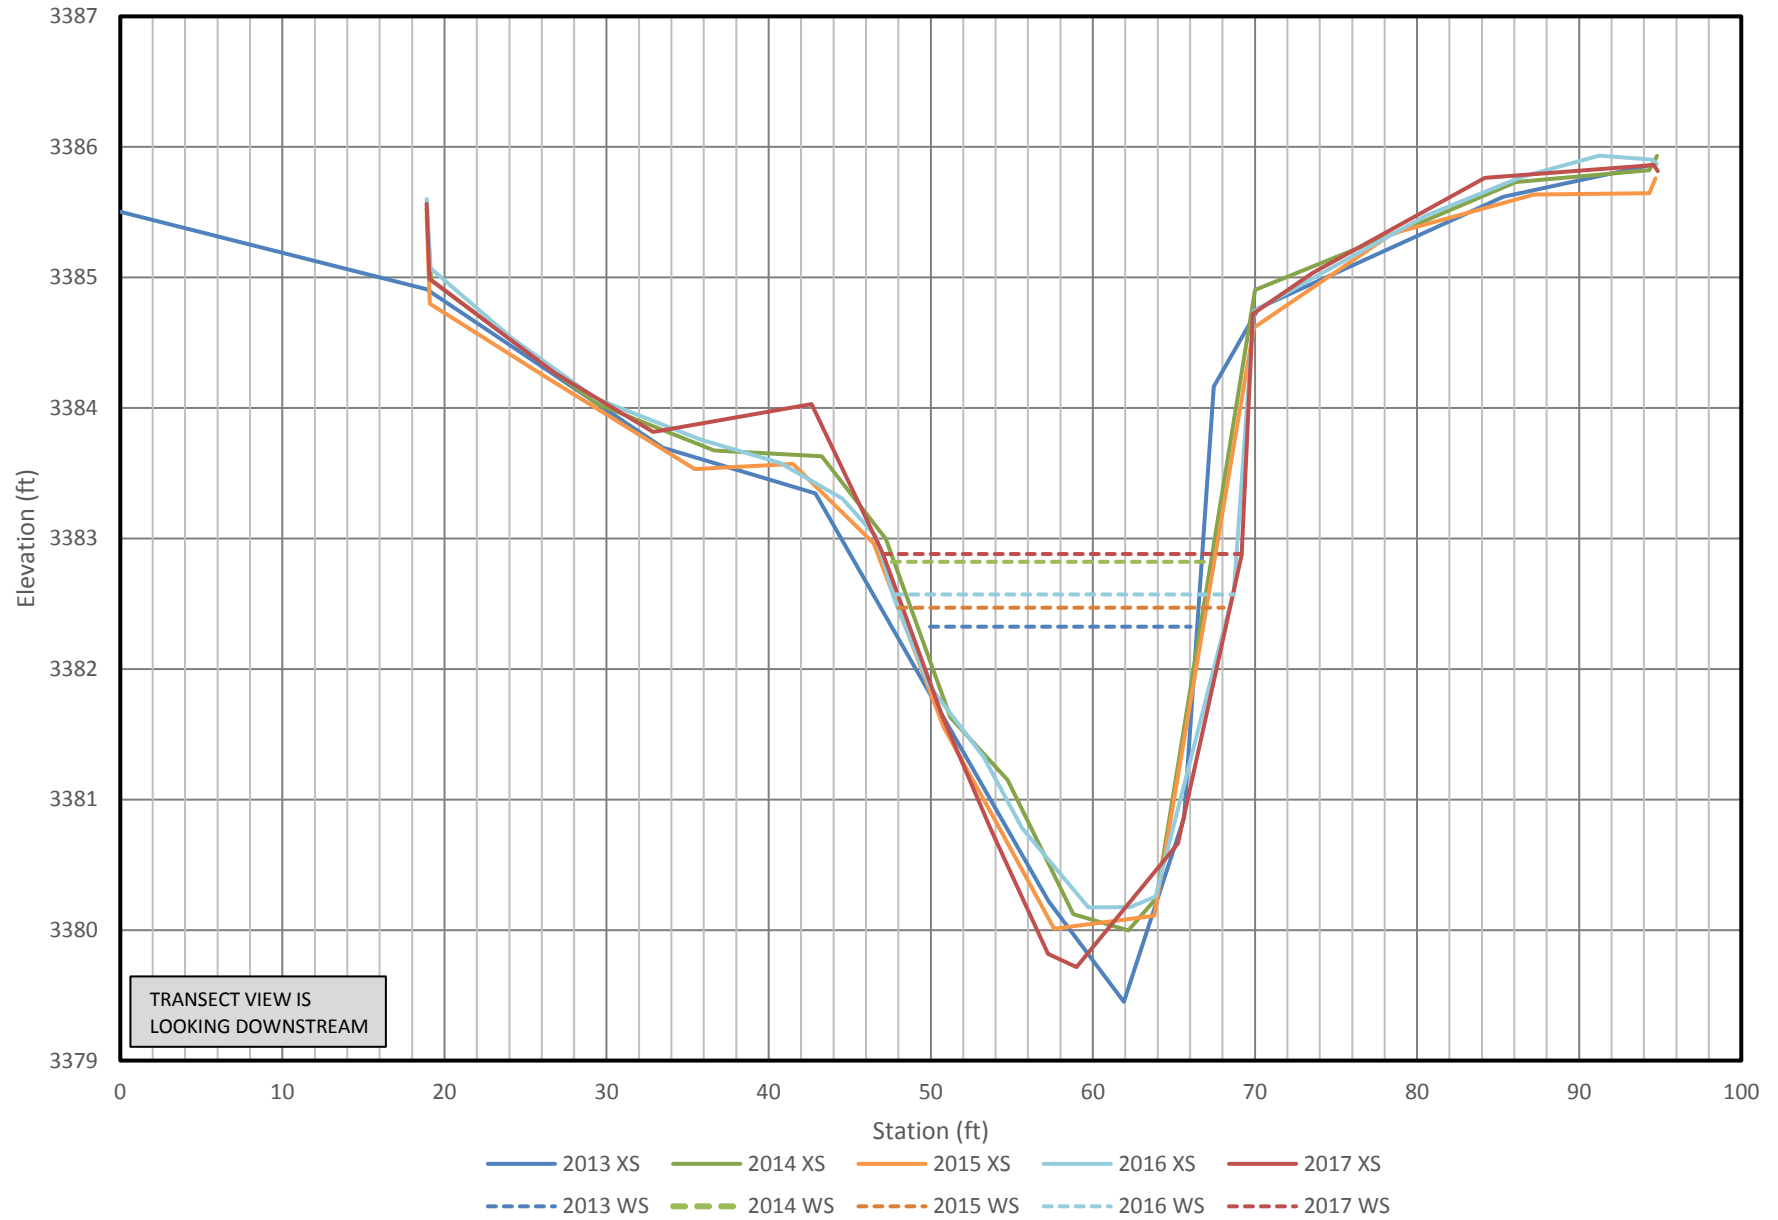
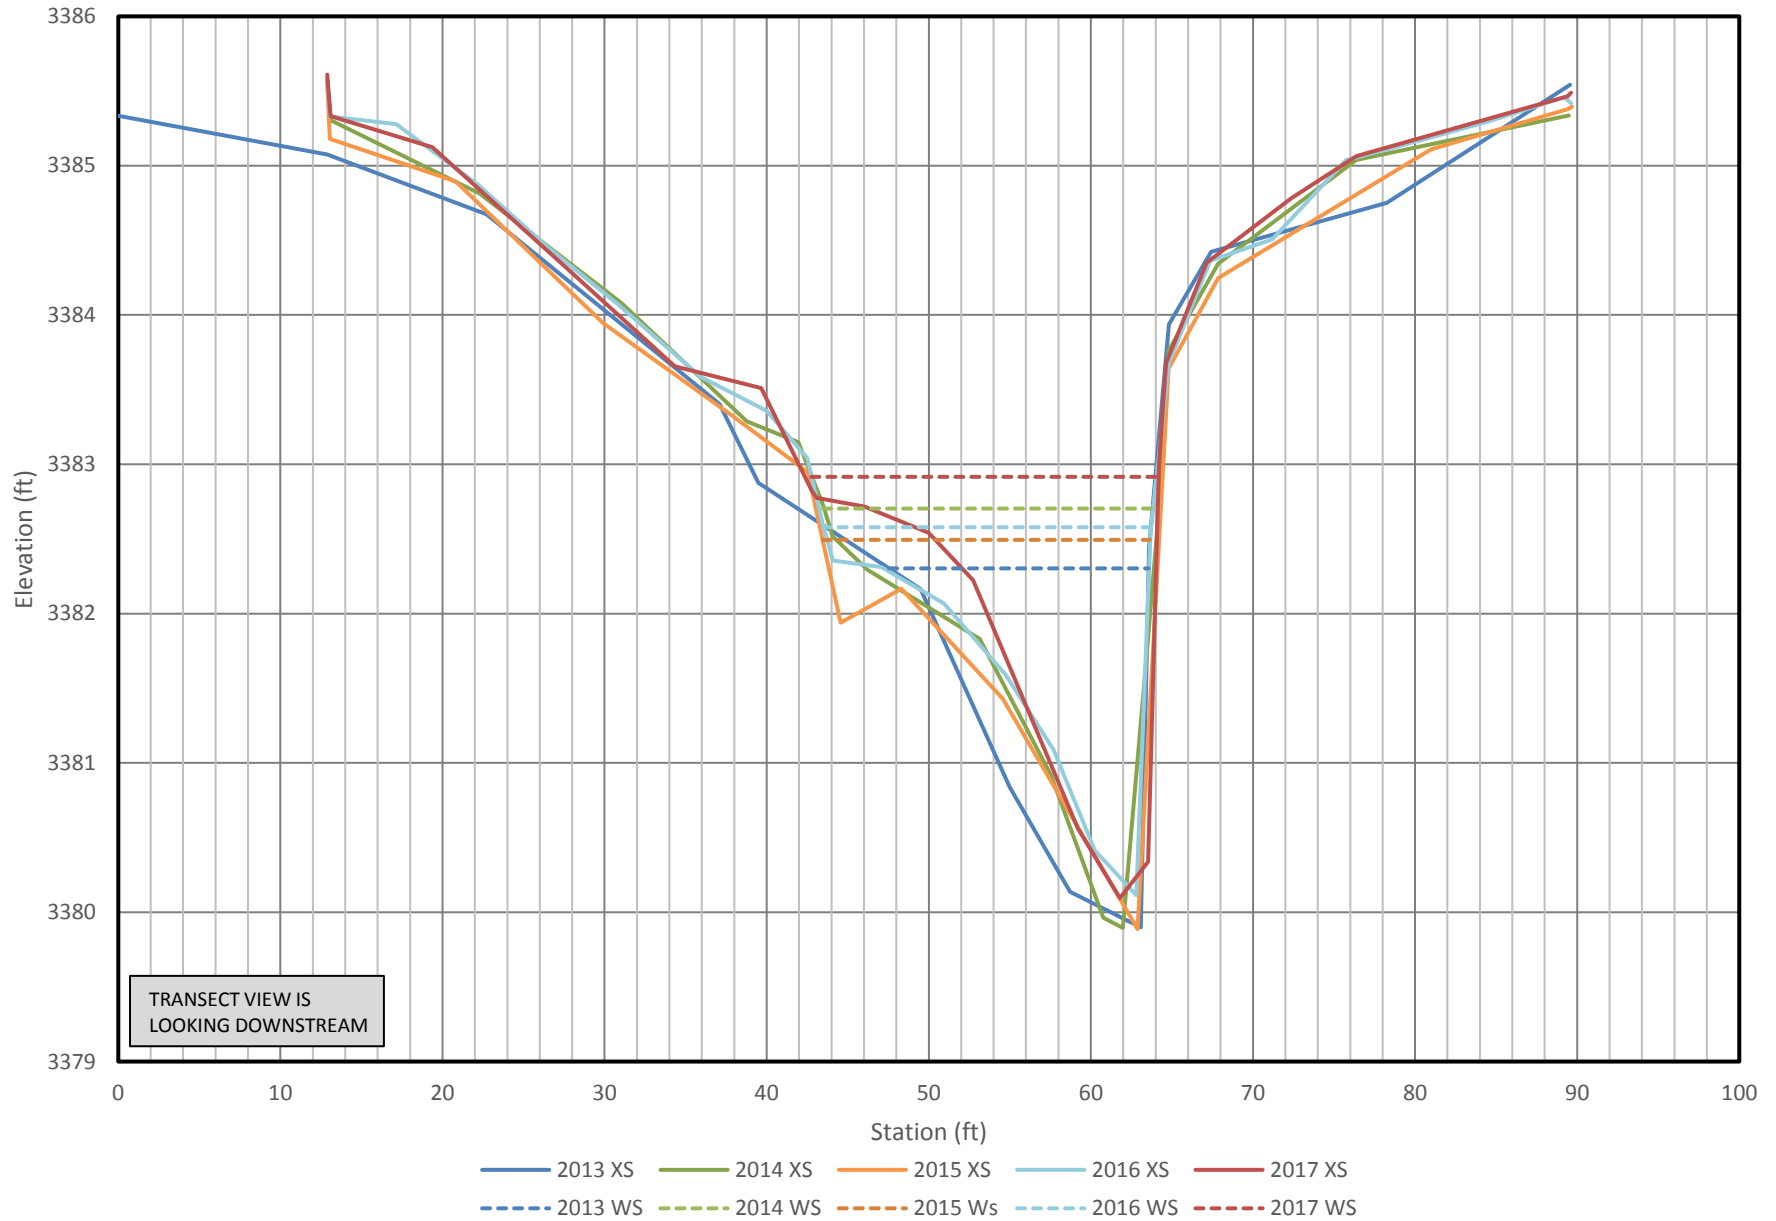
Two riffle and two pool transects have been surveyed each year since 2013 to document vertical and lateral adjustments to the reconstructed stream channel. Plots of each transect are included in Appendix B. Both pool transects indicate the channel has maintained deeper water habitat in the vicinity of the rootwads installed along the outside bend downstream of the bridge. The channel is scouring against these woody features, which provide cover and depth for use by fish. Multiple fish have been

observed using this deeper habitat during each of the five monitoring events. Both riffle transects also appear to be maintaining channel width and depth, with only minor adjustments to the bed and bank elevations observed during the past five years. Inspection of the surveyed transects indicates no evidence of either aggradation or degradation of the channel since monitoring of this site began in 2013.

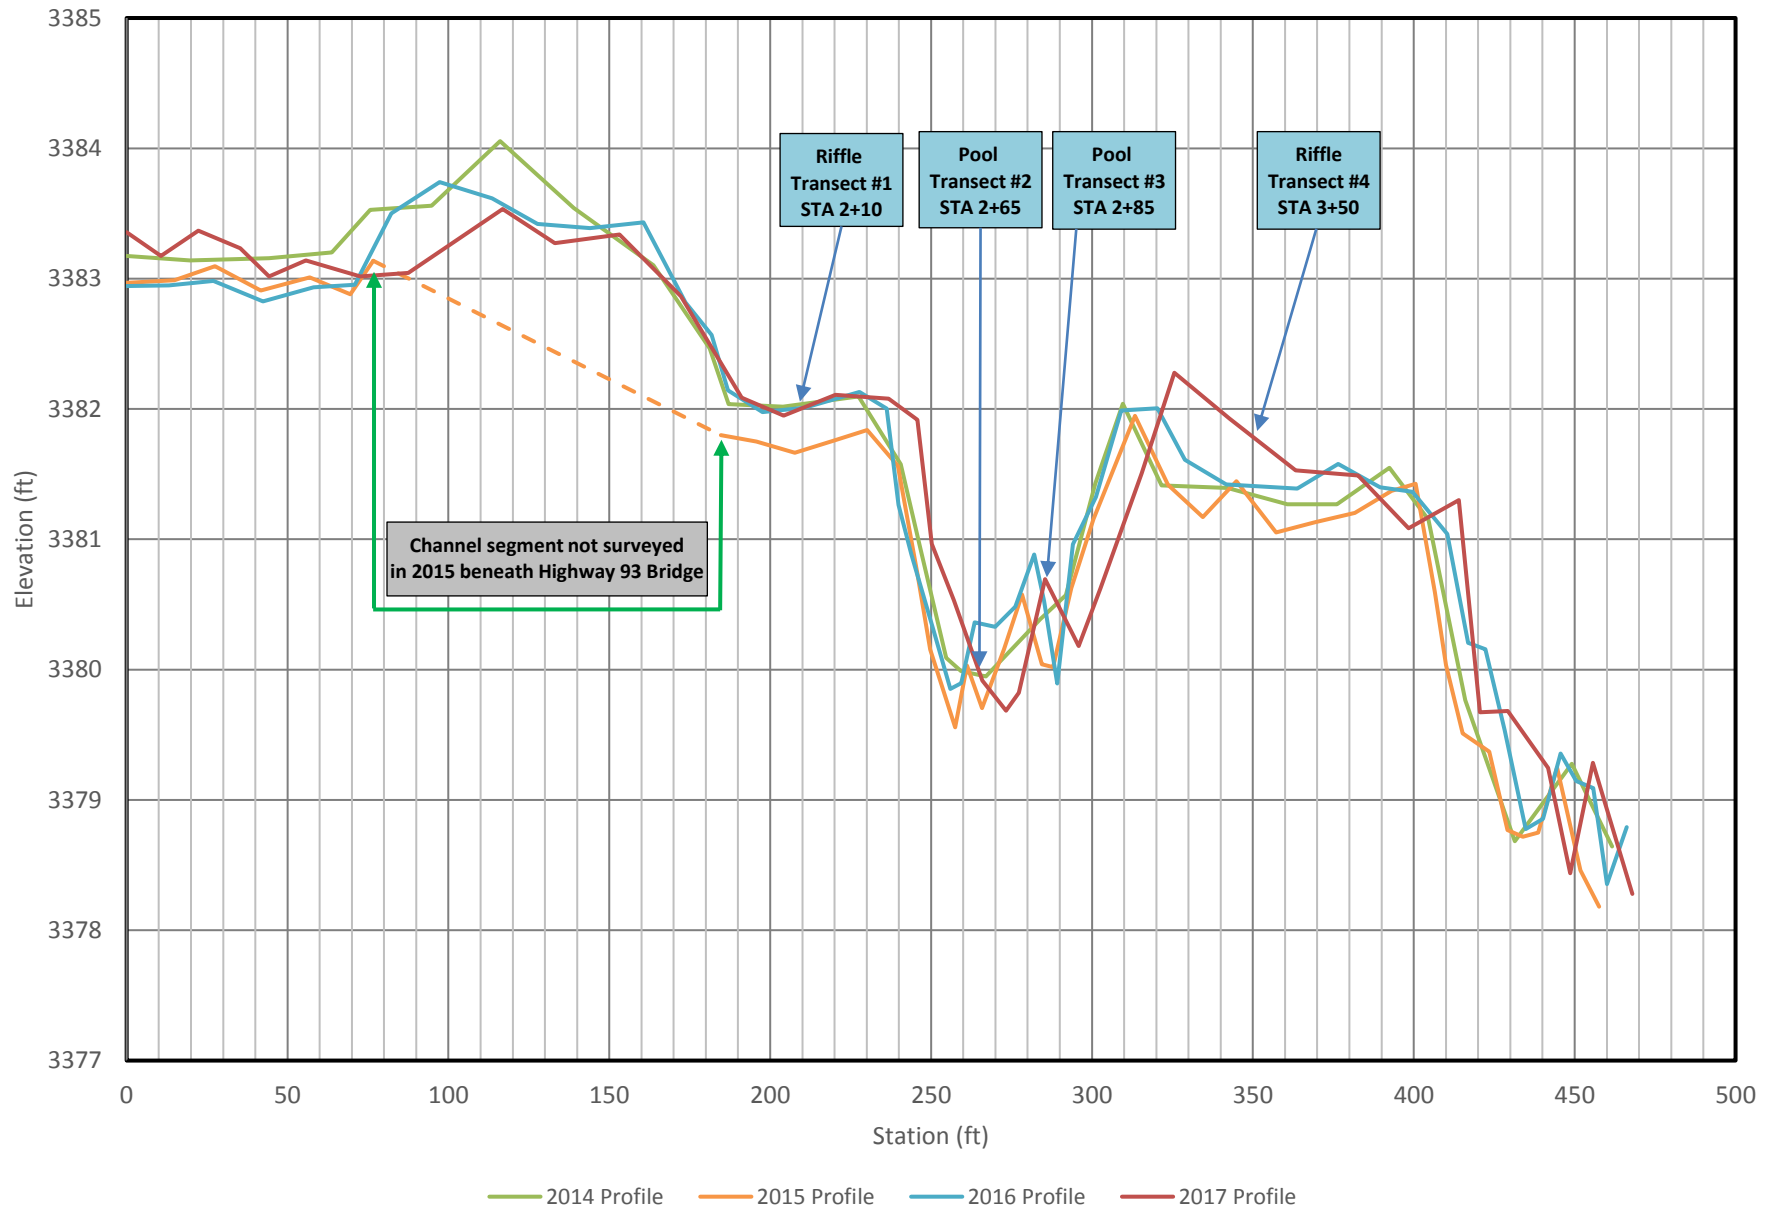
## Sweathouse Creek Longitudinal Profiles: 2014 - 2017

A longitudinal profile surveyed down the length of the channel thalweg was repeated in 2017 (see profile in Appendix B). The thalweg elevation has remained relatively consistent throughout the project reach over the past four years, with minor bed adjustments at riffle crests and pool tails. A riffle crest beneath the bridge has become lower by approximately 0.4 feet since 2014, which is likely due to settling of materials placed following construction. All other riffle crest elevations have remained relatively consistent (within 0.3') throughout the remainder of the project reach. Slight adjustments to bed elevation along the profile, such as those observed at the pools developing between STA 2+50 and 3+00 are most likely due to natural scour and depositional processes at play in a meandering channel, and are not attributed to channel instability within the project reach. The profile indicates the pool features along the right bank have maintained depth while the riffles have maintained an overall consistent channel slope. The channel planform is straight between STA 3+10 and 4+00, which is resulting in the extension of the riffle feature originally constructed at this location. Overall, the channel continues to maintain adequate capacity and slope to effectively convey incoming sediment throughout the relocated channel segment.

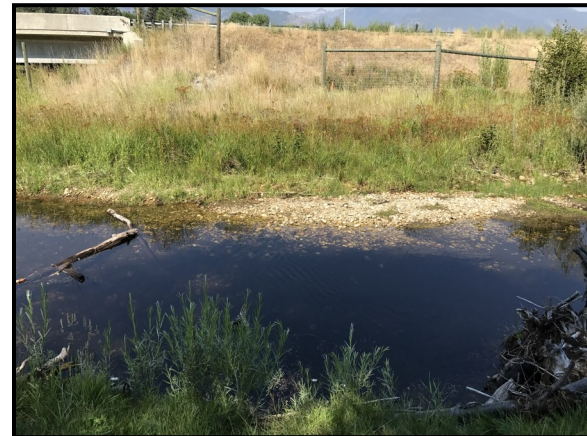
**2013** **2017**  
**Photo Point 4.2:** View of north bank and point bar development. **Compass:** 315 (Northwest)

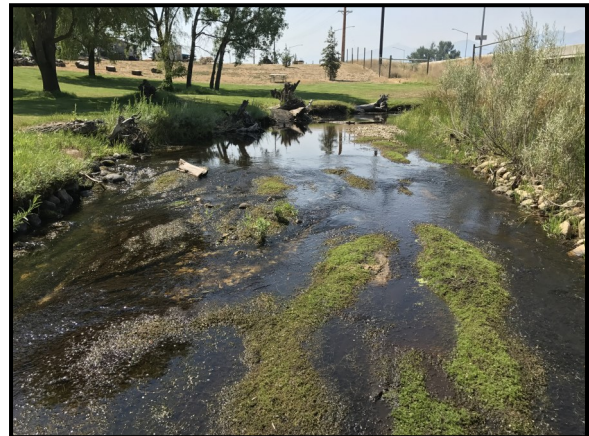
**Additional Photo 2: Point bar formation on north side of channel. Compass: 250 (West-Southwest)**

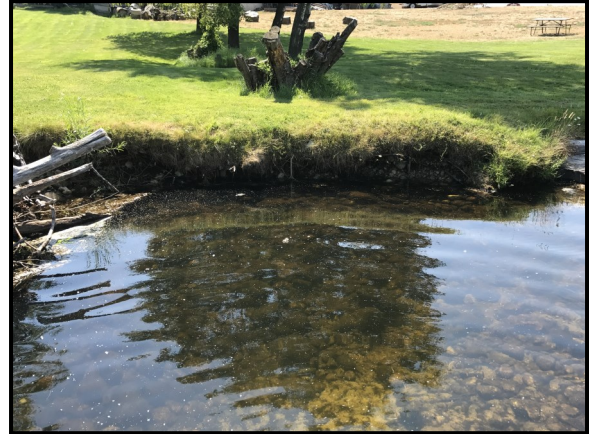
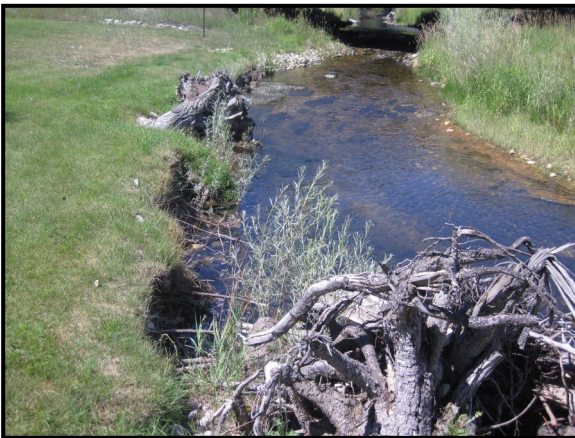
An erosion inventory conducted along both stream banks revealed no newly eroding banks in 2017. In 2014, erosion at EBR1 was noted along a 15' segment of the right (south) bank where one of the coir logs separated from the bank and washed downstream. The location of this erosion is noted on Figure 2 in Appendix A. This bank has become undercut and laterally migrated an additional 1 foot in the past year as a result of hydraulics in the vicinity of the root wad installed to provide bank protection (see Additional Photos 4 and 5 in Appendix C). All but a couple of willow sprigs installed along this 15-foot bank segment have eroded into the stream. The lack of woody vegetation establishment along the bank, presence of the large root wad, and decomposition of coir materials used to construct the bank factor into the potential that erosion may continue along this short bank segment.

The 15-foot section of eroding bank along Sweathouse Creek identified in 2014 showed no signs of migrating further in 2015 or 2016; however it appears to have undercut and laterally eroded approximately 1 foot southward in the past year. Erosion along this bank is resulting from the hydraulics generated by the adjacent rootwad, lack of woody vegetation establishment along the bank, and degradation of the coir fabric used to originally construct the bank. This erosion is relatively short in length, is not currently threatening any infrastructure and is migrating at a rate of less than 1 foot per year. As a result of these factors, corrective actions do not appear warranted.

**2013**  
**Additional Photo 4: Eroding Bank EBR1 prior to bank collapse** **Compass: 90 (East)**

Installation of woody fascines along the toe of the eroding bank would provide temporary protection from erosion; however, the establishment of woody vegetation along the bank will be the most effective treatment to reduce erosion potential. If woody vegetation establishment along the bank is not feasible due to adjacent land use practices, installation of additional rootwads would suffice to prevent further erosion along the bank. The 15-foot segment of bank erosion is equivalent to less than 3% of the 600' bank length within the project reach, not including the stream banks beneath the Highway 93 Bridge. The short length of erosion, relatively slow pace of lateral movement, and lack of infrastructure in jeopardy provide a justifiable basis for not undertaking corrective actions along this bank.
