MONTANA DEPARTMENT OF TRANSPORTATION STREAM MITIGATION MONITORING REPORT

*Bowser Creek
Flathead County, Montana*

*Project Completed: 2010
Monitoring Report #6: December, 2018*

MDT Project Number: NH 15(93)
Control Number: 2038-011

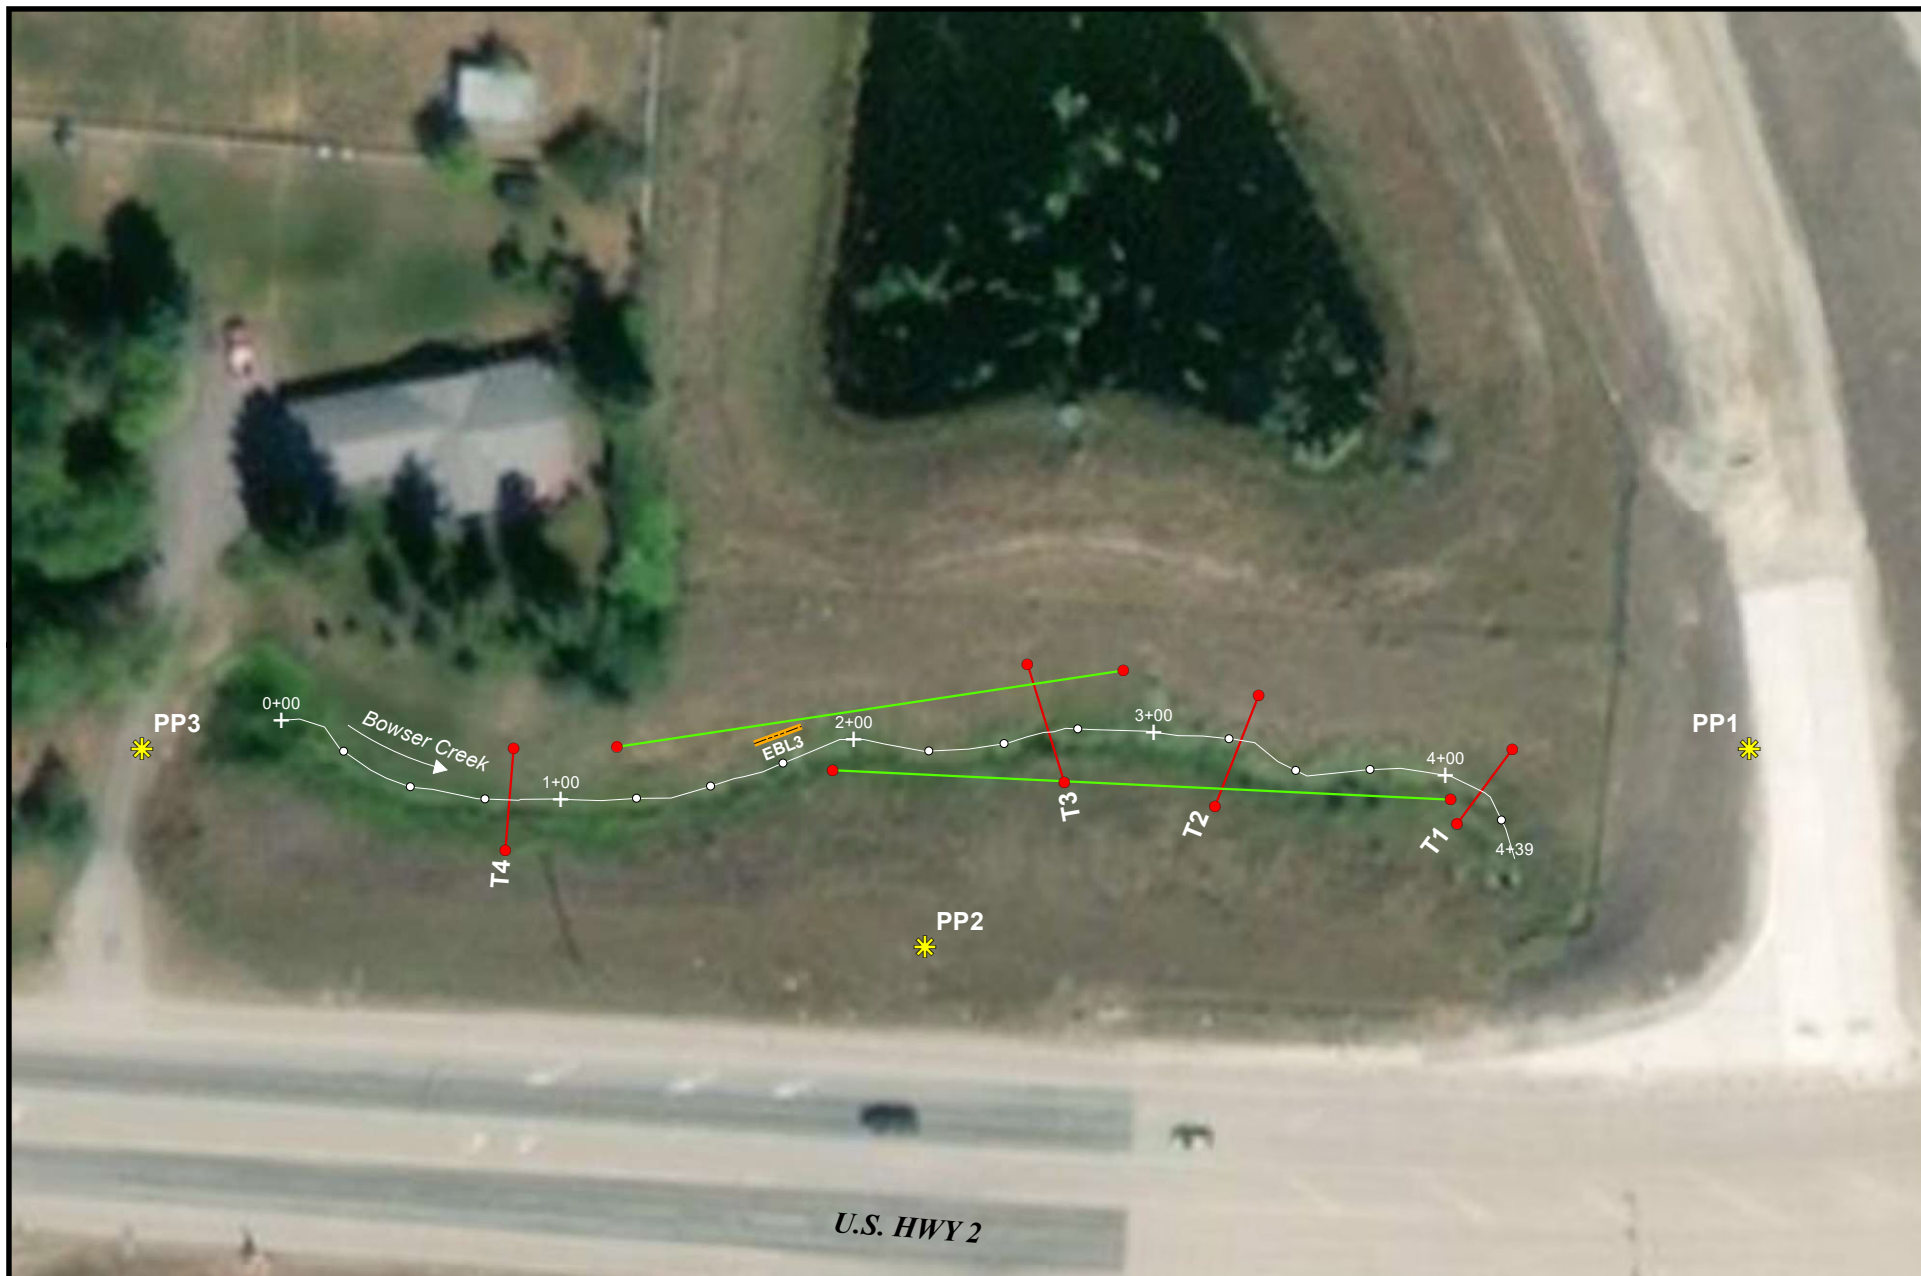
The prevalence of dense groundcover along the stream banks and thick mats of watercress across much of the stream bed during the late summer created challenging conditions to accurately determine the extent and cause of bank erosion, as well as photo-documenting erosion along banks that were covered with vegetation. As a result, a bank inventory was performed in April, 2016 prior to the growing season to determine causes of erosion. Currently eroding bank locations are provided on Figure 2 in Appendix A, while photos of each eroding bank can be found in Appendix C.

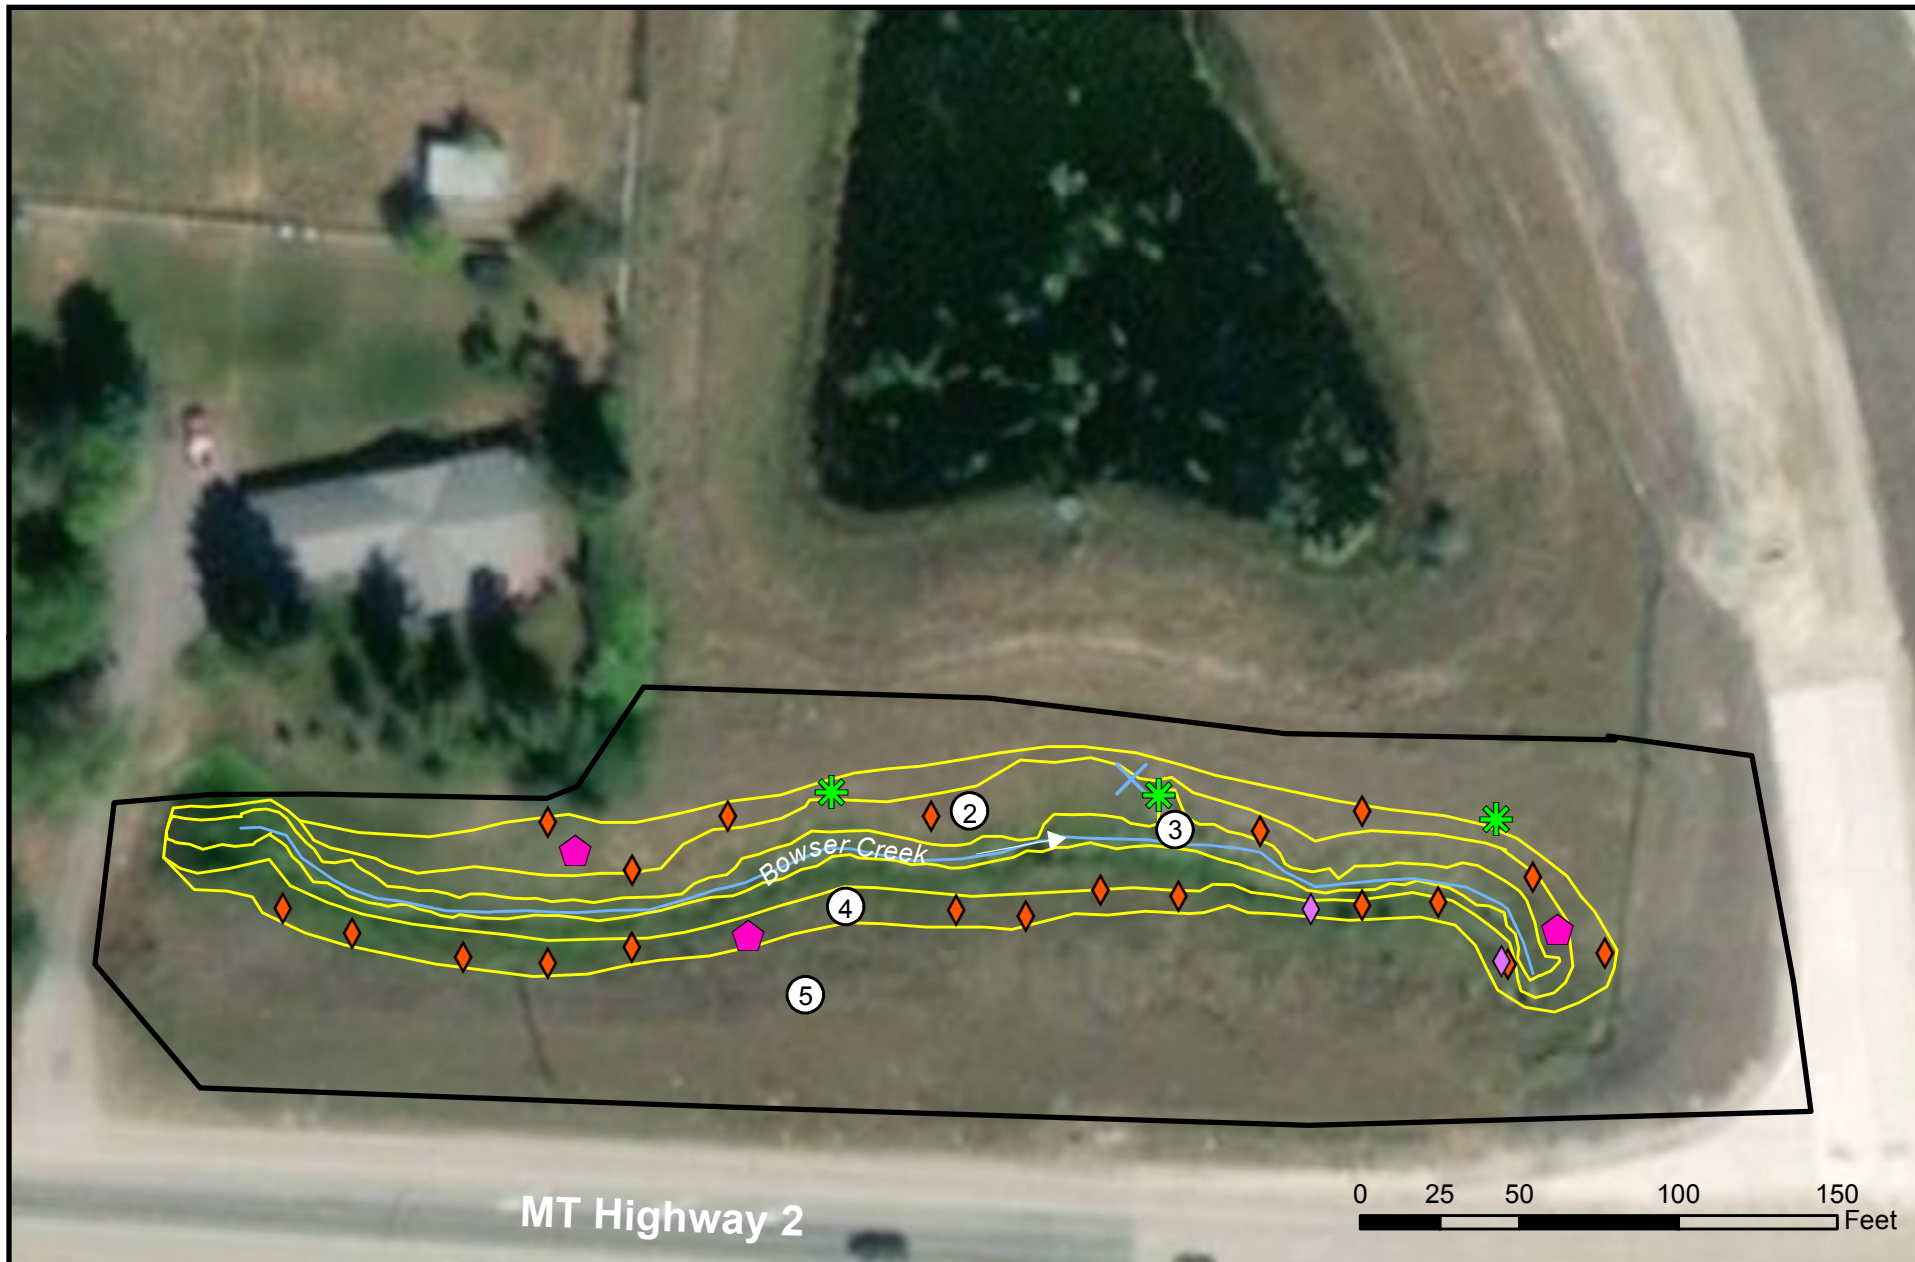
A total of six Montana Listed Priority 2B noxious weeds were identified within the Bowser Creek stream mitigation site and are listed in Table 5. Locations of twenty-nine noxious weed infestations are provided on Figure 3 in Appendix A, with the exception of those observed as isolated occurrences and those in trace amounts (i.e., common tansy (*Tanacetum vulgare*)). A low cover class (1 to 5 percent) was identified for all mapped weed occurrences within the project area. In 2018, a visual estimate of 14% of the project area was colonized by noxious weeds, representing a decrease by 1% since the 2017 monitoring event. Infestations of Canada thistle, the most prevalent noxious weed, were located throughout the project area. In 2016 through 2018, Canada thistle was so commonly observed that it was identified as a dominant species in community Type 4 (Figure 3, Appendix A).

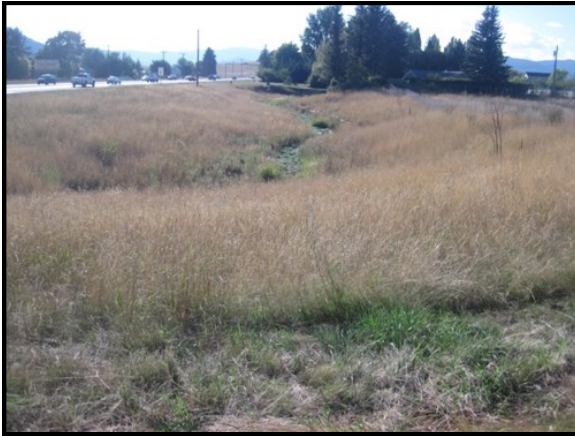
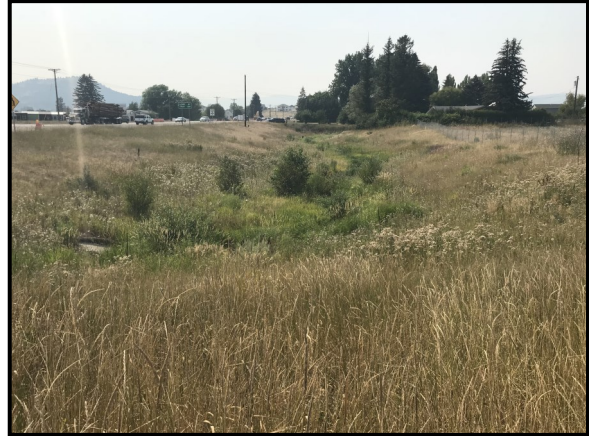
Photo 1: View looking west (upstream) of Bowser Creek.

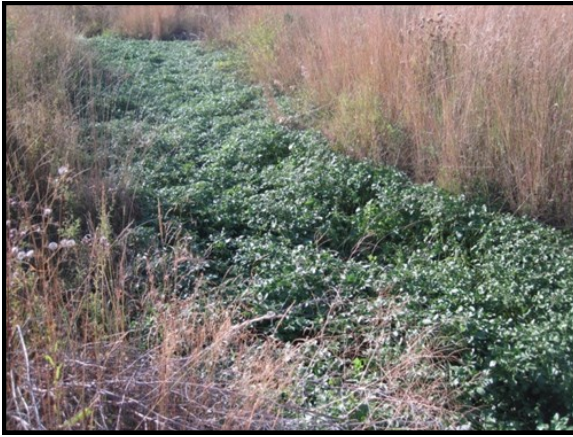
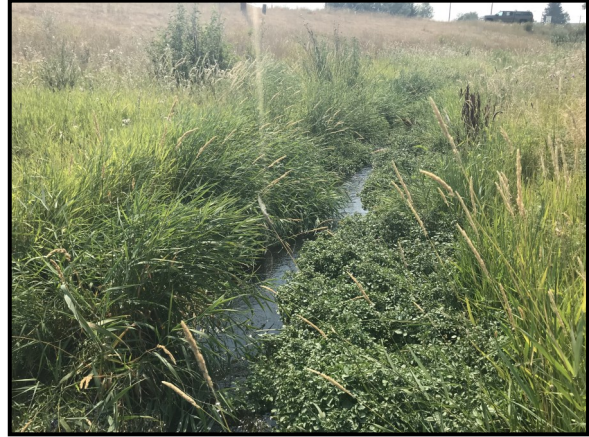
Vegetation community Type 3 – *Nasturtium officinale* was identified within the channel. Watercress dominated this community type with more than 50% cover growing in the channel bed and 6 to 10% cover along both stream banks. This community has been consistently observed in dense stands along the stream bed during the growing season, and had expanded to both stream banks during the 2017 and 2018 monitoring events.

Additional Photo 1: Prolific watercress growth shown in 2013 was less prevalent in 2018.

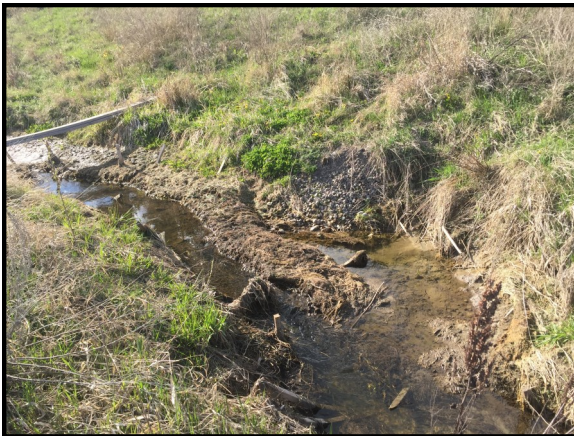
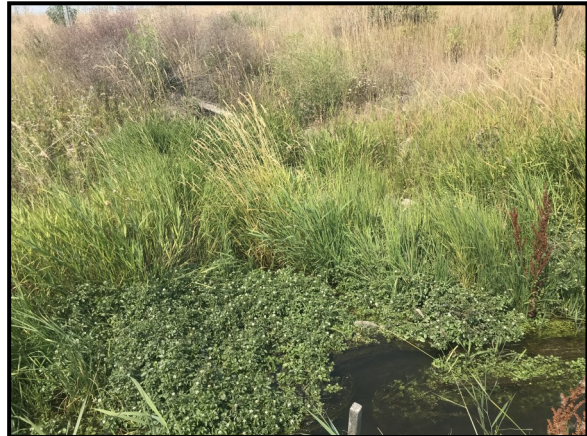
- Bank erosion along the left (north) side of the channel does not appear caused by scour during high flows as is typical of snowmelt driven streams.
- A retention pond has been constructed approximately 100 feet north of Bowser Creek. It appears the water surface elevation of the pond is higher than Bowser Creek, and may be a source of water seeping into Bowser Creek.
- The seepage of water from either the retention pond or from a naturally high groundwater table saturates the north bank and create localized instability where the seeps daylight along the north side of the stream channel.
- Saturated, fine grained materials along the north bank of Bowser Creek are transported downstream during high water events, resulting in bank retreat in locations where seeps enter Bowser Creek.

The bank erosion inventory conducted in 2016 identified slumping and washing of materials at three locations along the left (north) bank; however, no new erosion has been observed during the past two monitoring events. Based on these observations, the majority of bank length previously identified as eroding has stabilized. Continued calving along 15 feet of the bank at EBL3 is due to a seep entering the channel at this location, and remains the only actively eroding bank section. This bank length represents less than 2% of the overall reconstructed bank length of 880 feet.

Additional Photo 2: Eroding bank EBL4.

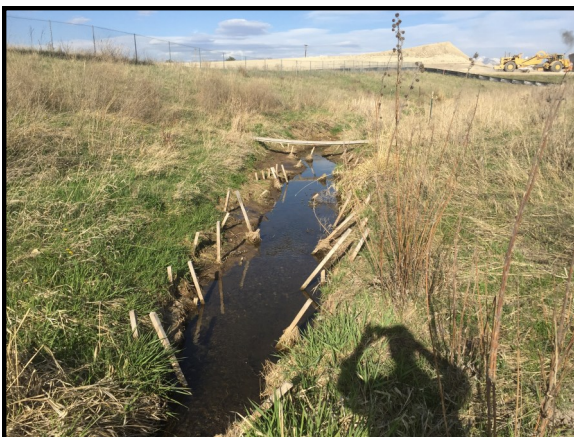
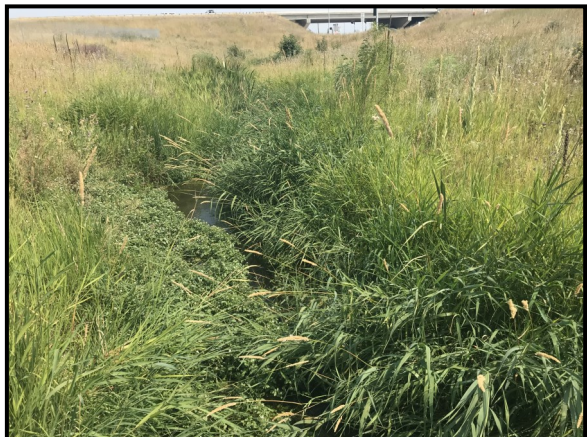
Two segments of the channel are wider than originally constructed due to a combination of the natural degradation of coir logs placed during construction and bank slumping where seeps enter the channel from the north. These channel segments are unlikely to recover back to the design dimension due to the unnatural hydrology and continuous saturation caused by seepage from the adjacent retention pond; however they provide a diversity in channel form and are not continuing to degrade or erode. Based on the vast majority of the reconstructed channel performing as intended, attempts to narrow the channel through these relatively short, over-wide segments remains unwarranted.

Additional Photo 3: Widened channel segment.
