MONTANA DEPARTMENT OF TRANSPORTATION STREAM MITIGATION MONITORING REPORT

*Mill Creek
Ravalli County, Montana*

*Project Constructed: 2011
Monitoring Report #6: December, 2018*

MDT Project Number: NH7-(114)59
Control Number: 2015004

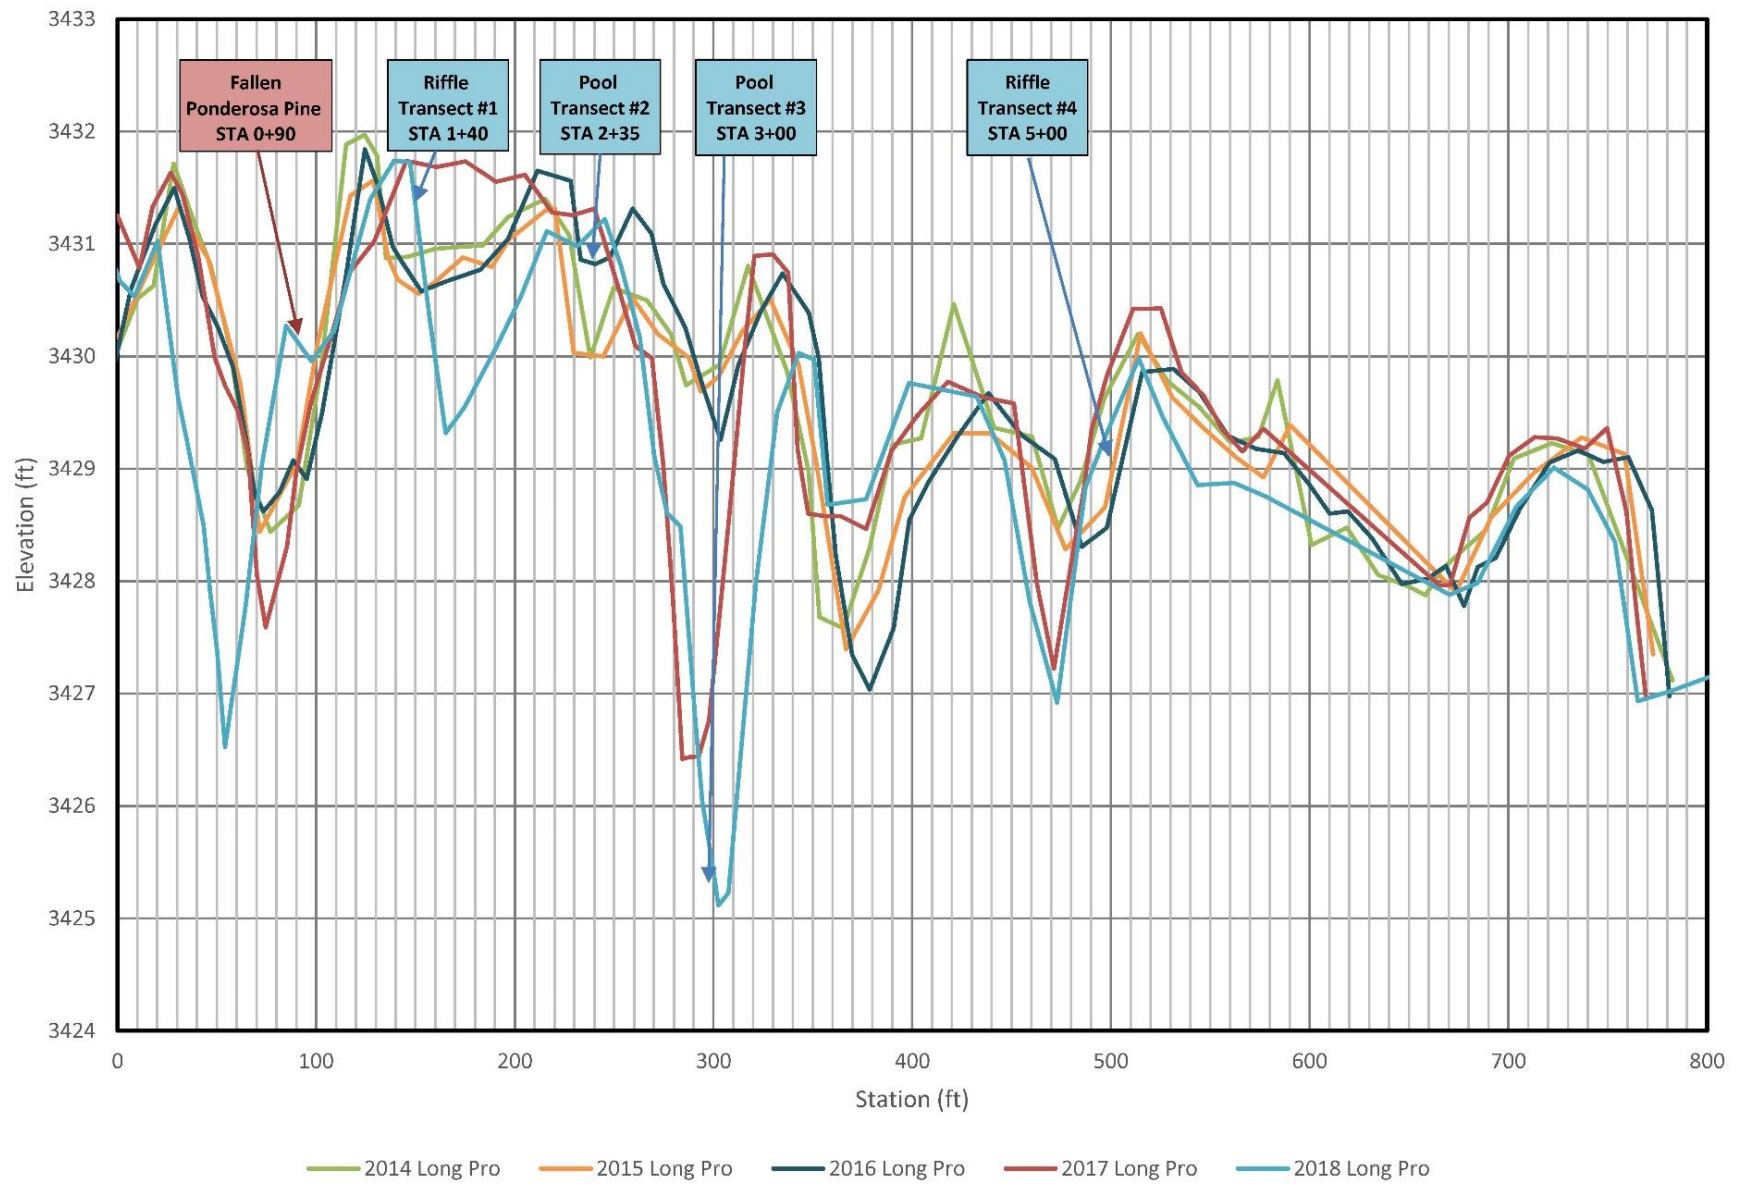
Figure 2. Thalweg longitudinal profile along Mill Creek, 2014 – 2018.

A longitudinal profile of the channel thalweg surveyed each year from 2014 to 2018 is provided in Figure 2, while plots for each surveyed transect are included in Appendix B. Transects #2 and #3 were originally installed to document channel dimensions at scour pools formed by woody debris jams, while transects #1 and #4 were surveyed at riffles. While transect #1 was originally positioned at a riffle, survey data from 2013-2015 indicated the channel transitioned to more of a pool feature by forming a point bar on the left side of the channel and thalweg near the right bank. In 2016, a large ponderosa tree fell into the channel just upstream from transect #1, resulting in a mid-channel gravel bar deposit forming near this transect. In 2017, the mid channel bar further developed, causing a split flow. In 2018, additional deposition closer to the right bank forced flows against the left bank, which scoured a relatively deep pool feature.

Inspection of the stream bed longitudinal profile and cross sections at each of the four monitoring transects over the past six years reveal a stream bed that is adjusting over time to incoming sediment loads and woody debris complexes. Mill Creek exhibits active bedload transport, as evidenced by the frequency of point bars and a thalweg that shifts from one side of the channel to the other. The adjusting banks and bed within the monitoring reach provide evidence that the channel is naturally adjusting to fluvial processes during and following high flow events. Given the channel is actively moving but does not threaten infrastructure, efforts to stabilize banks or prevent naturally active bed movements are unwarranted. Allowing the channel to freely adjust and migrate has resulted in the development of several high-quality features, including deep scour pools and riffles that provide productive and diverse habitat that benefit aquatic species.

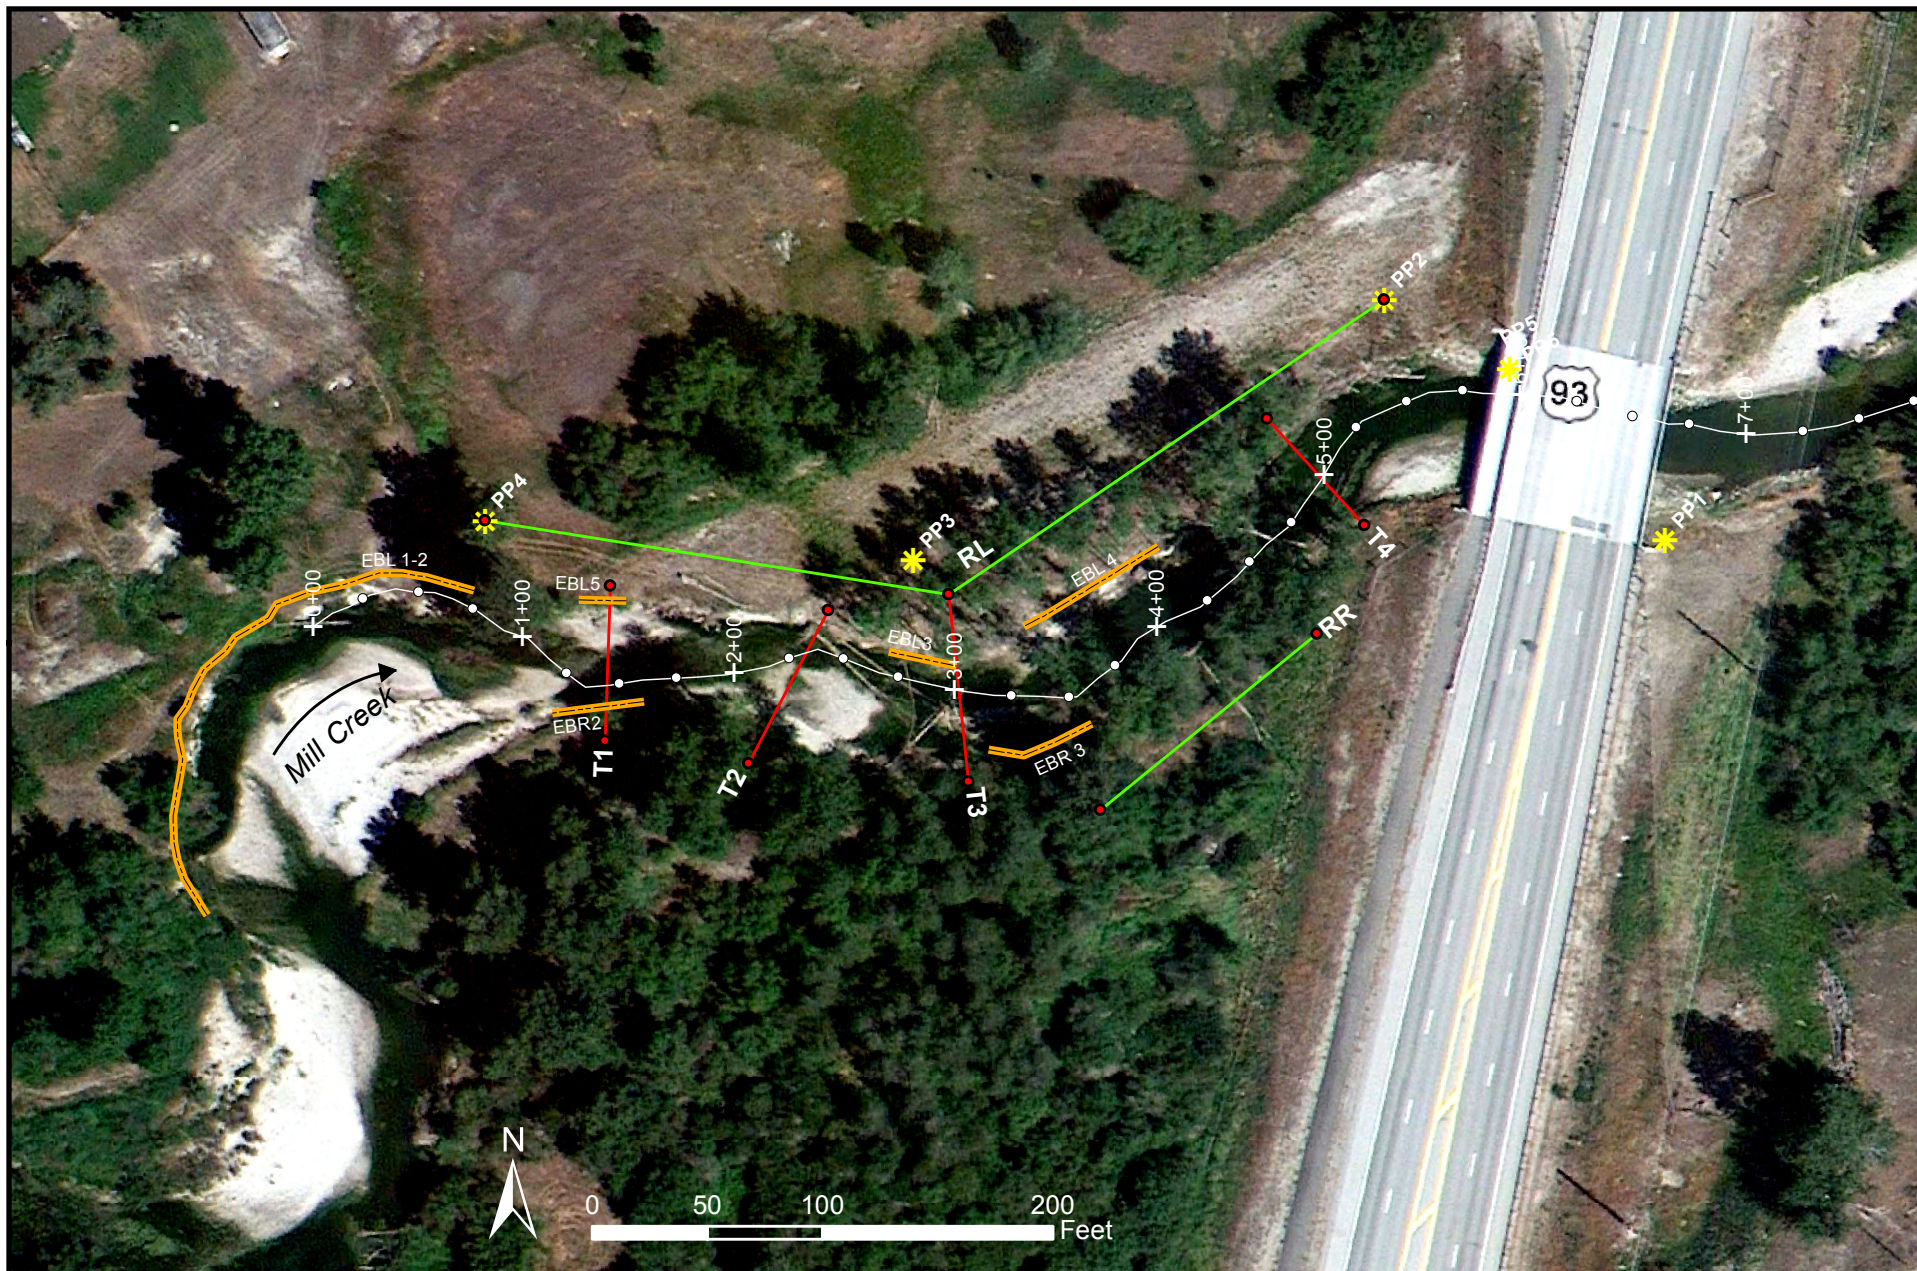
Over the past six years, erosion has been observed both upstream and within the project reach, with the extent and severity of erosion documented in each monitoring report. Over this monitoring period, erosion has been attributed to adjusting bank lines that occur as a result of natural scour and depositional processes that occur during and following high flows events. In 2018, bank erosion was noted at six locations within the project reach, and continues to occur along a sharp meander bend immediately upstream of the monitoring reach. Descriptions of erosion at these locations is provided in the following section, while the locations of eroding banks are illustrated on Figure 3 in Appendix A.

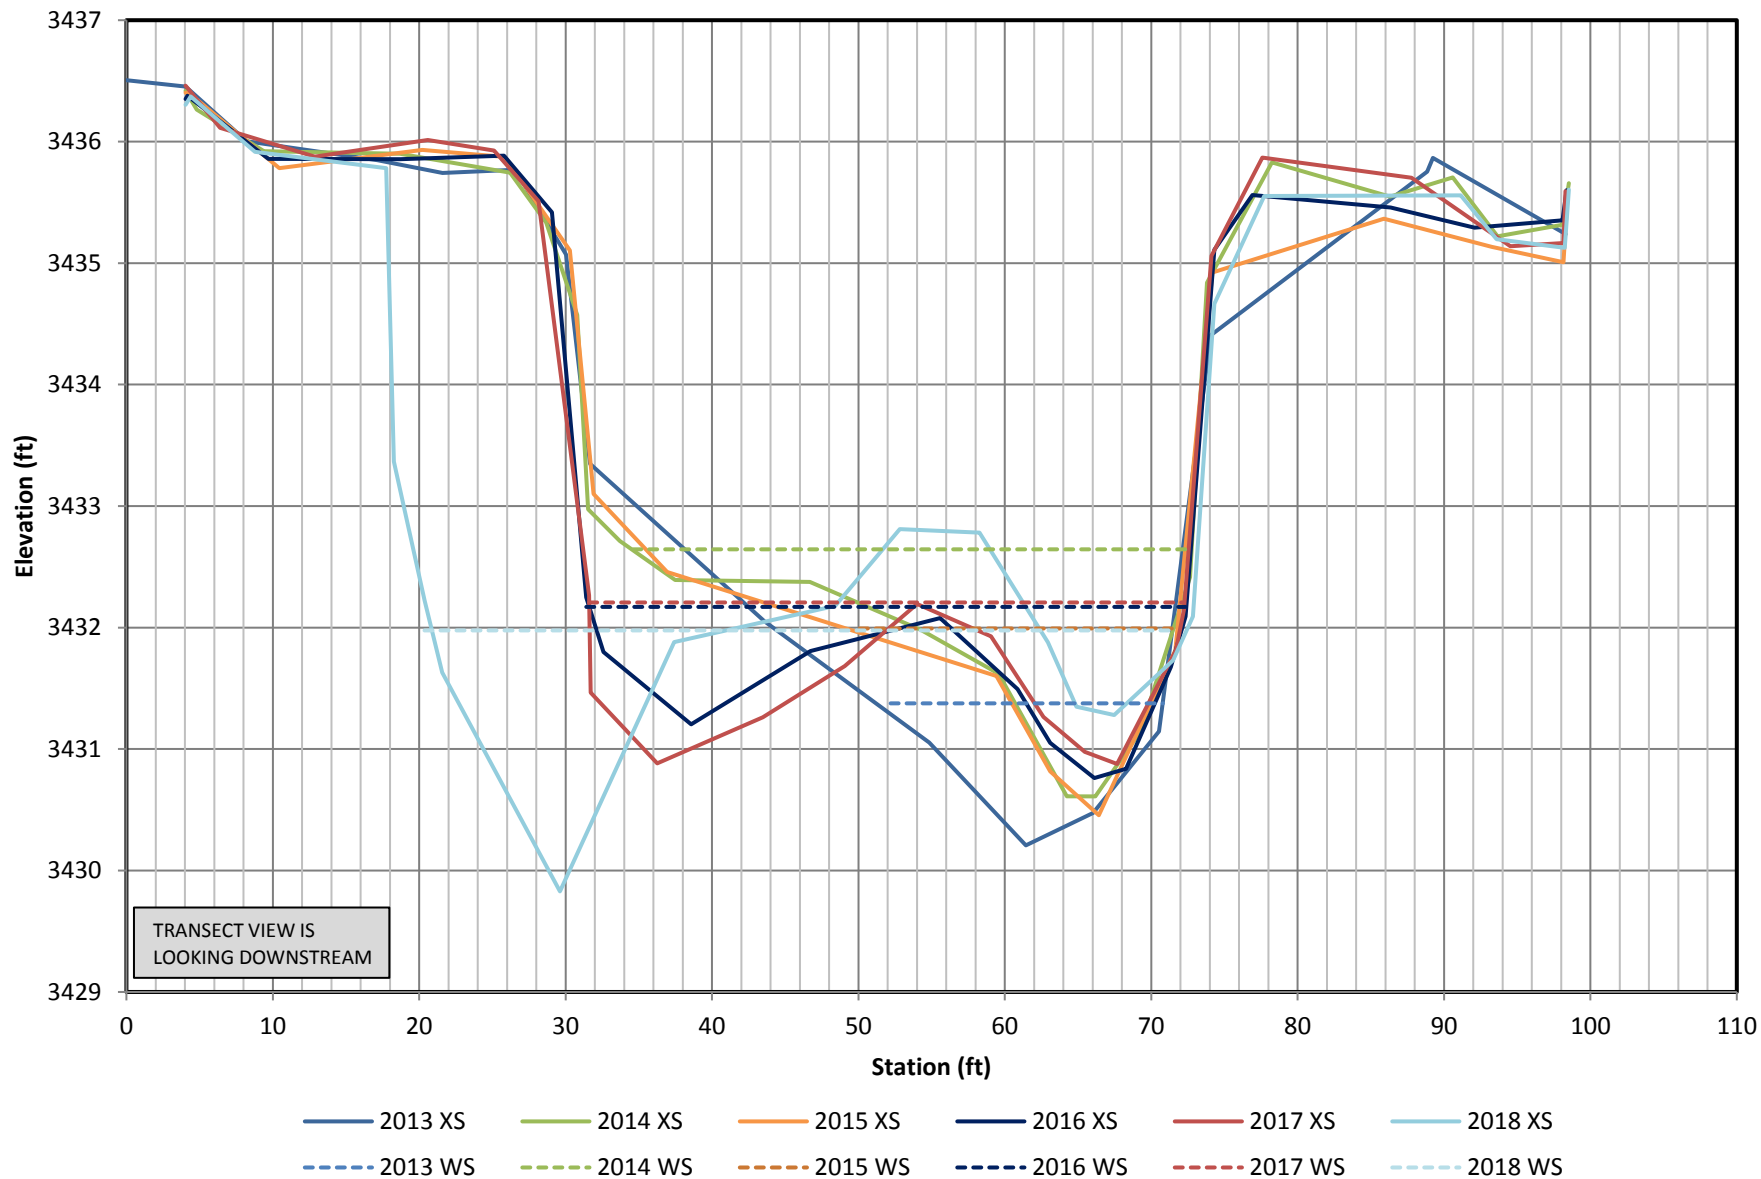
Mill Creek Transect #1 - Riffle

Monitoring across this transect over the past six years depicts an actively adjusting channel due to both depositional and scouring processes.

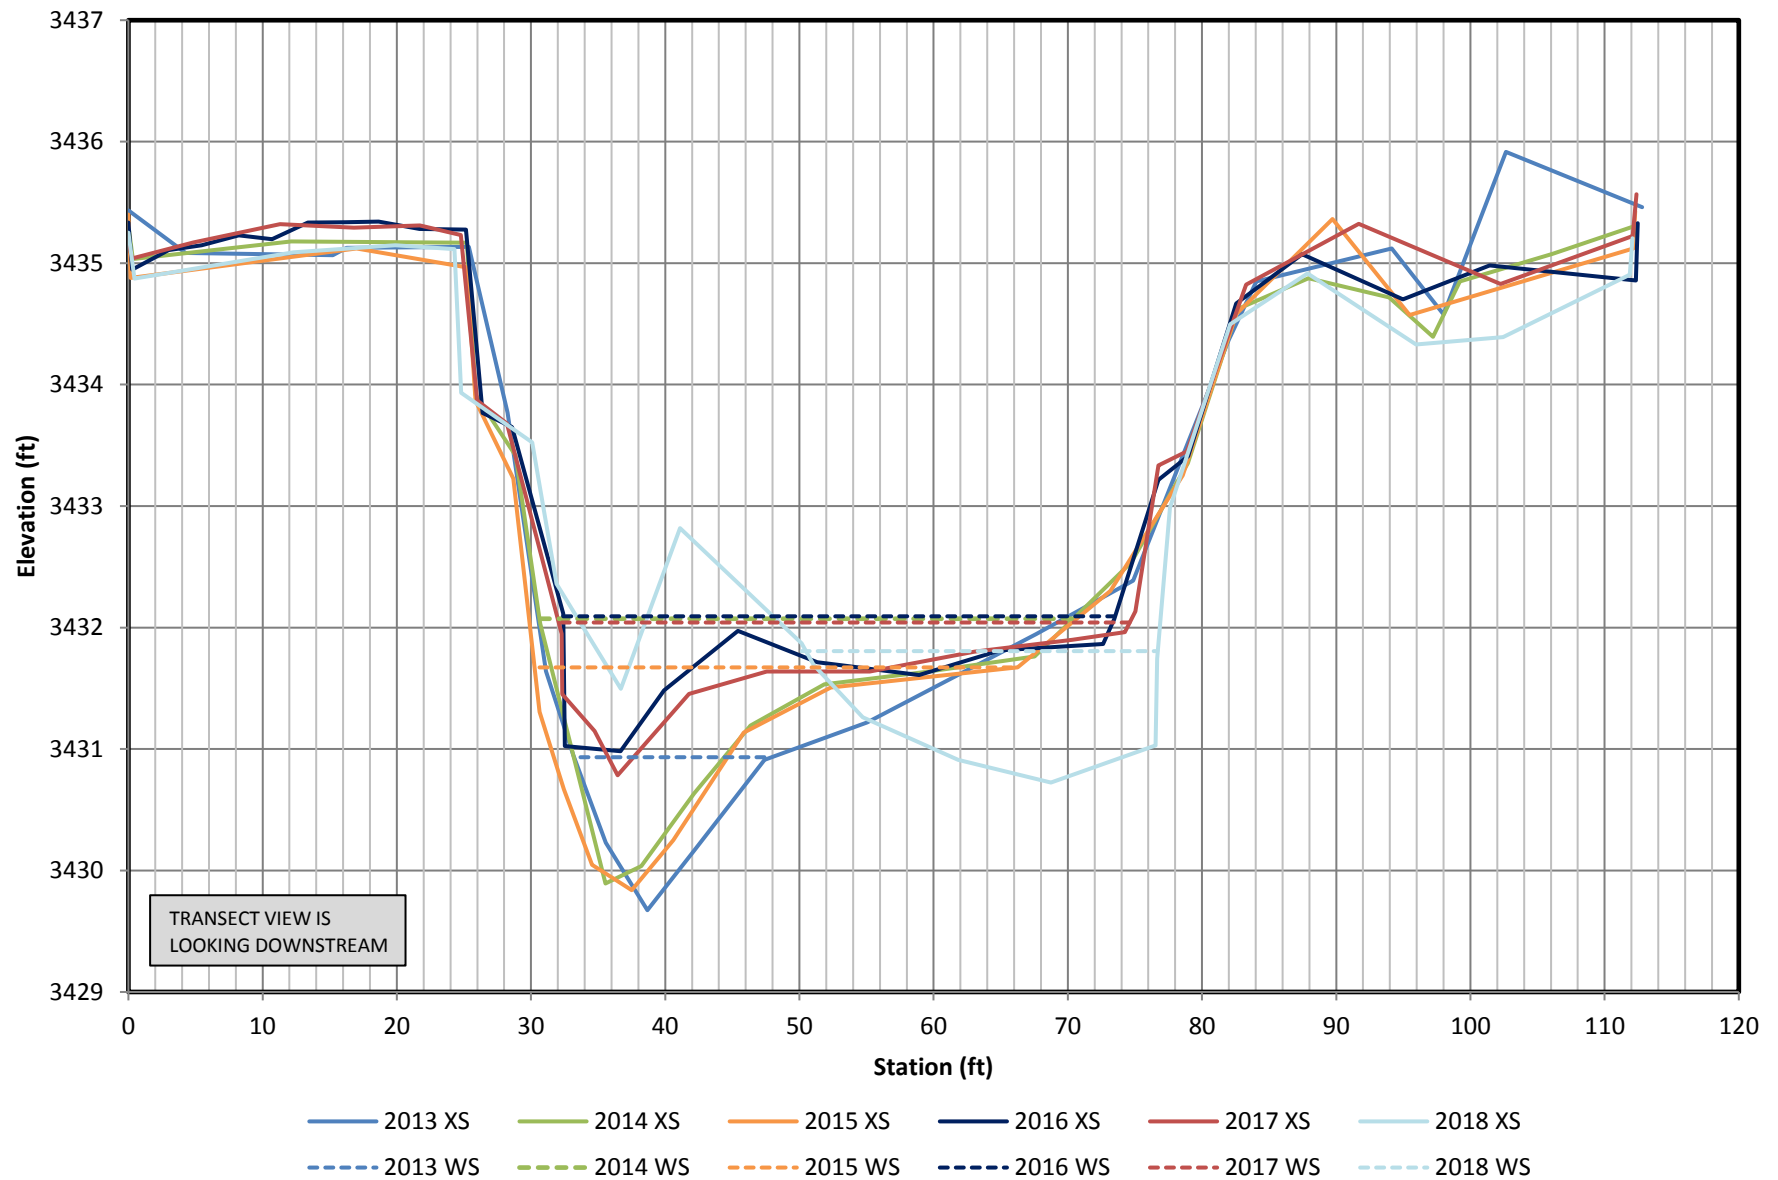
Mill Creek Transect #2 - Pool

Transect #2 was originally established at a pool adjacent to a woody debris jam formed along the left (north) bank. Between 2015 and 2017, a gravel deposit formed along the left bank which continued to form in 2018 causing the channel thalweg to shift over toward the right bank. The resulting scour against the right bank has developed a shallow pool at transect #2. The shift in thalweg location across the channel over the past six years at this transect provides additional evidence of a dynamic channel that adjusts over time as debris jams form and gravels deposit. The adjustment to the channel transect at this location is considered a natural response to frequent gravel deposits and bar development, which is commonly observed in high bedload streams. These adjustments are considered beneficial to the channel over time, as they provide a diversity in habitat complexity within the active channel.

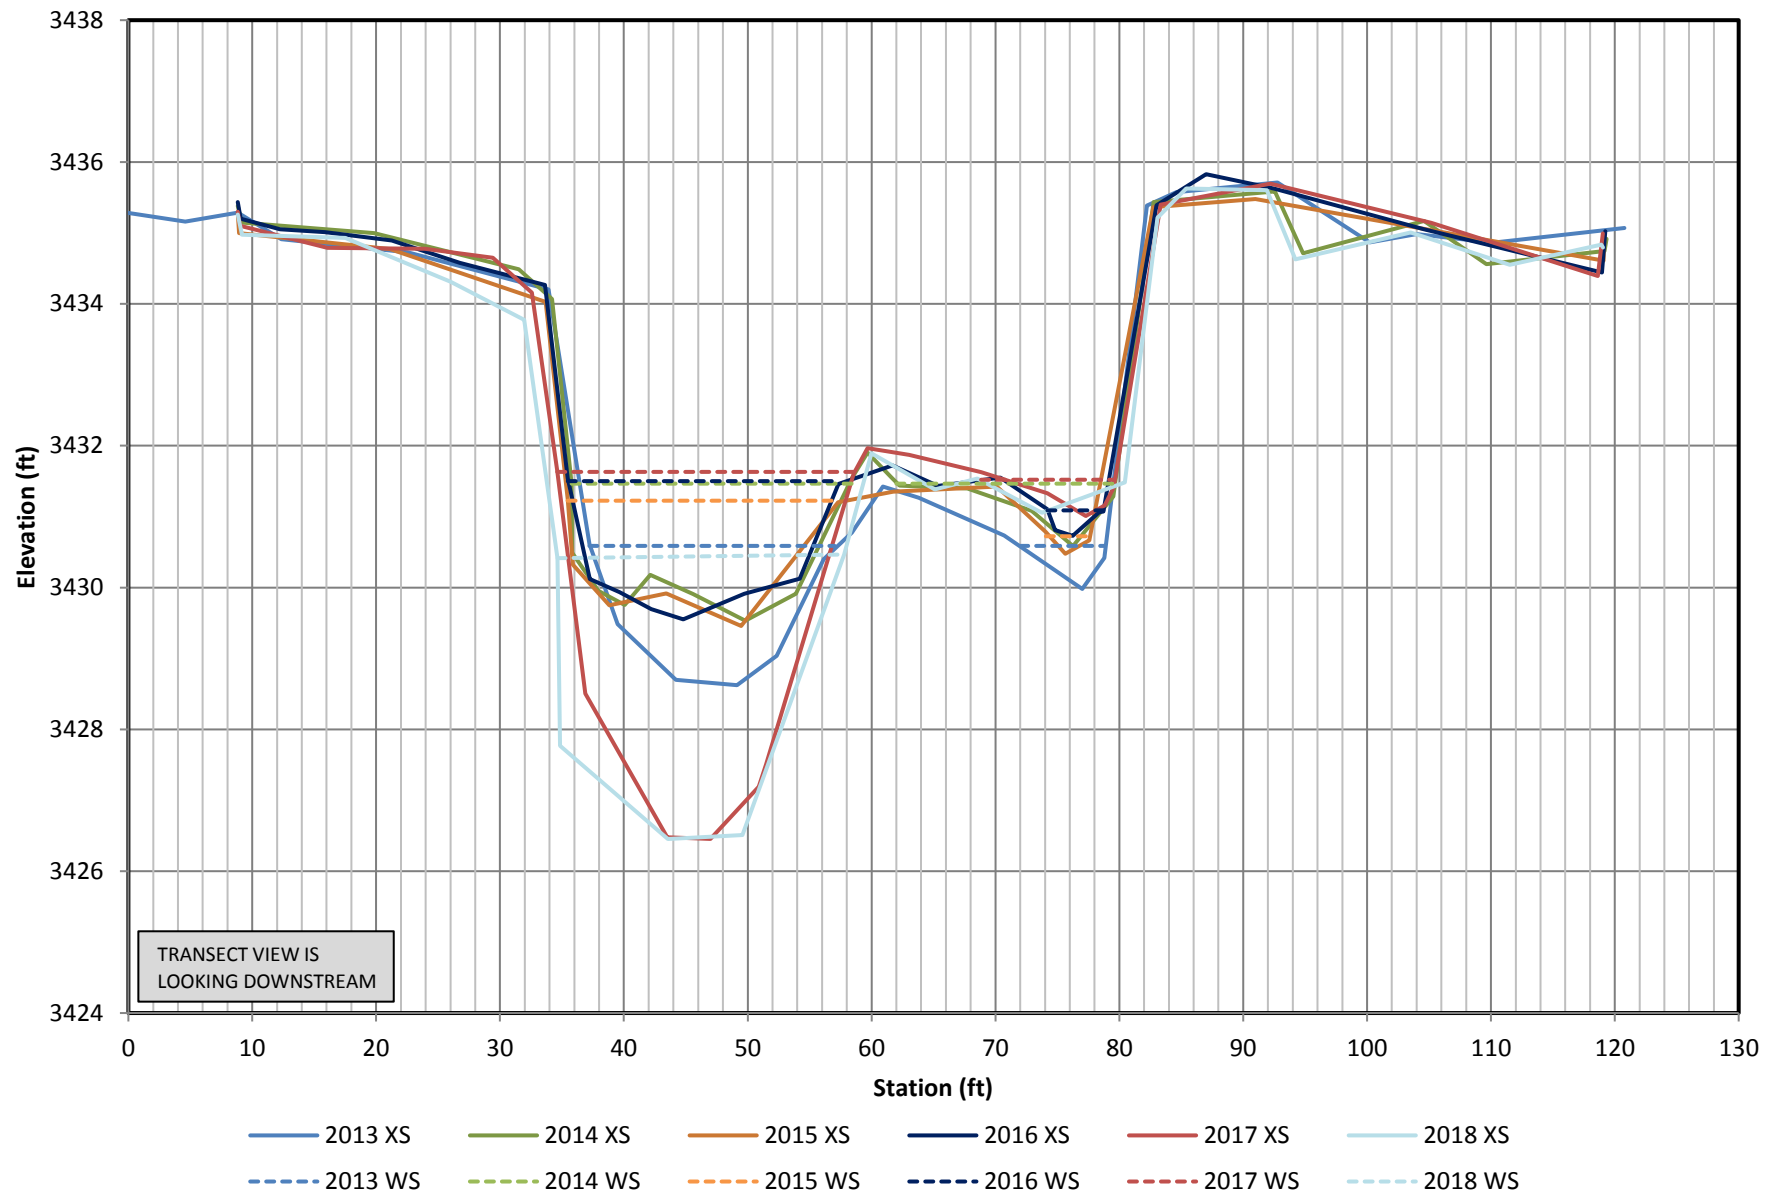
Mill Creek Transect #3 - Pool

In 2017, a deep pool developed at transect #3 adjacent to a woody debris jam. In 2018, this debris jam remained a scour feature in the center of the channel, and the deep pool adjacent to it is continuing to provide habitat complexity within the project reach. The pool here is three feet deeper than it was in 2016, and has remained the deepest pool within the project reach for the past two years.

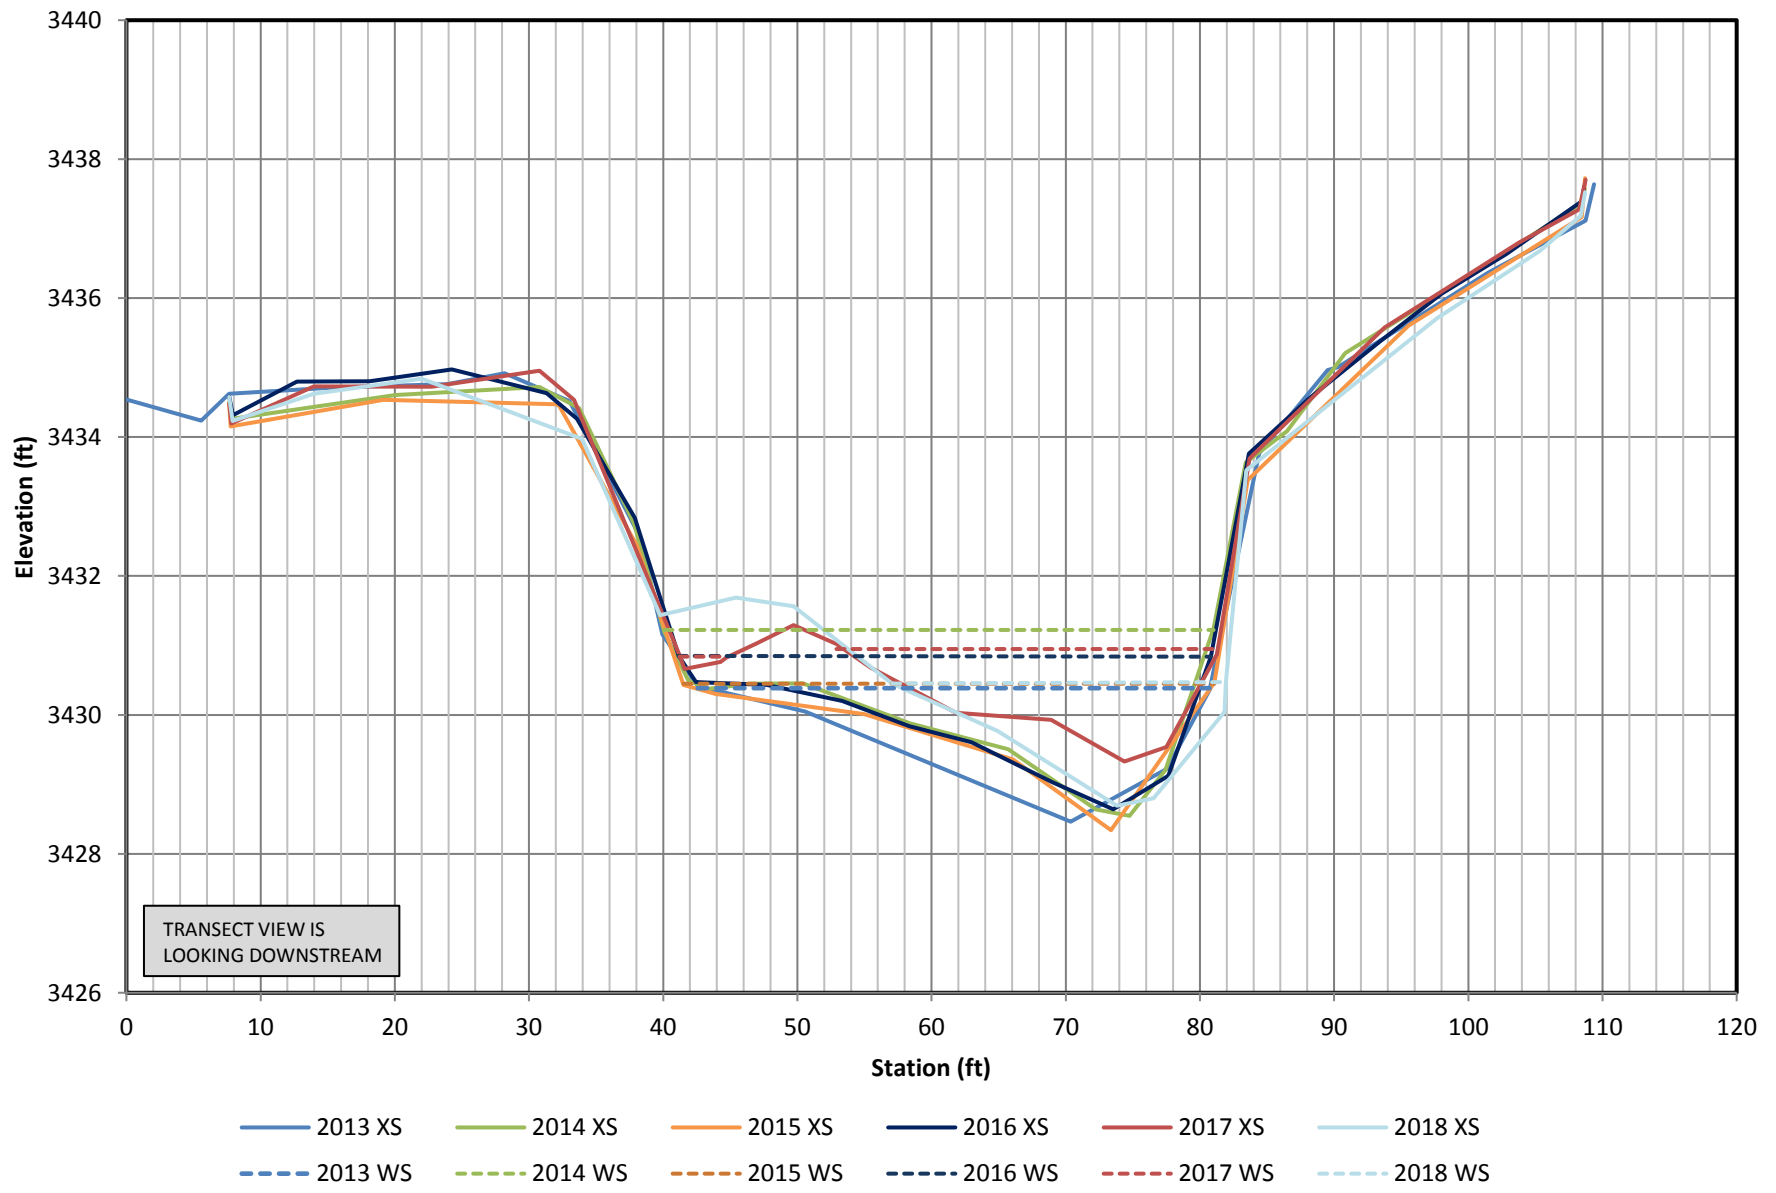
Mill Creek Transect #4 - Riffle

Transect #4 was originally positioned at a riffle just above the last meander bend upstream of the U.S. Highway 93 Bridge. Repeated surveys in 2018 reveal a developing point bar on the left bank and deeper thalweg along the right bank. Although the stream bed at this transect aggraded between 3 and 4 inches between 2016 and 2017; the channel did not continue to aggrade in 2018. Bar development along the left bank may eventually result in erosion along the right bank; however no erosion has been observed in the vicinity of transect #4 to date.

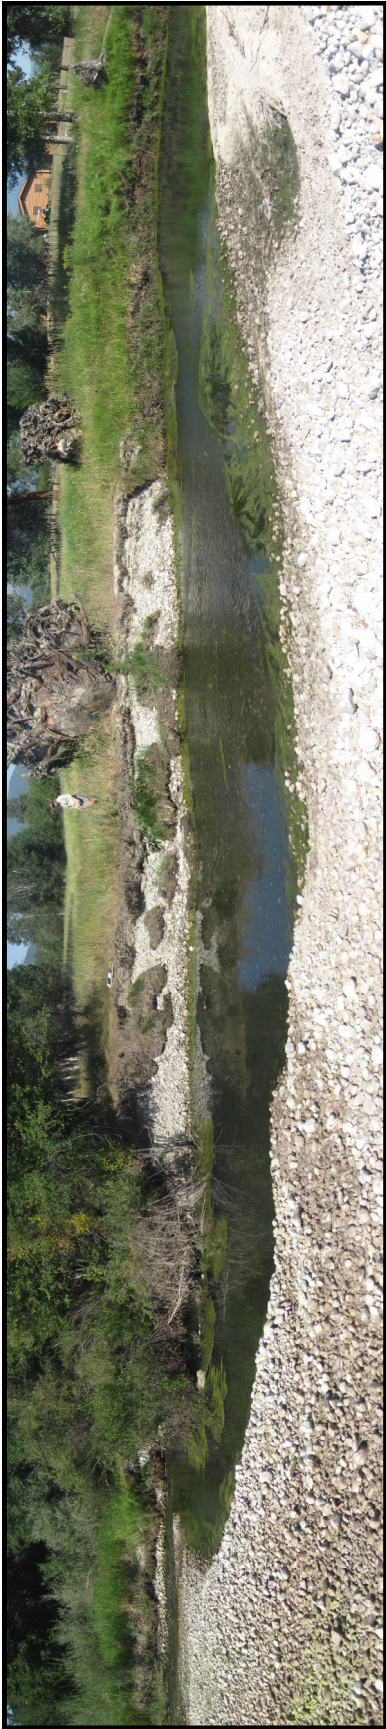
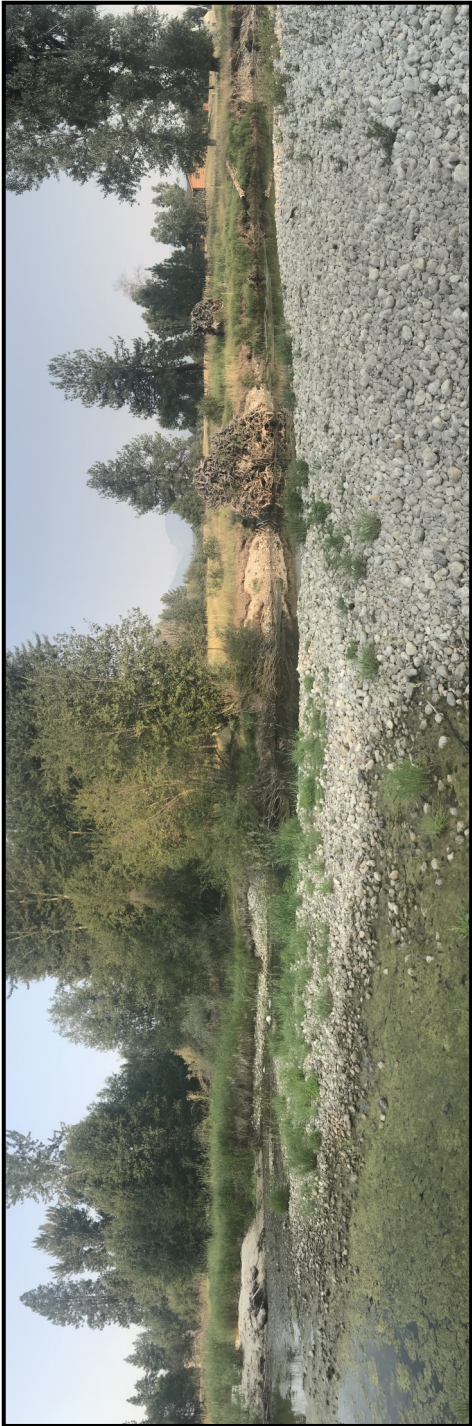
Banks EBL1 and EBL2 were originally documented as two separate eroding bank segments that combined into one long, 247-foot eroding bank in 2014 (herein referred to as EBL1-2). These eroding bank areas occur on private land upstream of the project reach, but have been documented in previous monitoring reports due to the potential of continued erosion affecting the project reach. The upper 150 feet of EBL1-2 has shown relatively little change over the past four monitoring years, has migrated northward approximately one to three feet since 2014 (see Additional Photo 1 in Appendix C). The lower 100 feet of the bank has migrated northward at a more rapid pace than the upper bank segment since 2014, especially in the vicinity of a large ponderosa pine tree that fell into the channel in 2016. The bank has migrated northward approximately 10 feet in the past two years adjacent to the exposed root ball of this tree (see Additional Photo 10 in Appendix C).

Bank erosion at EBL1-2 is due to an advancing point bar, which places the channel against a relatively high, herbaceously vegetated stream bank that runs along a relatively sharp meander bend. Root wads and large rocks placed on, but not keyed into the toe of the banks are causing increased scour against the bank toe. The vegetation community along these banks include speckled alder, Kentucky bluegrass, smooth brome, sedges, common yarrow, western-wheat grass, Canadian goldenrod, and ox-eye daisy, most of which are upland species less capable of withstanding erosive forces. The downstream end of the bank retreated between 3 and 7 feet from 2013 to 2014, an additional 2-5 feet from 2014 to 2015 and approximately 5-10 feet further since 2016. Based on the combination of eroding factors, severity of erosion along EBL1-2 is considered high. Although this bank has consistently retreated northward over the past six years, its effect on the restored channel segment below it does not appear to be consequential. Rather, the eroding bank has resulted in the recruitment of large woody debris to the channel, which is beneficial toward the development of diverse aquatic habitat.

Additional Photo 1: Upper end of eroding Bank EBL1 -2

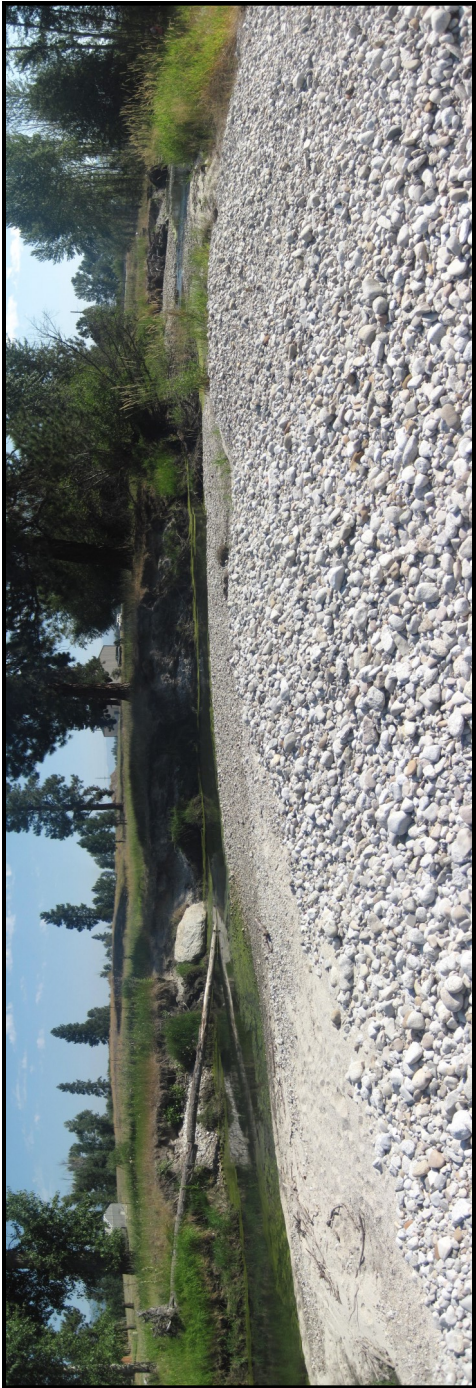
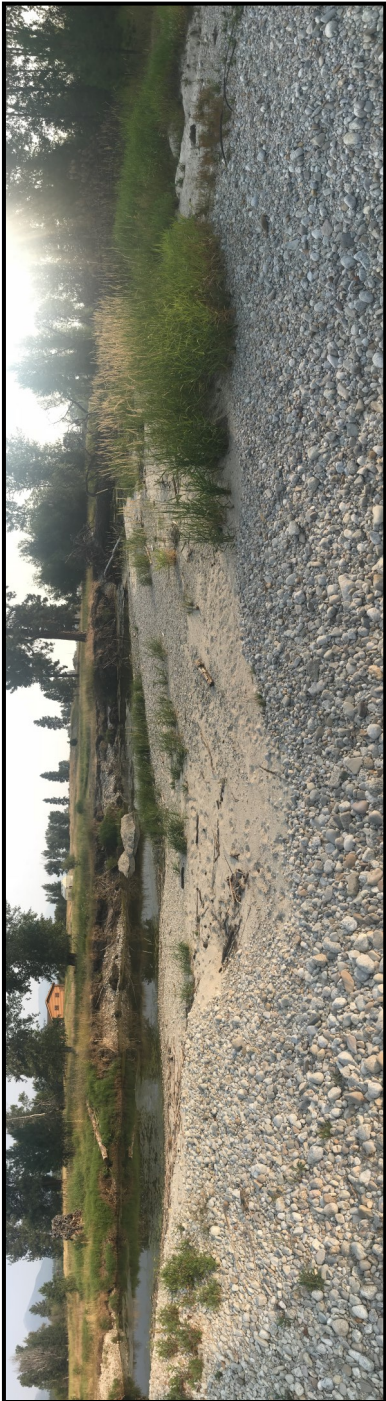
Eroding bank EBL1-2 has continued to advance northward, particularly near the downstream end of the eroding bank. Erosion along this bank has resulted in a large ponderosa pine tree falling into the channel in 2016, which has induced additional scour in the vicinity of the root ball and trunk. The bank has retreated northward approximately ten feet in the past two years near the downed tree, but otherwise has not jeopardized the project reach or any infrastructure. The fallen tree has resulted in more diverse habitat and the development of a deep pool immediately downstream.

Additional Photo 2: Lower end of eroding Bank EBL1-2

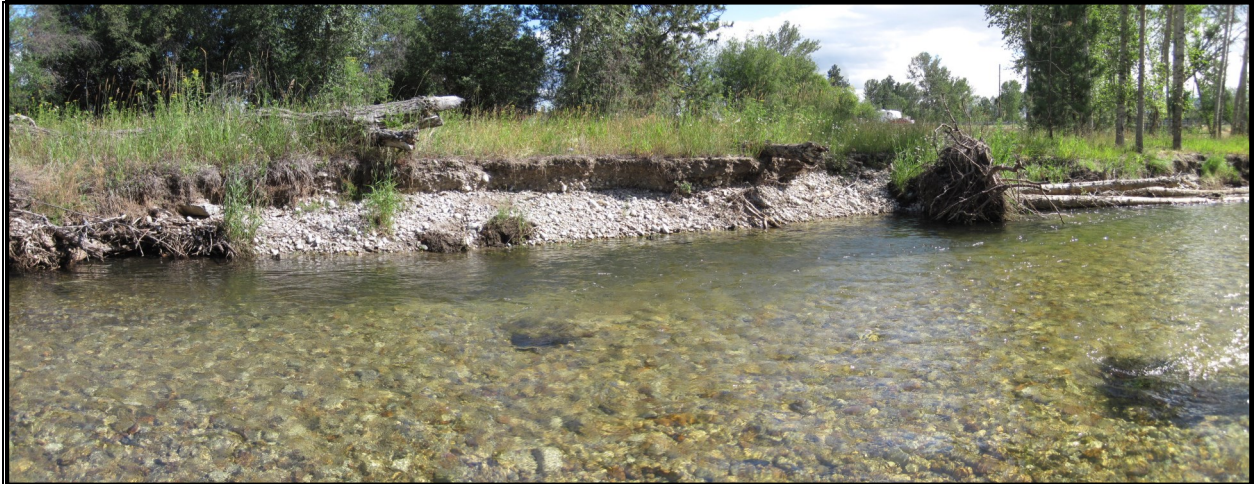
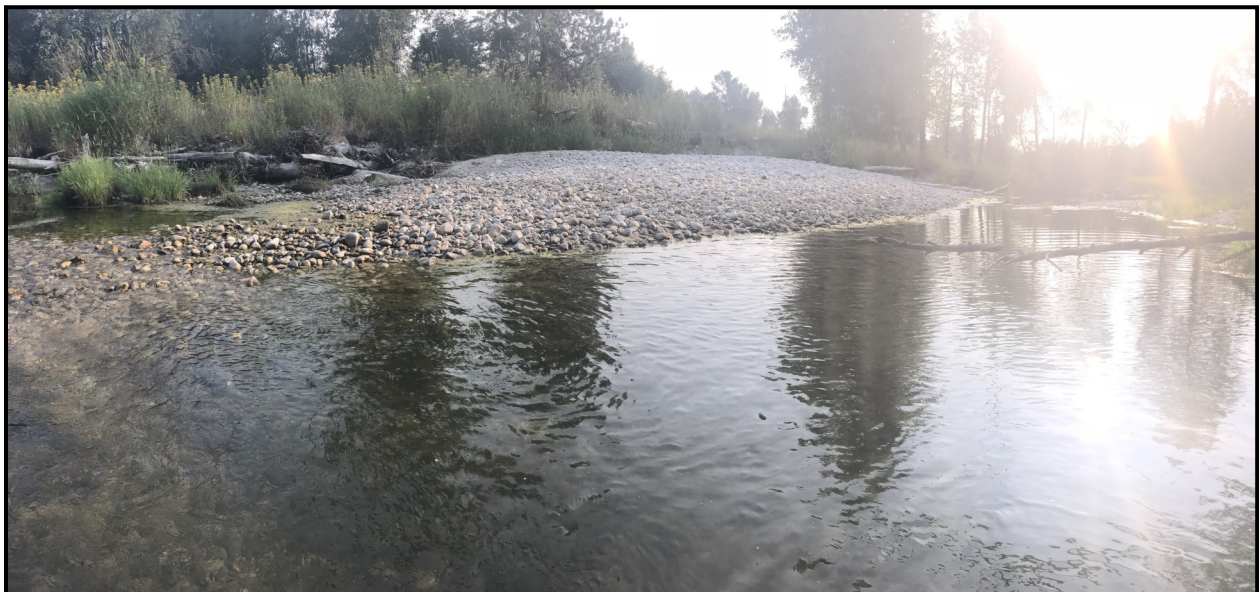
Signs of active erosion at EBL3 were originally observed in 2014 at the head of the former channel alignment which is now largely backfilled with gravel, cobble, and soil. Erosion was originally observed along approximately 90 feet of the bank between the upstream extent of the backfill and the root ball of a fallen tree. While gravel deposition

along this bank reduced the erosion between 2015 and 2017 (see Additional Photo 3), high flows in 2018 eroded approximately 30 feet of the bank toe along the downstream end of this bank (see Additional Photo 4). The vegetation community along this bank consists of short-awn meadow foxtail, white and red clover, Kentucky bluegrass, common tansy, and ox-eye daisy. Erosion along this bank occurred as a riffle developed just upstream, sending water toward the bank during high flows. The erosion is not jeopardizing the backfilled channel alignment, does not jeopardize any infrastructure, and is occurring as part of the channel naturally adjusting. As a result, no corrective actions are warranted at this location.

Additional Photo 3: Upper section of Eroding Streambank EBL3

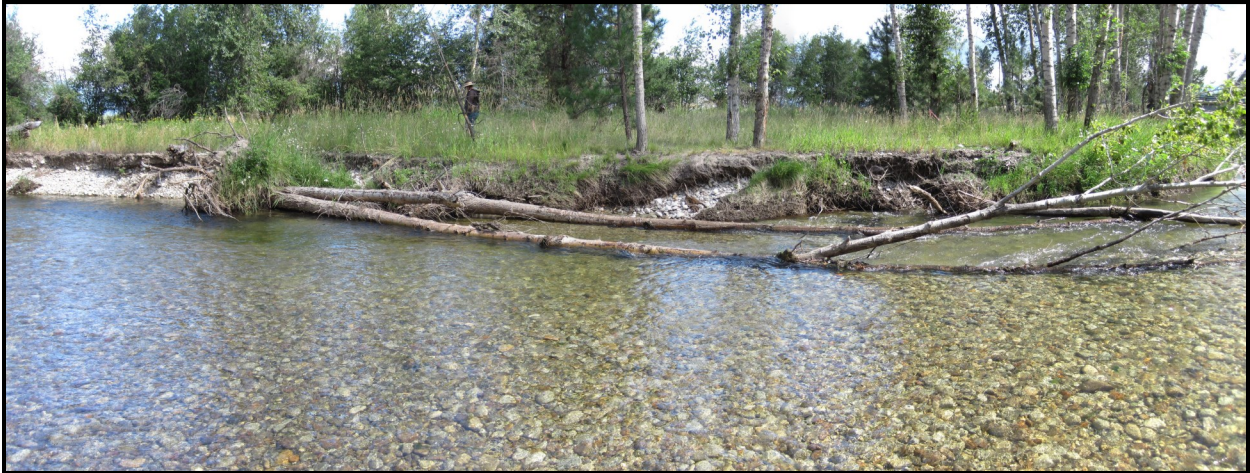
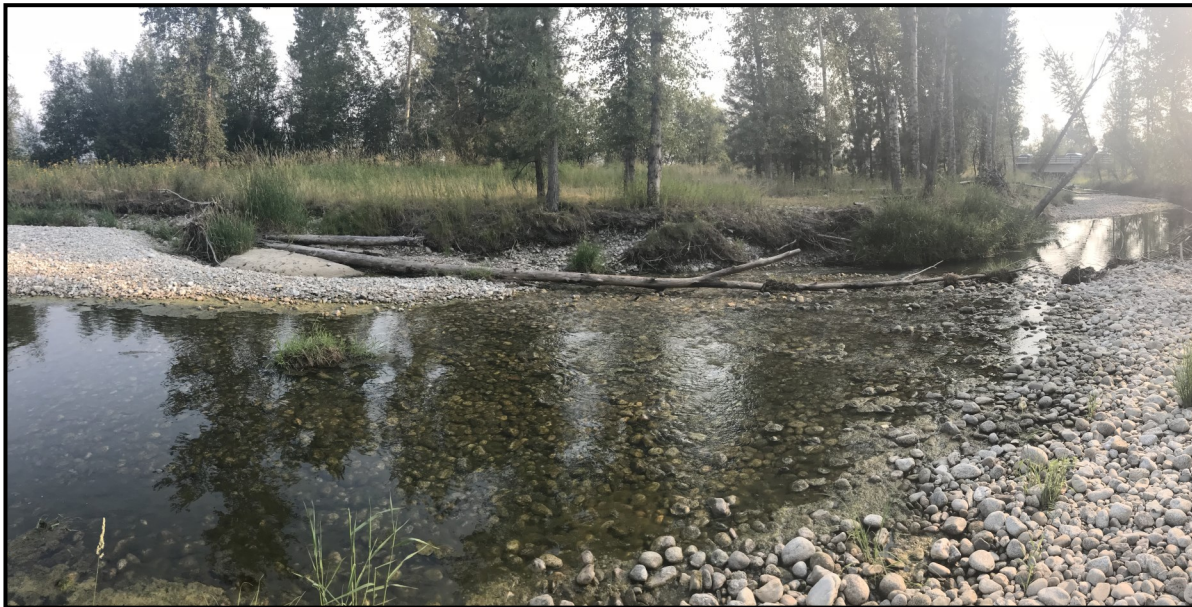
Additional Photo 4: Lower section of Eroding Streambank EBL3

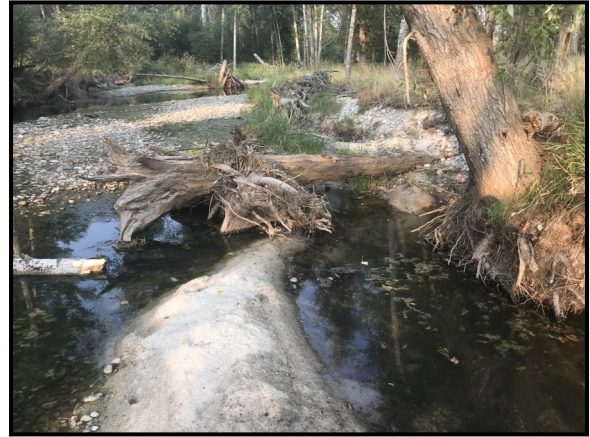
Lateral erosion at bank EBL4 has continued the past three years, as evidenced by a log jam forming adjacent to the bank causing localized scour (see Additional Photo 5 in Appendix C). The bank has retreated approximately two feet in the past year and 8-10 feet in the past six years, although the eroding bank length has not increased. Bank instability at this location was potentially caused by removal of the trees for use in log revetment construction, or by natural channel adjustments and debris jams forming following construction. These debris jams are considered beneficial to the restored channel alignment, as they improve habitat complexity and generate pool scour features to the benefit of fish. The dominant vegetation along the bank includes reed canary grass and smooth brome, the former of which offers dense roots capable of withstanding erosion more effectively than most species. Erosion severity along this bank is considered low, as it does not jeopardize any infrastructure elements or the newly installed bridge downstream. As a result of the erosion occurring from natural channel adjustments, no corrective actions are warranted at this location.

Additional Photo 5: Eroding streambank EBL4

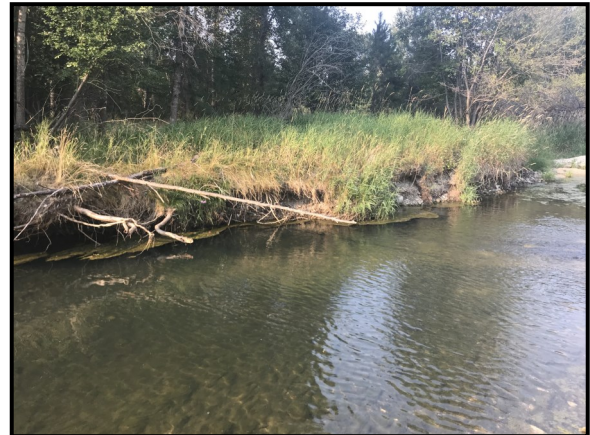
Erosion at EBR2 was originally noted in 2014 along 65 feet of the channel across from the head of the deactivated stream channel. Erosion at this location was tied to channel adjustments and scour along the outside of a meander. Additional erosion along this bank segment was not observed between 2015 and 2017; however the bank showed signs of erosion again in 2018 including undercutting, slumping sod mats, and root exposure (see Additional Photo 7 in Appendix C). As such, a 40-foot segment of this bank segment returned to the list of actively eroding banks. While this bank began eroding again in 2018, movement of the bank is not jeopardizing any infrastructure and is occurring as part of natural channel adjustments. As such, no corrective actions are warranted along this bank.

Additional Photo 7: Eroding streambank EBR2

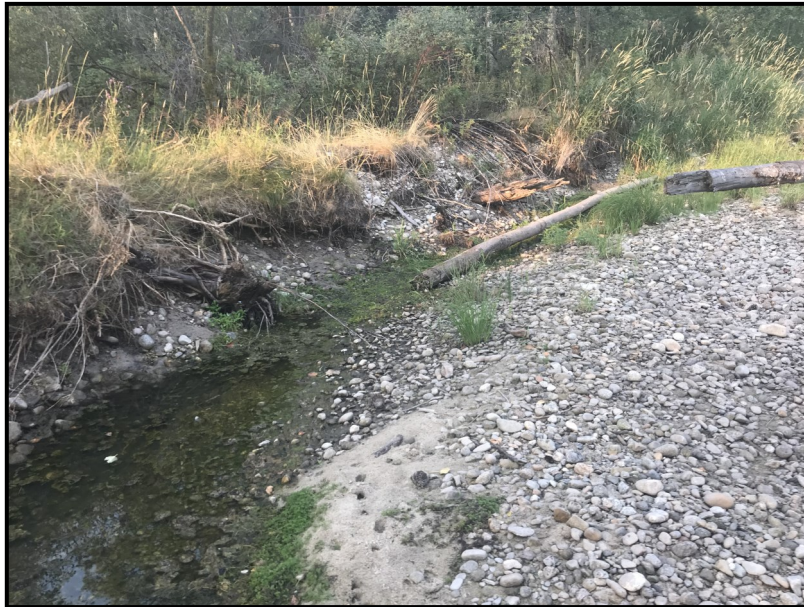
Eroding bank EBR3 was observed in 2017 adjacent to a woody debris jam and was characterized by upper bank sloughing and toe scour. Vegetation along the upper bank

includes reed canary grass, oxeye daisy, woods rose, wheatgrass, brome, small cottonwood saplings, and young willows. The bank did not appear to retreat further during 2018 flows, as the adjacent debris jam broke up and a gravel bar has formed adjacent to the bank (Additional Photo 8 in Appendix C).

Additional Photo 8: Eroding Bank EBR3—2018

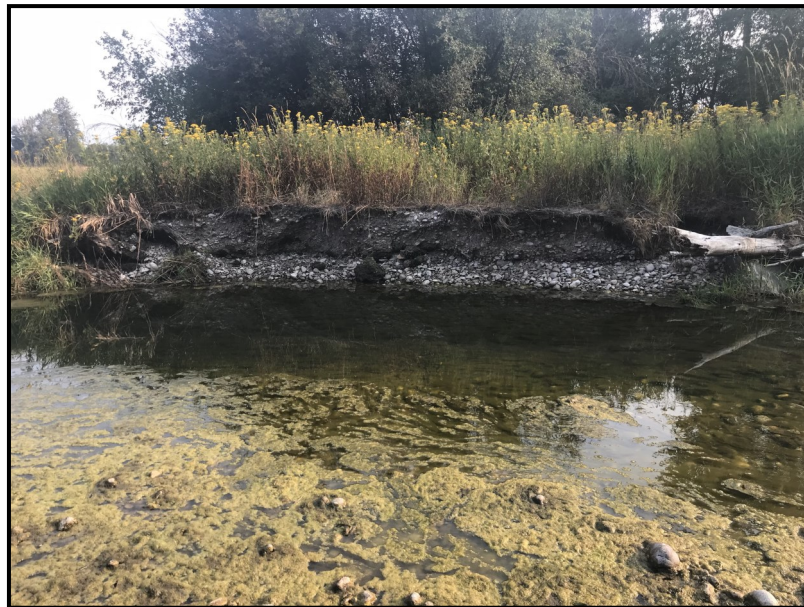
A newly eroding bank segment was observed in 2018 on the left bank near the upstream end of the monitoring reach (EBL5). Erosion along this 20-foot bank segment is due to gravel depositing on the inside of the meander bend and just below the downed ponderosa pine tree. This deposit focuses high flows toward the left bank, which is primarily vegetated with upland species including short-awn meadow foxtail, white and red clover, Kentucky bluegrass, common tansy, and ox-eye daisy. This bank retreated approximately four feet in the past year, as evidenced by bank transect #1.

Additional Photo 9: Eroding bank EBL5—2018
