MONTANA DEPARTMENT OF TRANSPORTATION STREAM MITIGATION MONITORING REPORT

*Mill Creek
Ravalli County, Montana*

*Project Constructed: 2011
Monitoring Report #6: December, 2018*

MDT Project Number: NH7-(114)59
Control Number: 2015004

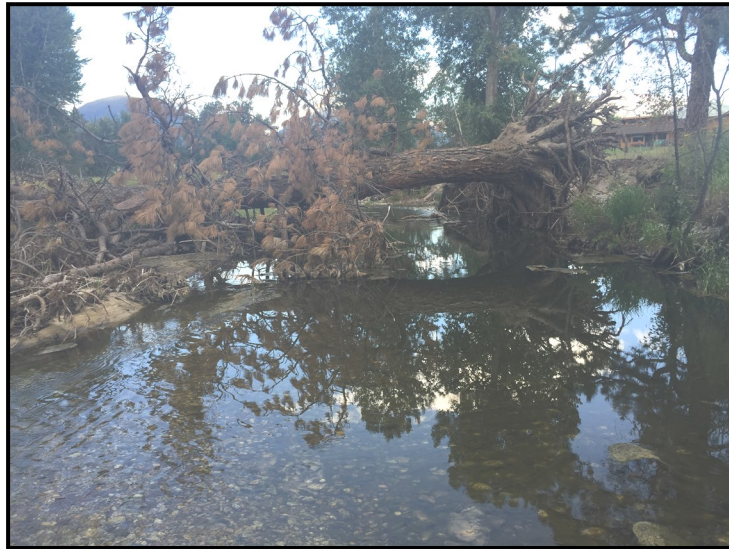
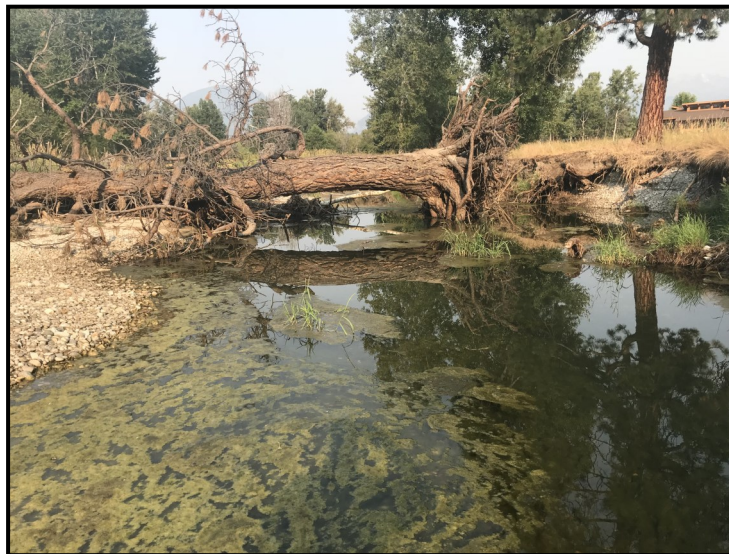
Additional Photo 10: Ponderosa pine in channel near downstream end of EBR2
