MONTANA DEPARTMENT OF TRANSPORTATION STREAM MITIGATION MONITORING REPORT

*Mill Creek
Ravalli County, Montana*

*Project Constructed: 2011
Monitoring Report #7: December, 2019*

MDT Project Number: NH7-(114)59
Control Number: 2015004

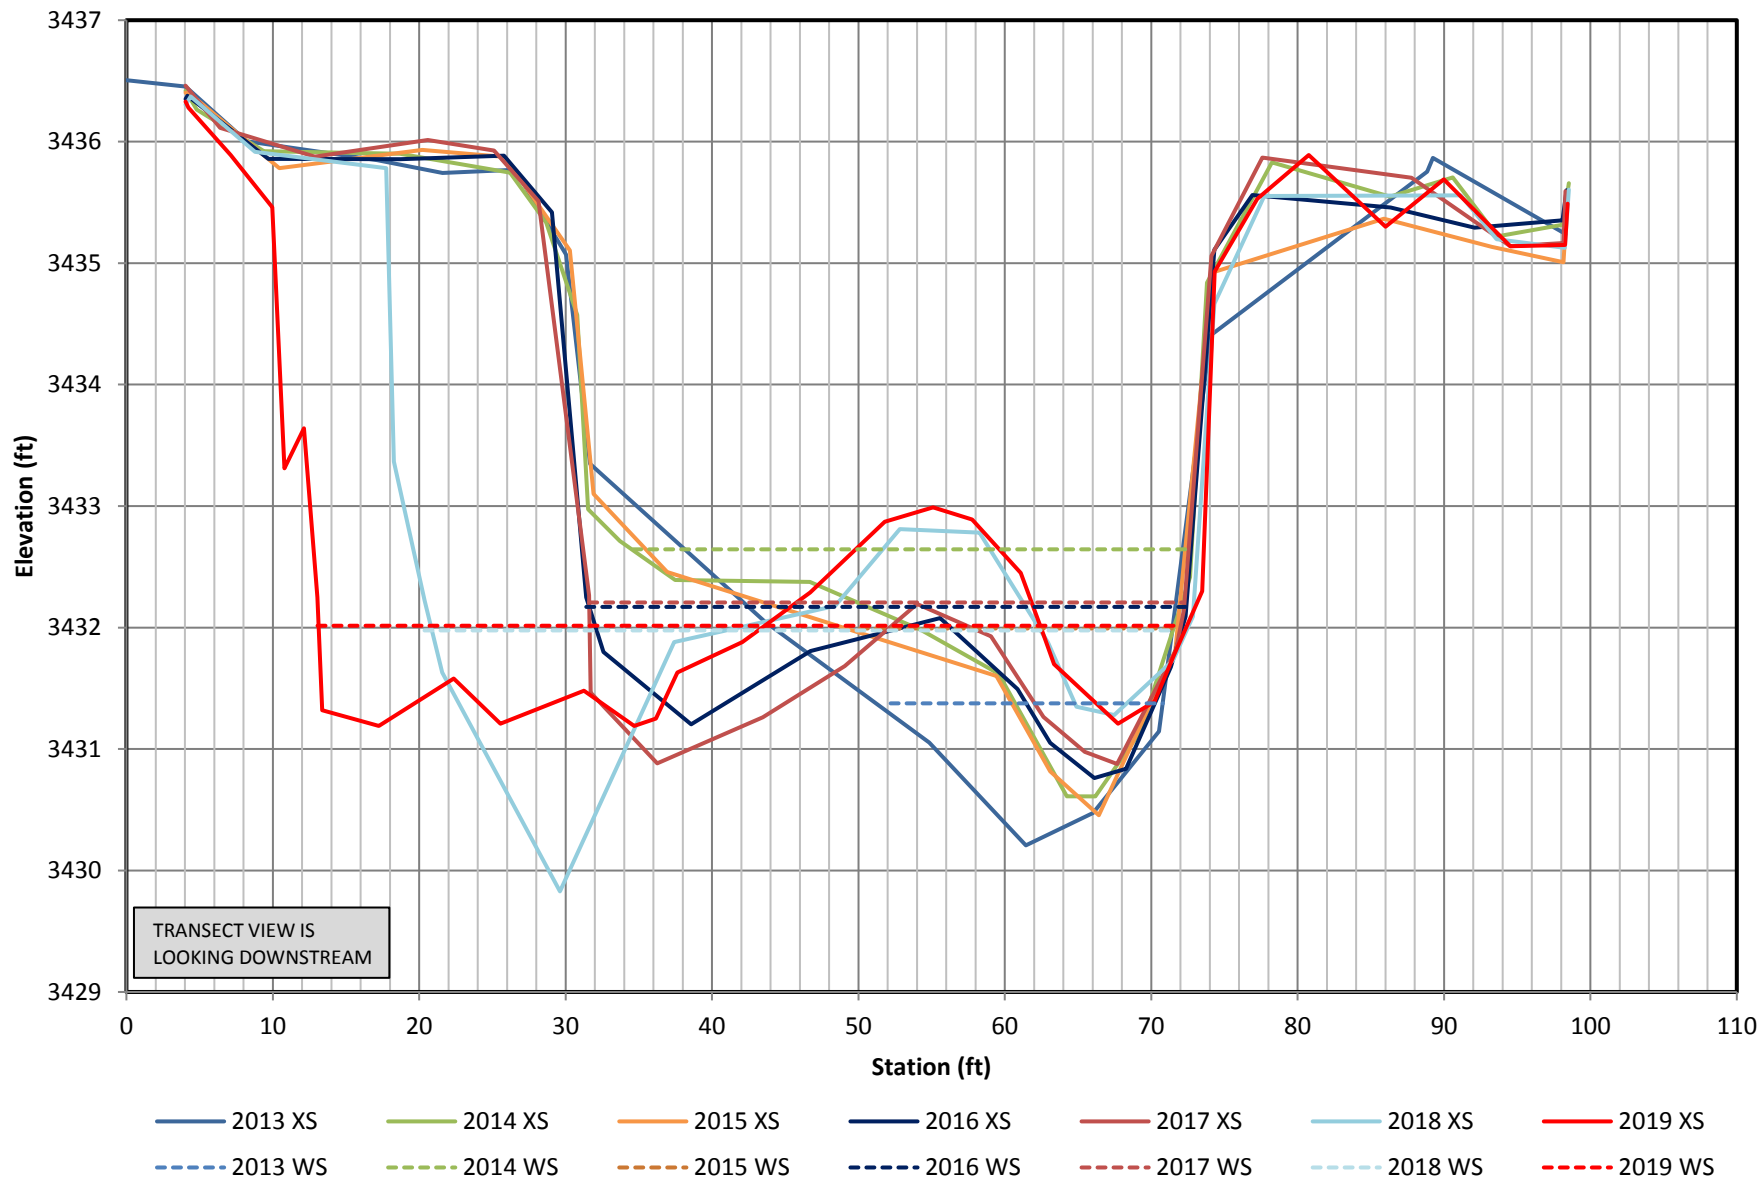
Mill Creek Transect #1 - Riffle

While transect #1 was originally positioned at a riffle, survey data from 2013-2015 indicated the channel transitioned to more of a pool feature by forming a point bar on the left side of the channel and thalweg near the right bank. In 2016, a large ponderosa tree fell into the channel just upstream from transect #1, resulting in a mid-channel gravel bar deposit forming near this transect. In 2017, the mid channel bar further developed, causing a split flow. In 2018, additional deposition closer to the right bank forced flows against the left bank, which scoured a relatively deep pool feature. In 2019, the pool partially filled and the left bank eroded northward roughly 10 feet. Monitoring across this transect over the past seven years depicts an actively adjusting channel due to both depositional and scouring processes, and transitions from pool to riffle features at specific locations (see photos of transect #1 on pages C-13 through C18).

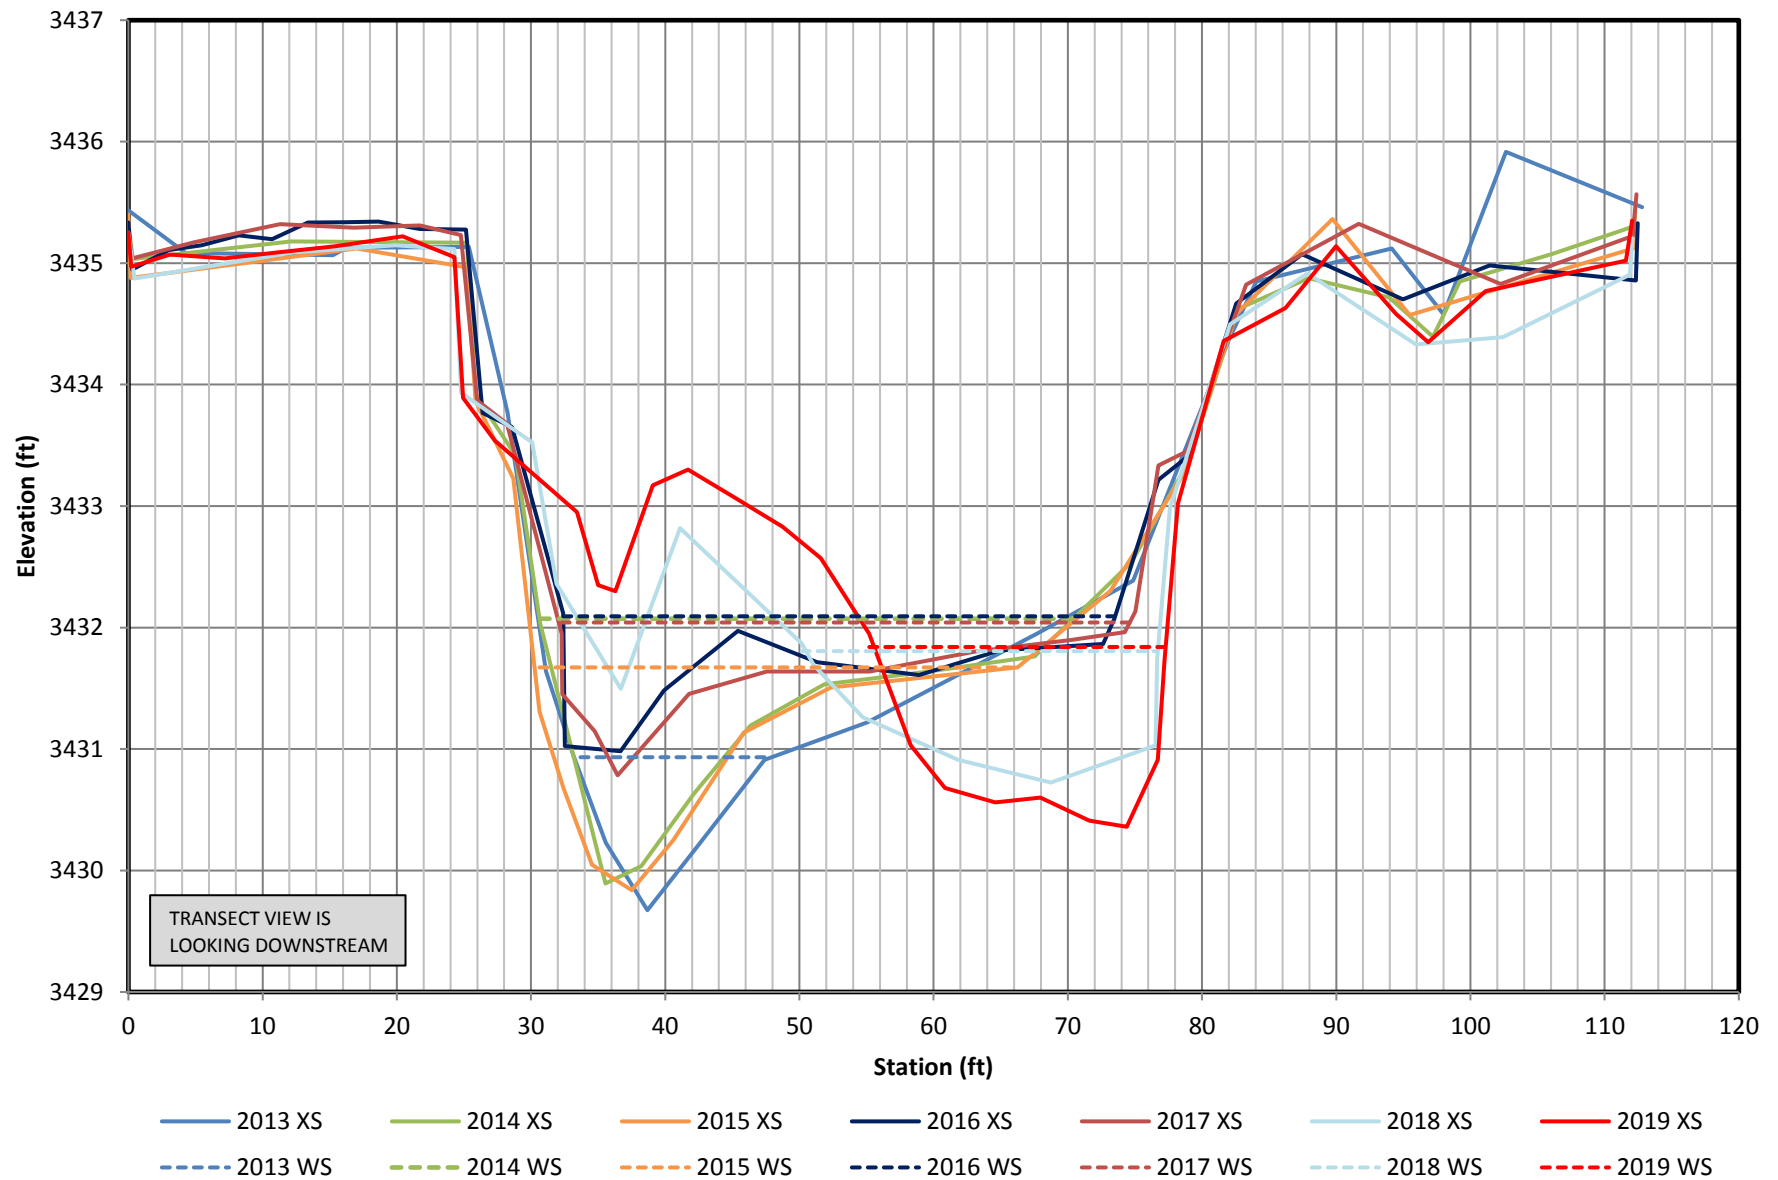
Mill Creek Transect #2 - Pool

Transect #2 was originally established at a pool adjacent to a woody debris jam formed along the left (north) bank. Between 2015 and 2017, a gravel deposit formed along the left bank which continued to form in 2018, causing the channel thalweg to shift over toward the right bank. This gravel bar has enlarged, creating a pool on the right side of

the channel (see photos of transect #2 on pages C-19 through C22). The shift in thalweg location across the channel at this transect provides additional evidence of the dynamic scour and depositional processes occurring in Mill Creek over time. The adjustment to the channel transect at this location is considered a natural response to frequent gravel deposits and bar development, which is commonly observed in high bedload streams. These adjustments are considered beneficial to the channel over time, as they provide a diversity in habitat complexity within the active channel.

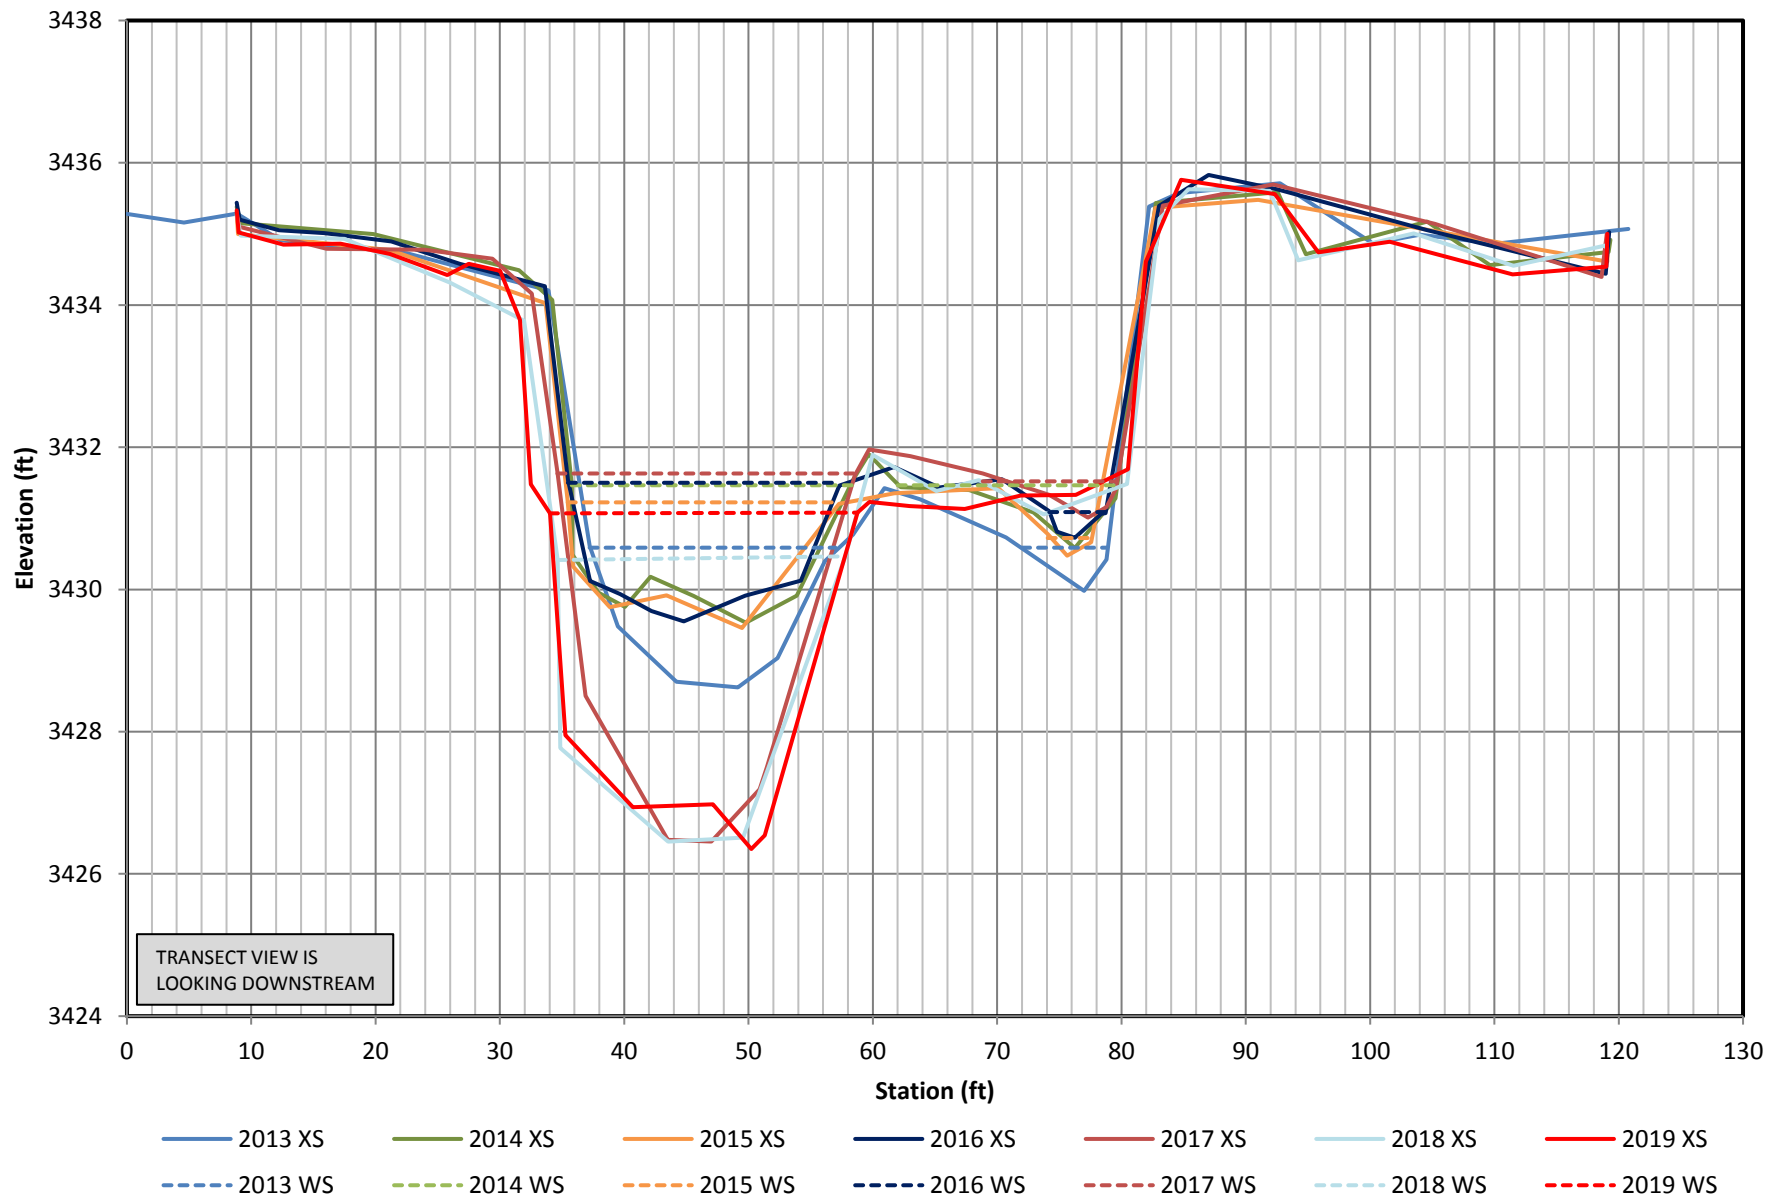
Mill Creek Transect #3 - Pool

In 2017, a deep pool developed at transect #3 adjacent to a woody debris jam. This pool has maintained itself over the past two years due to scour against the adjacent woody debris jam (see photos of transect #2 on pages C-23 through C26). The pool here is three feet deeper than it was in 2016, and has remained the deepest pool within the project reach for the past three years.

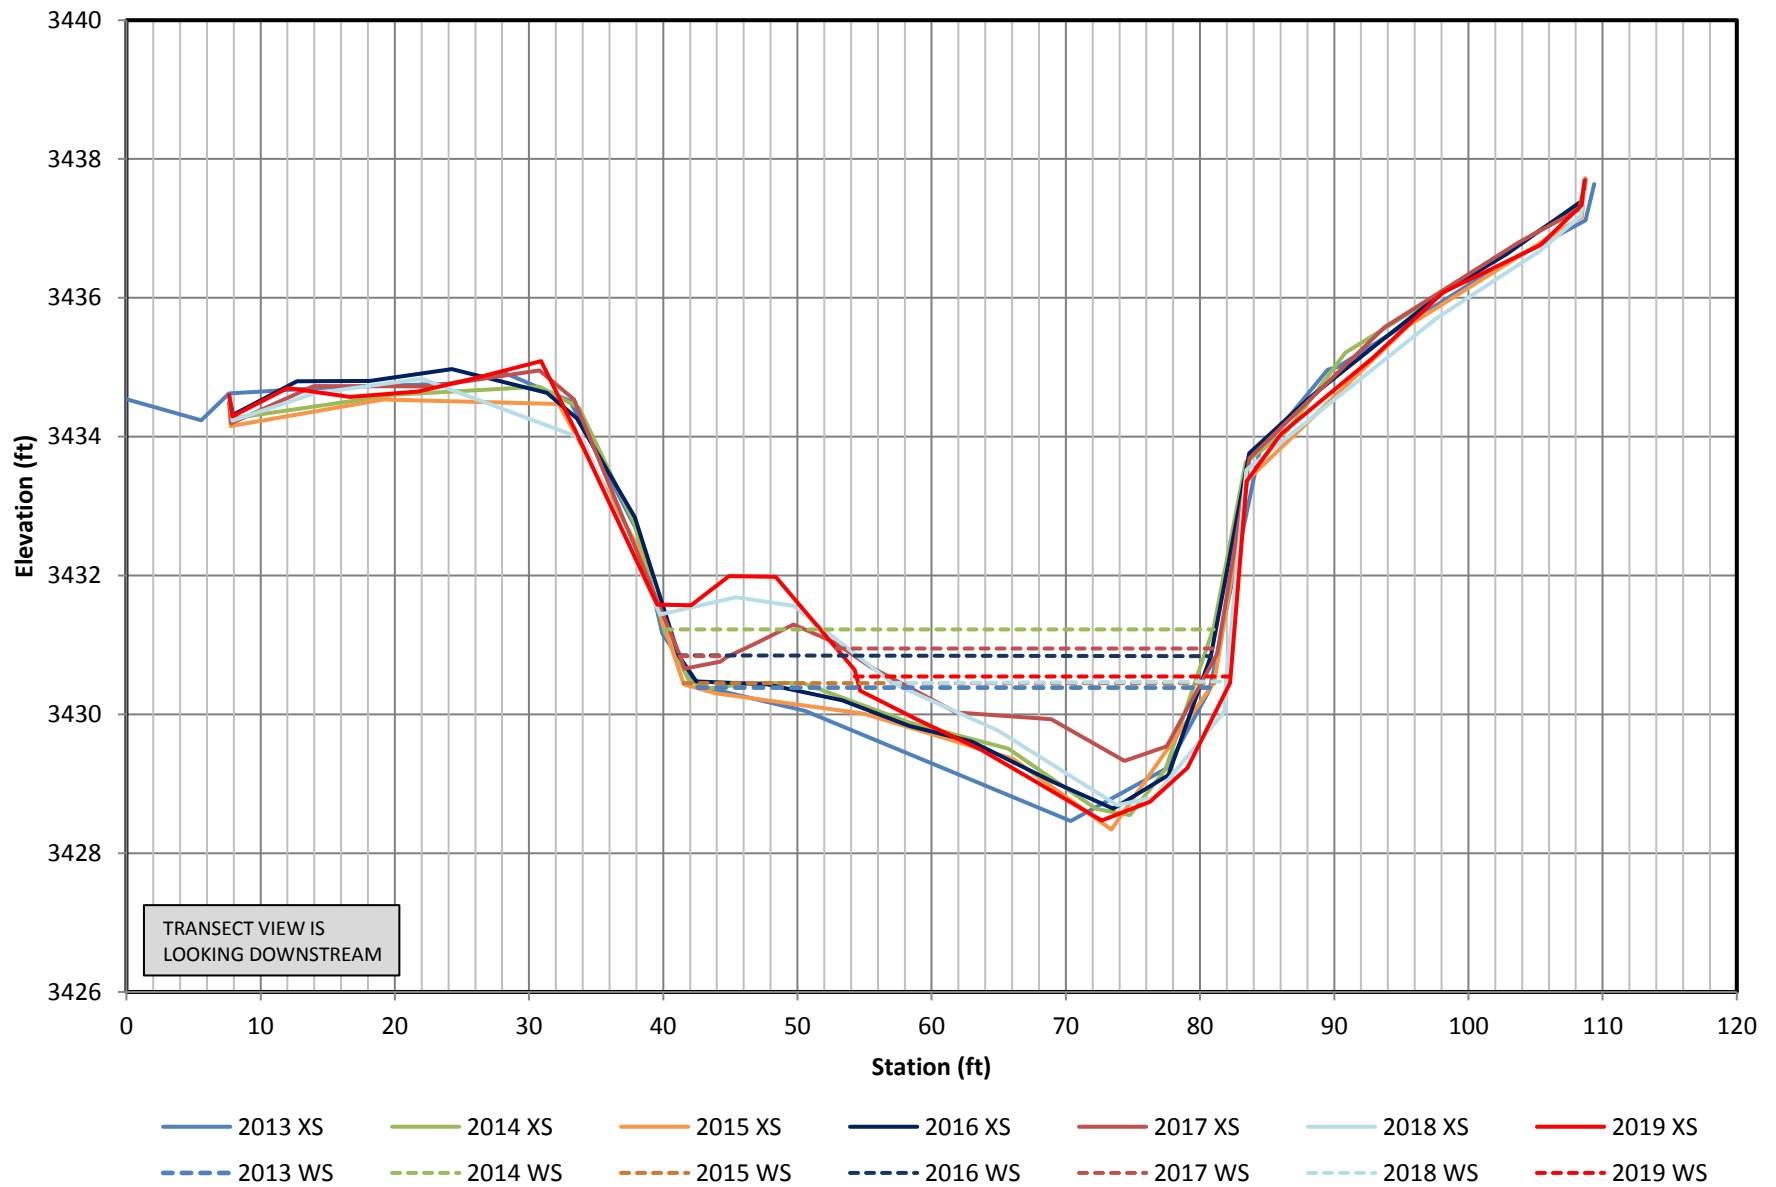
Mill Creek Transect #4 - Riffle

Transect #4 was originally positioned at a riffle just above the last meander bend upstream of the U.S. Highway 93 Bridge. A point bar has continuously developed on the left bank, with deeper thalweg along the right bank. As a result, this transect has developed into a shallow pool. Bar development along the left bank may eventually result in erosion along the right bank; however no erosion has been observed in the vicinity of transect #4 to date (see photos of transect #2 on pages C-27 through C30).

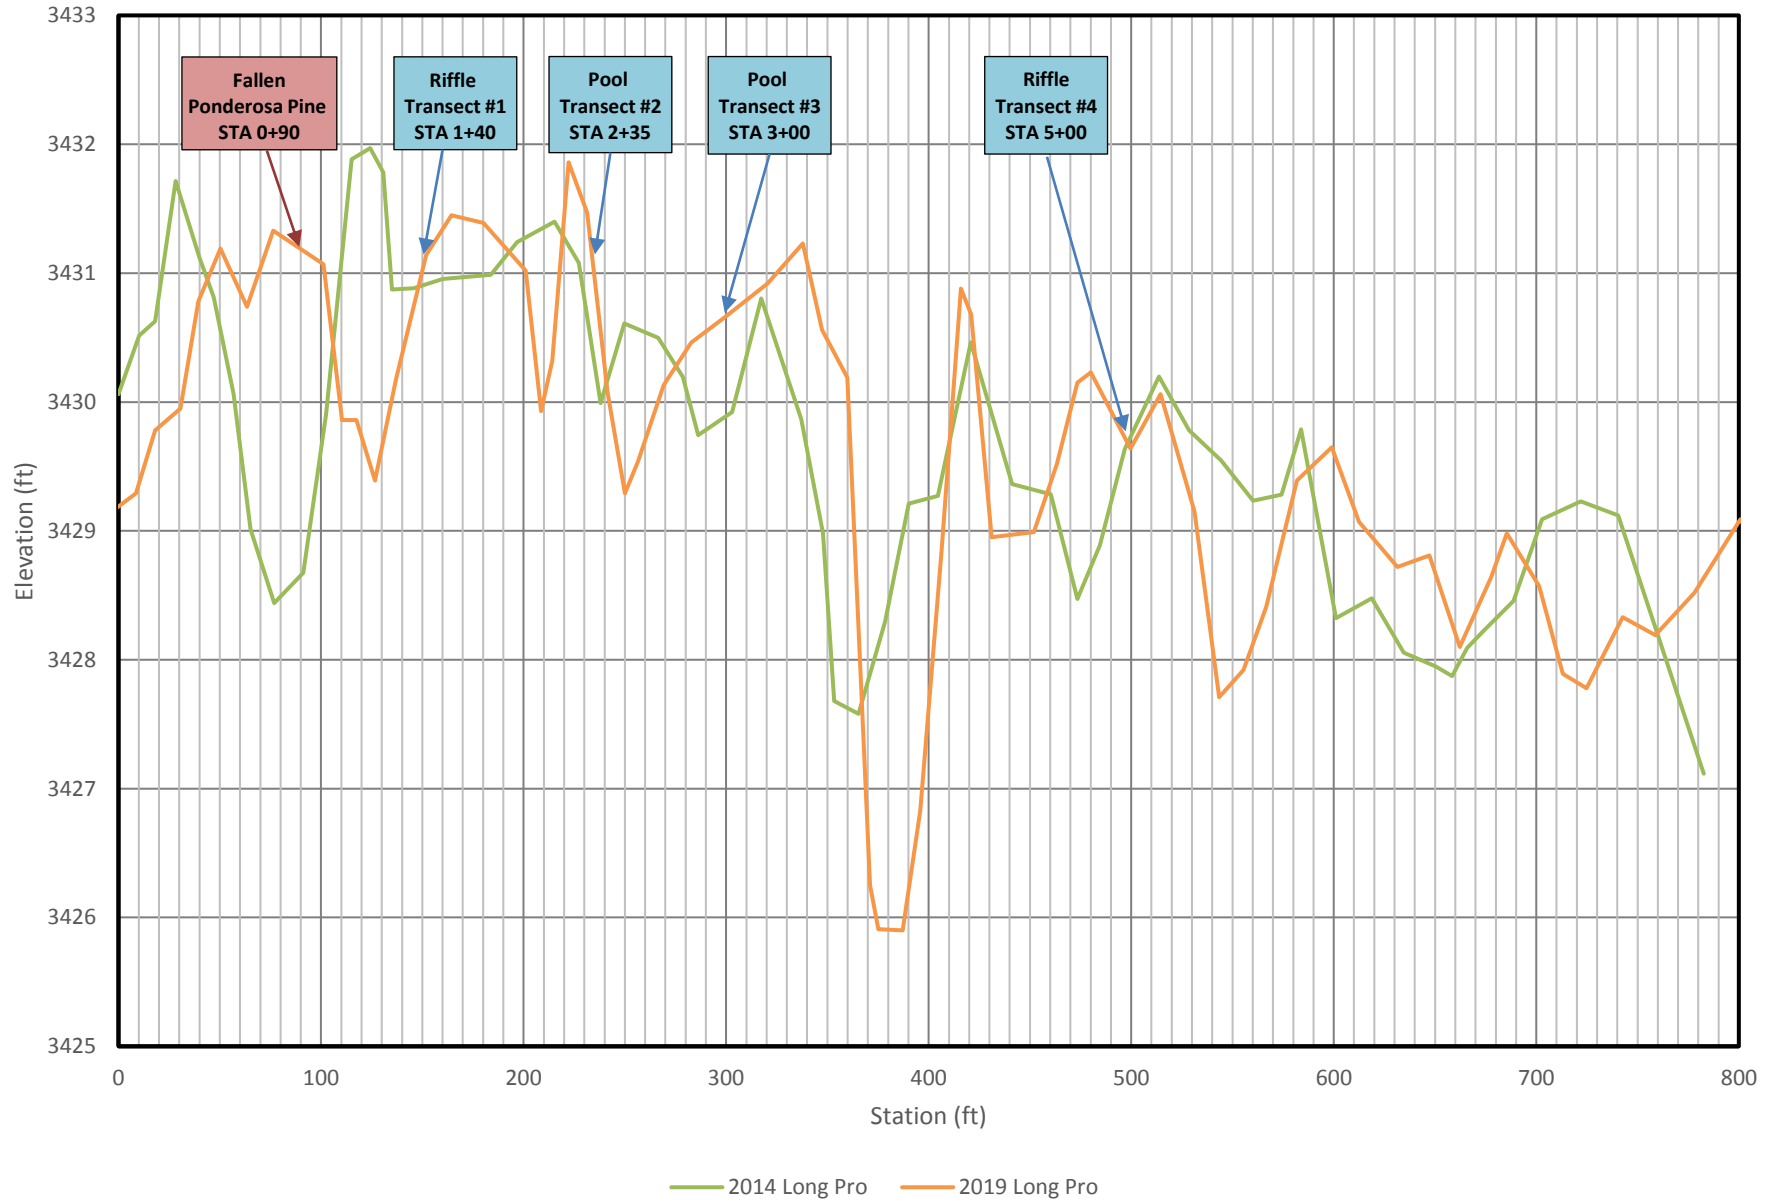
Mill Creek Longitudinal Profiles: 2014 and 2019

The longitudinal profile of the channel indicates the presence of several pool and riffle features, which are adjusting spatially as the channel reacts to incoming gravel and woody debris. Two deep pools exist within the project reach, both of which have been observed to hold schools of trout. Five shallower pools exist, and are formed by scour against the stream banks and smaller debris. Overall, the project reach indicates a healthy diversity of aquatic habitat features, and has remained stable since 2014. No signs of aggradation or degradation exist, and the reconstructed channel appears to be maintaining a relatively consistent gradient since monitoring efforts began.

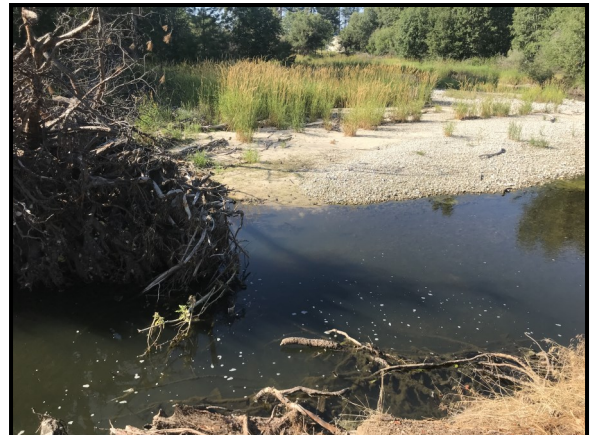
Photo Point 4.2: View across stream channel toward south bank. **Compass:** 180 (South)
Note: toppled Ponderosa pine tree obscures view on left side of photo

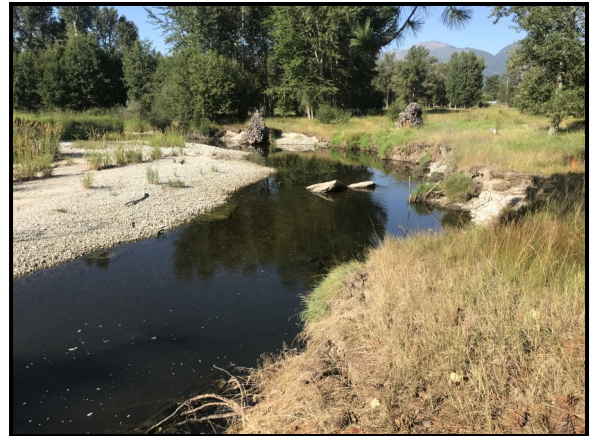
Photo Point 4.3: View of point bar formation from Photo Point 4. **Compass:** 225 (Southwest)

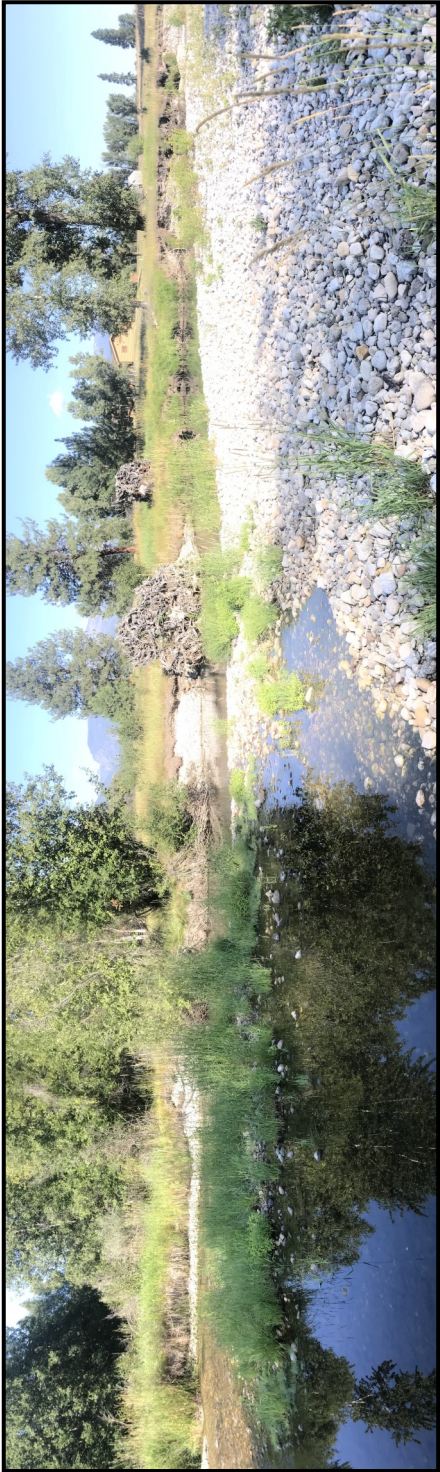
Banks EBL1 and EBL2 were originally documented as two separate eroding bank segments that combined into one long, 247-foot eroding bank in 2014 (herein referred to as EBL1-2). This eroding bank occurs on private land upstream of the project reach, but has been documented in previous monitoring reports due to the potential of continued erosion affecting the project reach. The upper 150 feet of EBL1-2 has shown relatively little change over the past four monitoring years, and has shown a bank retreat rate of between 0.2 and 0.6 feet per year (see Additional Photo 1 in Appendix C). The lower 100 feet of the bank has migrated northward at a more rapid pace than the upper bank segment, especially in the vicinity of a large ponderosa pine tree that fell into the channel in 2016. The bank has migrated at a rate of 6-7 feet/year for the past three years adjacent to the exposed root ball of this tree (see Additional Photo 10 in Appendix C).

Bank erosion at EBL1-2 is due to an advancing point bar, which places the channel against a relatively high, herbaceously vegetated stream bank that runs along a relatively sharp meander bend. Root wads and large rocks placed on, but not keyed into the toe of the banks are causing increased scour against the bank toe. The vegetation community along these banks include speckled alder, Kentucky bluegrass, smooth brome, sedges, common yarrow, western-wheat grass, Canadian goldenrod, and ox-eye daisy, most of which are upland species less capable of withstanding erosive forces. The downstream end of the bank retreated at a rate of 1.5 to 3 feet/year from 2013 to 2014, and 3 to 7 feet per year between 2015 and 2018. A 10-foot lateral migration in the past year alone represents the highest rate of erosion noted along this bank since 2013. Based on the combination of eroding factors, severity of erosion along EBL1-2 is considered high, particularly along the lower end of the bank. While erosion rates are high at this location, it has resulted in the recruitment of large woody debris to the channel, which is beneficial toward the development of diverse aquatic habitat.

Additional Photo 1: Upper end of eroding Bank EBL1 -2

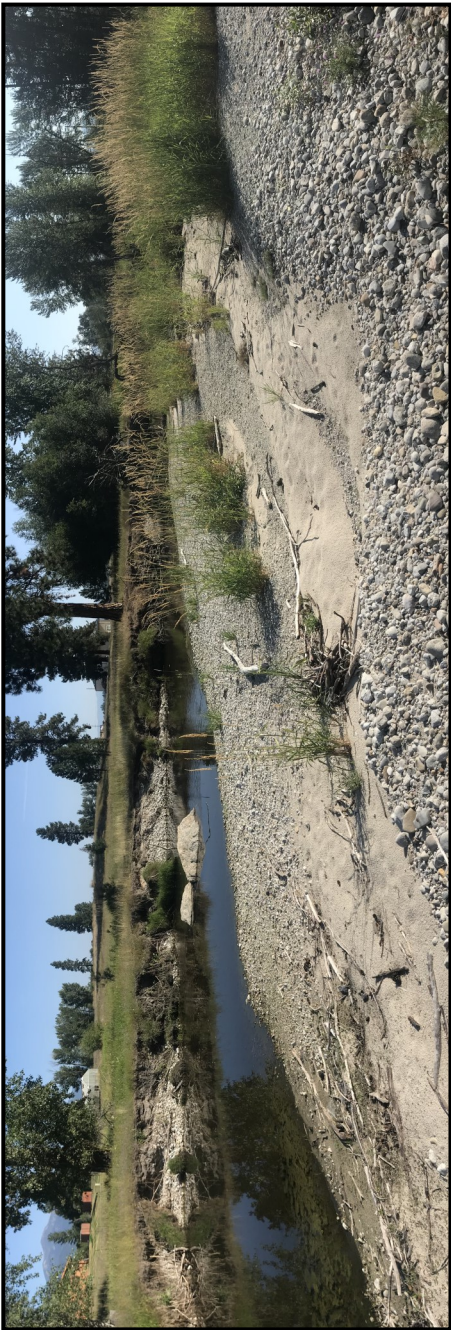
Additional Photo 2: Lower end of eroding Bank EBL1-2

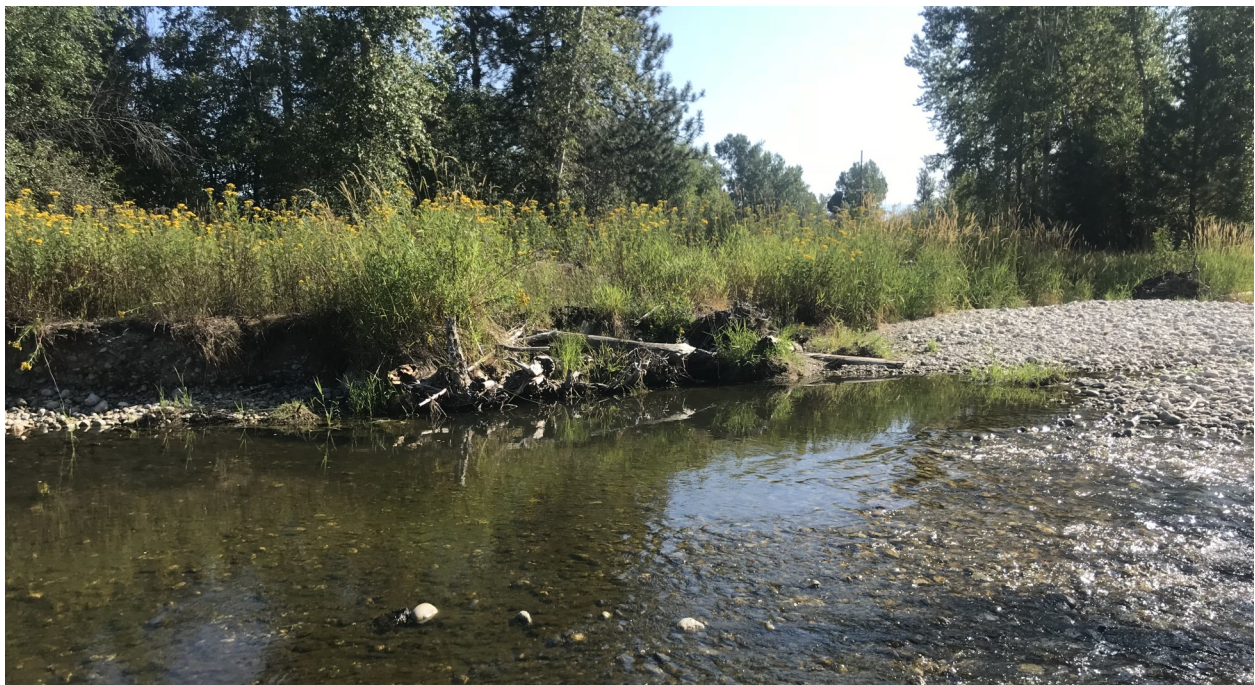
Signs of active erosion at EBL3 were originally observed in 2014 at the head of the former channel alignment which is now largely backfilled with gravel, cobble, and soil. As a result, this area is no longer classified as eroding and has been removed from the list of actively eroding banks.

Additional Photo 3: Upper section of Eroding Streambank EBL3

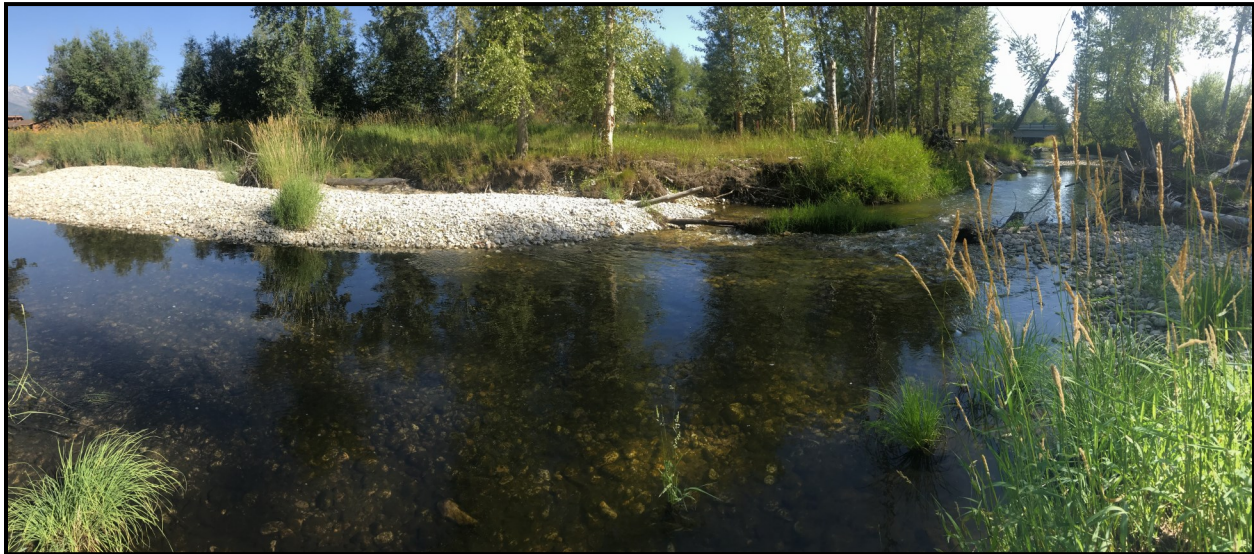
Additional Photo 4: Lower section of Eroding Streambank EBL3

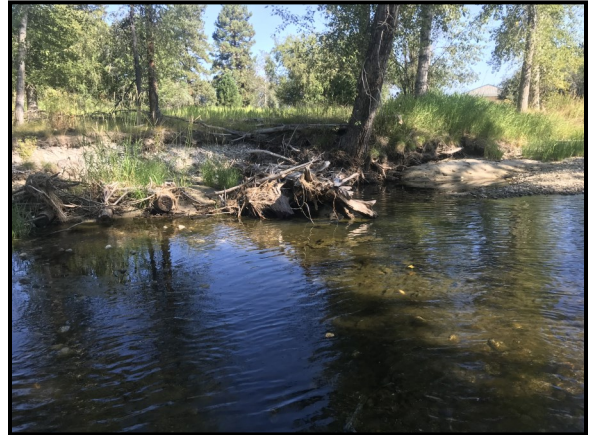
Lateral erosion at bank EBL4 has continued the past four years, as evidenced by a log jam forming adjacent to the bank causing localized scour (see Additional Photo 5 in Appendix C). The bank has retreated approximately one foot in the past year and 9-11 feet in the past six years, although the eroding bank length has actually reduced since the initial bank erosion inventory in 2013. Bank instability at this location was potentially caused by removal of the trees for use in log revetment construction, or by natural channel adjustments and debris jams forming following construction. These debris jams are considered beneficial to the restored channel alignment, as they improve habitat complexity and generate pool scour features to the benefit of fish. The dominant vegetation along the bank includes reed canary grass and smooth brome, the former of

which offers dense roots capable of withstanding erosion more effectively than most species. Erosion severity along this bank is considered low, as it does not jeopardize any infrastructure elements or the newly installed bridge downstream. As a result of the erosion occurring from natural channel adjustments, no corrective actions are warranted at this location.

Additional Photo 5: Eroding streambank EBL4

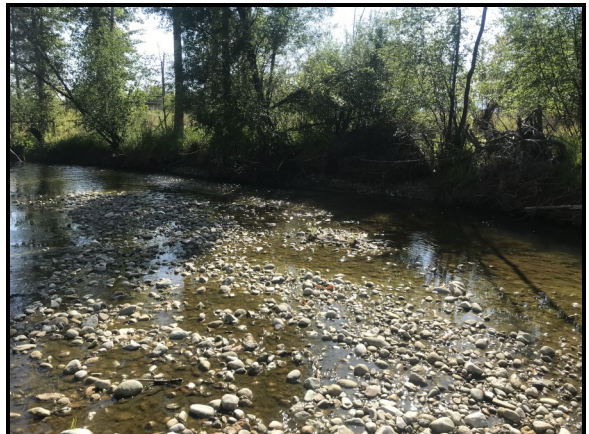
Eroding bank EBR1 was observed in 2014 and is directly across the channel from EBL4. Previous monitoring efforts documented fallen trees both into the channel and away from the channel along this bank. Continued erosion was not observed along the bank between 2015 and 2017, however minor erosion along the toe of the bank was noted in 2018 (See Additional Photo 6 in Appendix C). No additional erosion was observed in 2019; as such it has been removed from the list of actively eroding banks.

Additional Photo 6: Eroding streambank EBR1

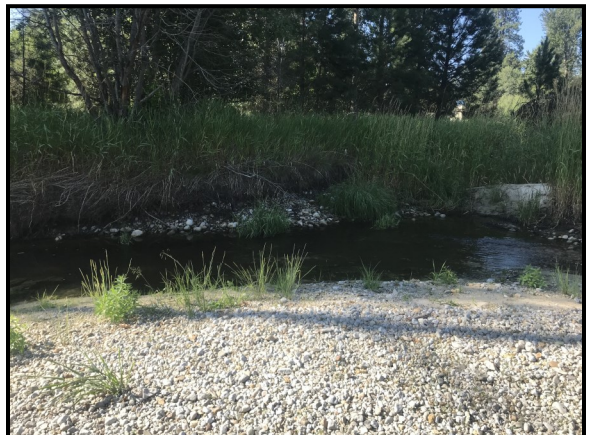
Erosion at EBR2 was originally noted in 2014 along 65 feet of the channel across from the head of the deactivated stream channel. Erosion at this location was tied to channel adjustments and scour along the outside of a meander. Additional erosion along this bank segment was not observed between 2015 and 2017; however the bank showed signs of erosion again in 2018 and 2019, including undercutting, slumping sod mats, and root exposure (see Additional Photo 7 in Appendix C). The eroding bank length doubled from 40 feet to 81 feet in 2019 due to the development of a gravel bar on the north side of the channel, and subsequent scour against the south bank. The erosion is resulting from the natural dynamics of the channel's fluvial processes, and does not need to be corrected despite the eroding bank length doubling in the past year. Movement of the bank is not jeopardizing any infrastructure and is occurring as part of natural channel adjustments. As such, no corrective actions are warranted along this bank.

Additional Photo 7: Eroding streambank EBR2

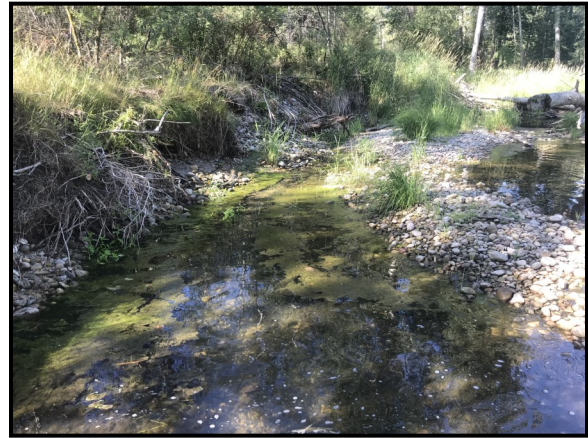
Eroding bank EBR3 was observed in 2017 adjacent to a woody debris jam and was characterized by upper bank sloughing and toe scour. Vegetation along the upper bank includes reed canary grass, oxeye daisy, woods rose, wheatgrass, brome, small cottonwood saplings, and young willows. The bank appeared to retreat by approximately 1 foot or less during high flows in 2018 or 2019, as the adjacent debris jam broke up and a gravel bar has developed adjacent to the bank (Additional Photo 8 in Appendix C). Given the bank's relatively slow retreat rate and the lack of adjacent infrastructure or fencing, corrective actions are not warranted along this bank at this time.

Additional Photo 8: Eroding Bank EBR3

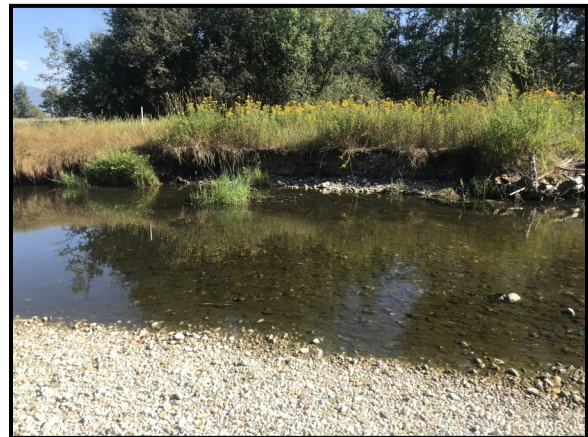
Erosion was observed in 2018 on the left bank near the upstream end of the monitoring reach (EBL5). Erosion along this 20-foot bank segment is due to gravel depositing on the inside of the meander bend and just below the downed ponderosa pine tree. This deposit focuses high flows toward the left bank, which is primarily vegetated with upland species including short-awn meadow foxtail, white and red clover, Kentucky bluegrass, common tansy, and ox-eye daisy. This bank retreated approximately four feet in 2018, and an additional 10 feet in 2019, as evidenced by bank transect #1. Erosion at this location is now connected to the long eroding bank EBL1-2 described above. This bank has been mapped separately, as it lies within the project reach as opposed to EBL1-2,

which lies upstream of the mitigation area. While the creek has begun to erode into the backfilled area that was the former channel alignment at EBL5, it is not threatening to abandon its existing configuration and overtake the former alignment. The former alignment has been completely backfilled to the height of the surrounding floodplain, and does not provide a preferential flow path for Mill Creek to establish. An updated eroding bank inventory within the Mill Creek project site is summarized as follows:

Additional Photo 9: Eroding bank EBL5

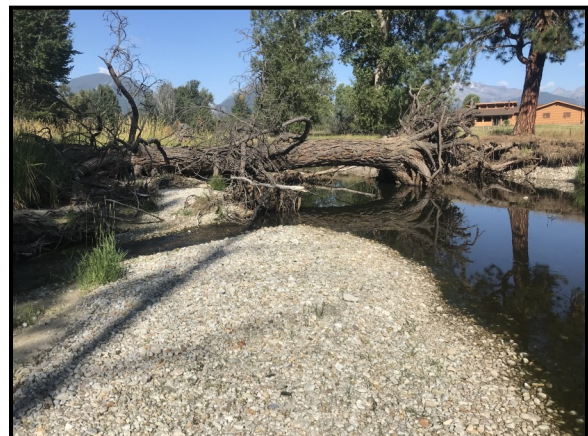
Additional Photo 10: Ponderosa pine in channel near downstream end of EBR2
