MONTANA DEPARTMENT OF TRANSPORTATION STREAM MITIGATION MONITORING REPORT

*North Fork Bear Creek
Ravalli County, Montana*

*Year Project Completed: 2011
Monitoring Report #7: Submitted December, 2019*

MDT Project Number: NH-7-1(114)56
Control Number: 2015 003

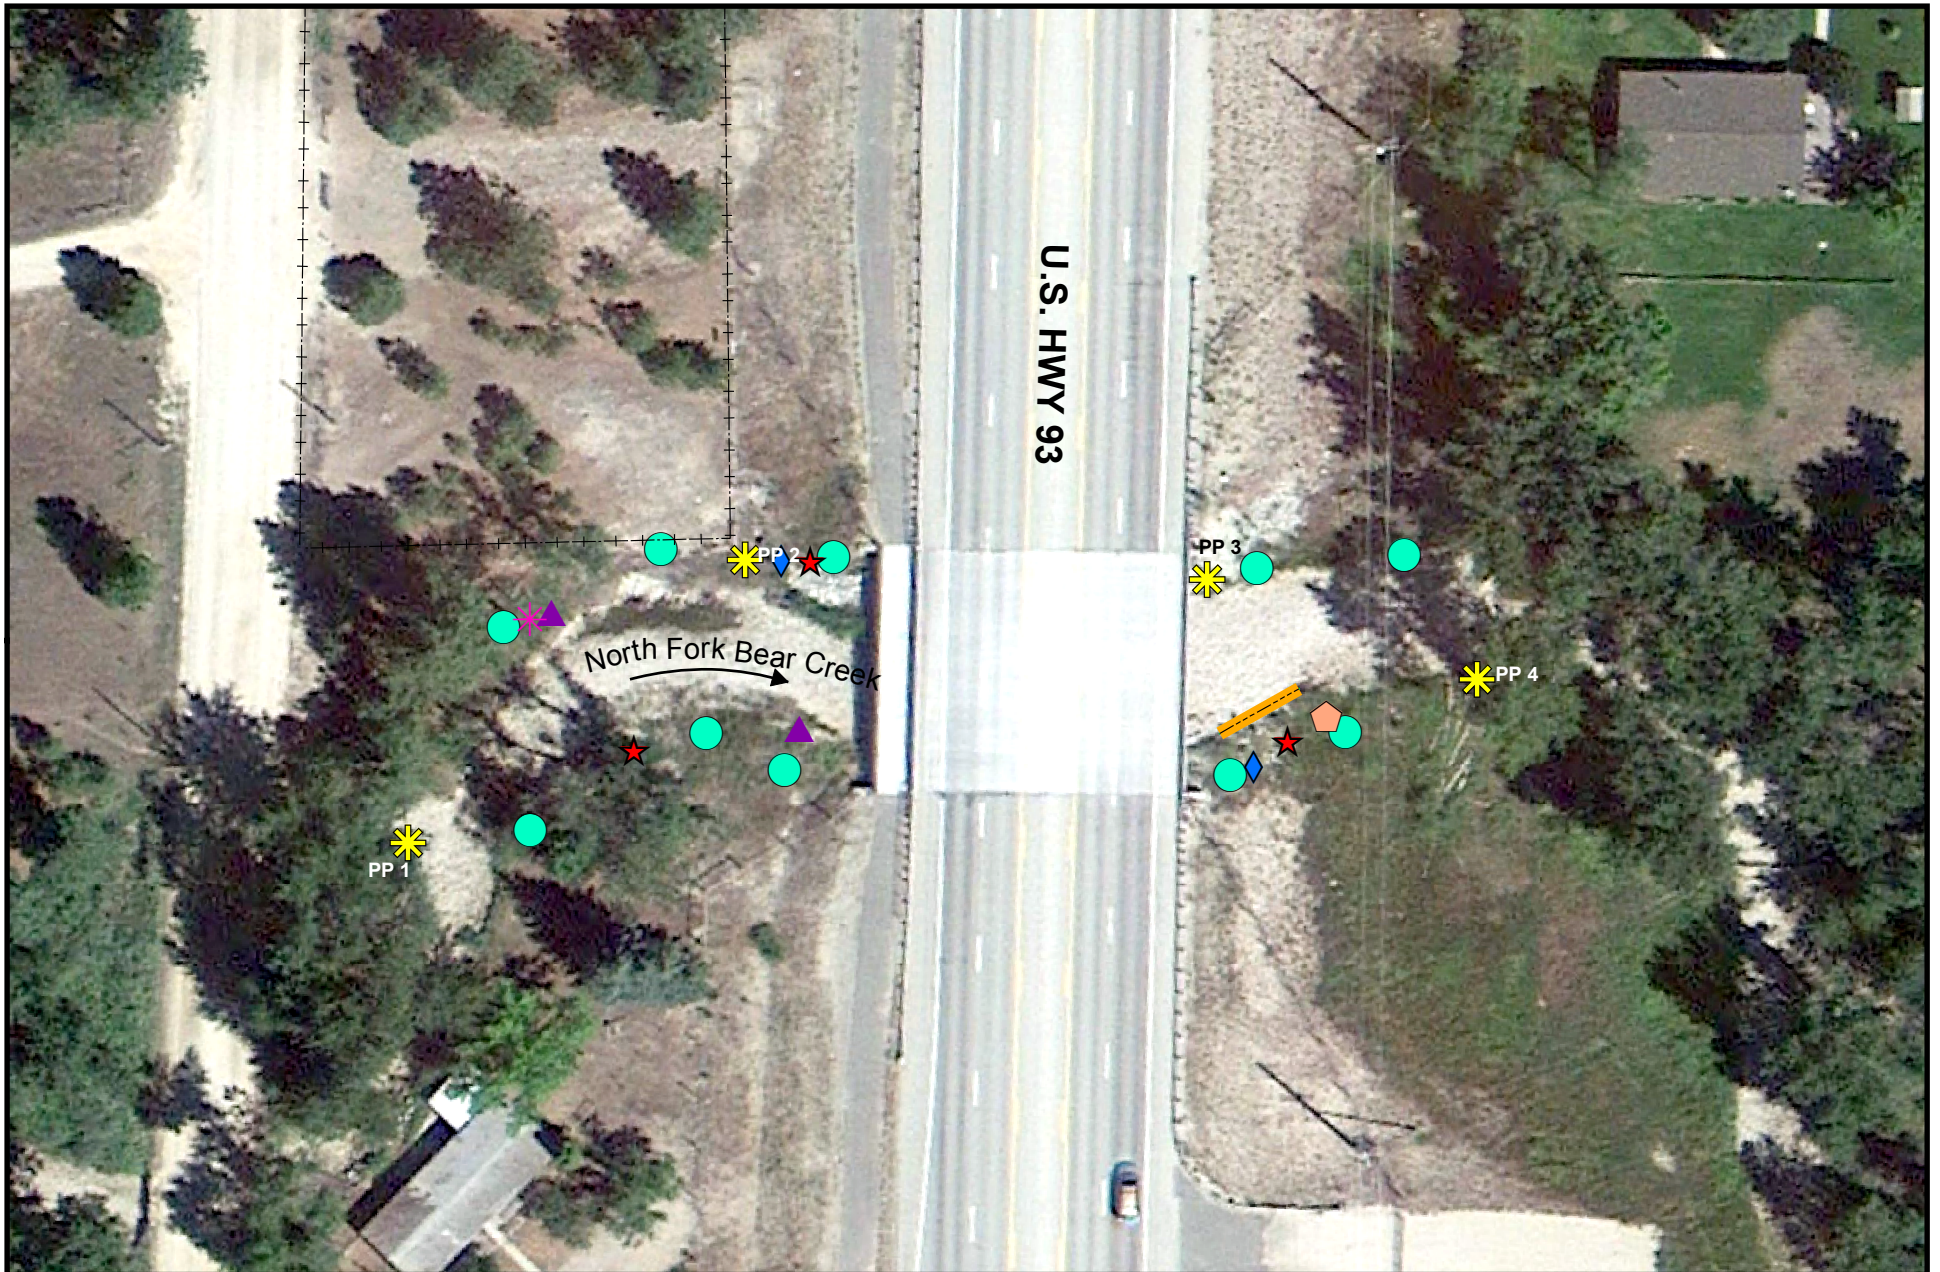
Figure 2

Eroding Bank

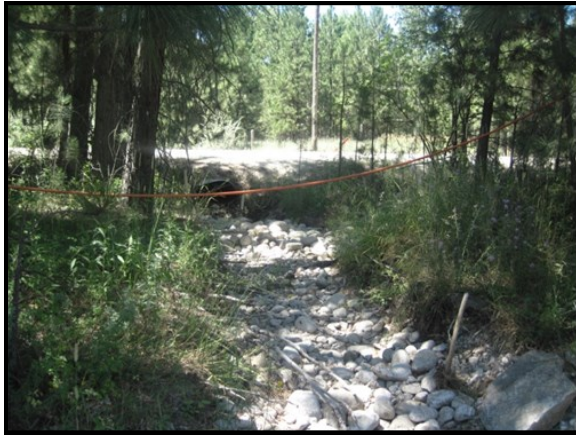
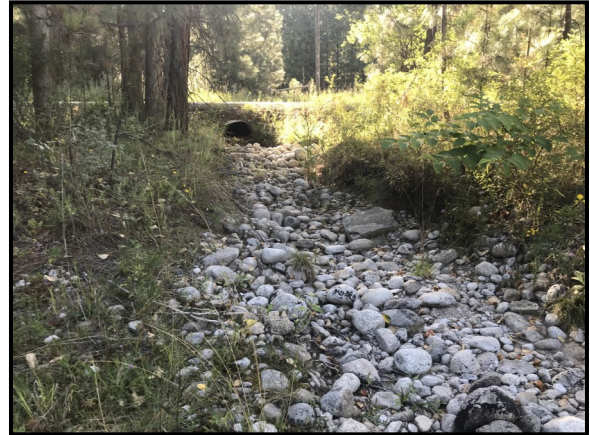
2013
Photo Point 1.1: View of tributary/culvert entering from west. **Compass:** 270 (West)

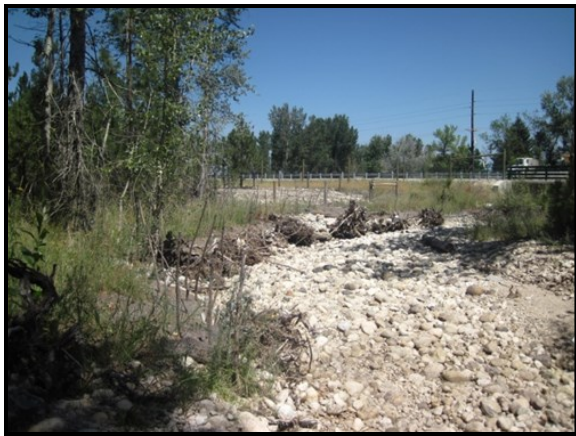
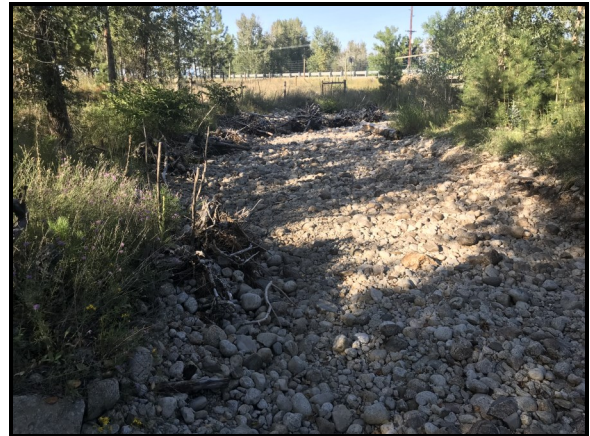
2013
Photo Point 1.2: View of north streambank looking downstream. **Compass:** 45 (Northeast)

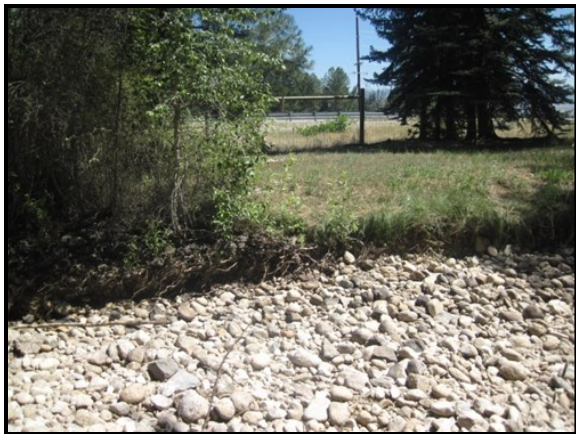
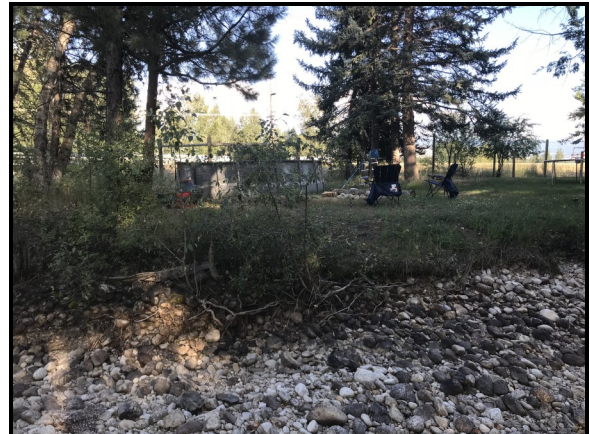
2013
Photo Point 1.3: View of south streambank. **Compass:** 90 (East)

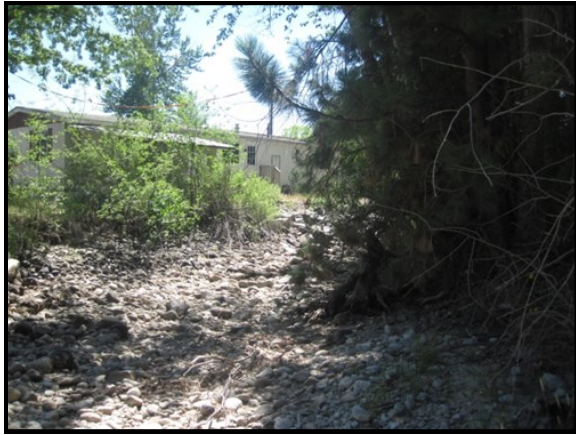
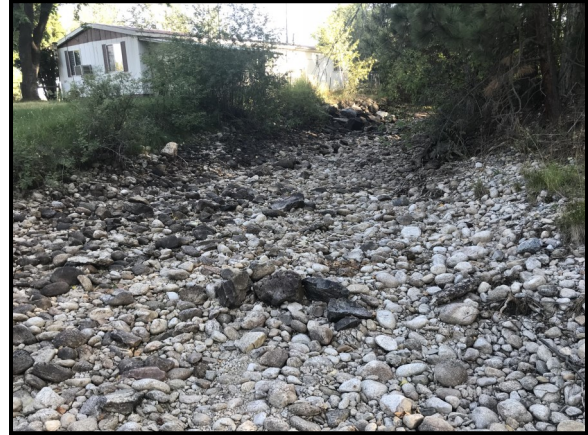
Photo Point 1.4: View of dry channel looking upstream. **Compass:** 230 (Southwest)

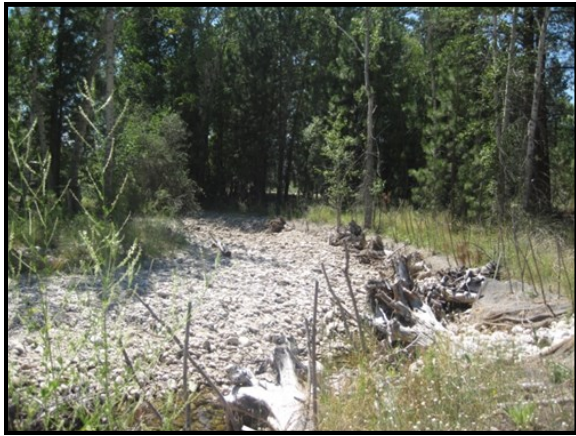
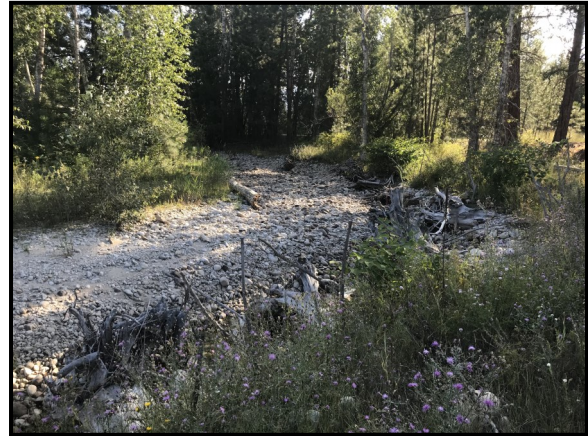
Root wads placed along the north bank both upstream and downstream of the bridge remain stable eight years following installation. Cobble placed atop one of the rootwads upstream of the bridge partially washed out during 2014; however no additional bank erosion has been noted in this area during the past five years. Given the integrity of the channel, no measures are currently warranted to improve bank stability within the project reach, and the project site is currently meeting success criteria for bank stability.

Photo Point 2.1: View of root wads on north bank. **Compass:** 225 (Southwest)

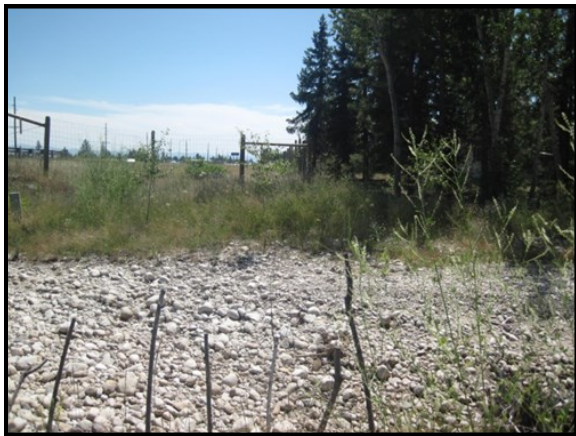
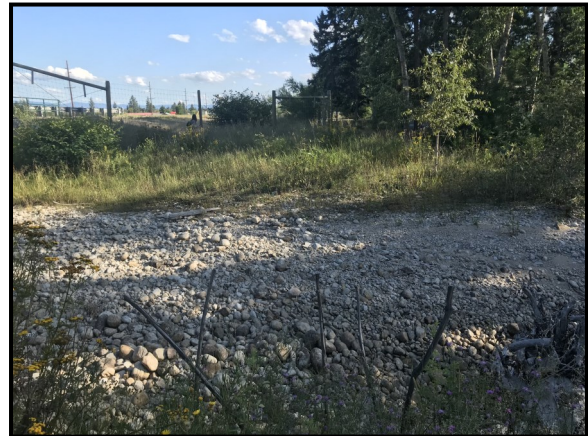
Photo Point 2.2: View across channel of south streambank. **Compass:** 180 (South)

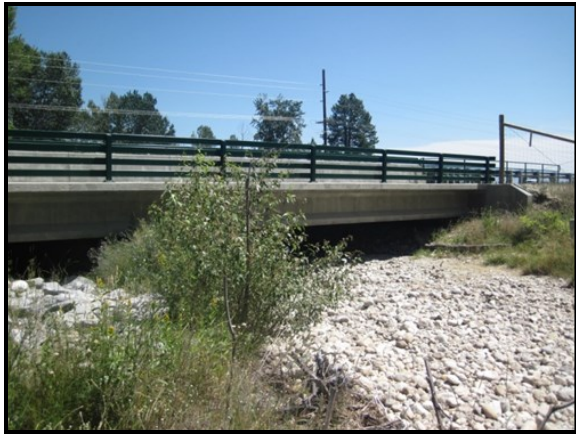
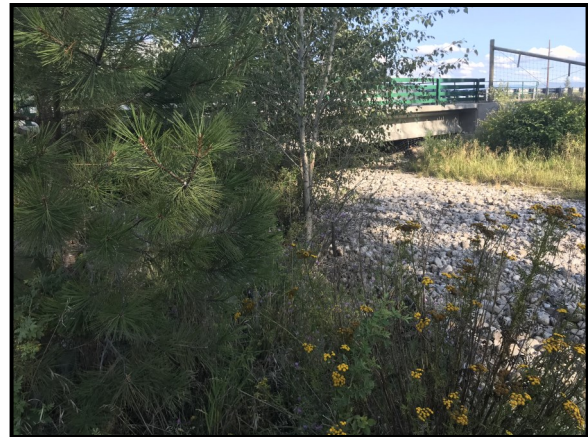
Photo Point 2.3: View from north bank looking across channel. **Compass:** 135 (Southeast)

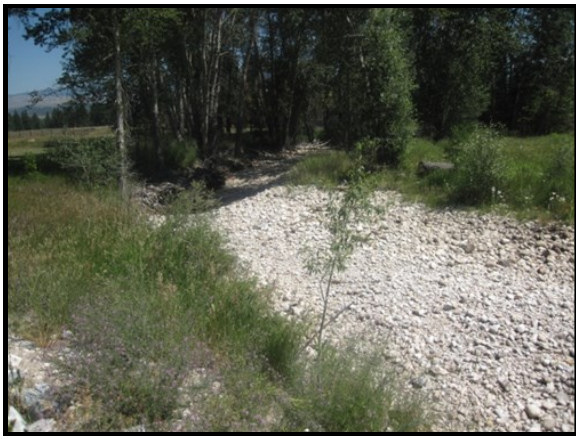
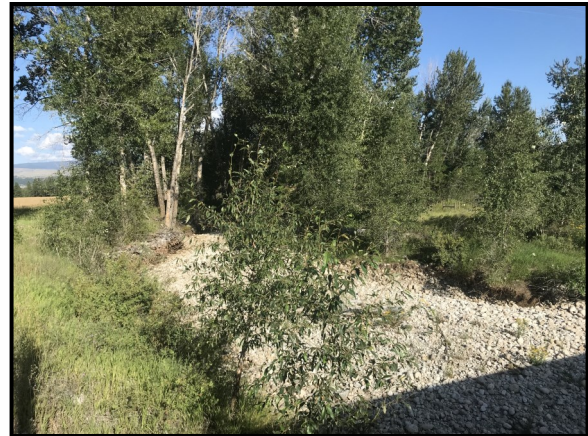
Photo Point 3.1: View downstream from north bridge abutment. **Compass:** 90 (East)

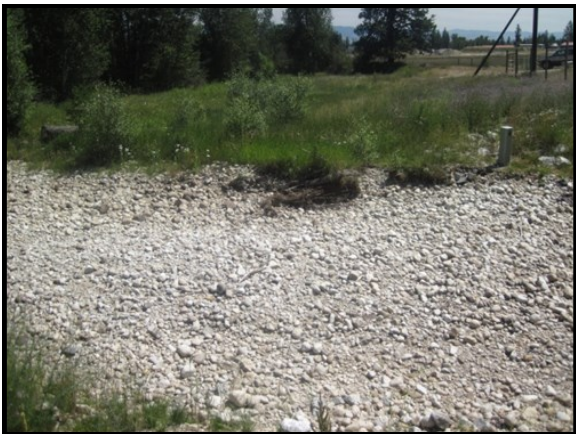
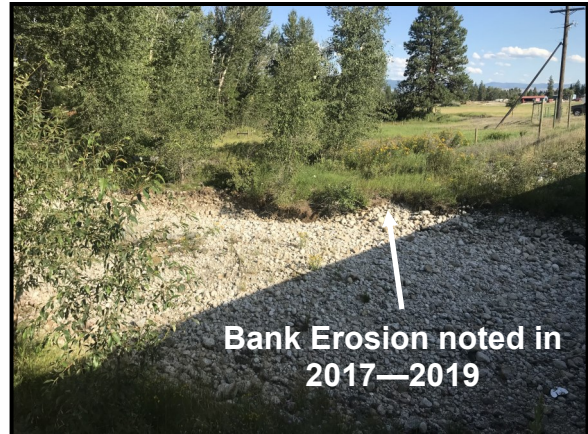
One eroding bank was identified within the project reach, which occurs just downstream of the highway bridge along the right (south) bank. Erosion along this 25-foot long bank segment was initially observed in 2017 and retreated approximately 3 feet in 2018, capturing an MDT motion camera. The bank did not appear to erode further laterally in 2019, although a minor amount of undercutting beneath the bank was observed. The bank consists of cobble and gravel material and is vegetated with a mixture of herbaceous and woody species including common yarrow (*Achillea millefolium*), narrow-leaf cottonwood (*Populus angustifolia*), Woods' rose (*Rosa woodsii*), and spotted knapweed (*Centaurea stoebe*). Based on photo documentation, it appears the bank retreated approximately 4-5 feet between 2017 and 2018, but has not eroded further in the past year (see photo points 3.2 and 3.3 in Appendix B).

The 25 feet of erosion represents approximately 6% of the 420 feet of stream banks within the monitoring reach. The relatively short extent of erosion and lack of infrastructure in jeopardy of being damaged by continued erosion here makes stabilization or correction efforts unwarranted at this time. No other erosion was noted along the project reach and all root wads installed to prevent erosion upstream and downstream of the bridge appear to be intact and functioning properly. The overall stability through the reach and presence of pool features adjacent to the root wads indicate the channel is functioning properly and has developed natural bedform features.

Photo Point 3.2: View of south streambank from left abutment. **Compass:** 135 (Southeast)

The reconstructed stream banks within the project reach have remained largely intact, with erosion noted along only 25 feet, or 6% of the overall bank length. Erosion is limited to one bank segment just downstream of the highway bridge. While erosion at this location resulted in bank retreat by 4-5 feet between 2017 and 2018, no further lateral migration has been noted. Given the length of eroding bank is relatively short and the erosion is not currently threatening any infrastructure (fences, power poles, bridge abutments), bank stabilization efforts are unwarranted at this time.

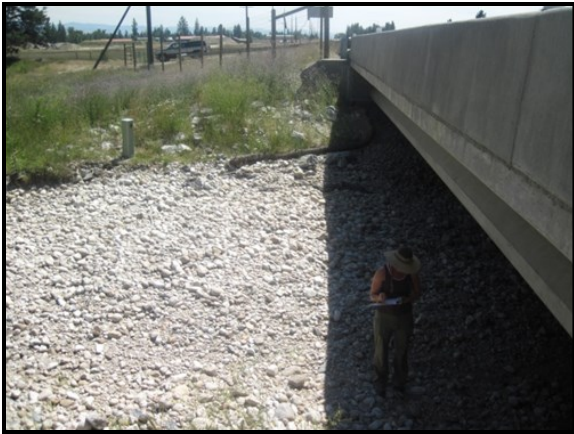
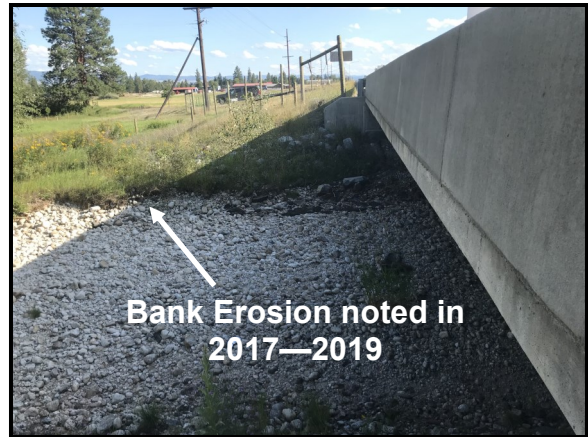
Photo Point 3.3: View across channel of south bank from north bridge abutment. Compass: 180 (South)

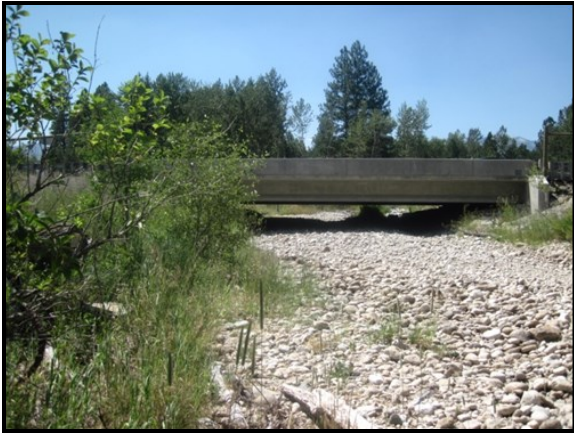
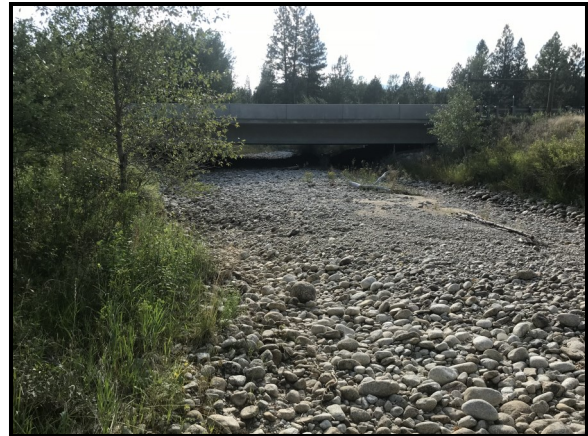
Photo Point 4.1: View from south bank looking upstream from downstream extent. Compass: 270 (West)

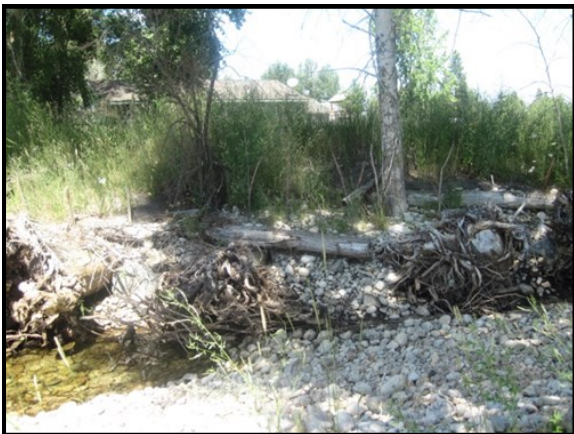
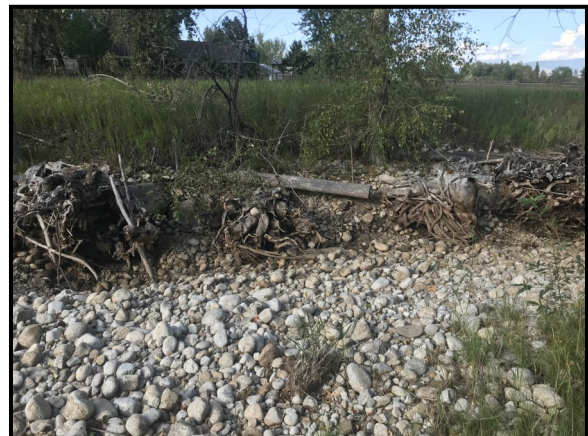
Photo Point 4.2: View of root wads on north bank downstream of bridge. Compass: 0 (North)
