**EXPERIMENTAL PROJECT CONSTRUCTION REPORT AND ANNUAL EVALUATION  
2014**

**CONTECH RIBBED ALUMINUM BOX CULVERT (ABC)**

**Project Name:** Jct. US 2 – North Belknap Crossing

**Experimental Project No.** MT-12-01

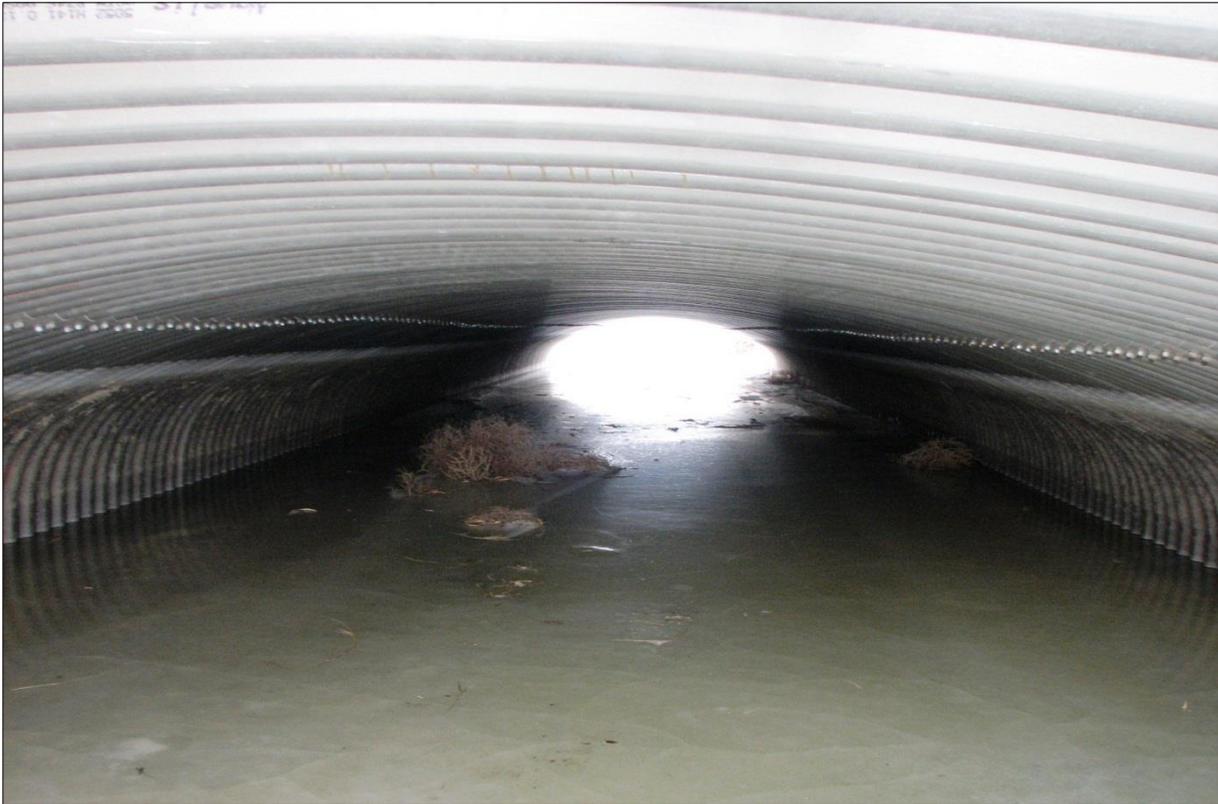
↑ Interior view of the culvert on west end looking east.

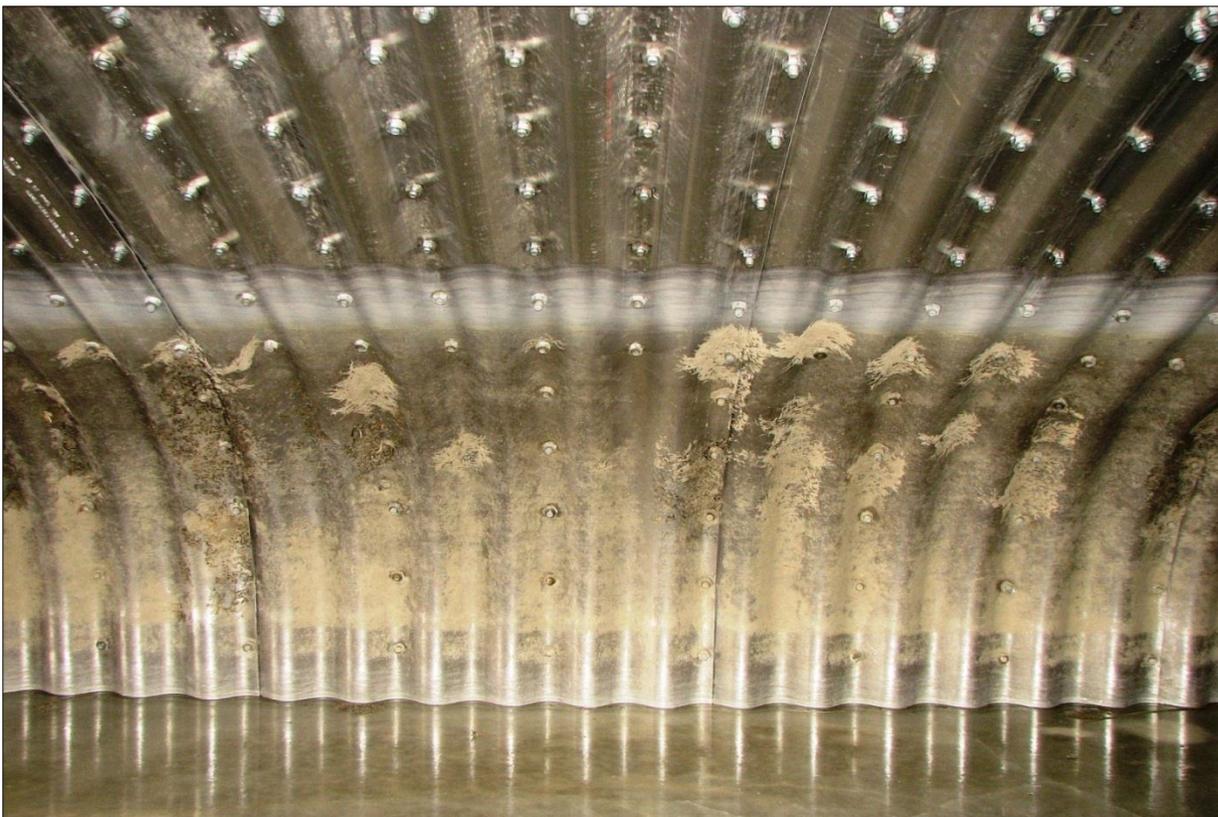
↓ View of interior side wall. Water level stain is clearly seen near top of culvert.

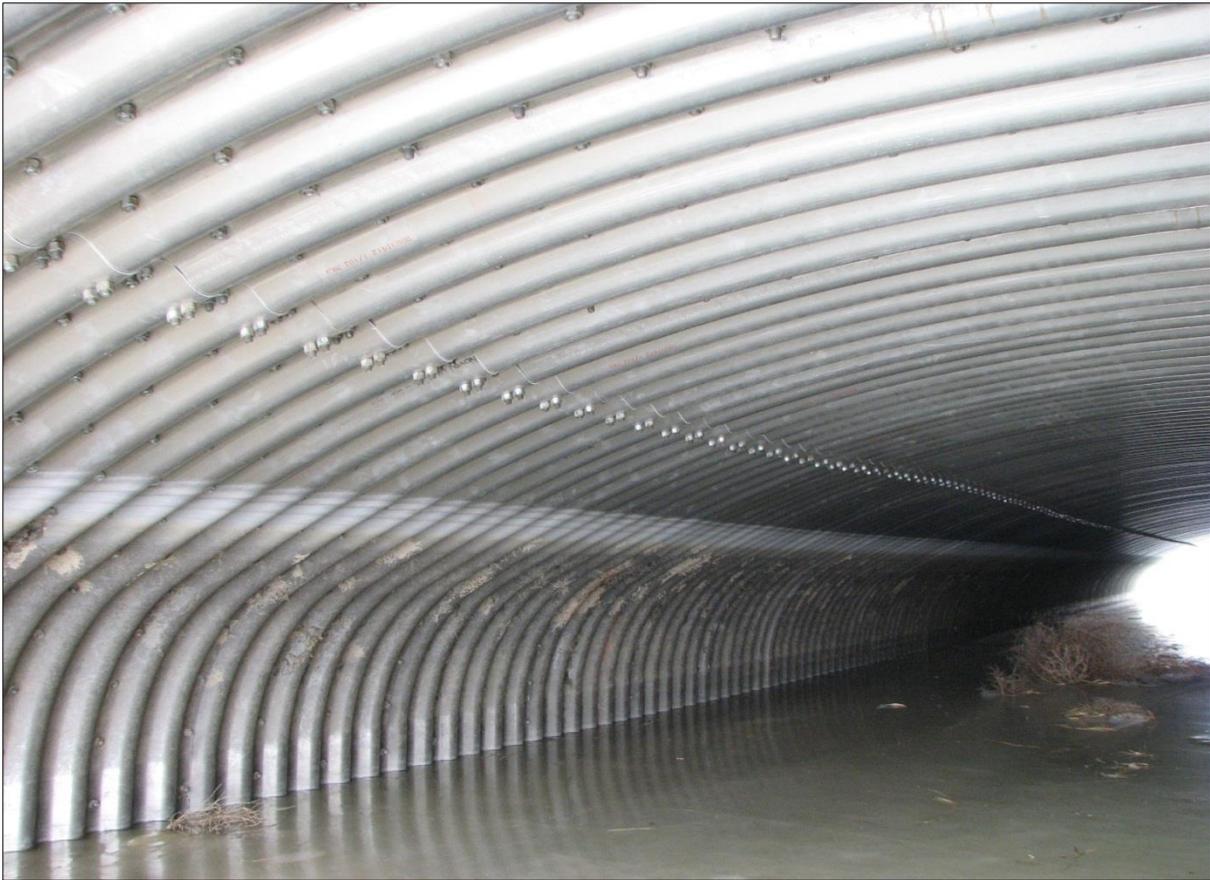
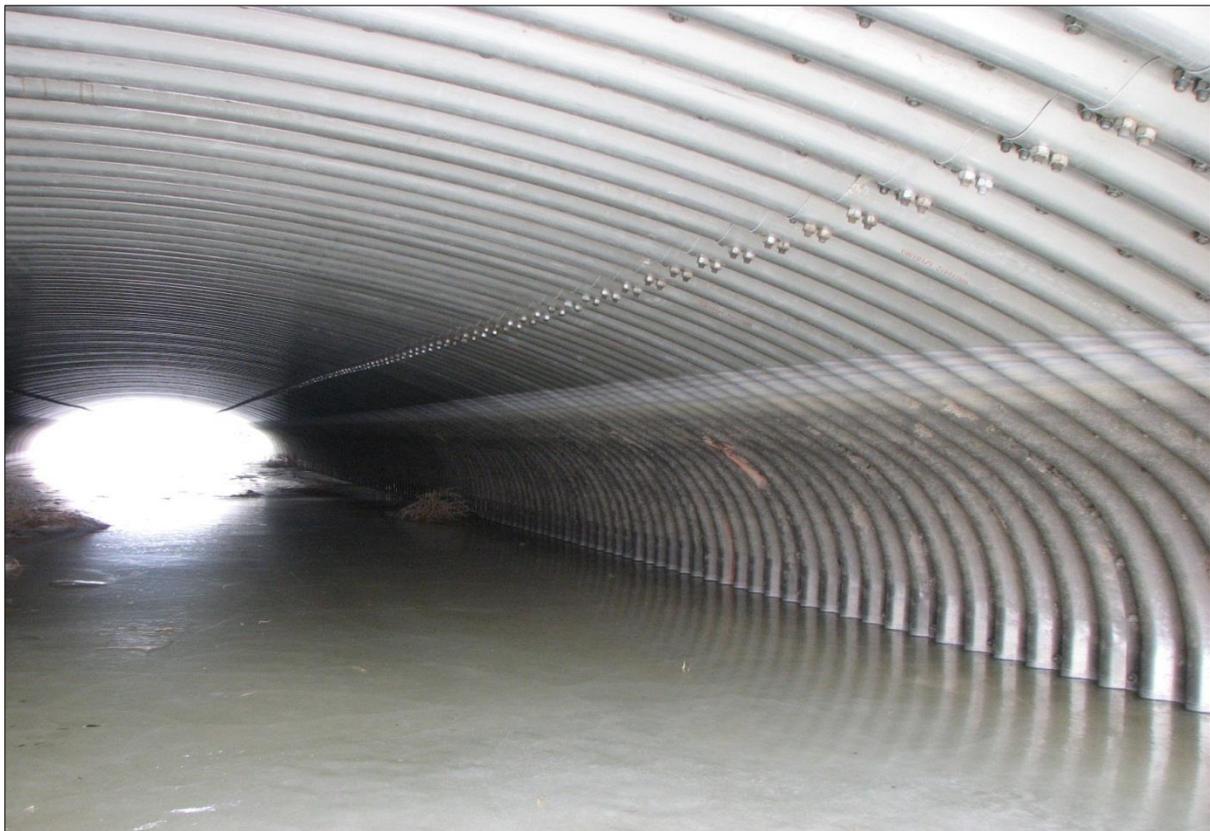
↕ ↔ Side angle images of sidewalls; views east.

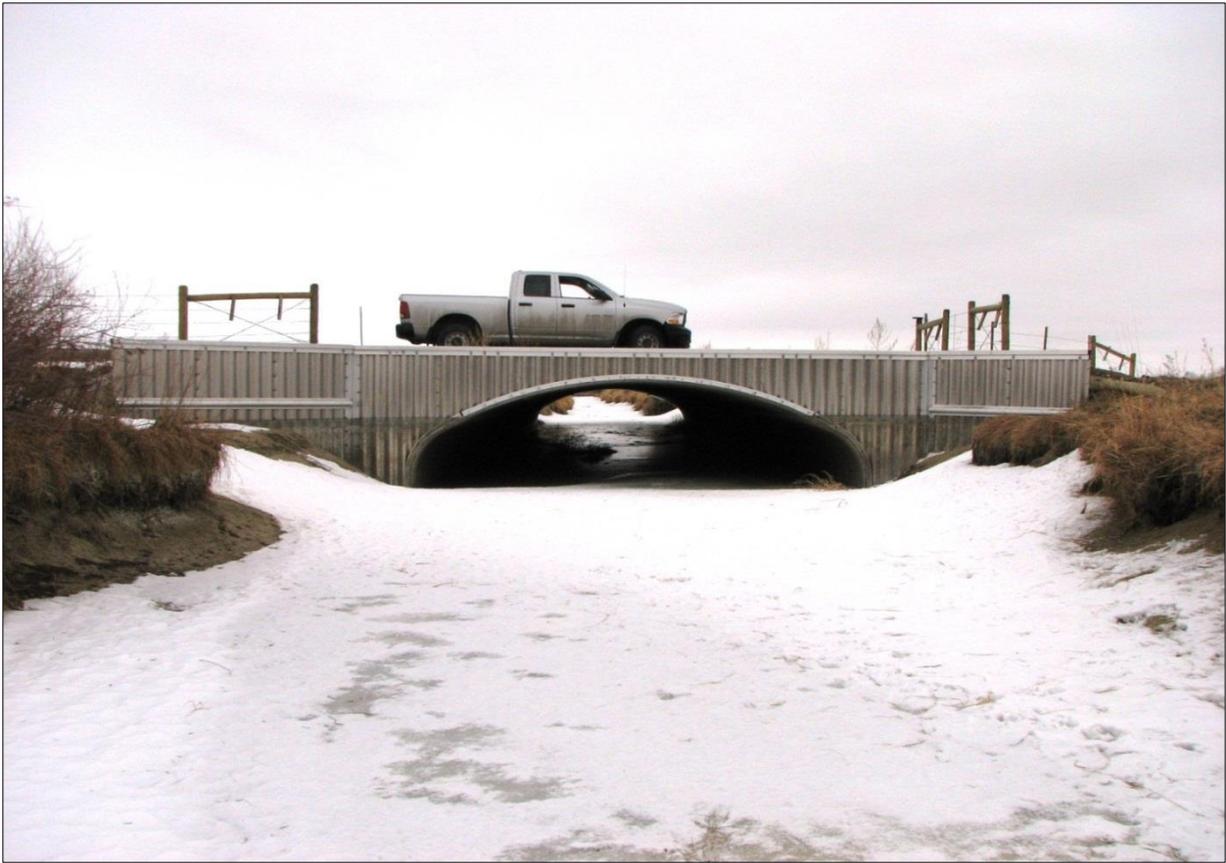
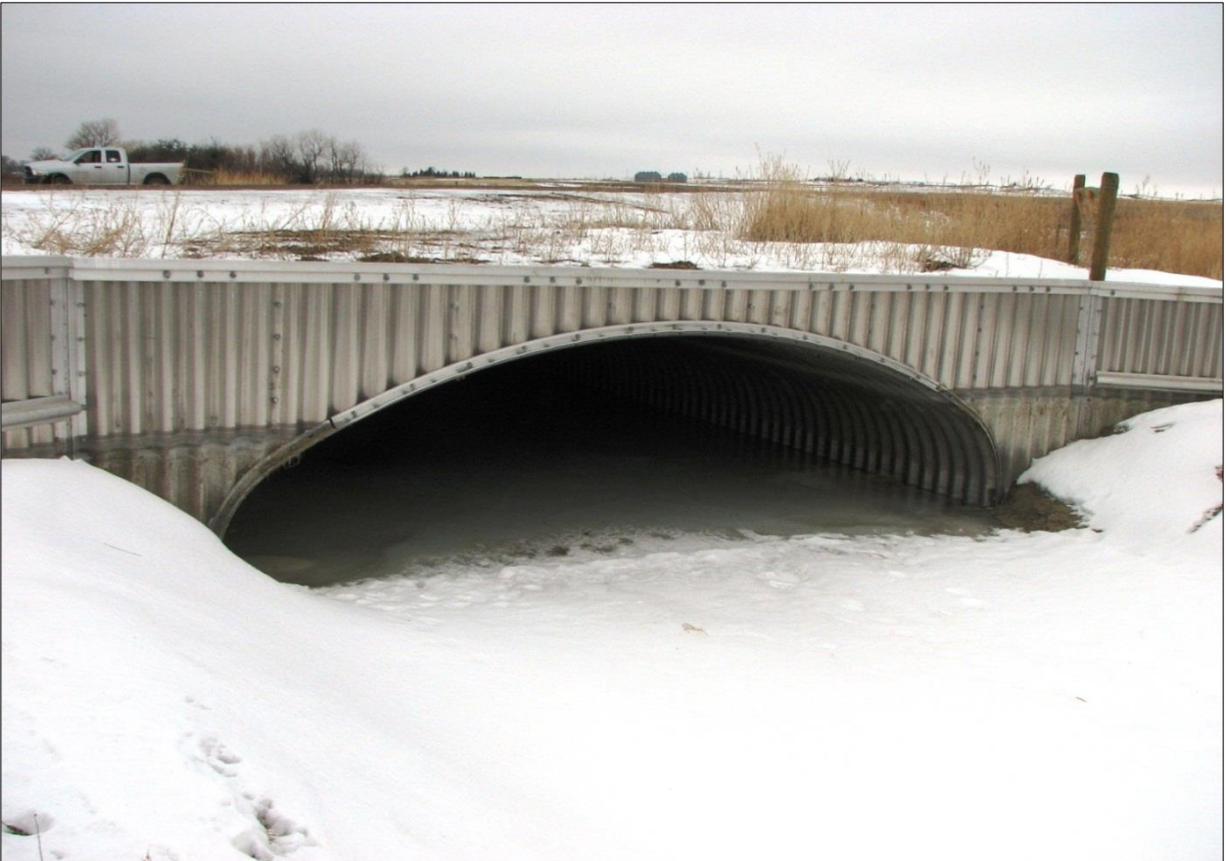
↑↓ Upper image of culvert inlet, lower image of culvert outlet.

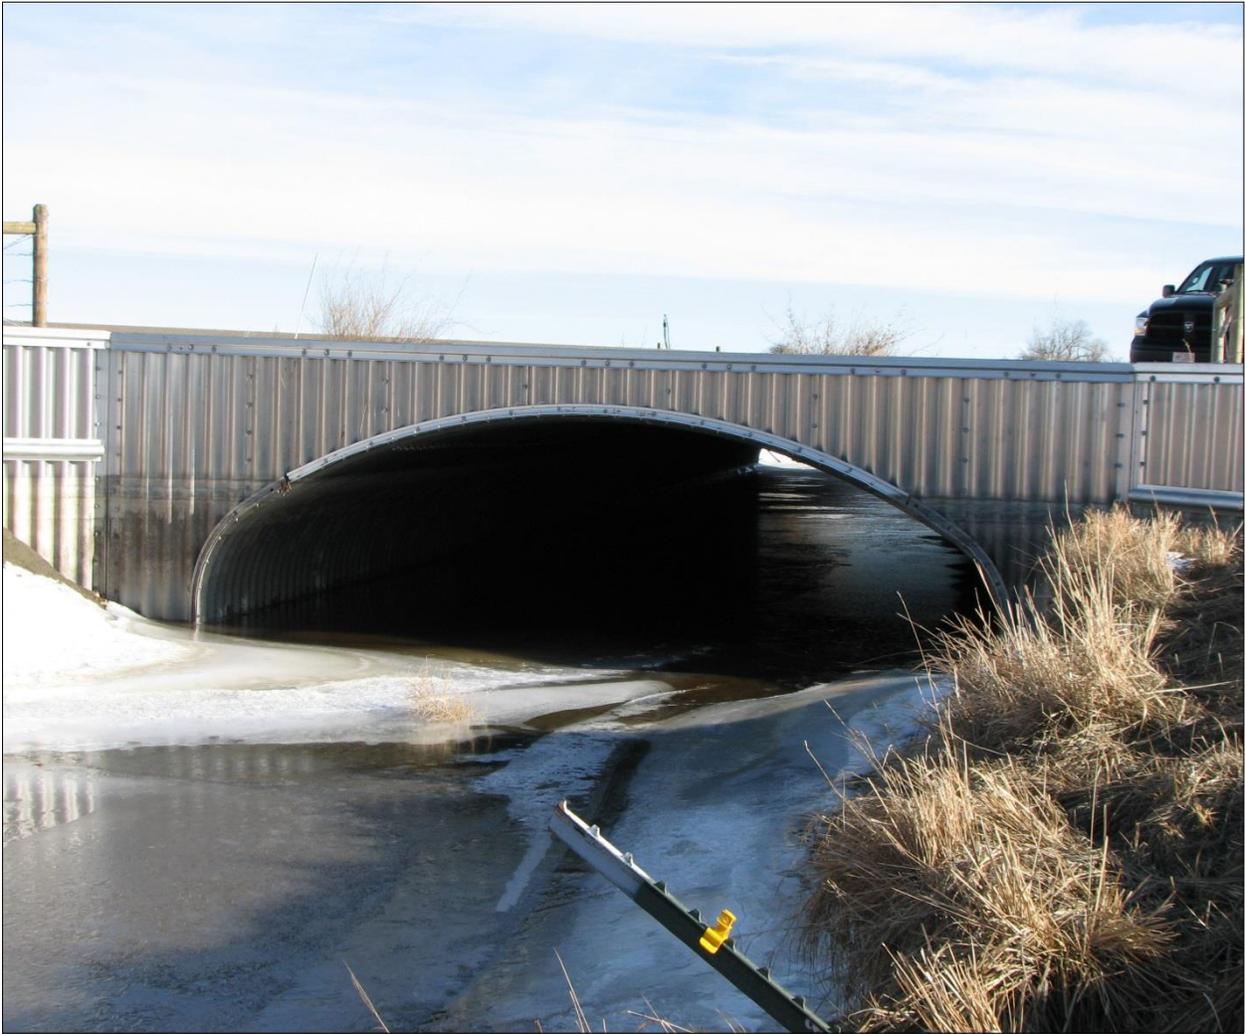
↑ View inlet; west side of culvert.

Due to the thinness of the ice a walk-in interior inspection was not possible. However the researcher was able to gain bank access (inlet and outlet) to see within the culvert to ascertain if any distress (bending or buckling of the shell plate) was noticeable.

No issues were detected in this inspection, all components were visually intact.

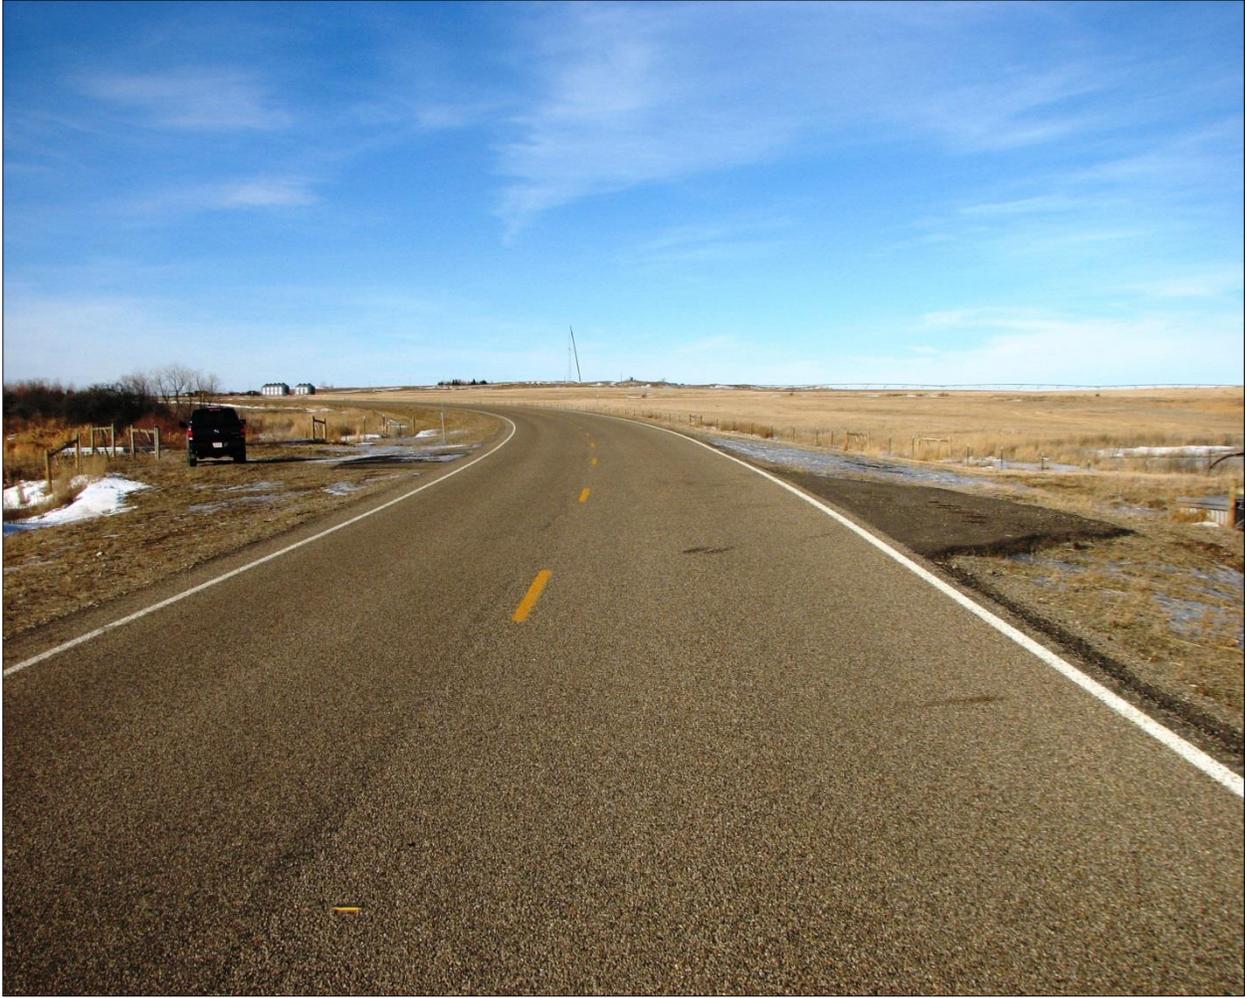
↑ View north. No issues with the roadbed were observed.

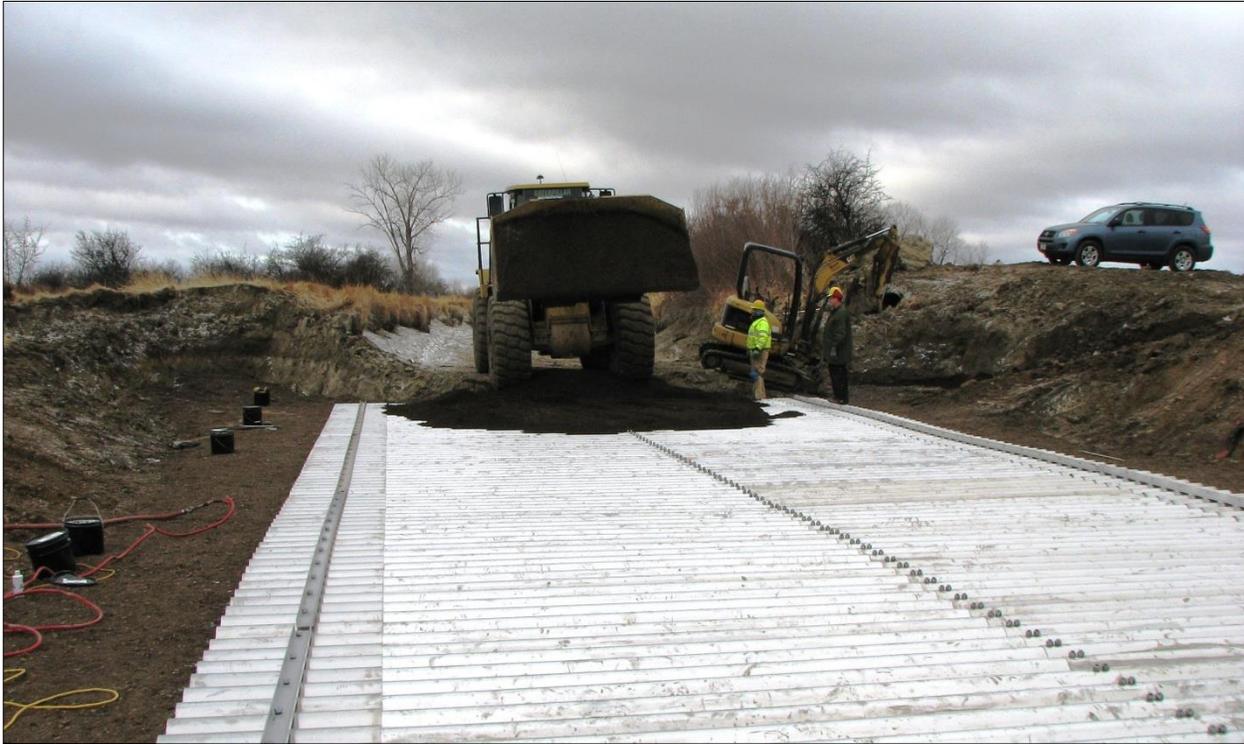
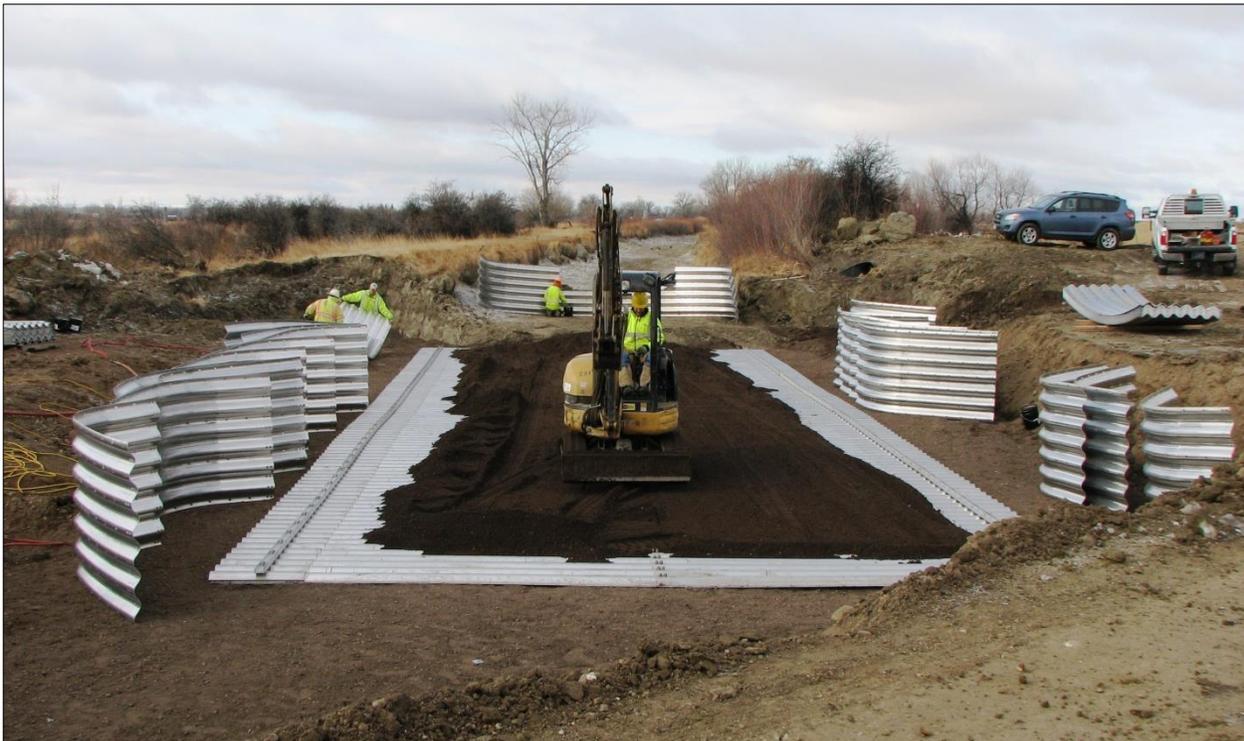
↑↓ The contractor elected to cover the base of the invert plate with a 4-5" layer of bedding. This was done to provide a safer work surface for the installers than walking on the deep corrugation of the plate, and (as a minor point) to add weight for a more stable base for installation.
