# Experimental Feature Final Report December 2022

Experimental Feature:	Centerline Rumble Strip Evaluation
Location:	Missoula District, Lincoln County, US Highway 2, RP 0.0-
	13.75
MDT Project Name:	JCT 508 – East & West
MDT Project Number:	NH1-1(10)0[8956]
Experimental Project Number:	MT-17-04
Principle Investigator:	Chad DeAustin, Experimental Project Manager (ExPM)
Technical Contact:	Justun Juelfs, Kalispell Maintenance Chief
Construction Date:	August 2017
Date of Inspections:	April 2018, September 2018, May 2019, October 2021,
	August 2022

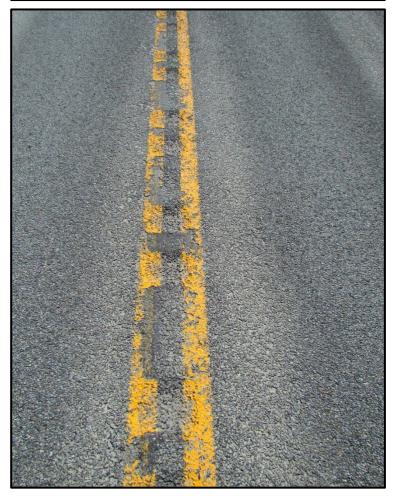
Close-up section of CLRS. No visual distress of the TS1 paving joint was observed.

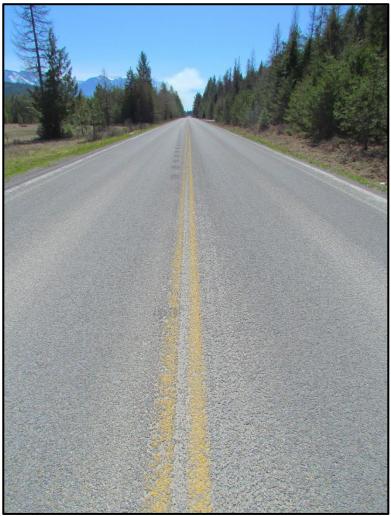
Representative view of CS2, non-CLRS, RP 12, view east. No visual distress of the CS2 paving joint was observed.

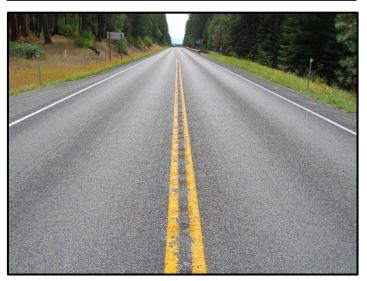
← Additional image of CLRS, RP 4, view east. No visual distress of the TS1 paving joint was observed.

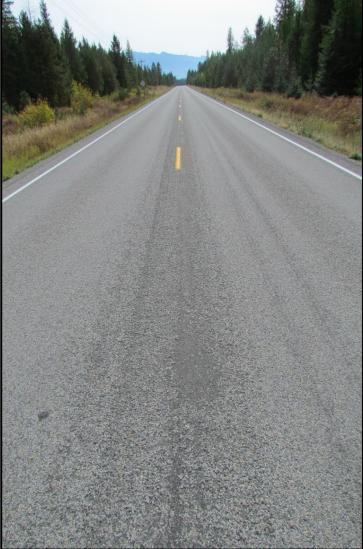
← Representative view of CS2, non-CLRS, RP 12.5, view east. No visual distress of the CS2 paving joint was observed.

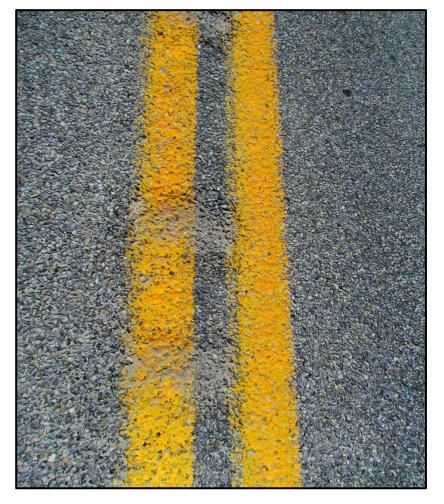
← Representative close-up of TS1 at approximate RP 0.5. No visual distress of the TS1 longitudinal joint was observed.

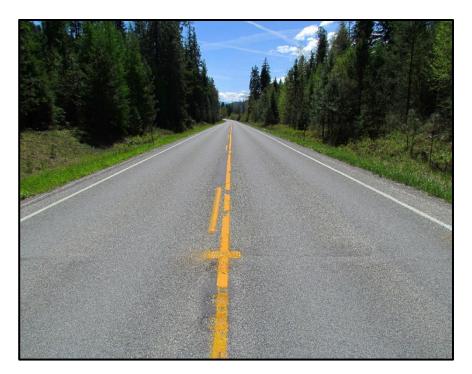
← Transition of TS1 and CS2 at approximate RP 8.2, view east. No visual distress of the CS2 longitudinal joint was observed.

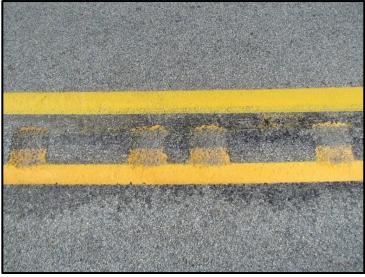
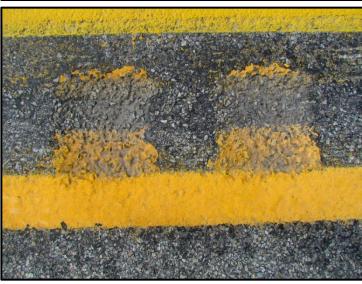
← Use up photos of TS1 at varying distance at approximate RP 0.5. The longitudinal joint throughout the test section was in good condition with intermittent chip stripping.

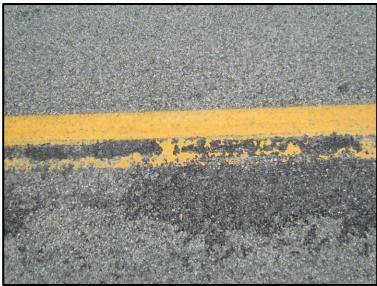
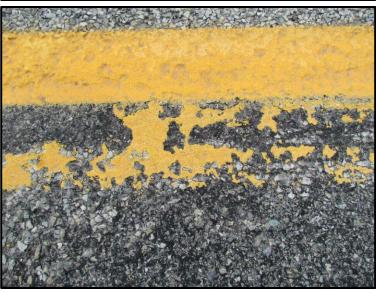
← ♥ Close up photos of the centerline without the rumble strips at varying distance at approximate RP 8.5. There was more chip stripping through the CS2 section compared to TS1.

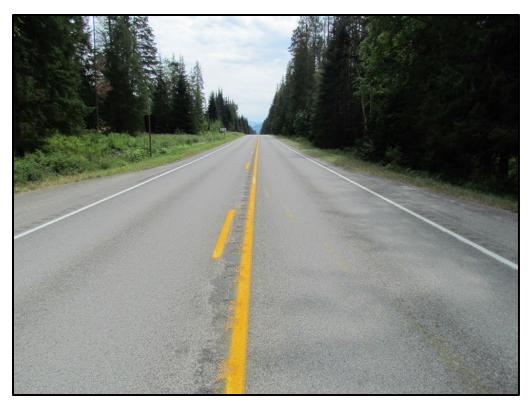
♠ RP 6.5, view east. Overview of TS1 highlighting a section of chip stripping at the centerline.

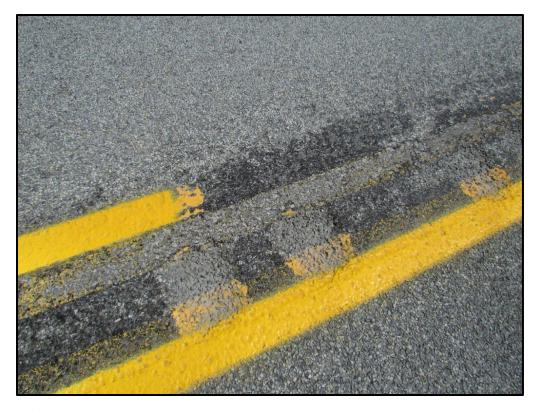
$\ensuremath{ \uparrow \! \! \! \uparrow}$  RP 6.5, close-up view. Closer view of the chip stripping.

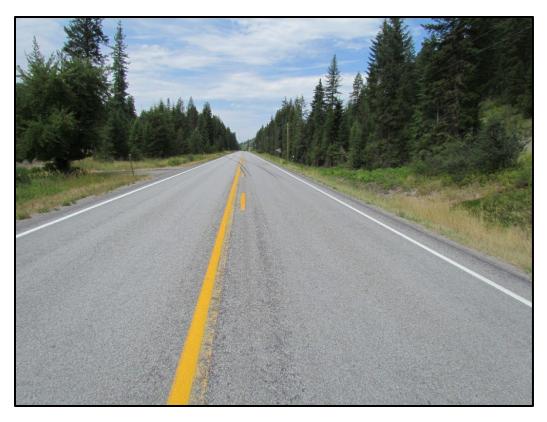
↑ RP 10.0, view west. Overview of the CS2 section highlighting an area of chip stripping.

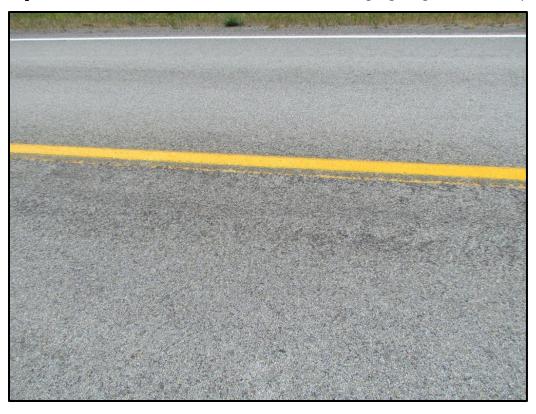
$\spadesuit$  RP 10.0, close-up view of the chip stripping.
