EVALUATION OF A CONVENTIONAL CHIP SEAL UNDER AN OVERLAY TO MITIGATE REFLECTIVE CRACKING (INFORMAL)

Annual Report

Project name: St. Xavier N & S

Project Number: SFCS 313-1(18)22

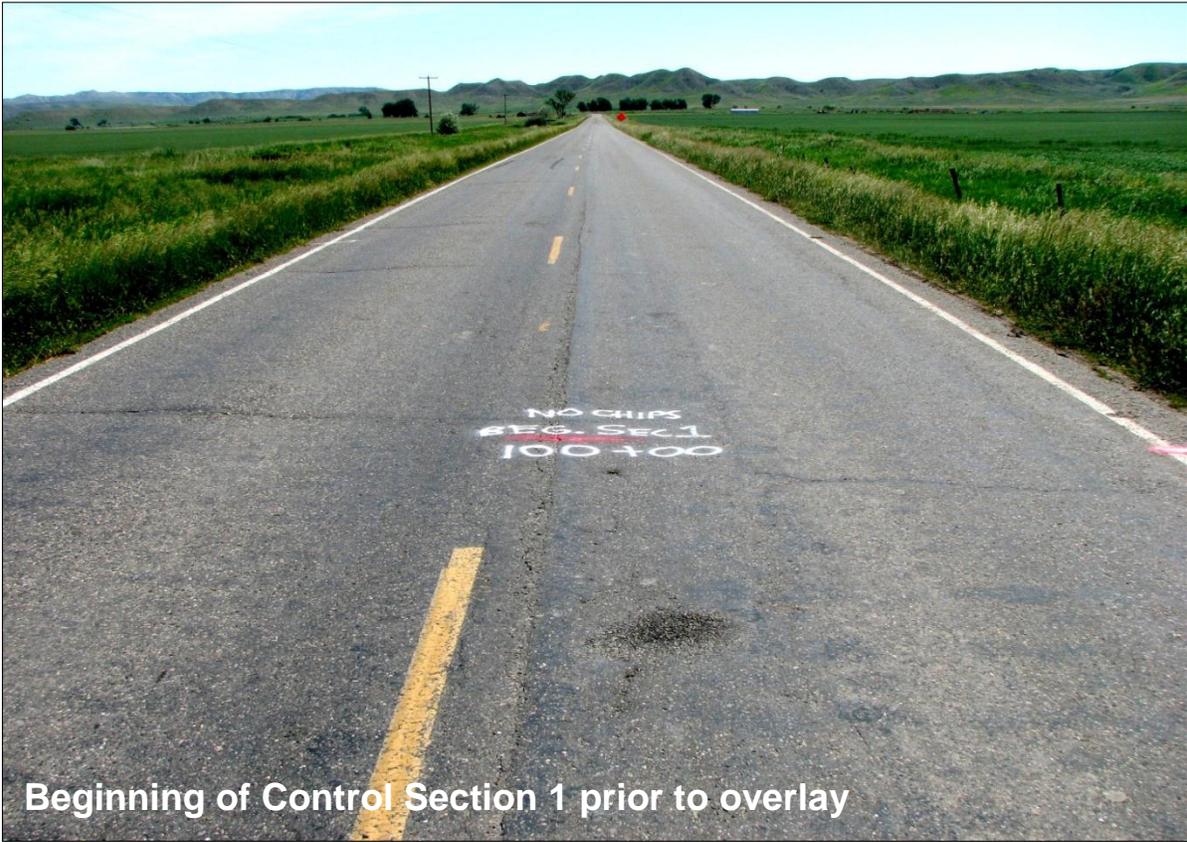
June 2008

Beginning of Control Section 1 prior to overlay

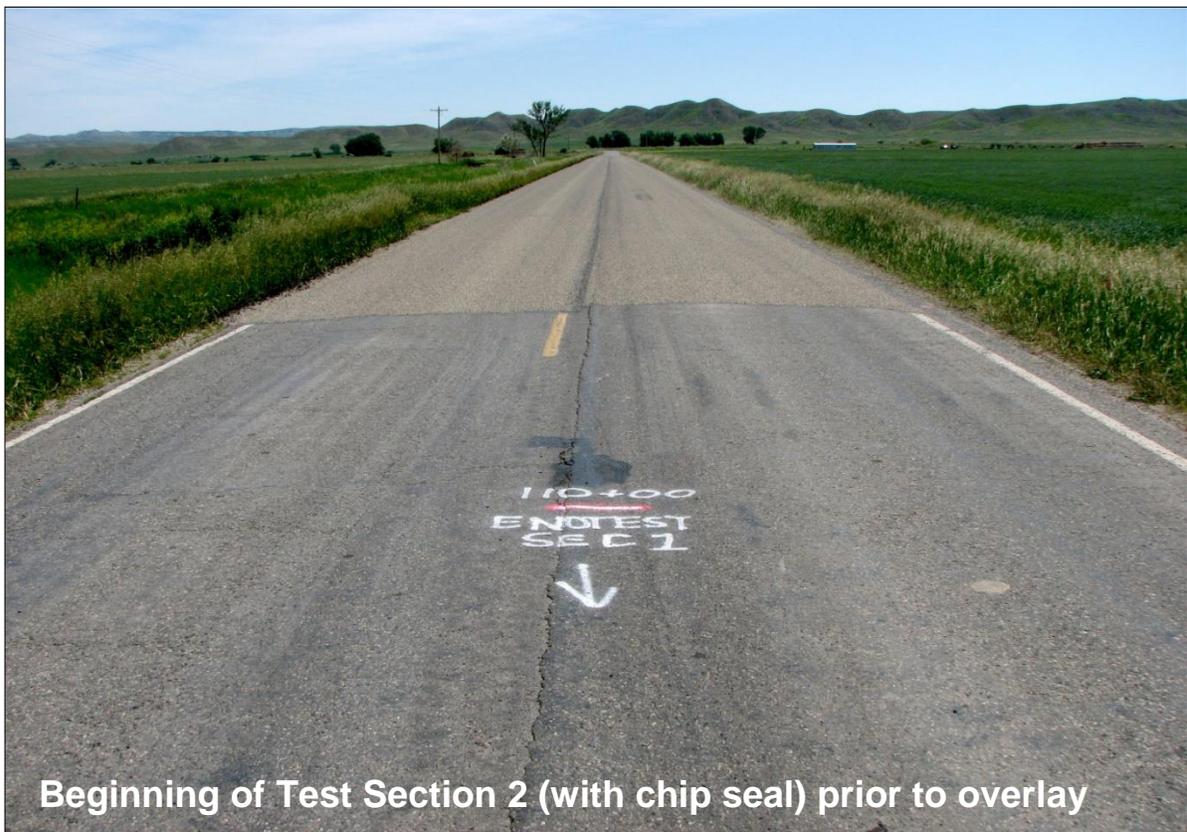
Beginning of Test Section 2 (with chip seal) prior to overlay

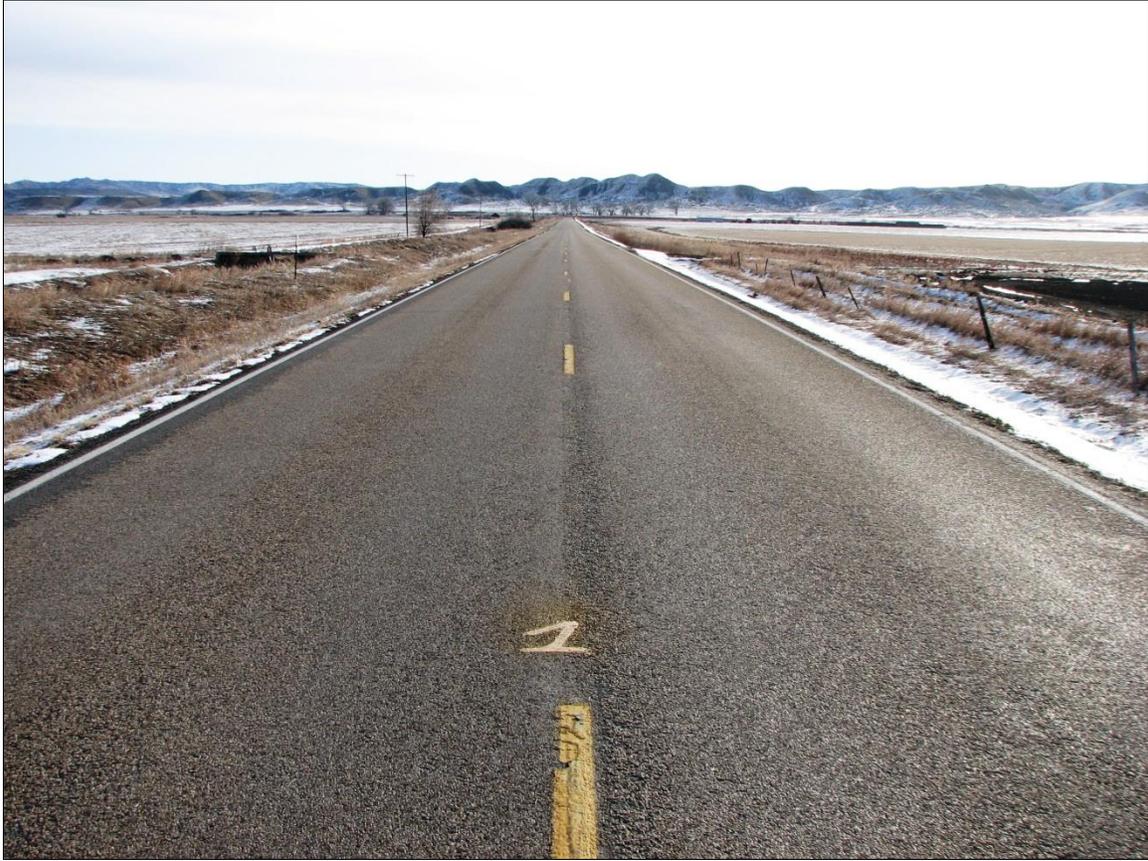
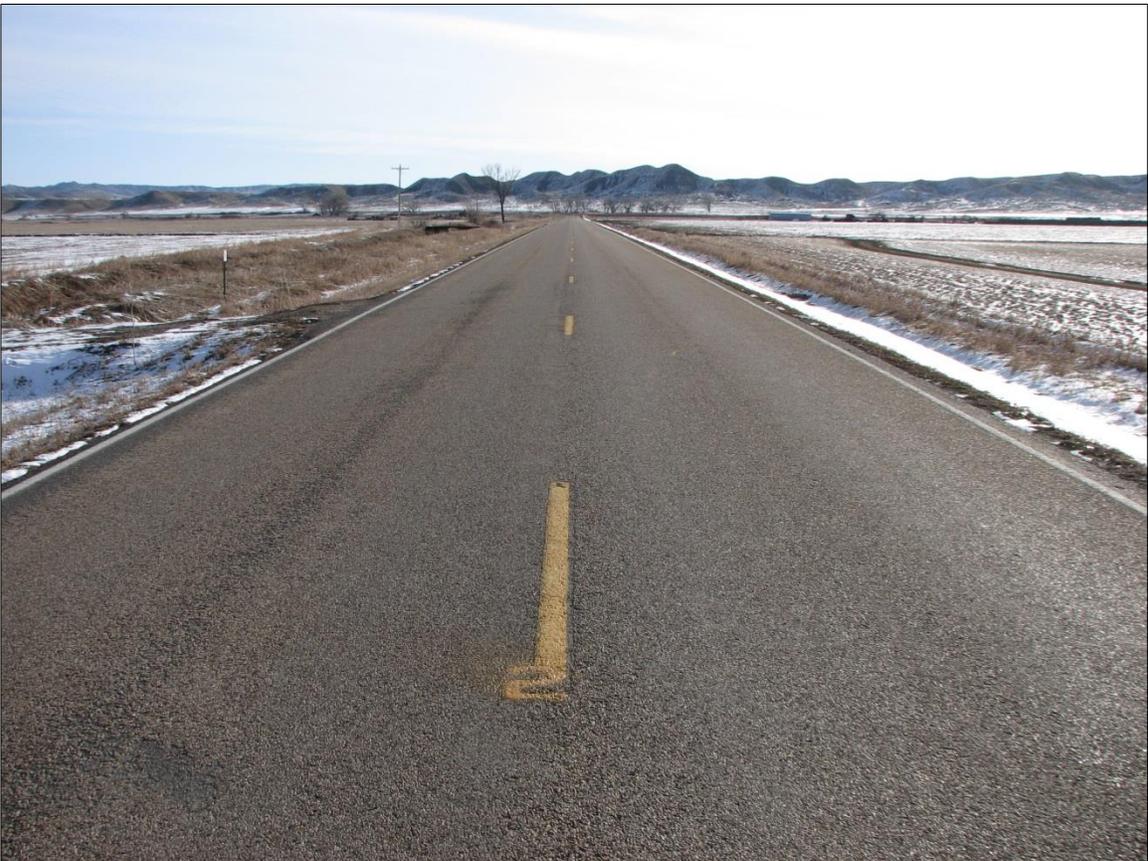
March 2015: Sections 1 & 2 (views east)

During the March 2015 inspection it was found the control section 1 had formed two (2) transverse cracks rated as moderate severity ($>1/2"$ - $<3/4"$). No cracks were visible on test section 2.

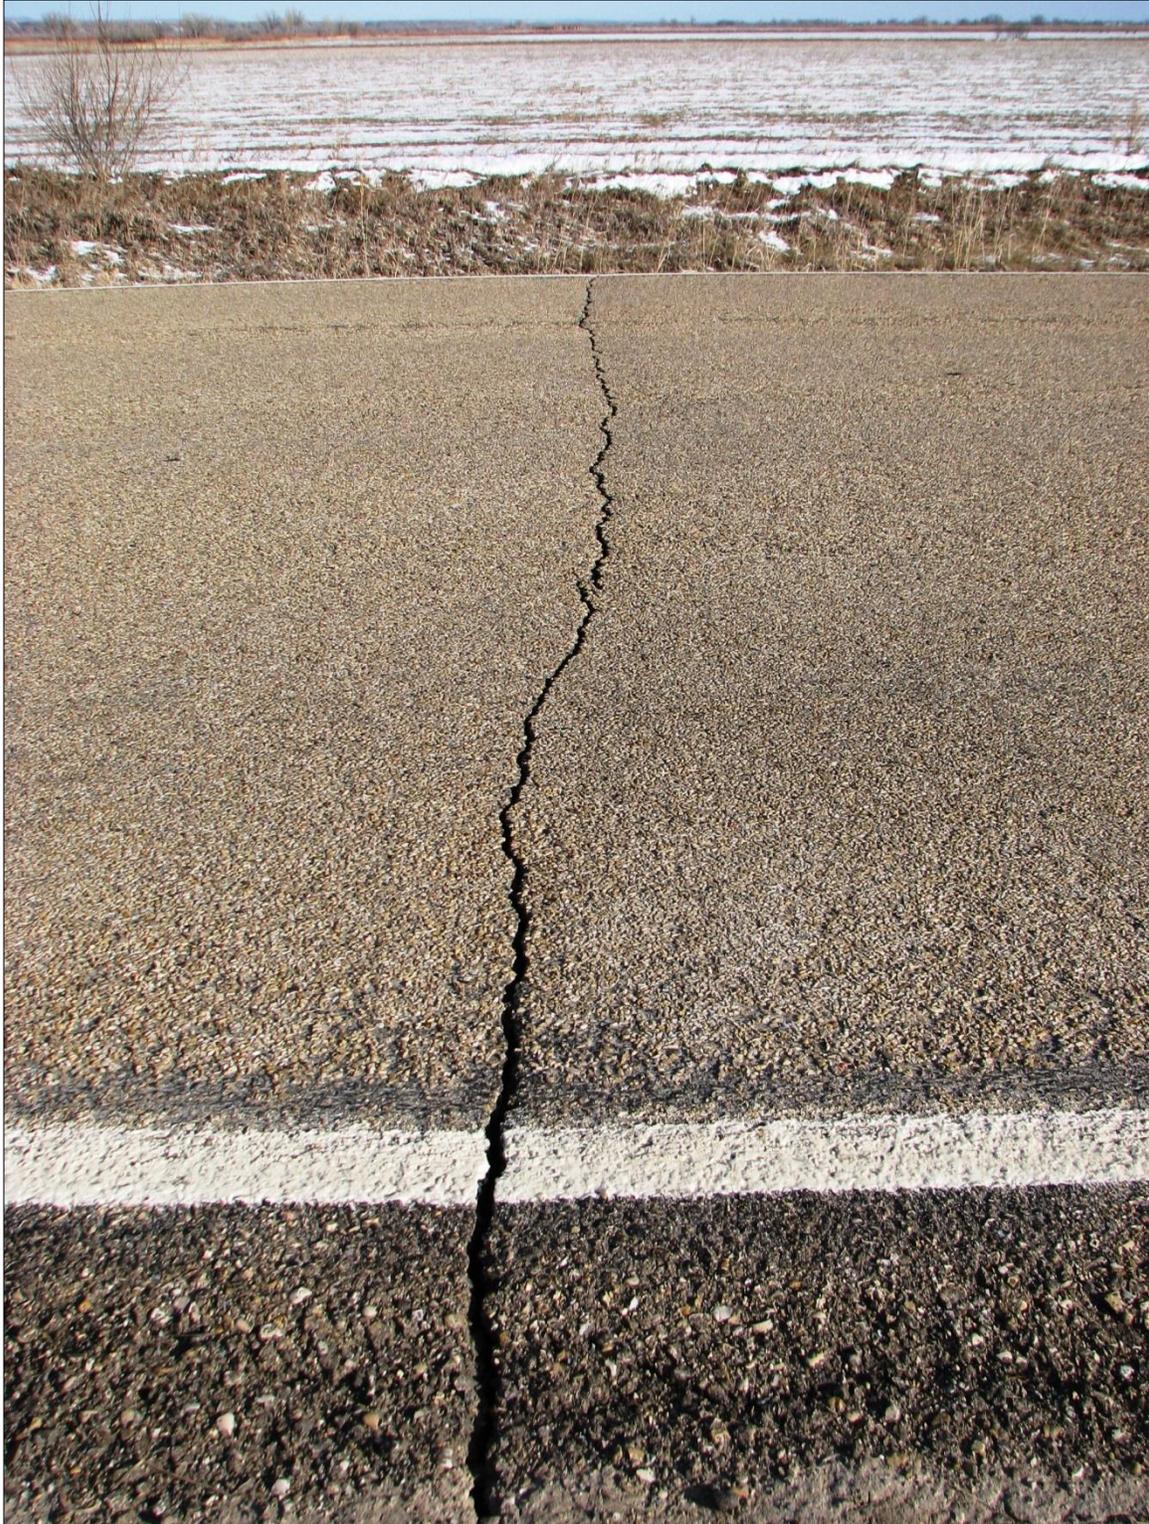
March 2015: Control Section 1 – Example of Moderate Severity Cracking
