EXPERIMENTAL EVALUATION REPORT

Thin-Whitetopping Bonded Composite

Location: Glendive, Montana – Dawson County

Project No.: STPP 20-1(6)0 P-20, Highway 16, Milepost 0-0.6

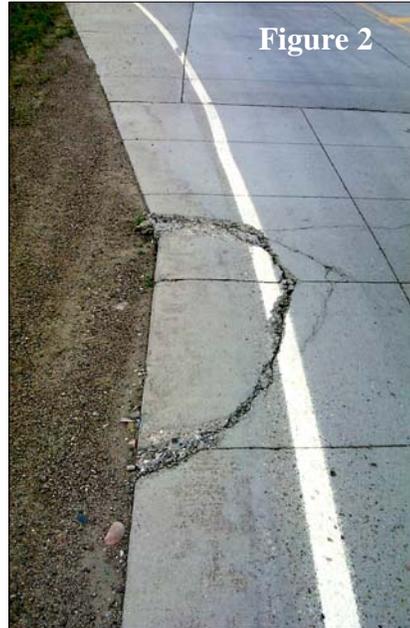
Additional panel cracking was located on the north end of the southbound lane on the west side of the road. It was originally observed that large truck traffic exiting off the interstate (due to the angle of turn) would roll over this section half on the pavement and partially on the gravel shoulder. The main reason for cracking at this location may be due to the lack of supporting shoulder and heavy loadings. The cracking pattern also reflects lack of

support. Figure 2 shows the current, progressive cracking of panels that was first documented in the first annual evaluation (north-end, south bound), the image was the condition of the area 2004. Truck tire imprints were seen in the gravel. Figure 3 is the condition of the panel as seen in 2005. This area is continuing to deteriorate in each annual inspection. No panel deflection was seen as heavy trucks passed over. However, due to the nature and location of the cracking, this area will most likely deteriorate to the point in which it will require repair of the pavement. On the south end of the southbound lane, westside, panels are continuing to

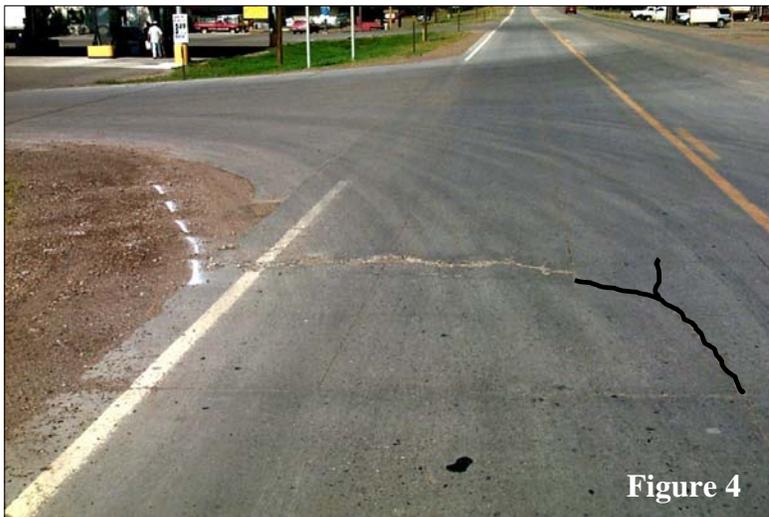
deteriorate as first documented in the 2002 report. This began as sympathy cracking from the full-depth portion and has progressed towards the truck stop approach. Load transfer from the gravel curb onto the whitetopping may be the major factor for panel cracking at this site. Figure 4 shows the area of

deterioration, a white line has been sprayed on the area where tire treads are seen in the gravel. A black line has been superimposed on the image to better see the cracks.
