Great Falls Experimental Whitetopping Annual Evaluation

Location: Great Falls, Montana; Intersection of N. W. Bypass & 3rd St. N. W.
(U5206 & U5203). Three southbound lanes of 3rd St. N. W.

Report Date: September 6, 2001

Report Origin: Pavement Analysis & Research
Craig Abernathy

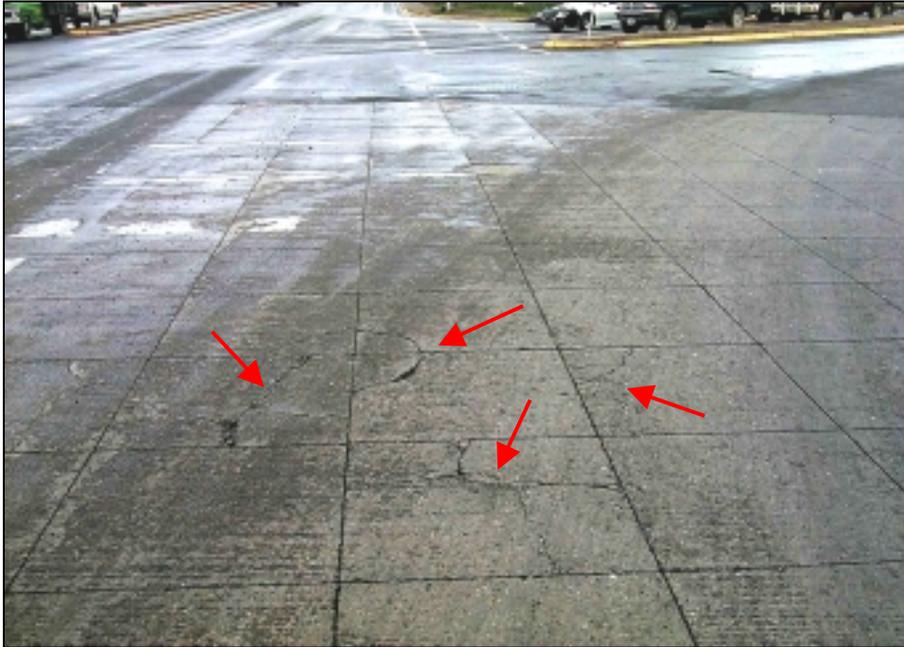
Since the 2000 evaluation, additional panel cracking was observed in the right-hand turn lane adjacent to the repaired area (see figure 1). This panel cracking may be an extension of the underlying AC stripping which was determined as the main factor of failure and consequential

replacement of the 10' x 15' panels earlier in the year. The moisture stripping the bottom AC layer may be attributed to the close proximity of the storm sewer line directly under the lane. Cracking is mostly hairline in nature and no debonding of the individual panels was noticed during this inspection.

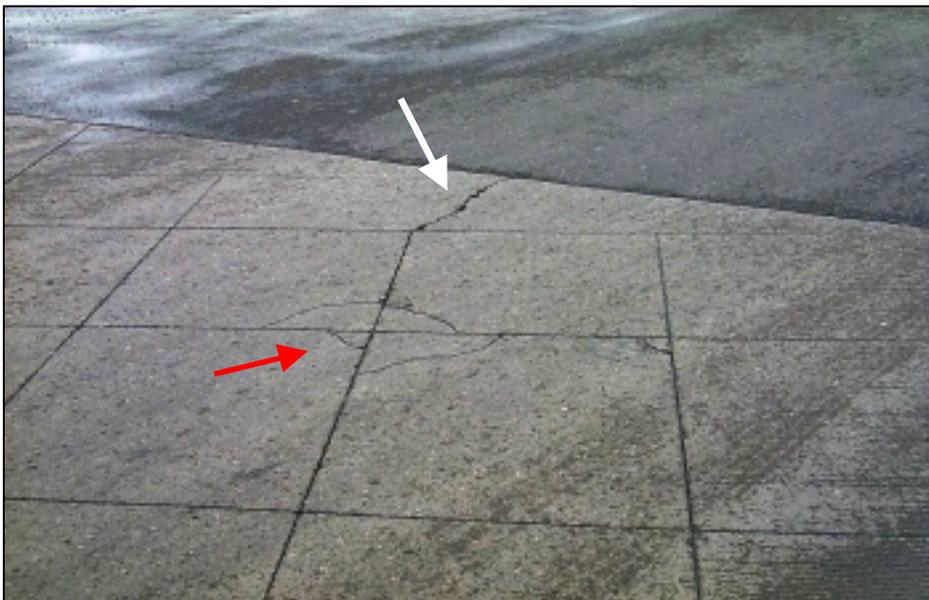
Cracked panels were observed at the end of the whitetop where it meets the AC pavement (right-turn lane onto the N. W. Bypass). As current diagrams show, no storm lines are in this area. Figure 2 shows the area of deterioration. The red arrow points to cracking, which is indicative of isolated AC failure possibly due to sufficient lack of support to the overlying PCCP layer. The white arrow points to a sympathy crack. This panel was over-large and should have been sawed initially, which may have eliminated this type of crack. It should be noted

that historically, this lane carries the highest truck traffic.

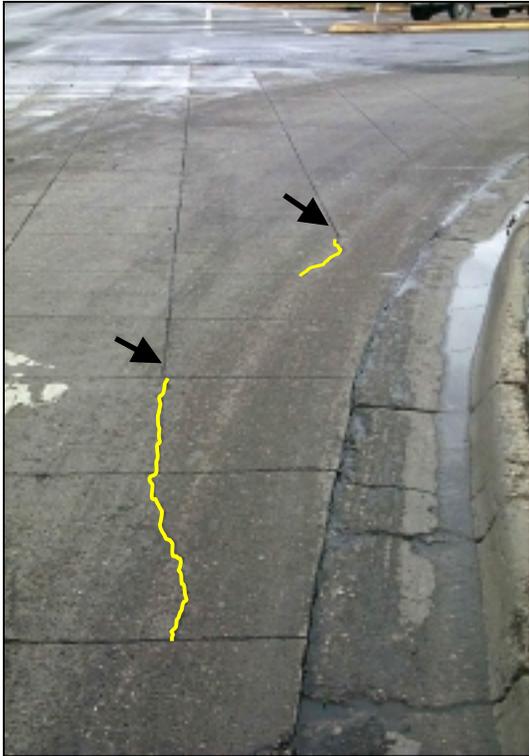
Sympathy cracking was also observed in the far side of the right-turn lane (Figure 3), the yellow lines depict the outline and direction of the crack, arrows show where the saw cut ended and panel cracking began.

Continuing the saw cut through to the adjacent panels may have eliminated this set of cracks. However, the panels could be too small, when cut, to transfer loads effectively. This area will be watched closely in future inspections.

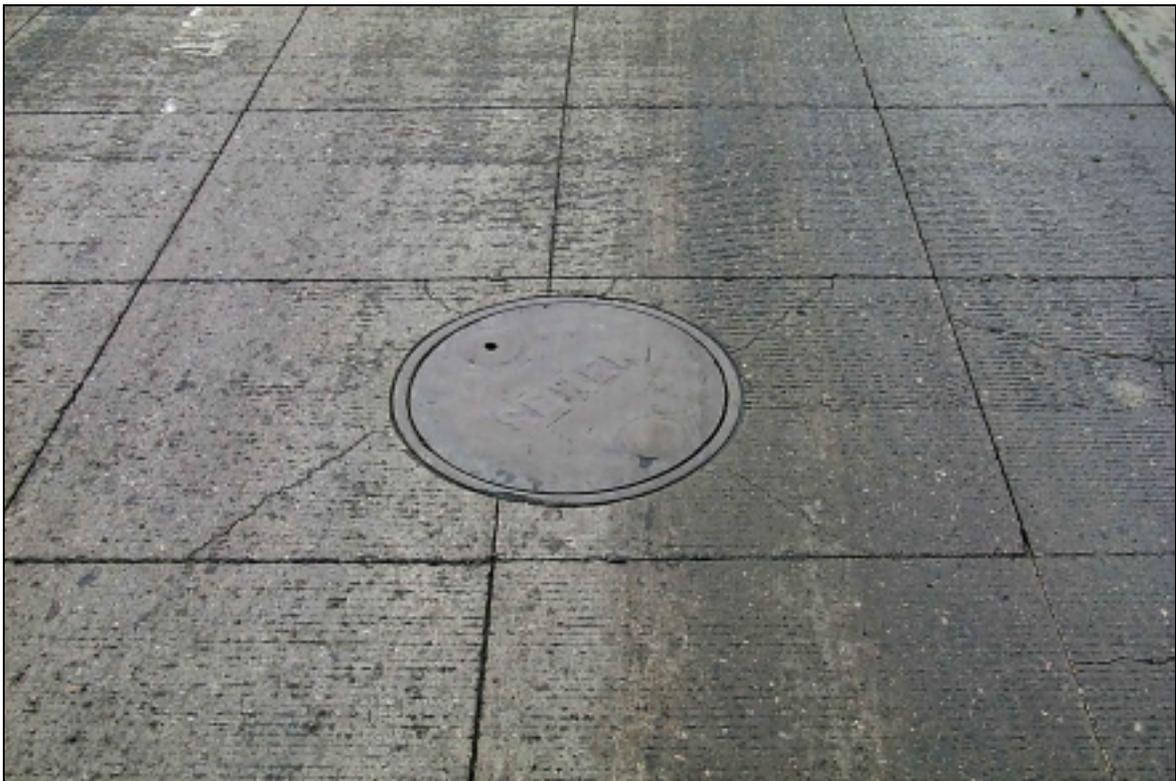
Additional cracking was observed in the same lane just prior to the repaired area (several feet north of the area). As in other sections of the right-lane, this may be an indication of AC stripping due to abnormal water infiltration or normal corner-cracking indicative of this type of pavement. Figure four shows cracking around the first manhole cover going south when approaching the whitetop pavement.
