## **EXPERIMENTAL PROJECT CONSTRUCTION REPORT**

### **EVALUATION OF HIGH DENSITY POLYETHYLENE PIPE (HDPE) CULVERT IN A MAINLINE APPLICATION**

**Location:** Highway 59 (P-18); C000018, Rosebud County, Glendive District

**Project Name:** Angela North & South

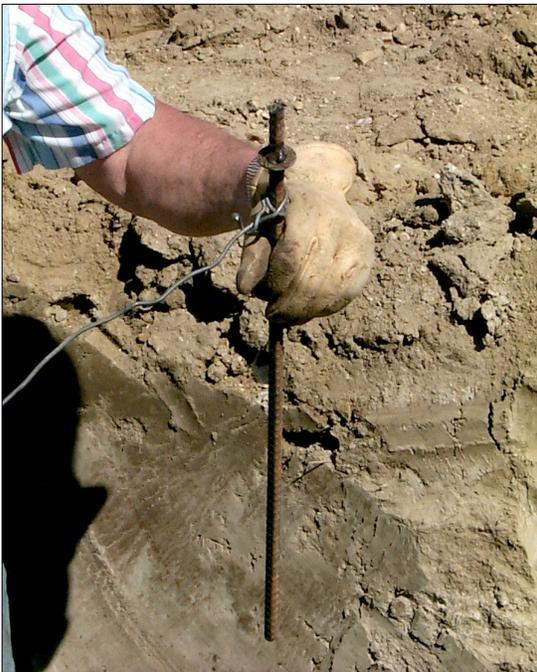
It was determined to secure the pipes with rebar and wire harness to the pipe and ground during bedding. The wire was cut prior to the completion of the backfill. ↑ →

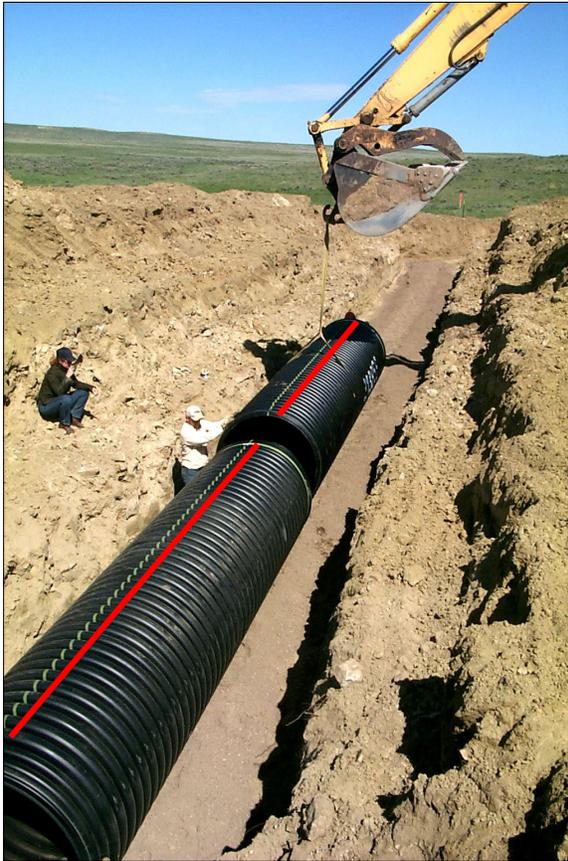
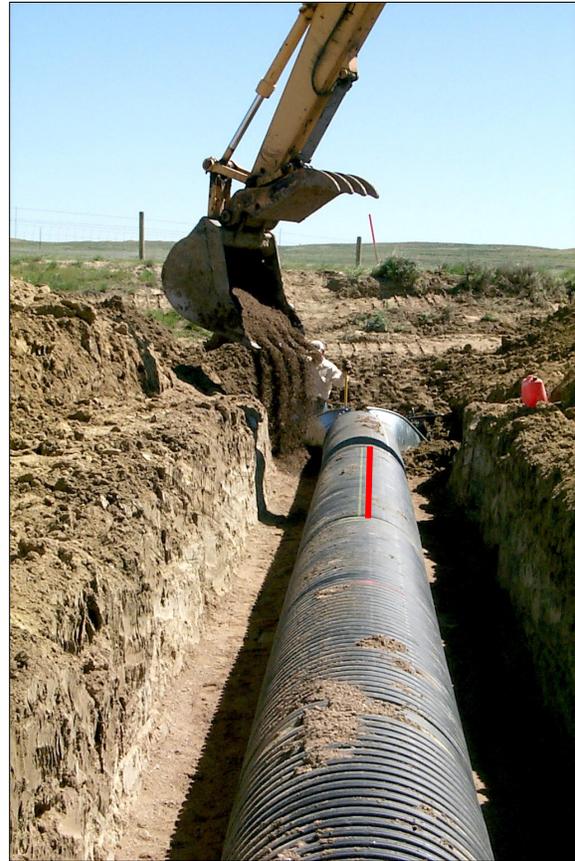
### Vent Tube

During installation there was an issue of the correct alignment of the HDPE with regards to the vent tube. The ADS representative stated that the vent tube indicated by the green stripe which runs along the length of the pipe (a red line has been superimposed next to the stripe for reference) as when placed should, visually, be located at the top of the pipe when set in the bedding (as seen in the left image versus only one top stripe alignment with the image on the right). The vent tube is used in the manufacturing process of the product and not related to any installation criteria and is no more than 5-6 millimeters in diameter located in the interior of the pipe not visible on the exterior. It is only found on HDPE size of 900mm and above. In contacting the ADS Application Engineering staff for a detailed response with this issue, they explained that this is not a critical element in the placement of the pipe. In an extreme case if the vent tube is punctured, it may allow water to migrate into the vent and enter the pipe at the joint under a high hydrostatic event. To their knowledge this has never been a problem, or led to any product failure to date.

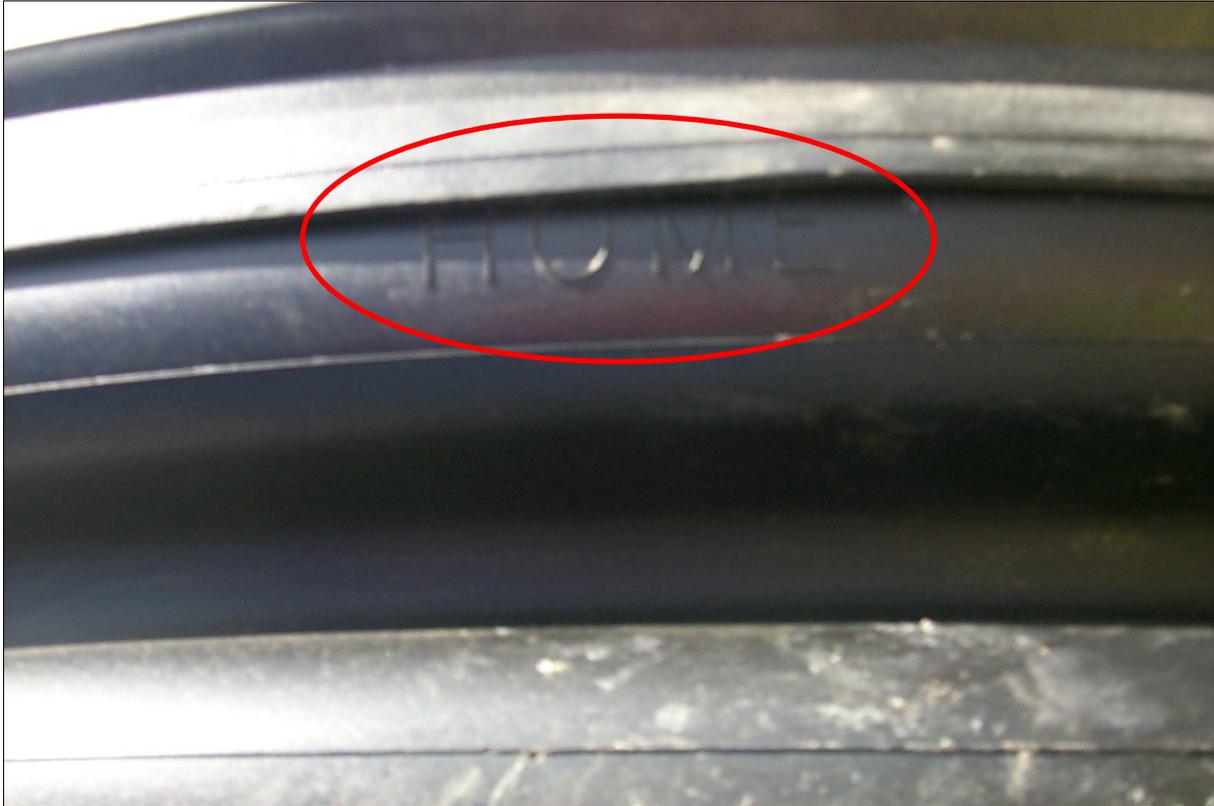
### **Bell and Spigot Guide**

As part of the installation of the HDPE pipe, the manufacturer molds the word 'HOME' at the area where pipe and spigot meet (as seen with the red circle). This is meant as a guide for installation. It was unsure where the bell section should be in relationship to the 'HOME' guide as no information was received from the manufacturer. The ADS Application Engineering staff explained that the target range for placement is where any part of the word is covered by the bell since this is the tolerance range for a proper fit. As you can see from the above image the pipe was in that range. For the other pipe section connections, the tolerance was as above or midway into home. The following are the gap ranges as supplied by ADS; note the following figures are for a straight alignment gap:

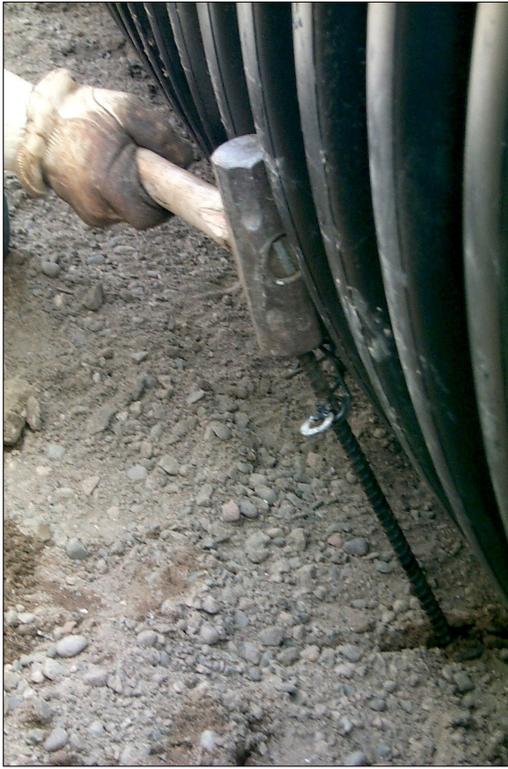
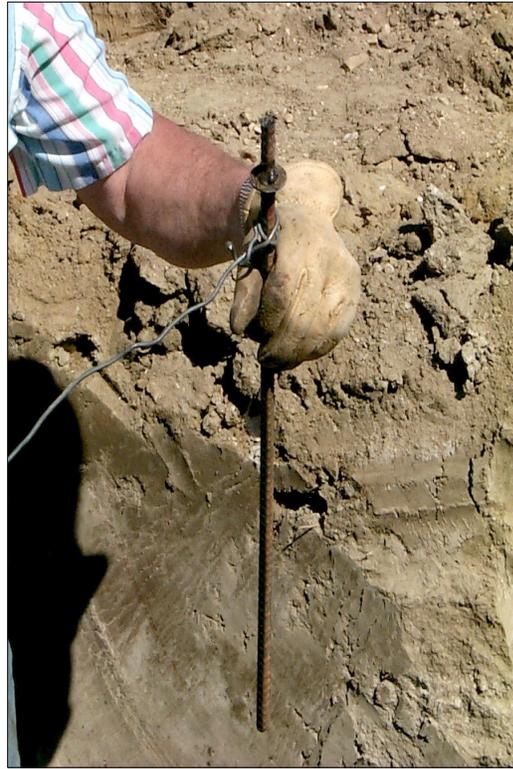
### **Securing the Pipe**

As stated earlier a rebar with a welded washer was used as an anchor to strap the pipe securely during the backfill process to prevent movement. This procedure was selected by the contractor based on his experience with placement of this type of light weight pipe. His reasoning is that the fill, during initial placement, may cause the pipe to float and this was an easy fix to alleviate that condition. Since this is not a standard installation practice for HDPE (as the use of a fabricated hold-down bracket is not mentioned in any ADS installation manual), it is suggested in a future installation, that this procedure not be followed in an effort to determine that not using a bracket will adequately place the pipe.

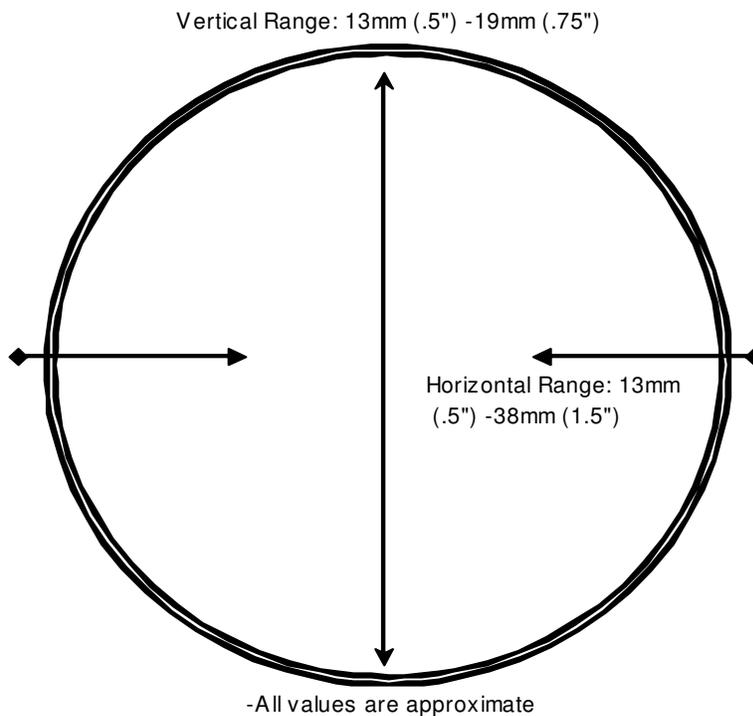
### **Noted Deflection**

During random interior measurements of all of the HDPE pipe, after completion of the compaction phase it was noticed the side walls of the pipes or the horizontal range had compressed on an average of 13mm (.5") – 38mm (1.5") conversely pushing the vertical range of the pipe from 13mm (.5") – 19mm (.75). Visually the end sections of the pipe had a concave aspect which was originally assumed the tightening of the FETS had caused the oval shape at the pipe ends, but subsequent interior measurements confirmed the deflection. It is assumed at this time the compaction phase is responsible for the deflection. Future evaluations will establish base data to ascertain any changes within the pipe over the duration of the experimental analysis.

Note that this deflection did not, based on visual inspection at the time of installation, affect the quality of the bell and spigot connection.

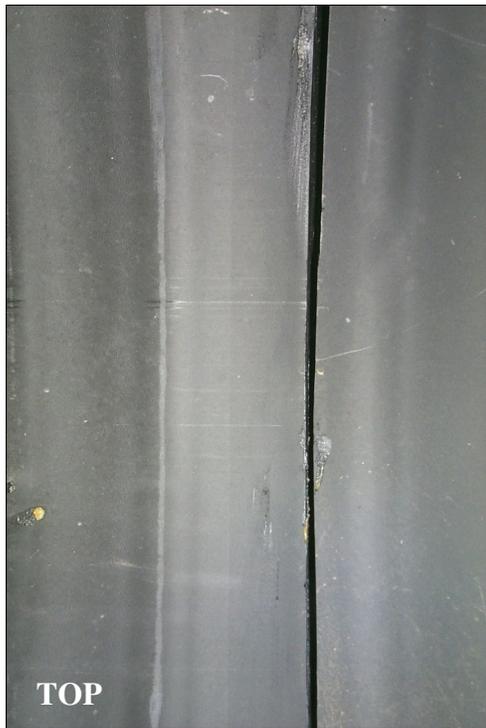
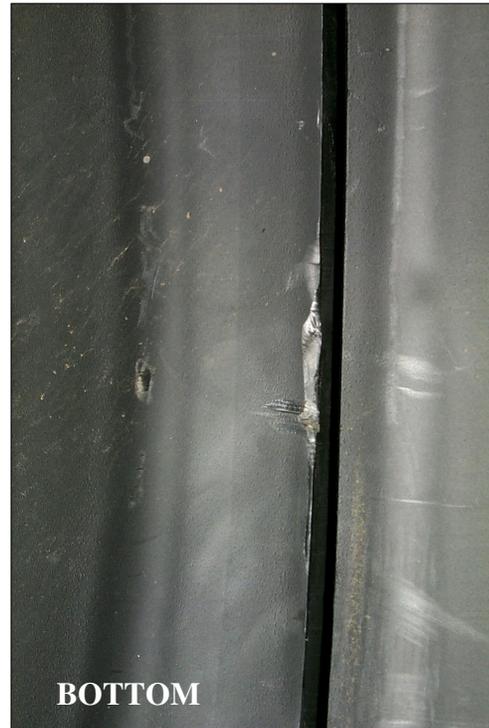
### **Interior Seam**

All seam connections were within gap tolerance. All pipe connected easily with an audible 'snap' as they were inserted into each other. The 1200mm pipe did display a larger gap at the bottom connection (up to 3/8") within gap tolerance (above images). It is unsure why the disparity of top and bottom gap width. It was speculated that either pressure of the pipe on the bedding may widen the gap or particulates may have entered into the seal at the base inhibiting a tighter fit.

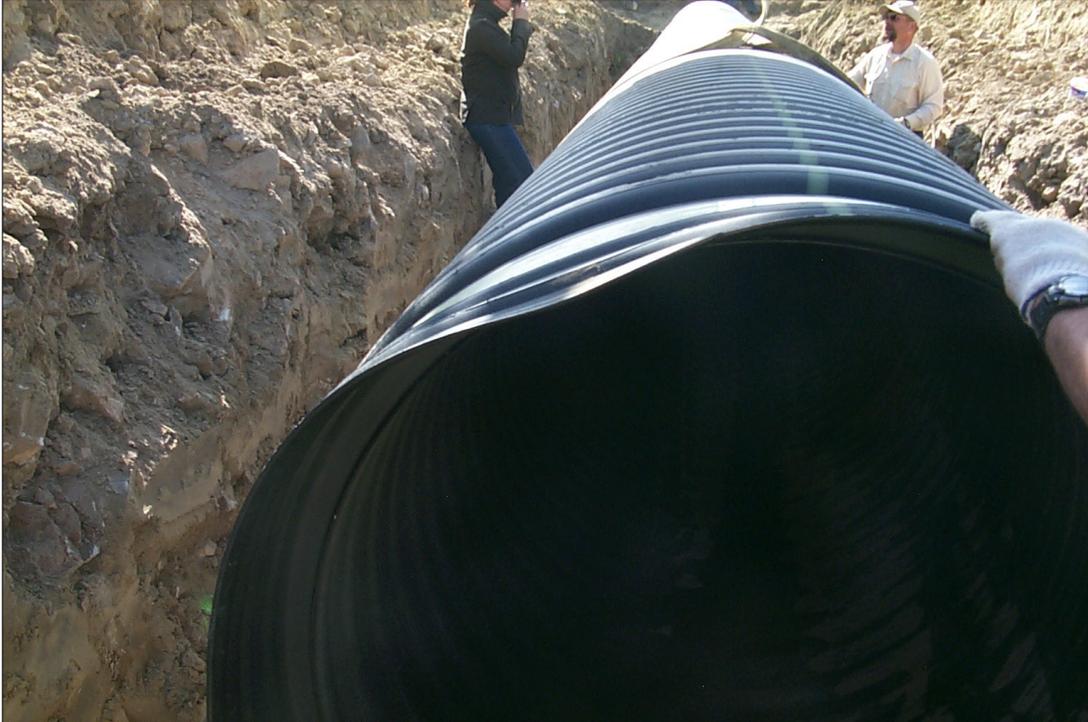
### **Deformed Lip at Bell**

One of the 1200mm pipe sections had a deformed end at the bell, most likely from improper shipping. It was easily pushed up by hand and held its shape while the next section was installed. There was no problem with the connection.
