Montana Department of Transportation
Research Programs
2013

Experimental Project Final Report

EVALUATION OF VARIOUS PAVEMENT FABRIC AND MAT APPLICATIONS TO
RETARD REFLECTIVE CRACKING

Project Name: Flesher Pass - East
Project Number: STPS 279-1(15)22: Control No. 6234000
FHWA Project Number: MT 00-18
Project Location: Secondary 279, C000279; RP 22.2-30.5, Lewis & Clark
County: Experimental site locations at RP 24
Average ADT: 560 (2009)
Description: Pavement reinforcement to mitigate reflective cracking on
hot mix asphalt (HMA) pavement
Date of Installation: September 2008
Date of Evaluation: April 2013
Principal Investigator: Craig Abernathy
Experimental Program Manager

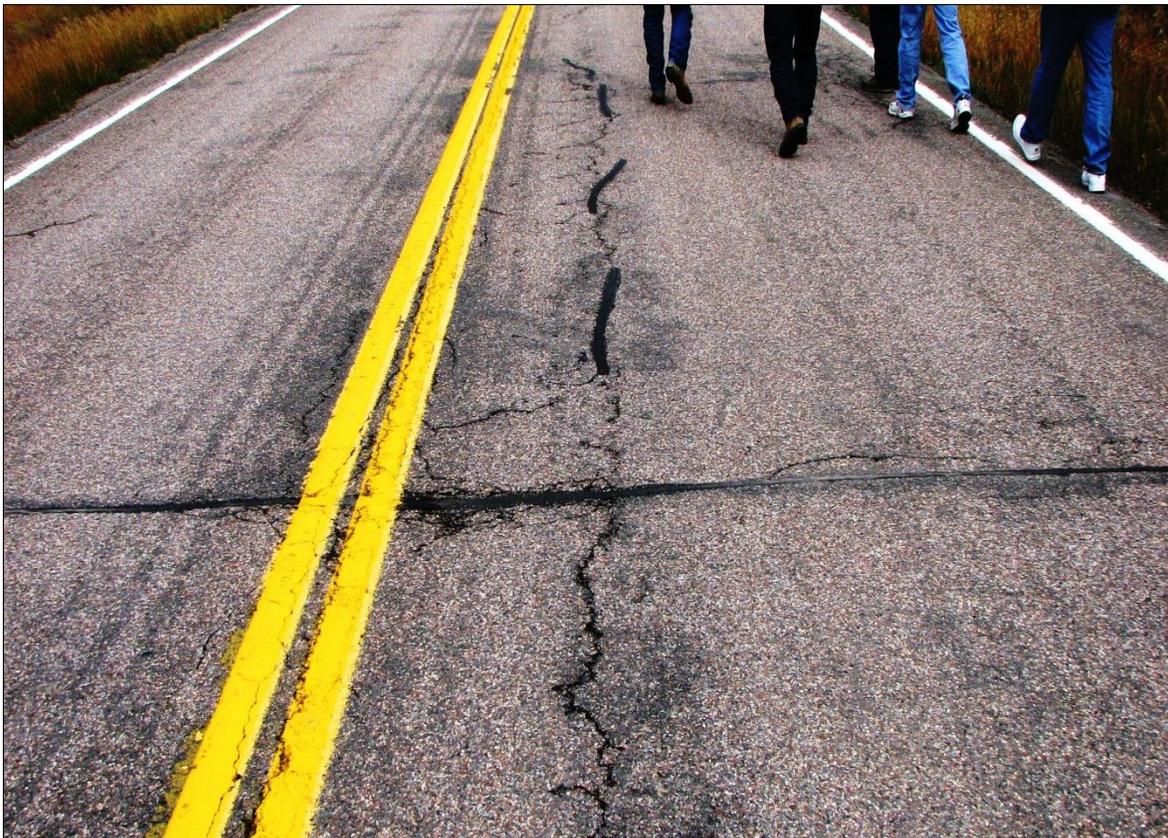
↓ August 2008 - Representative image of general condition of road bed prior to construction.

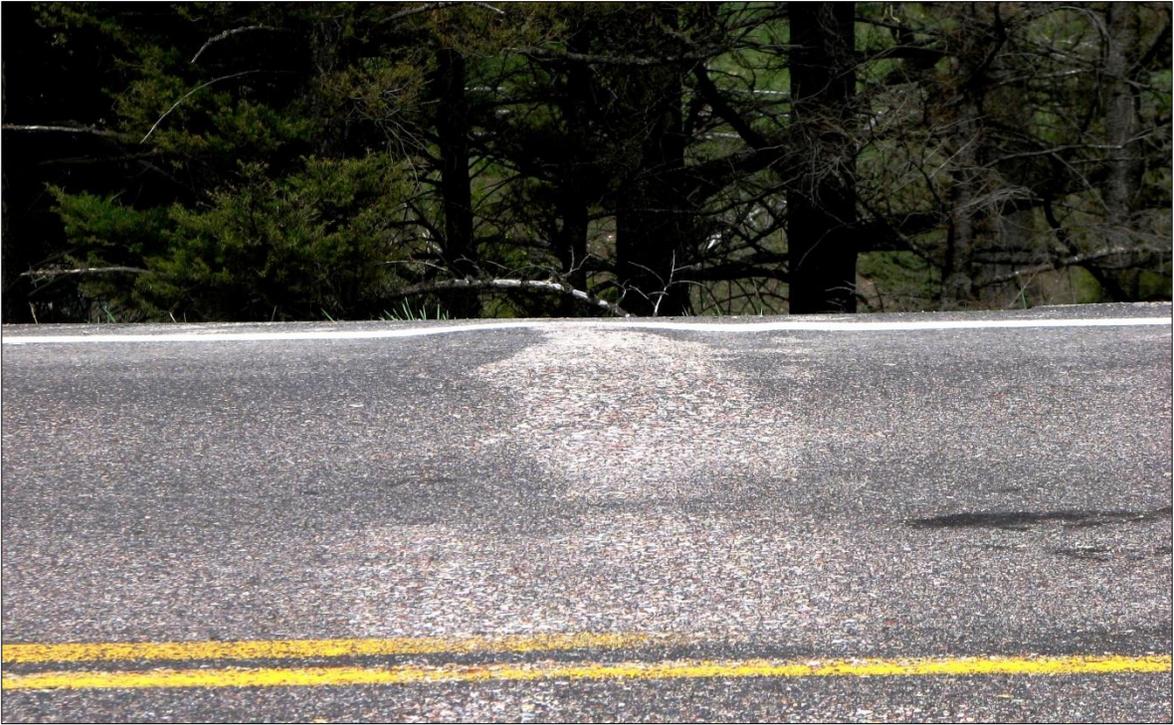
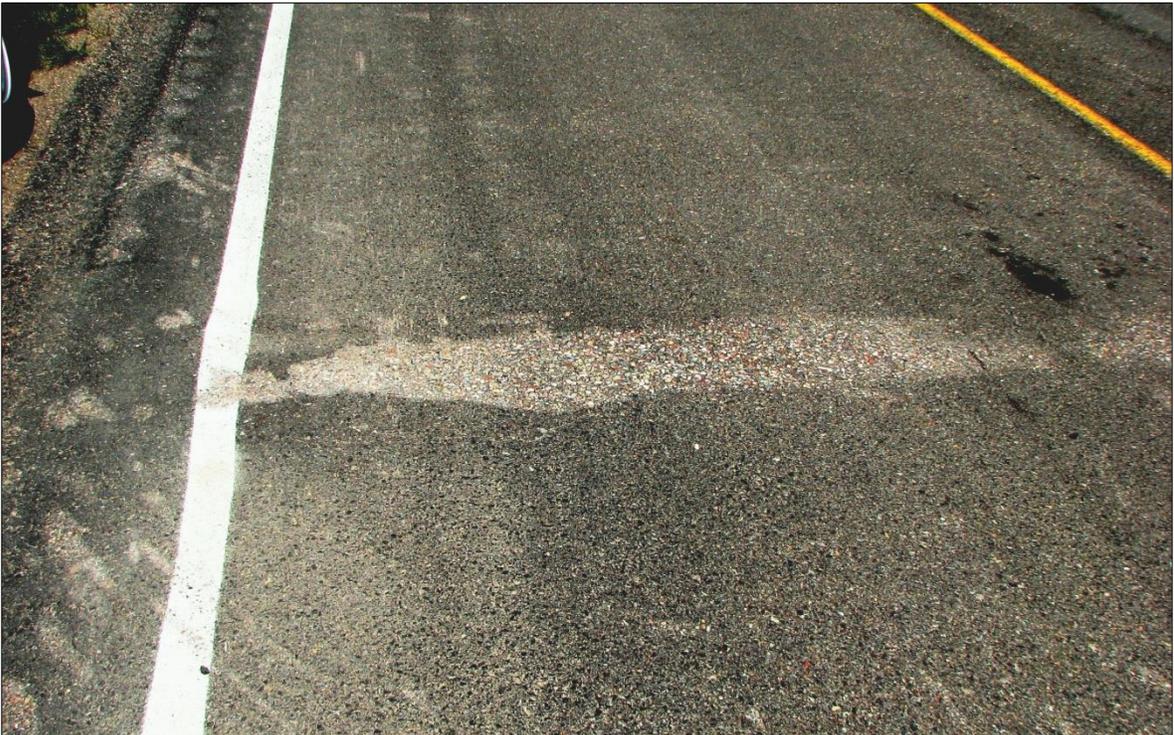
↑↓ As stated earlier in this report. There are areas of noticeable heaving in the pavement surface indicative of characteristic frost heave as shown in these two images documented in 2009. You can see the effect that snow plowing caused at the pavement surface. At the time of the site visit this appeared randomly throughout the project and not (at this time) specific to any one treatment. It will be watched closely in future evaluations.

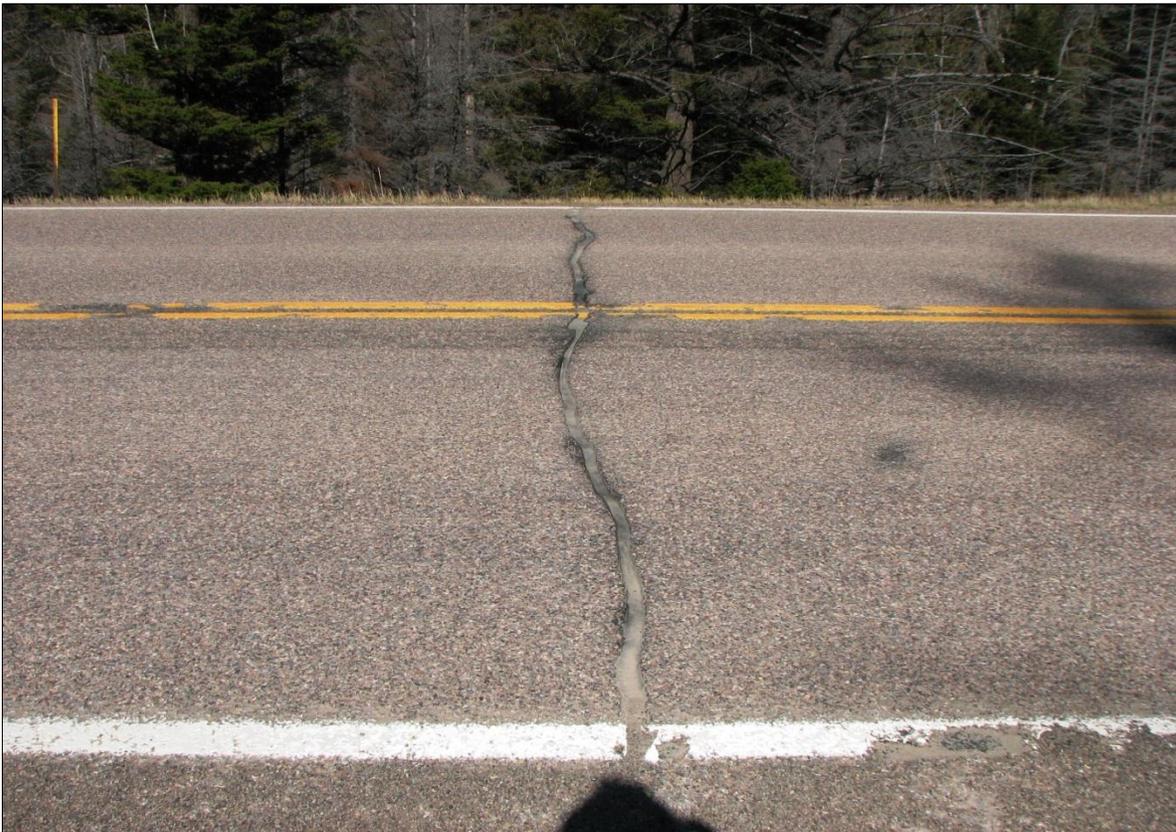
↑ Representative Image of Sealed Transverse Crack
