## CONSTRUCTION REPORT – SITE EVALUATIONS

### APPLICATION OF SEAL COAT ASPHALT EMULSION (OR FOG COATING) OVER EXISTING CHIP SEAL FOR IMPROVED CHIP RETENTION

**Project Name:** Beavertail Road Chip Seal

**Project Number:** MT 10-05

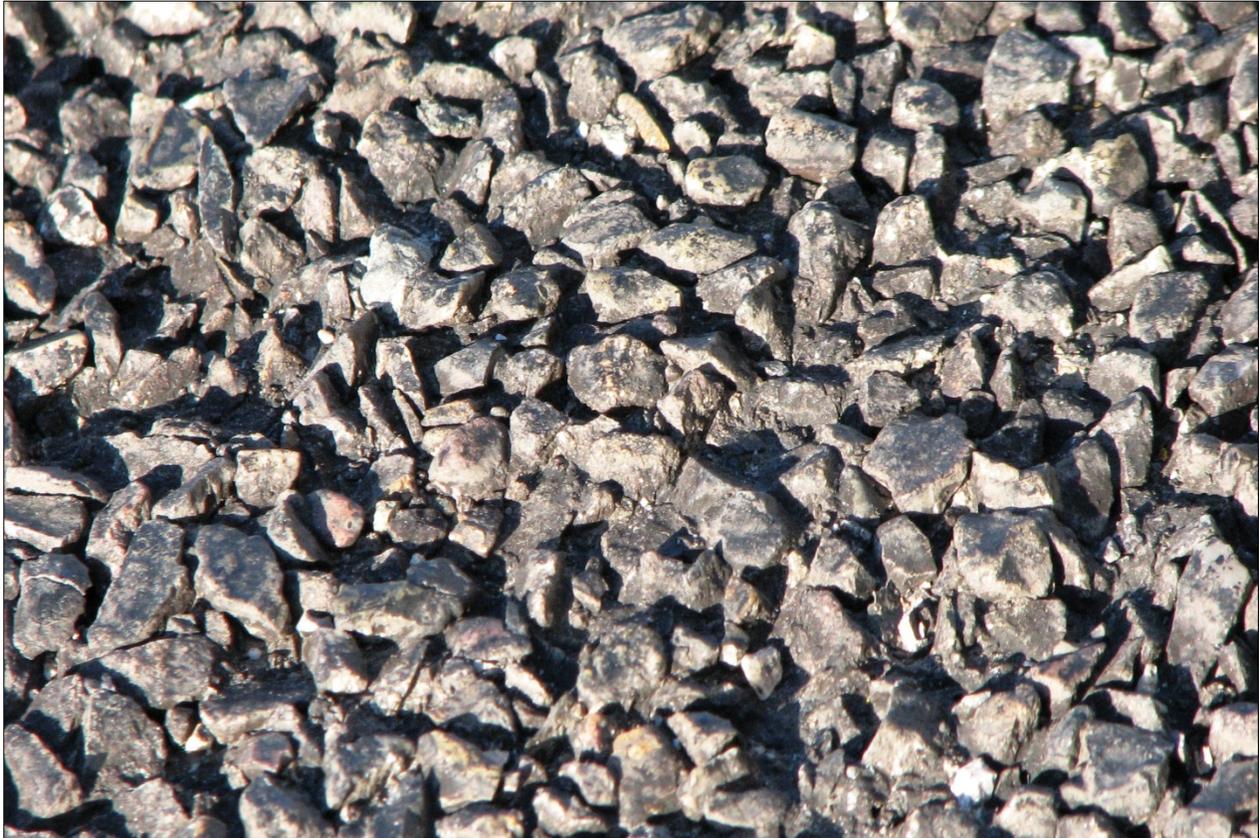
↑ Close-up of chipped surface of Test Section 1.

During the initial placement in August, and compared with the site visit conducted in November, the residual AC (locally specific to the top exposed aggregate), is beginning to display minor stripping due to either environmental elements, traffic to date, or a combination of both. This is considered normal and visually the road surface will lighten or become grayer over time.

Upon close examination of chip embedment with the AC as compared to the project control (section of the east end of the road which did not receive the post seal) the amount of AC that encompassed the test section aggregate was more prevalent than the control, and homogeneous penetration with the initial SS1 application (prior to chipping) and the post SS1 application. This was determined by using a small hand chisel to remove a small area of the seal to expose the relief.

To date the topical application of the SS1 (or fog seal) appears to have efficiently locked in the chips than compared to the control which may promote a more durable seal. Future evaluations will determine if this supposition is valid.

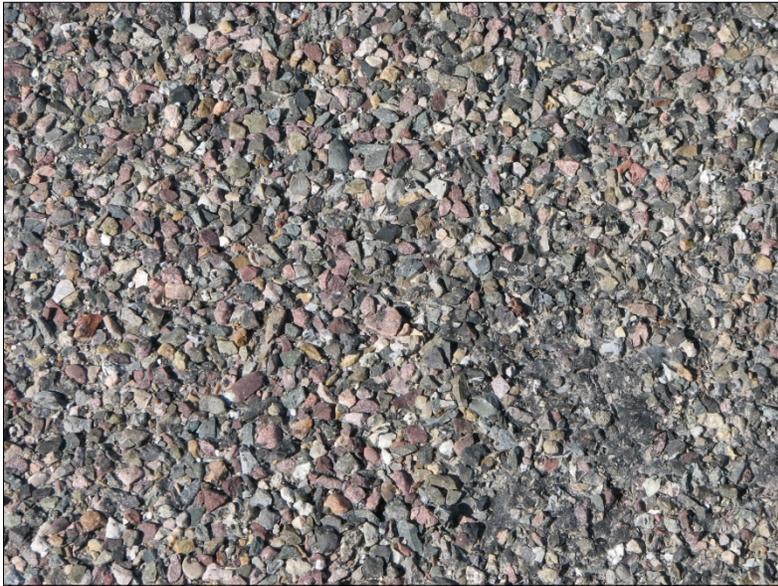
← Control section close-up of surface aggregate.

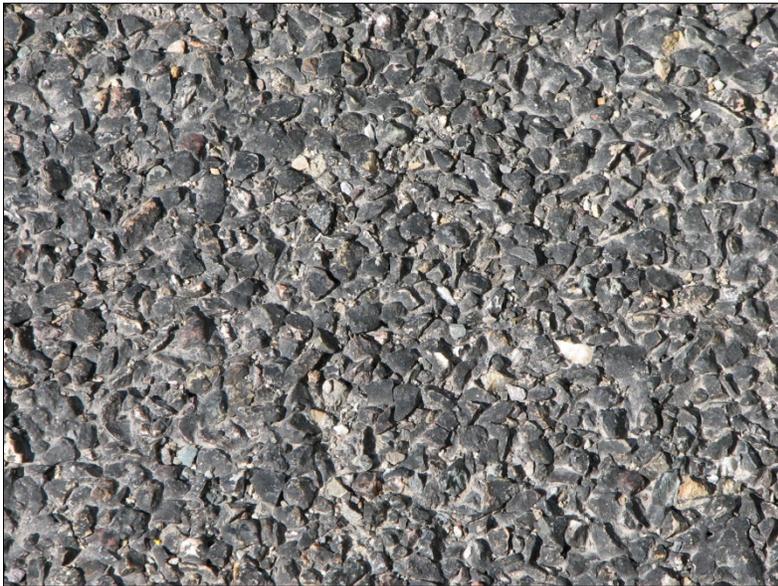
← Test section 1 close-up of surface aggregate.

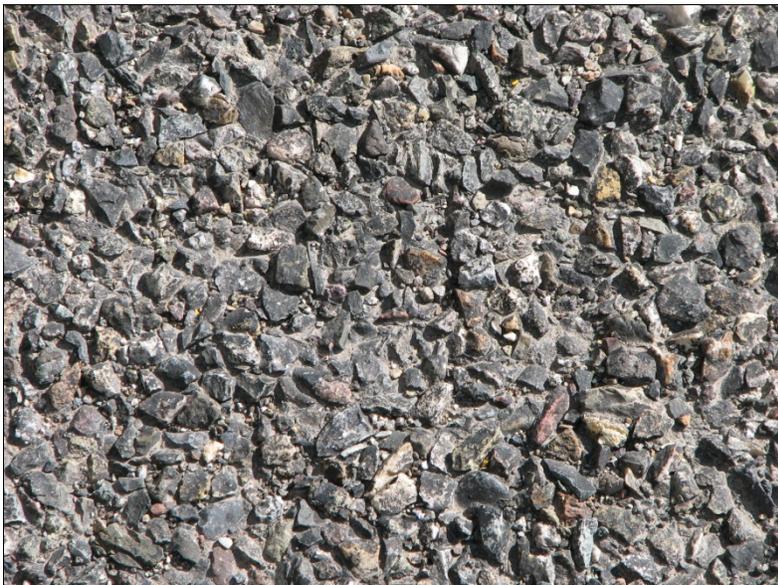
← Test section 2 close-up of surface aggregate.

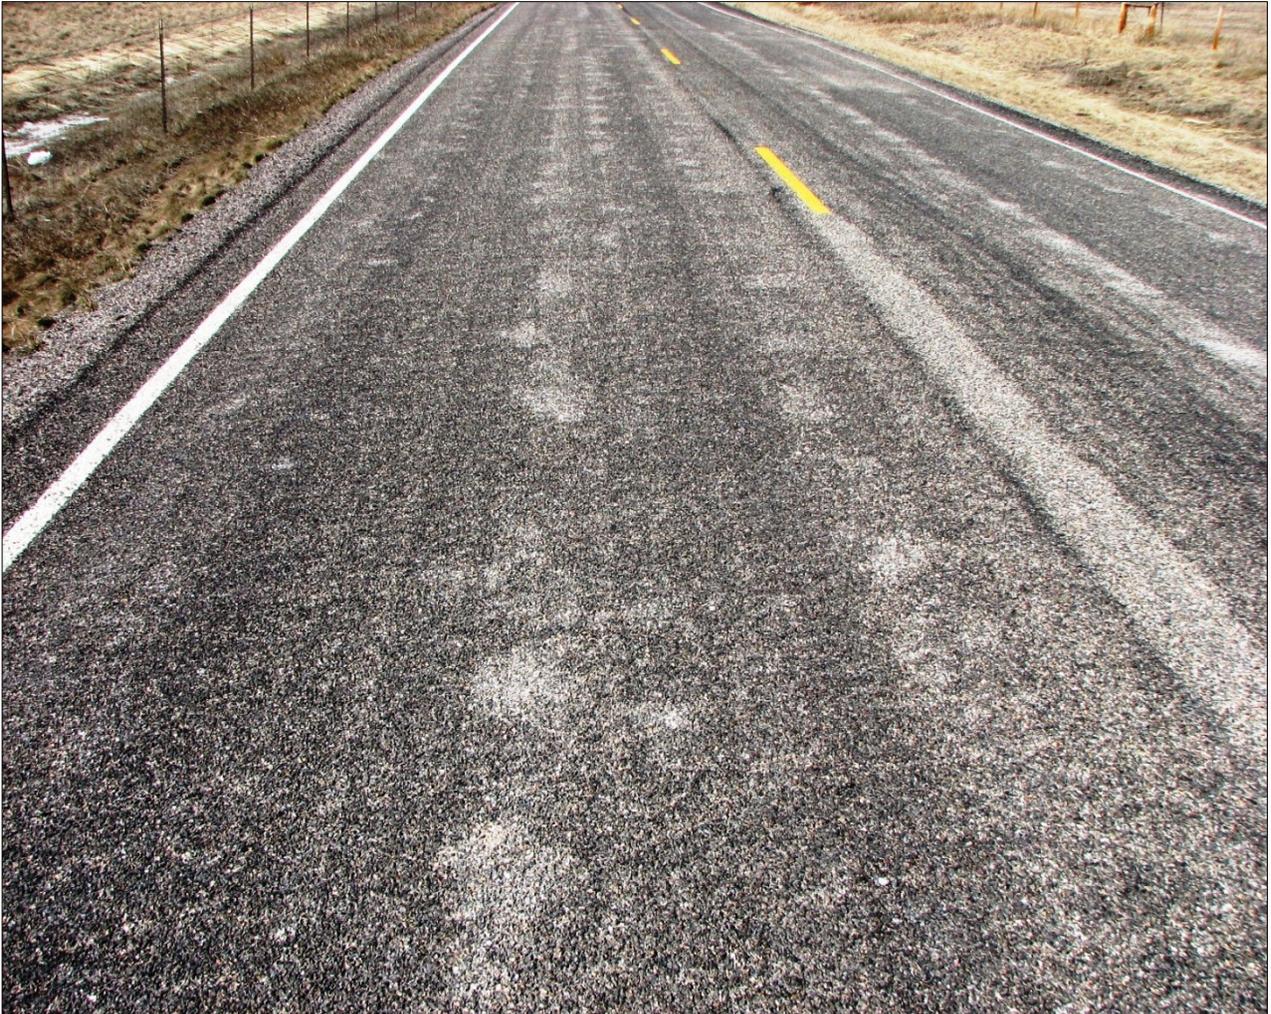
↑ The spotty appearance (lighter shading) of the road bed is predominant on all sections of the project including the control, but not as visible due to the lack of SS1 application. This condition primarily is located away from the wheel paths. This may indicate minor rutting. The lighter areas indicate possible snow plow chatter and the subsequent scouring of the top of the chip seal layer.

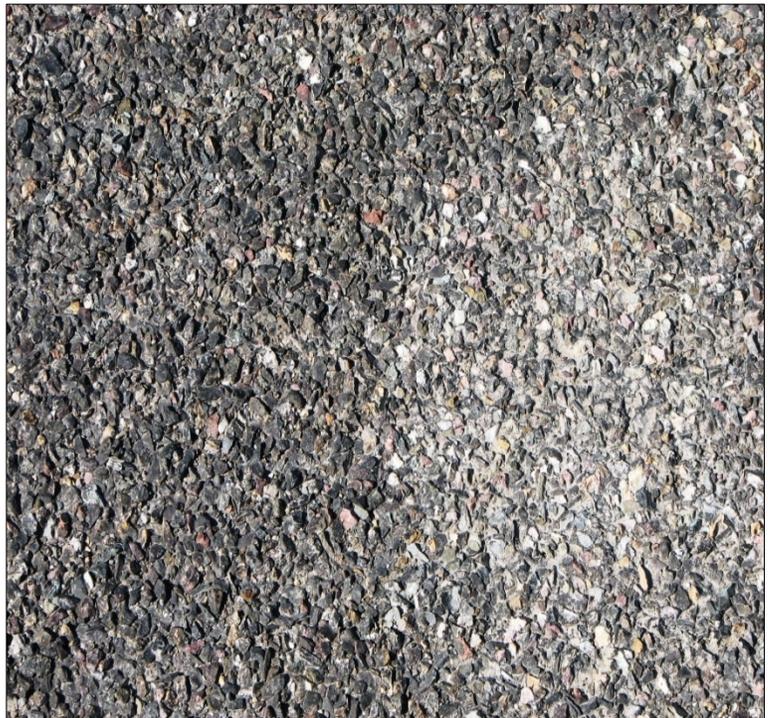
➔ On closer inspection these areas appear to have loss the topical application of SS1 and some minimum removal of higher relief chips.

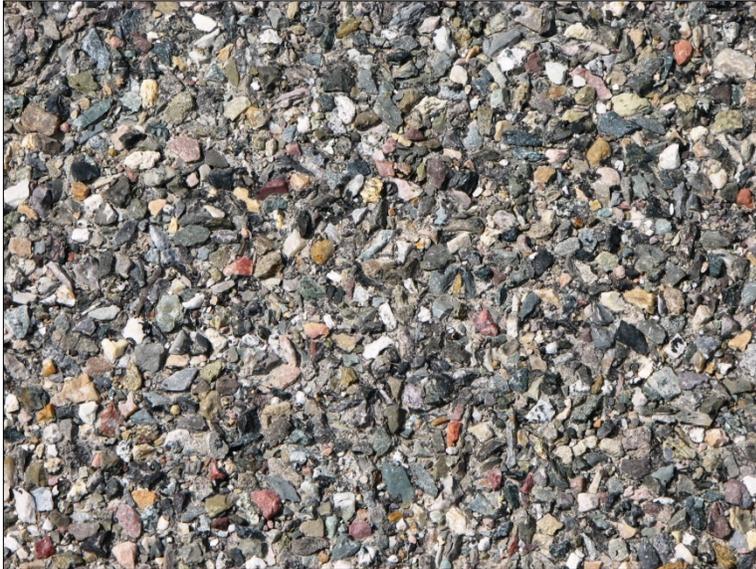
← Control section close-up of surface aggregate.

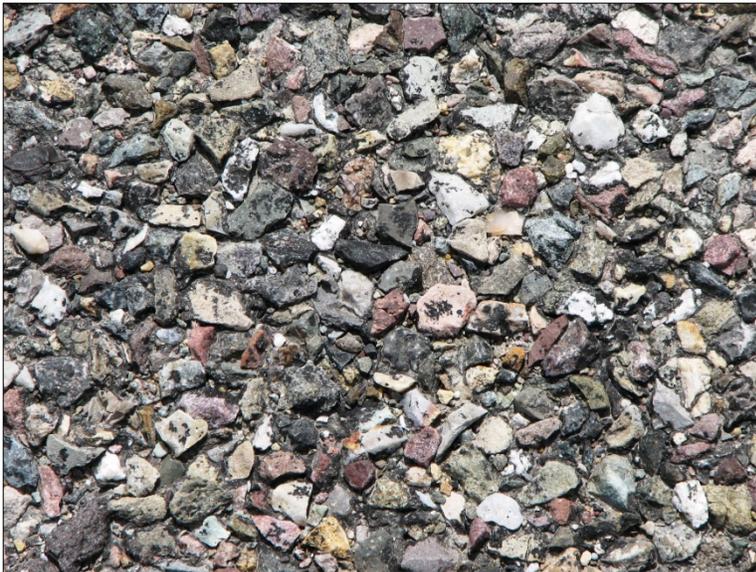
← Test section 2 (.05 gallon per sq. yd.), close-up of surface aggregate.

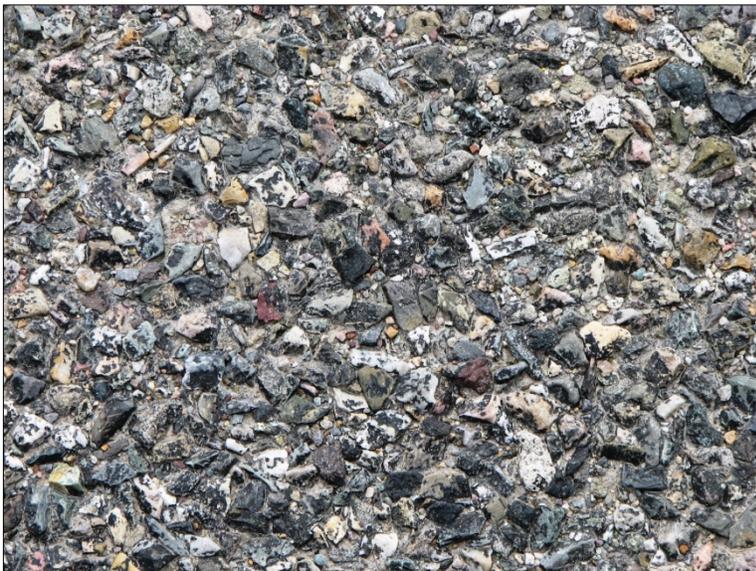
← Test section 1 (.1 gallon per sq. yd.), close-up of surface aggregate.

In comparing all three treatments, TS1 appears to have a tighter mat, rock embedment is firm and the SS1 application is evident.

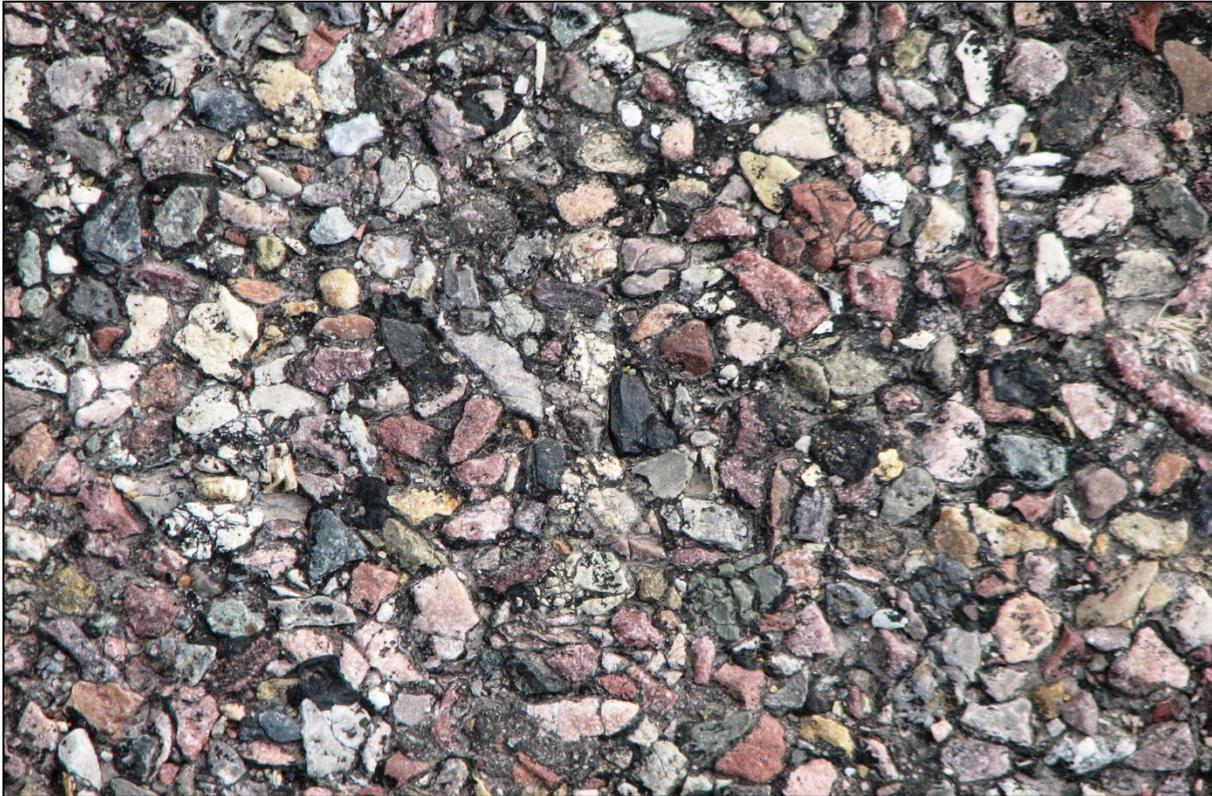
The images on page twenty-two (22) of the report attempts to show the average texture of embedded chip within the residual bitumen binder (RBB) on each of the test sections and control. The level of objective relief (the visual appearance of the ratio of binder to the exposed vertical area of the aggregate - example a seen in diagram below) is lesser in TS1, more apparent in TS2; and greater relief in the control. Basically stating (per visual observation); TS1 may have a tighter bond with the RBB.

↑ Section TS1 (.1 gallon per sq. yd.) close-up of surface aggregate.

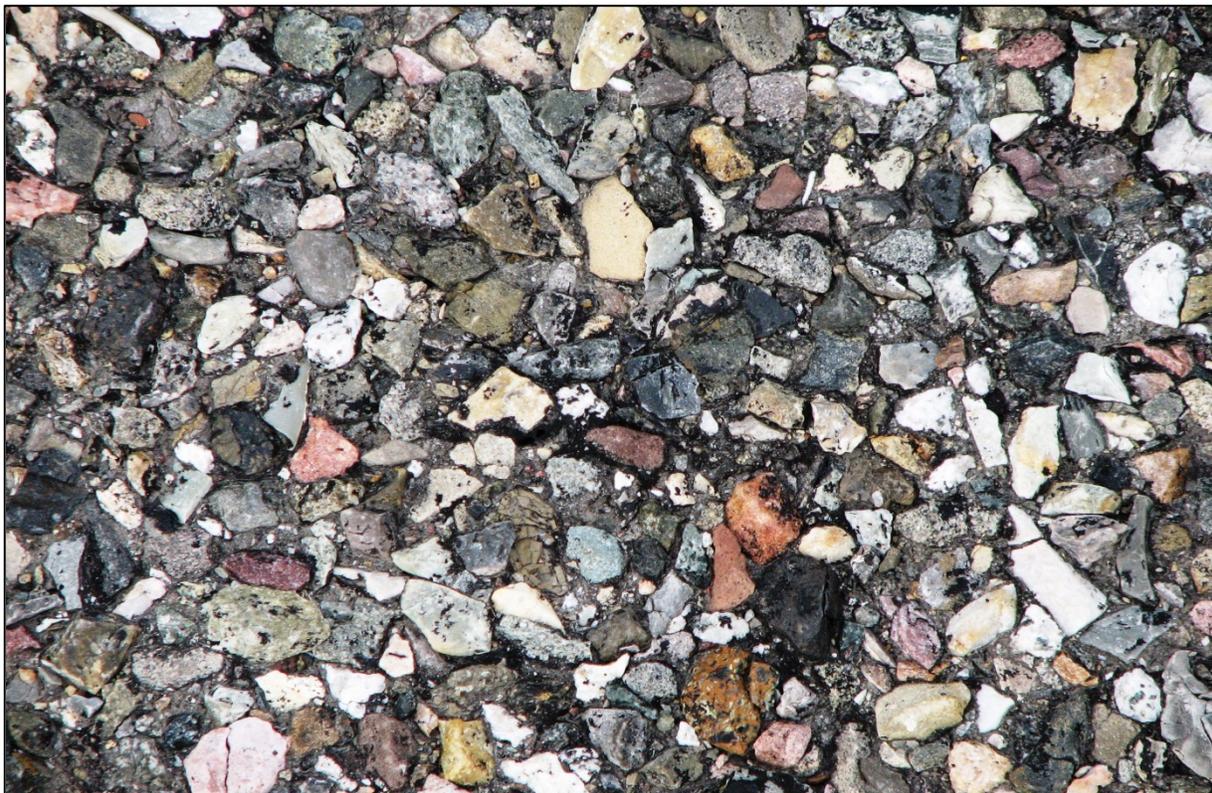
↓ Section TS2 (.05 gallon per sq. yd.) close-up of surface aggregate.

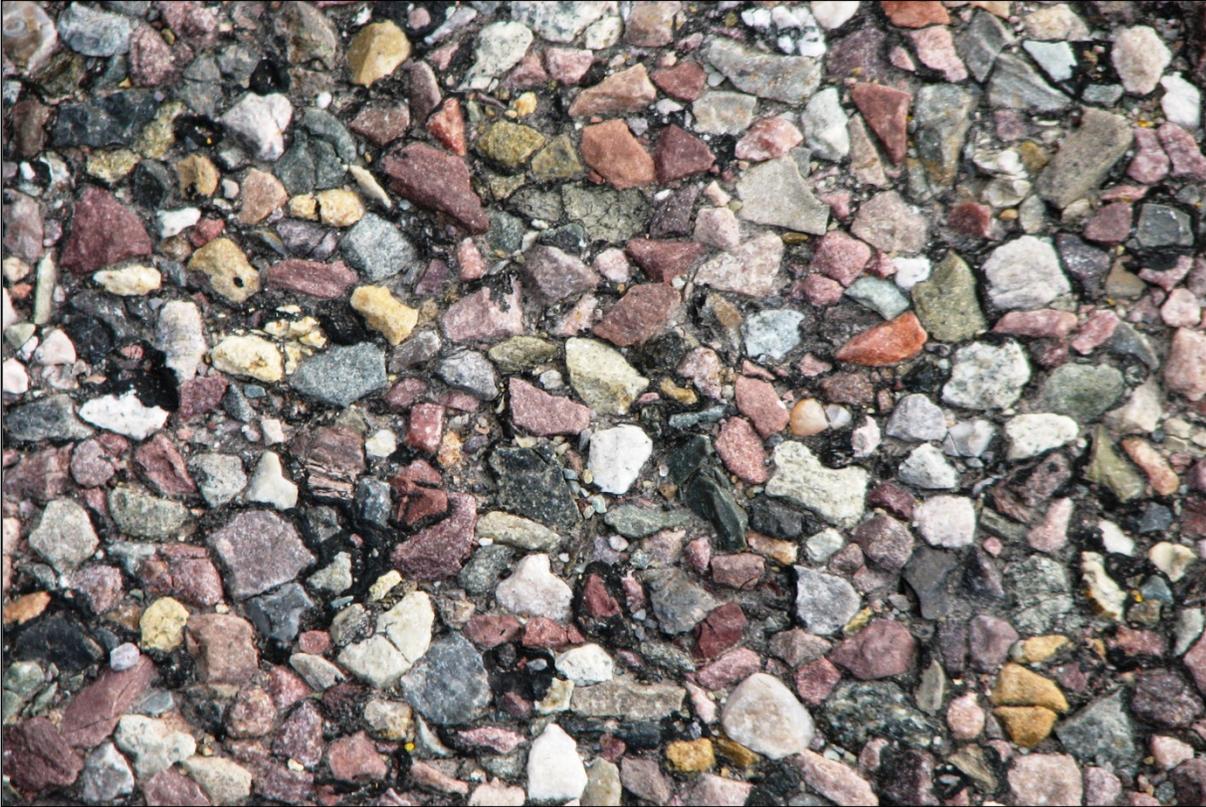
↑ Control Section: close-up of surface aggregate.

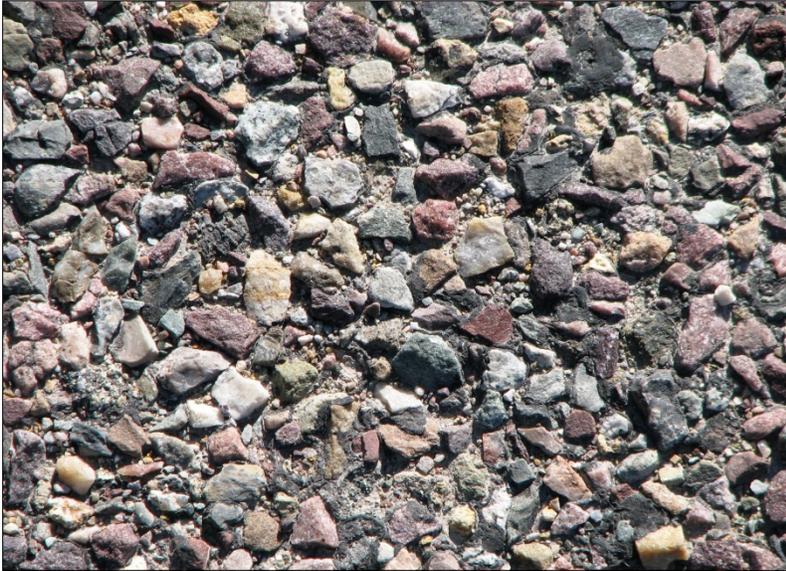
← Test section 1 (.1 gallon per sq. yd.), close-up of surface aggregate.

In comparing all three treatments, although subjective; **TS1** appears to have a tighter texture, rock embedment is firm. **TS2** also exhibits a tight mat however displays a slightly higher relief of exposed aggregate to binder as does the control.

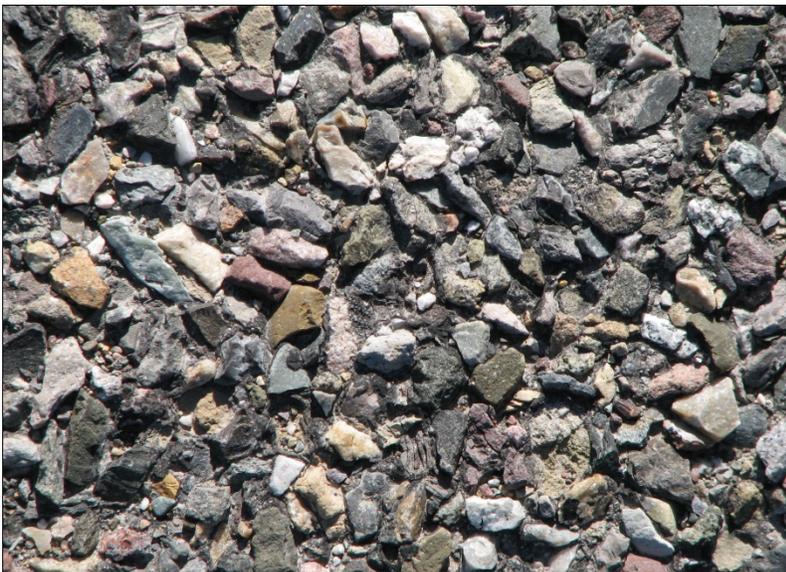
← Test section 2 (.05 gallon per sq. yd.), close-up of surface aggregate.

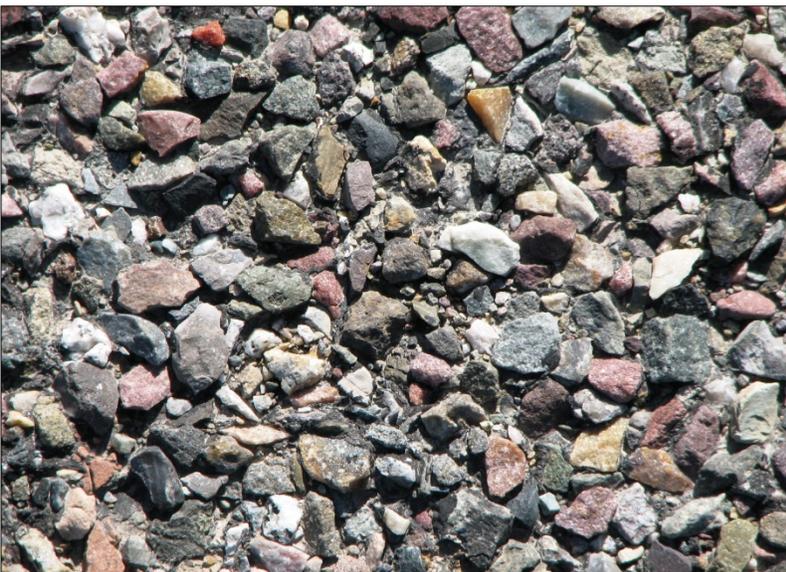
← Control section close-up of surface aggregate.
