**FIBER-REINFORCED POLYMER
(FRP) PULTRUDED DECKING MATERIAL AND HELICAL ANCHORING SYSTEM FOR
USE IN SNOW FENCE APPLICATIONS**

Location: Livingston, Montana. Interstate 90, MP-332, Park County

Project No.: IM90-7(63)331

Description: Seventh semi-annual evaluation of remaining test section of snow fence using proprietary EZ-Deck Fiber-Reinforced Polymer (FRP).

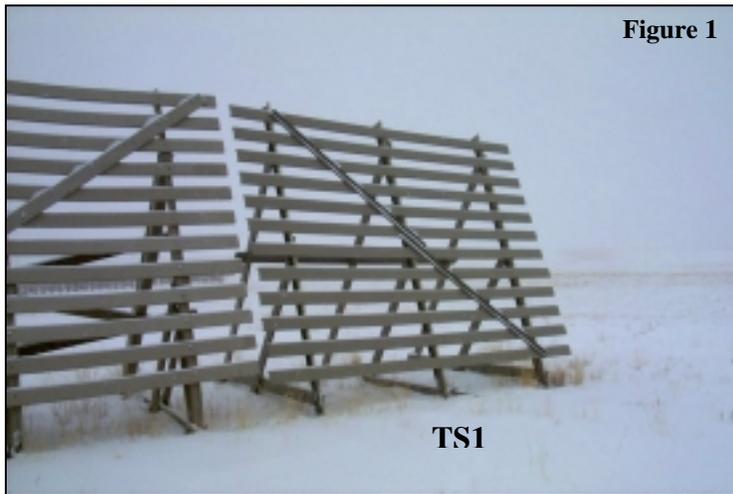
Inspections are held in late winter or early spring and late fall to document the environmental effects of seasonal extremes to the FRP material as well as stability of design. Figure 1 shows the remaining TS1 as seen on March 4, 2003.

No additional deterioration of the attachment hardware and planking material was observed since the last inspection. Snow accumulation on the leeward drift was an approximate depth of 60 centimeters (2 feet). Snow depth on the windward

side of the fence was approximately half that of the leeward. The trapping efficiency of this design appears to be the same as observed with the other sections of snow fence in this general snow transport area. TS1 has been rated as performing well. The next evaluation will be conducted in October 2003.

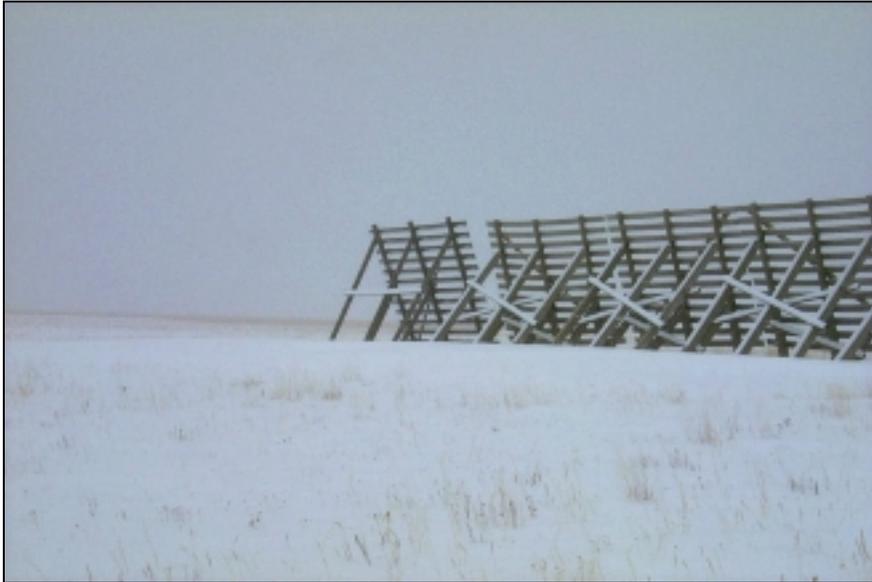
The evaluation consisted of a visual inspection of the FRP material and the structural supports. Special attention was given to the attachments of the FRP planks, (setting screws, bolts, FRP clips).
