FIBER-REINFORCED POLYMER (FRP) PULTRUDED DECKING MATERIAL AND HELICAL ANCHORING SYSTEM FOR USE IN SNOW FENCE APPLICATIONS

Location: Livingston, Montana. Interstate 90, MP-332, Park County

Project No.: IM90-7(63)331

Description: First semi-annual evaluation of two test sections of snow fencing using two proprietary materials; EZ-Deck FRP and A. B. Chance Helical Anchoring System.

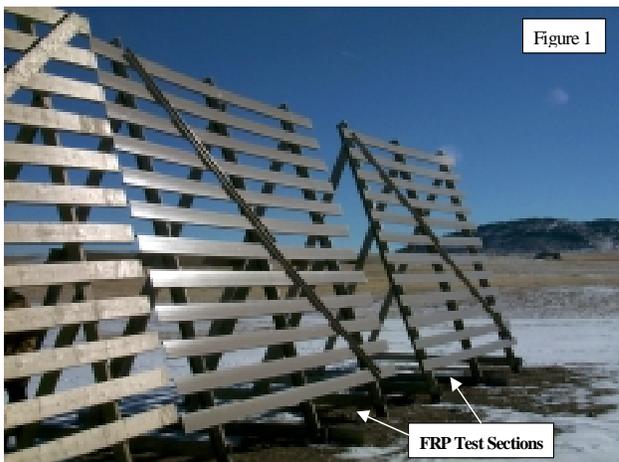
The evaluation consisted of a visual inspection of the FRP material and the structural supports. Special attention was given to the attachments of the FRP (setting screws, FRP clips) and the Helical Anchors used to secure the section to ground. At this time all connections used to attach the FRP planking to the frame are intact with no evidence of loose screws or chipping of the FRP rail attachments. All bolts used to secure the frame to the Helical Anchors were tight with no visual evidence of sawing action. There has been no apparent shifting of the overall frame assembly since construction in October 1999. Visual appearance of the FRP material shows no signs of sun or wind degradation. Figure 1 shows a frontal

view of the test site that has been positioned to the current plastic wood sections. The rebar used to assist constraint for lateral movements of the sill were still tight with no signs of the bars pulling up from the ground.

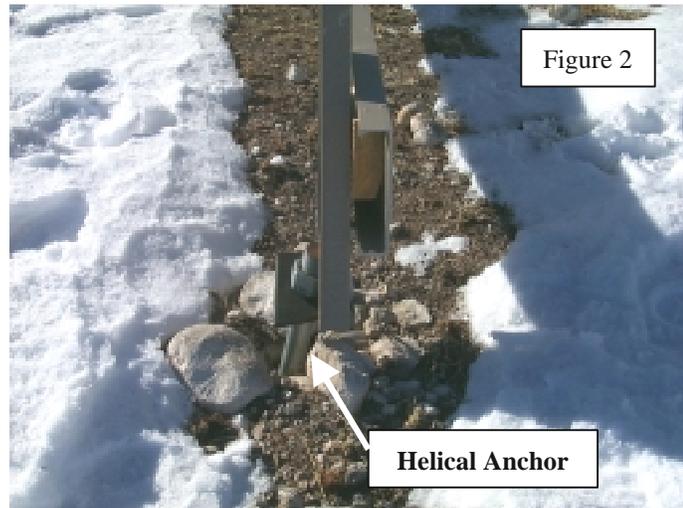
There was some movement with the post Helical Anchor on test section two (TS2) with the rear sill to frame attachment. The post, as seen in Figure 2, has shifted slightly to the right. Most likely caused by wind turbulence against the frame or by freeze/thaw action with the sub-soil. This threaded post is an extension attached to a u-shaped bracket bolt, which is located about ten inches below the surface. If the Helical Anchor had been rotated approximately 90° to the right this slight shift may not have occurred. At this time this is not considered to be a detriment. Further explanation of how this attachment system was installed can be found in the construction report.
