## **EXPERIMENTAL PROJECTS INSTALLATION REPORT**

### **TAPCO (BLINKERBEAM/BLINKSYNC) BLINKERCHEVRON TRAFFIC CONTROL SIGNAGE**

**Project Name:** Curve Near Beaverhead Rock

**Project Number:** HSIP 49-2(10)14

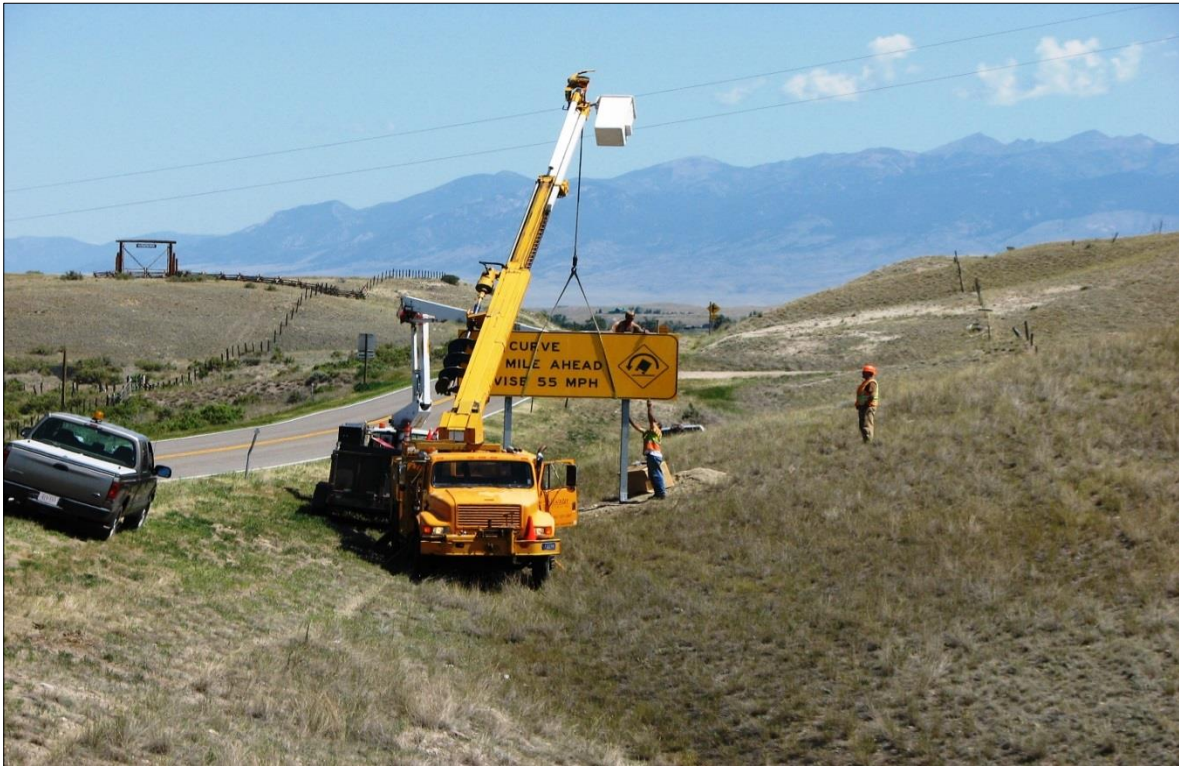
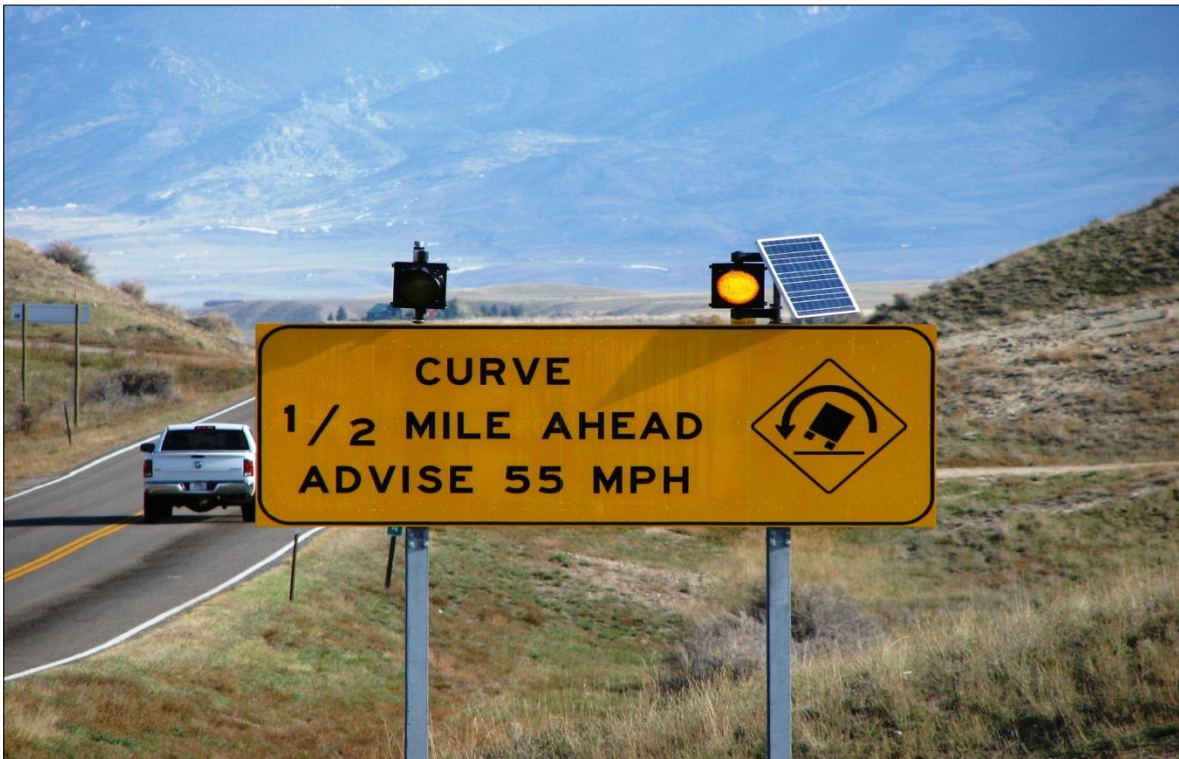
**Post-installation:** In early October, maintenance staff have reported several times the dual-light flashing approach warning signs were not working and one of the southbound LED chevrons were not activating.

The issue with the LED chevron appears to have been a defective battery which had to be replaced twice within a period of 1 month. The solar panel used in the approach warning signs were low-wattage models and were not adequately charging the batteries which supply power to the dual LED units. Subsequently larger solar capacity panels were installed and (to date) have corrected the problem.

↑ Erection of the solar dual flasher warning approach sign assembly.

↓ Northbound (identical to the southbound approach) completed dual flasher warning sign with the larger wattage solar panel replaced in October.

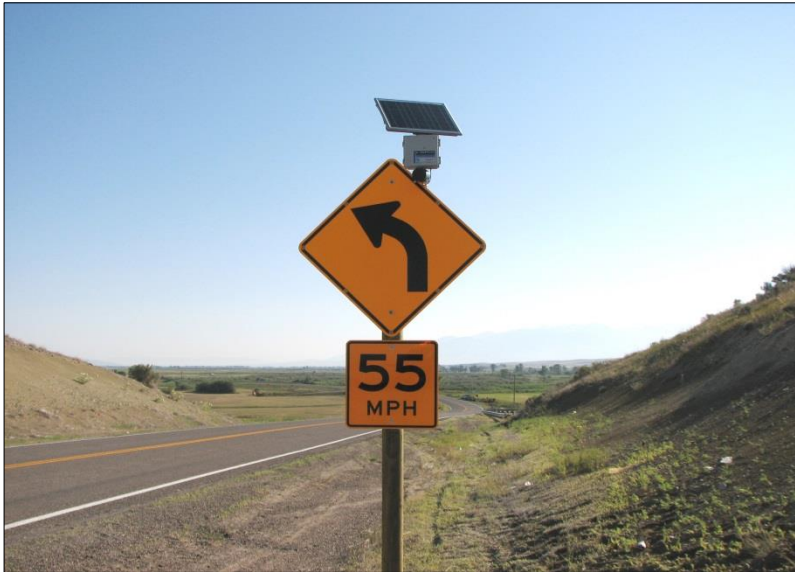
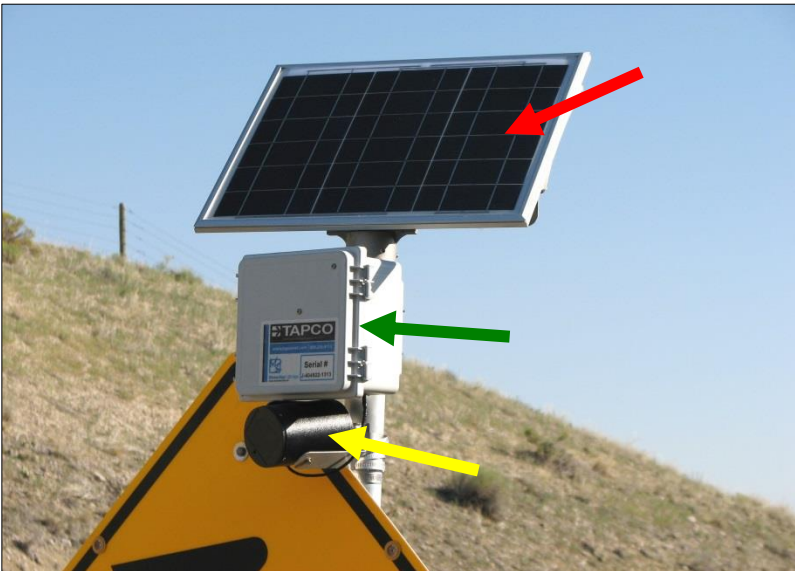
← This is the northbound advance-signal, wireless sequence master unit.

A similar unit is in place on the southbound approach to the curve.

← Close-up of the 13 watt solar panel (red arrow), the radio sequence control master cabinet (green arrow); and the doppler radar unit (yellow arrow).

Although difficult to see in this image the sign boundary edge have eight (8) high-intensity LEDs which will activate upon approach of an oncoming vehicle.

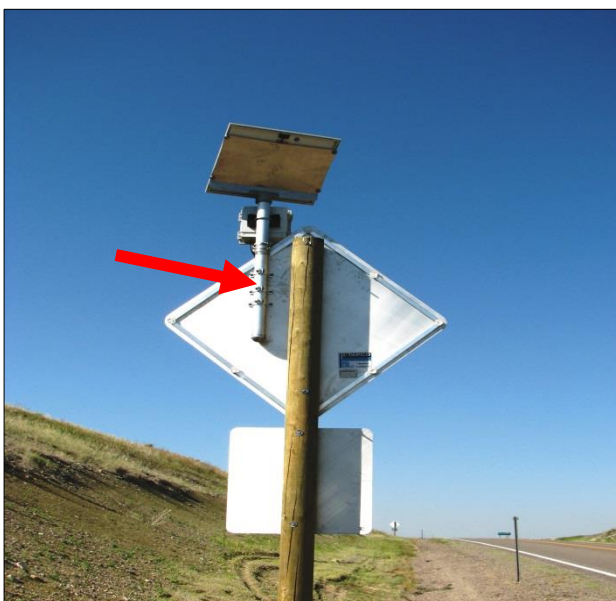
← Rear view of the northbound full system, radio sequence control unit.

The tube bracket (red arrow) which supports the solar panel and master control cabinet contains the unit's nickel-metal hydride (NiMH) battery.

Prior to installation the battery must be charge a minimum of 8 hours to function properly.

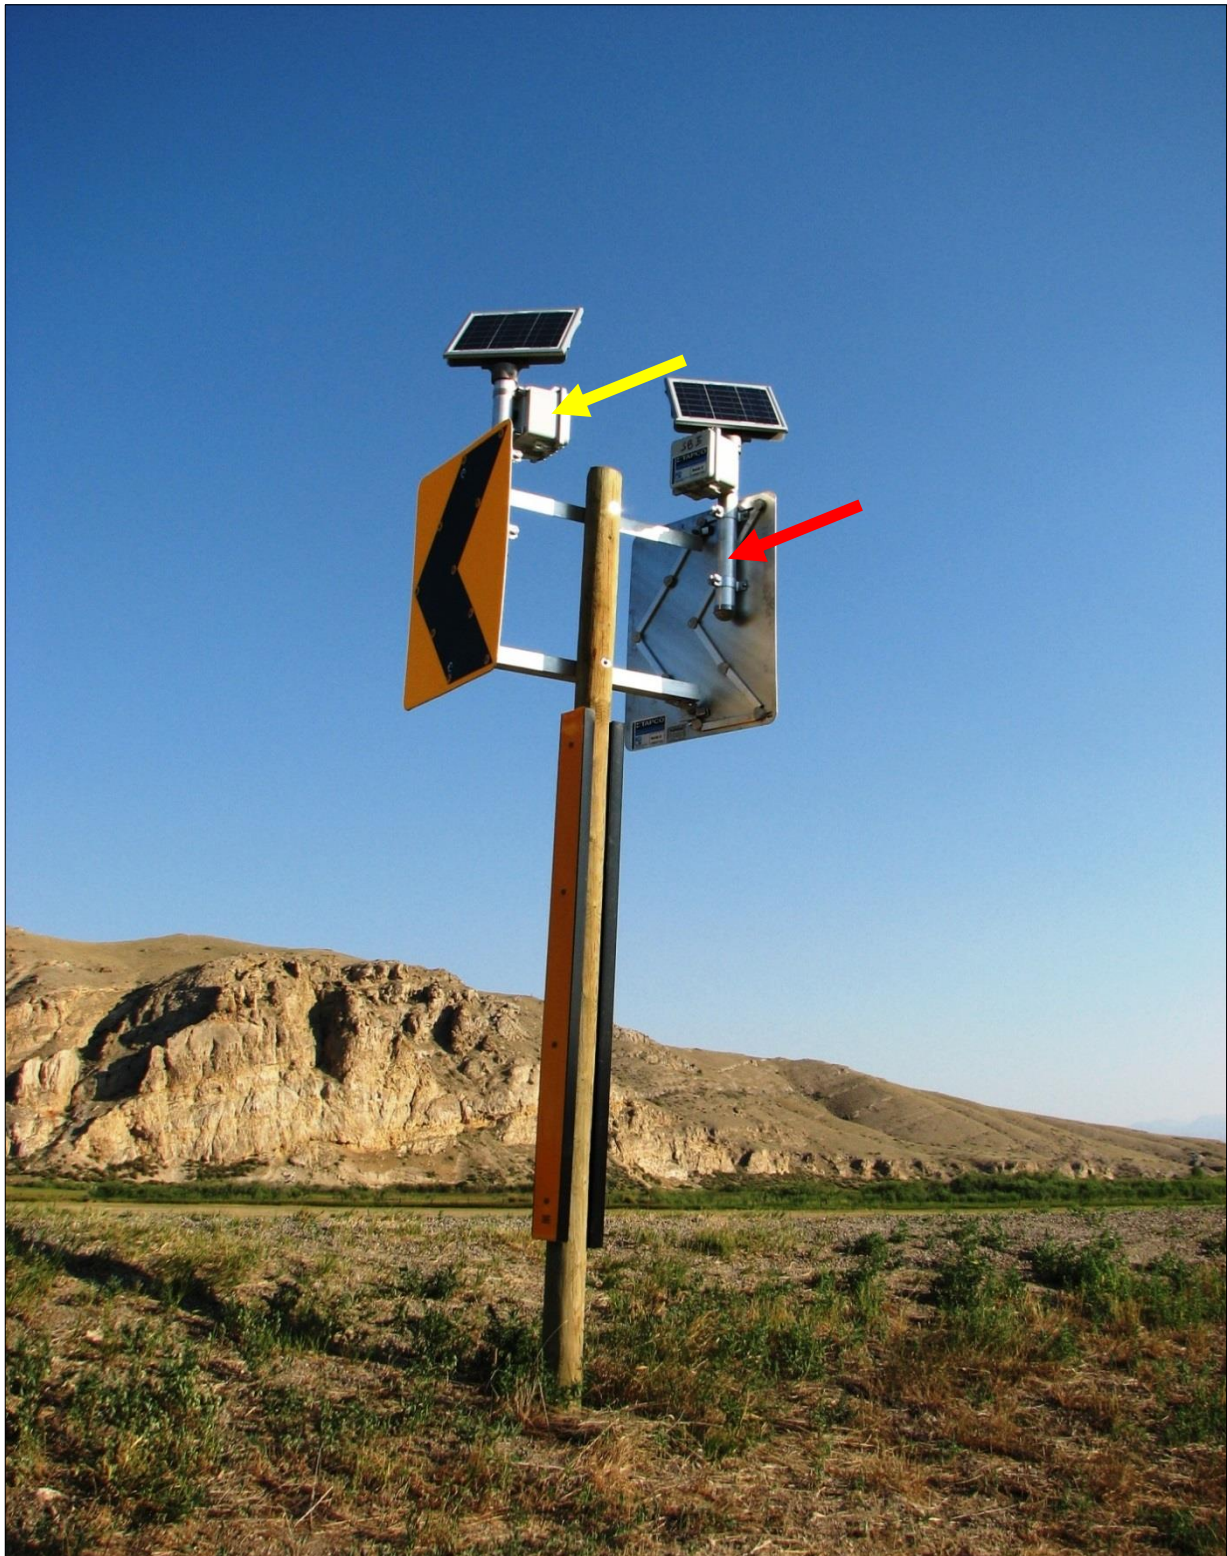
In a minor issue the dual chevron slave units (per post) are presently using one solar panel per individual chevron (refer to page 9); manufacturer specifications were to only have one (larger-wattage panel) to provide battery charge and power to both chevron units. Per consultation with District personnel and the vendor it was determined the currently installed panels will be adequate to supply sufficient charge to maintain functioning NiHM battery power.

↑ One of the six dual BlinkerChevron's installed on site. The chevron components are fixed on a four (4) inch post with added reflector panels. Each individual LED chevron has its own solar panel and slave radio control unit (yellow arrow). As in the advance signal master control, the NiMH battery is located in the tube bracket (red arrow).

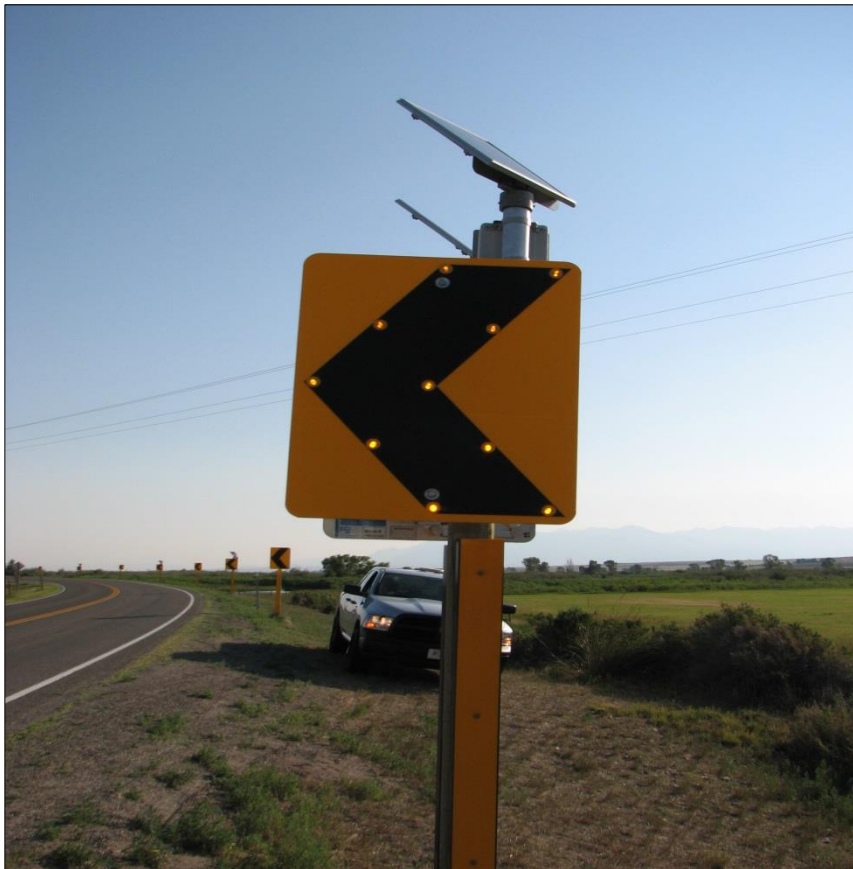
◀ Side view of the BlinkerChevron unit under activation. There are ten (10) high-intensity LED's per each panel.

The LED panels (upon inspection during activation) required to be angled correctly for maximum visual illumination to oncoming traffic.
