ASSESSMENT OF BURROWING MAMMAL
IMPACTS ON PAVED HIGHWAYS
IN MONTANA

FHWA/MT-10-010/8117-39

Final Report

prepared for
THE STATE OF MONTANA
DEPARTMENT OF TRANSPORTATION

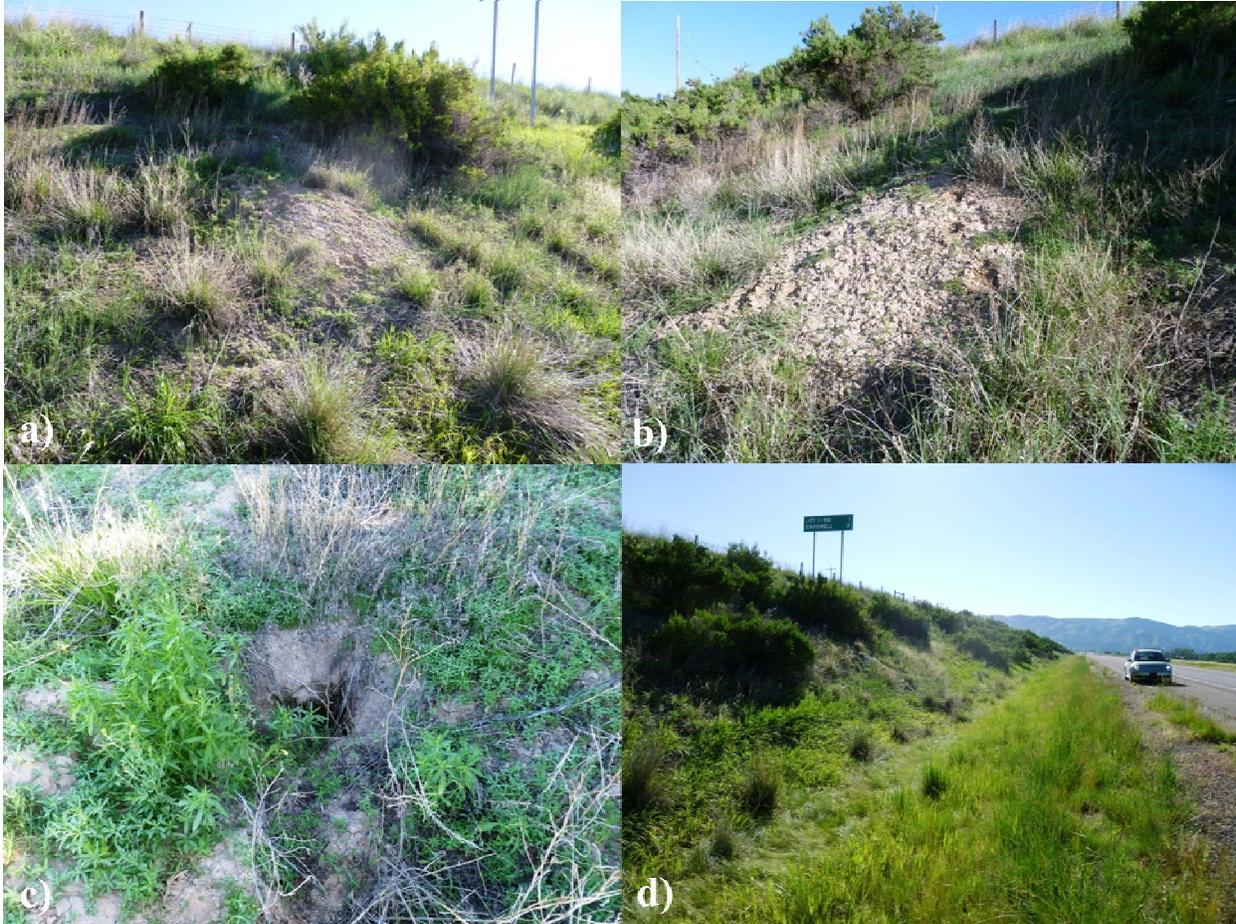
This site was located on a four-lane divided interstate highway surrounded by grassland and ranchlands spotted with small juniper bushes in silty soils (Figure 22). Several abandoned badger holes were located within the right-of-way along a quarter mile section of the highway. Badgers were not observed in the area and vegetation near the mounds was reestablishing. Mounds were prominent in an embankment adjacent to the drainage ditch on the north side of the westbound traffic lane. Burrowing activity may cause localized erosion issues but no indication of damage to the pavement or structural support was apparent or imminent.

Figure 22. Photos of Site 9: a) badger mound on embankment, b) badger mound on embankment, c) reestablishment of vegetation near badger hole, and d) longitudinal view of roadway.

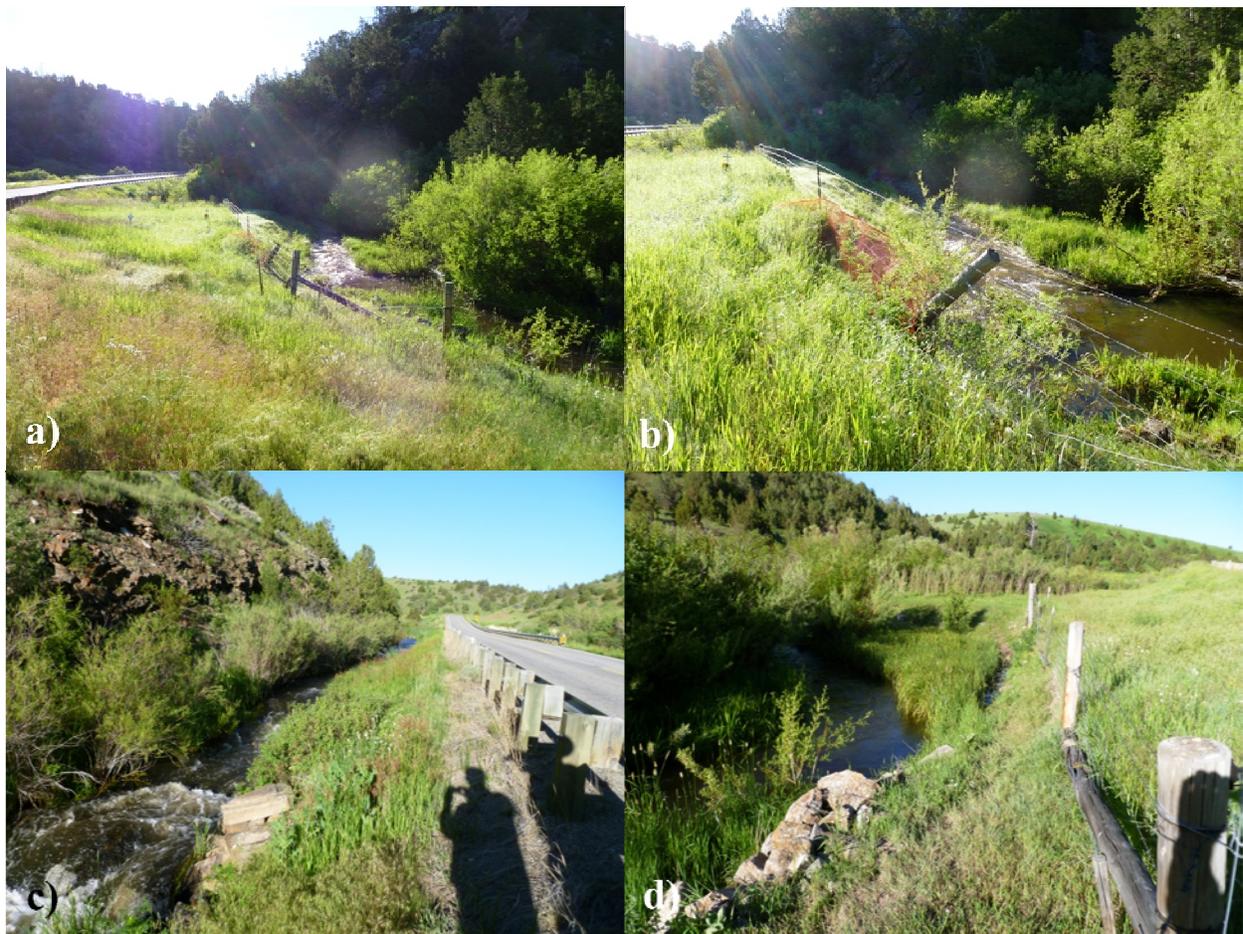
This site was located on a two-lane rural road in a forested area near an active stream abundant with willows (Figure 24). The main issue in this area was beavers, but minimal pocket gopher presence was also noted. Past damming of the stream diverted the water from its natural channel, subsequently eroding the road embankment at the edge of the right-of-way. The structural integrity of the roadway and pavement surface showed no obvious signs of distress from this activity.

Figure 24. Photos of Site 11: a) stream migration toward roadway, b) close-up of embankment erosion, c) longitudinal view of right-of-way adjacent to stream, and d) channel migration.

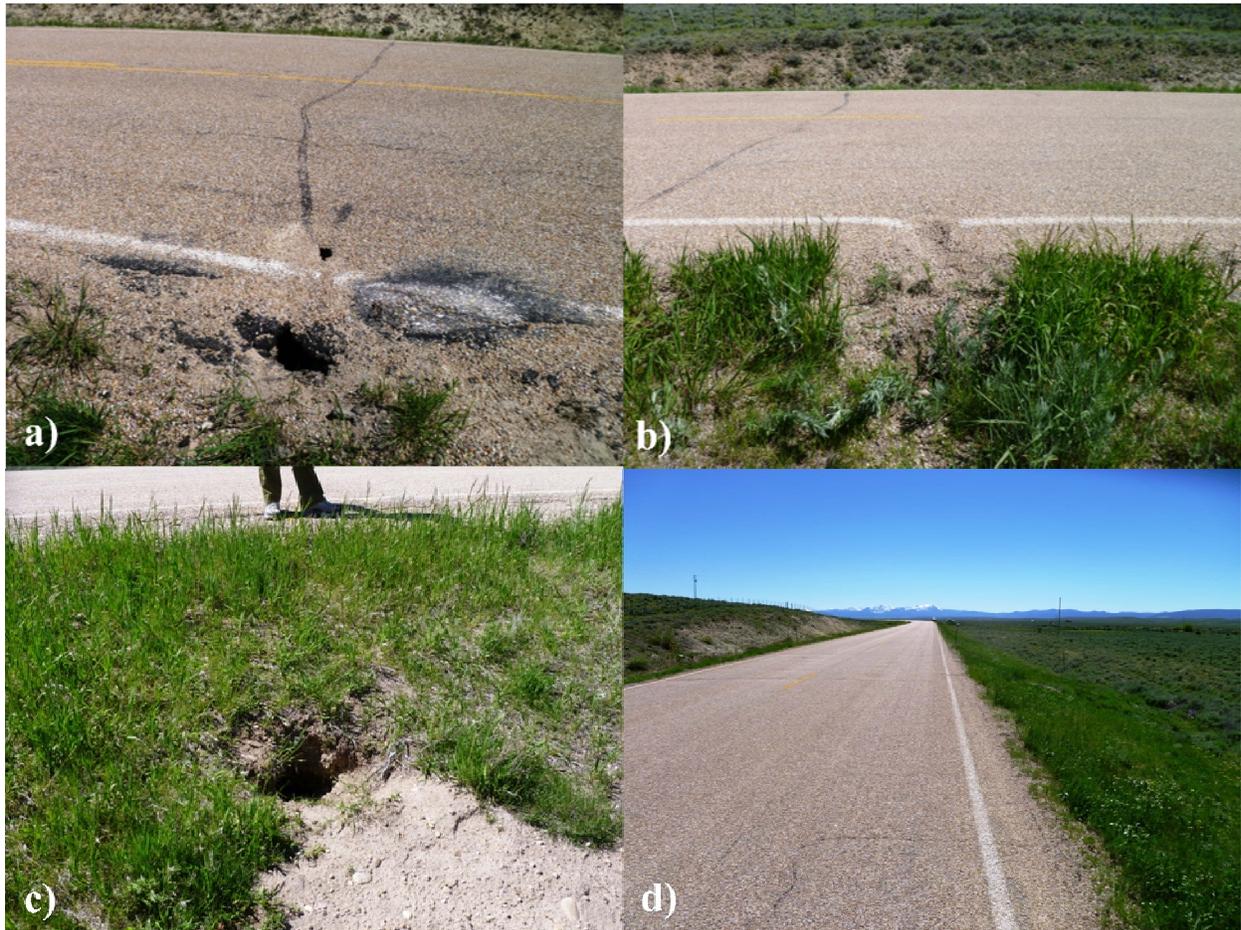
This site was approximately 10 miles from Site 13 on the same two-lane, rural highway (Figure 27). Ground squirrel and badger burrows were observed within the right-of-way up to the pavement edge for several miles. Similar to Site 13, some ground squirrel burrows extended under the pavement causing subsidence and further deterioration of existing cracks.

Figure 27. Photos of Site 14: a) transverse cracking in pavement coincident with ground squirrel activity, b) subsidence of paved shoulder near old burrow, c) badger burrow in right-of-way, and d) longitudinal view of roadway.

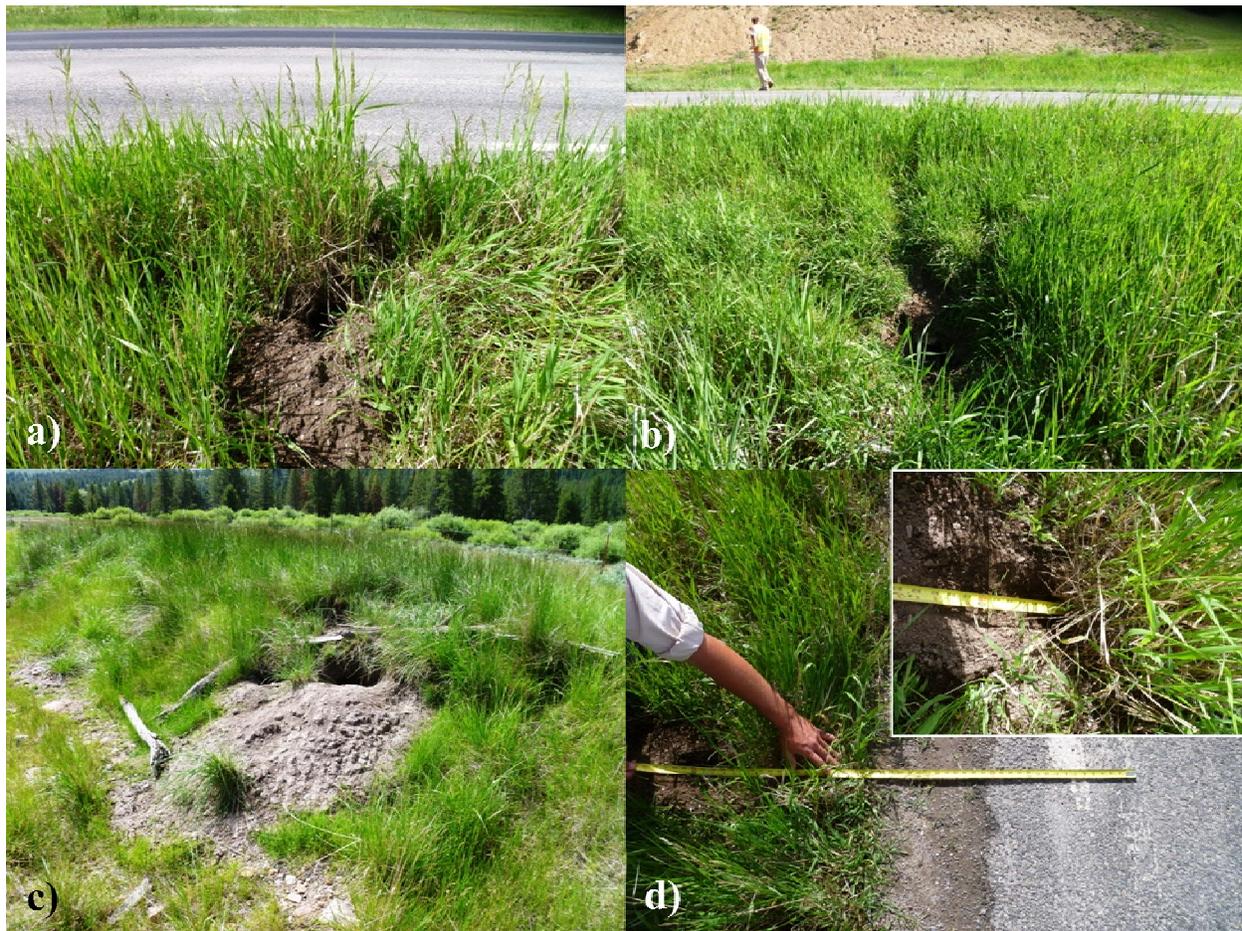
This site was situated on a rural two-lane road adjacent to sub-irrigated grass and ranchlands and partially forested areas with sandy, gravelly organic soils (Figure 30). Ground squirrel, pocket gopher, vole, and badger activity were observed. Pavement distresses on one section of road in the area were all repaired during a recent paving operation. Multiple transverse and longitudinal cracks were present in the pavement. The majority of the pavement distresses were due to the age of the pavement, poor base support, and significant log truck traffic. However, some ground squirrel burrows near the pavement edge extended under the road, which may initiate damage or exacerbate existing distresses. The shallow taper of the shoulder may also lend to further burrowing mammal activity.

Figure 30. Photos of Site 17: a) active ground squirrel burrow near roadway, b) burrow in right-of-way, c) badger burrow in right-of-way, and d) ground squirrel burrow under roadway.
