Appendix 1

Field Review Memorandum and Photo Log

Subject: **Summary of Field Review Conducted on October 26, 2011**
US 2 - Badrock Canyon Corridor Planning Study

PHOTO LOG

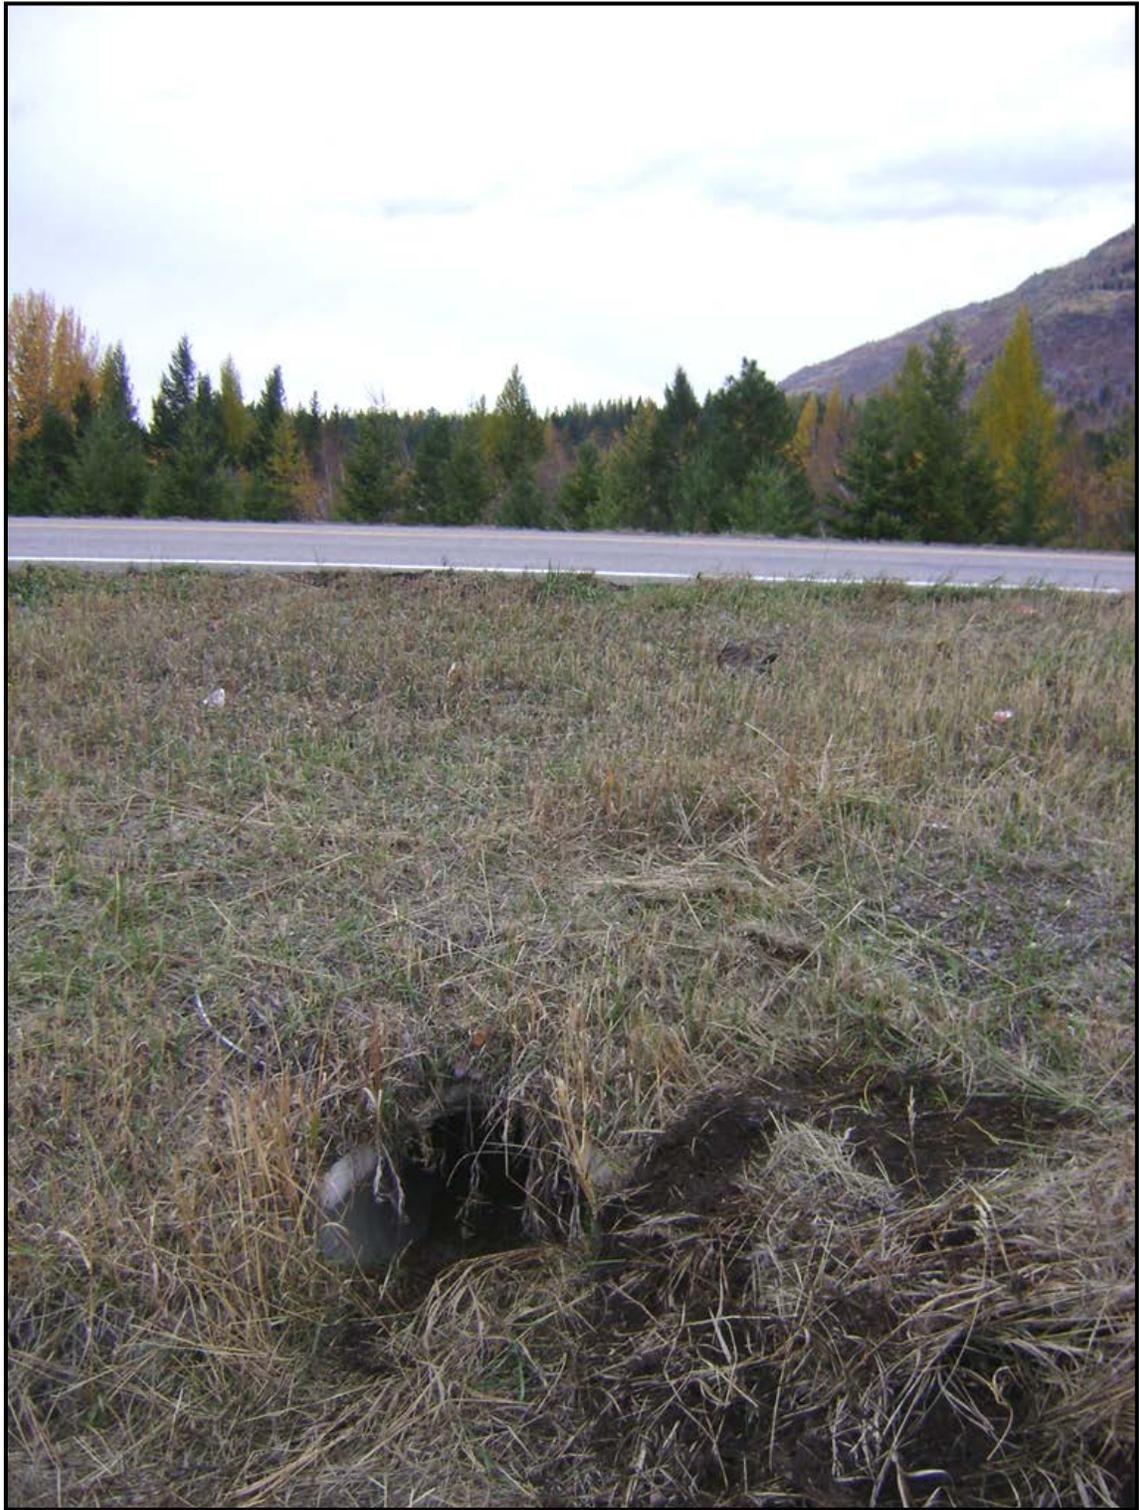
- Single 18-inch corrugated metal pipe (CMP) running underneath US 2 at RP 140.1 (Sta. 21). Photo 3.
- Two 18-inch CMP culverts running underneath US 2 at RP 140.8 (Sta. 55). Photo 17.
- Drainage issues associated with Berne Memorial Park spring. RP 140.8 (Sta. 56). Photo 19.
- Single 18-inch CMP (approximately sixty percent buried) running underneath US 2 at RP 141.3 (Sta. 73). Photos 28 and 29.
- Roadside drainage issues along south side of US 2 looking west. RP 140.6 (Sta 47). Photos 9.
- Roadside drainage issues along south side of US 2 looking west. RP 140.8 (Sta 56). Photos 19.
- Roadside drainage issues along south side of US 2 looking west. RP 141.3 (Sta 75). Photos 30 and 31.

Photo 3. Single 18-inch corrugated metal pipe (CMP) on south side of US 2 at RP 140.1 (Sta. 21).

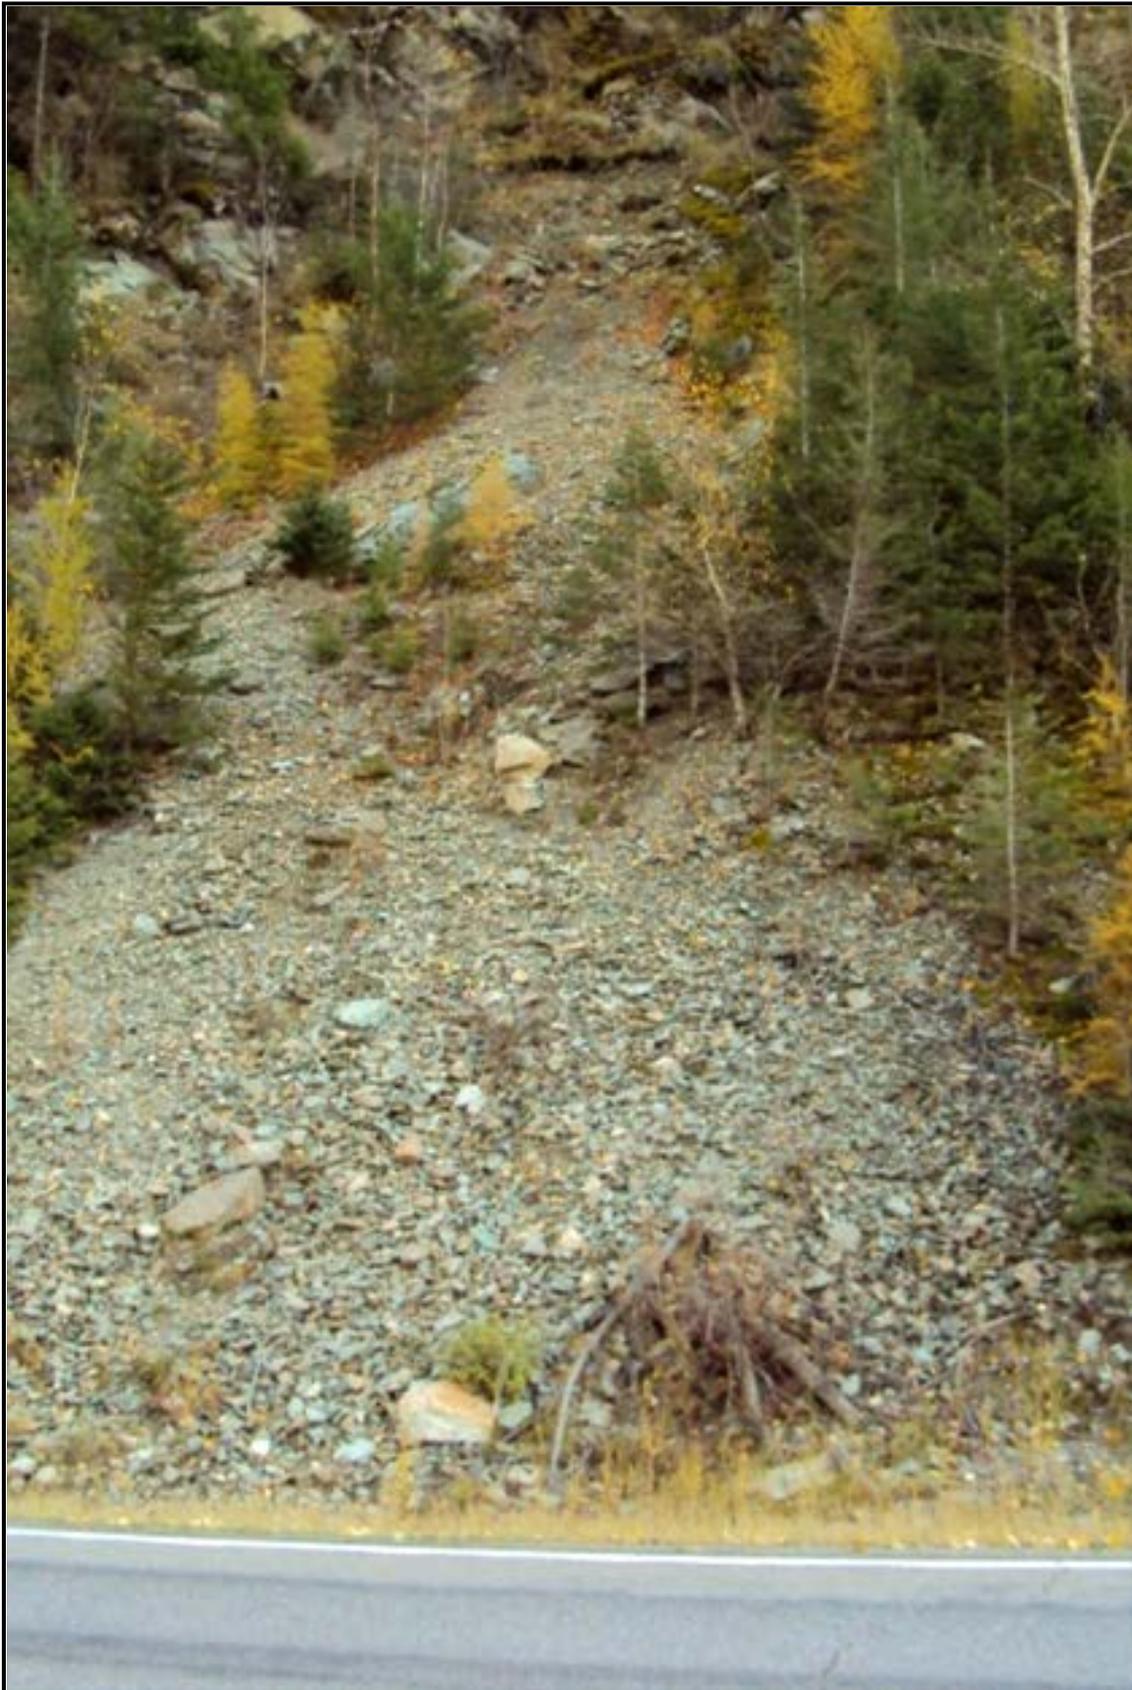
- Unstable geologic features on the south side of US 2 at RP 140.6 (Sta. 47). Photo 8.
- Culturally significant rock outcroppings on the south side of US 2 begin at 140.6 (Sta. 44) and extend to 141.1 (Sta. 73). Photos 8 to 14 and 23 to 25.

Photo 8. Unstable geologic features south of US 2. Potential for falling rock. RP 140.6 (Sta. 47).

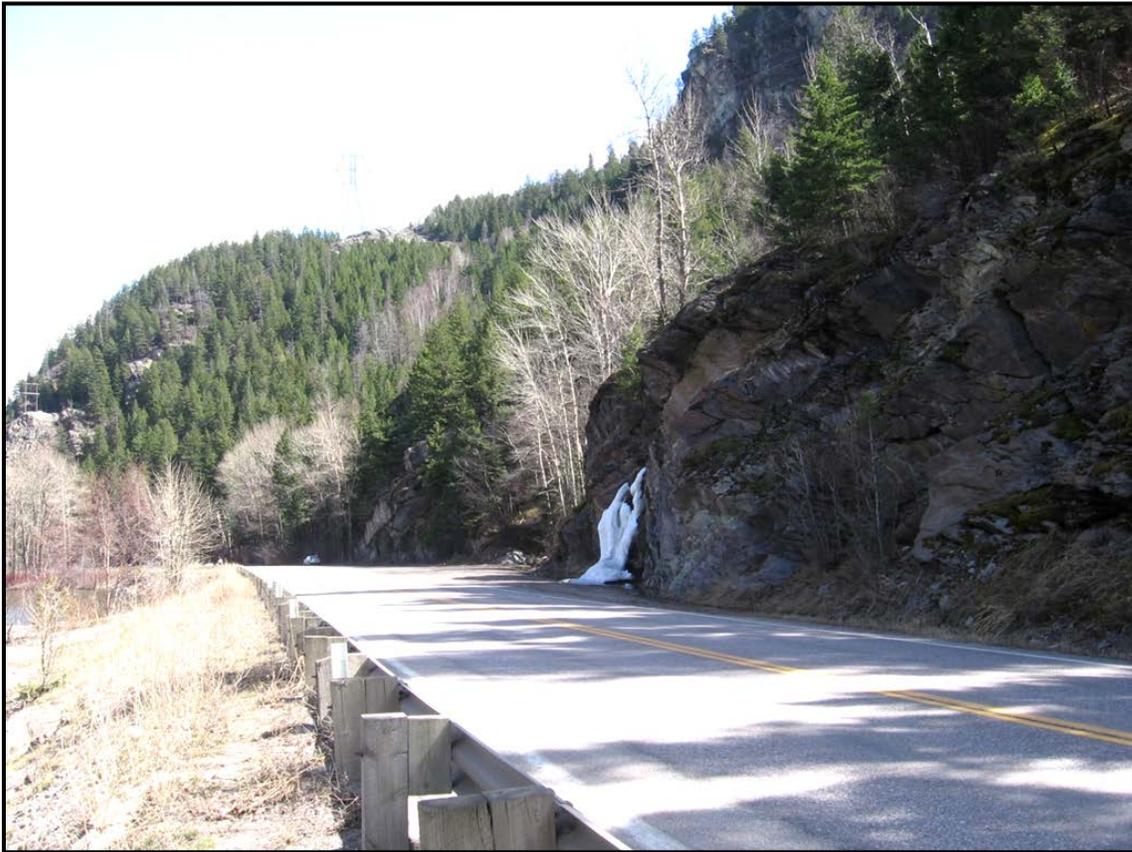
Photo 9. Looking east on the north side of US 2. Snow and ice on outcroppings to the south of US 2 may cause drainage issues. RP 140.6 (Sta. 47).

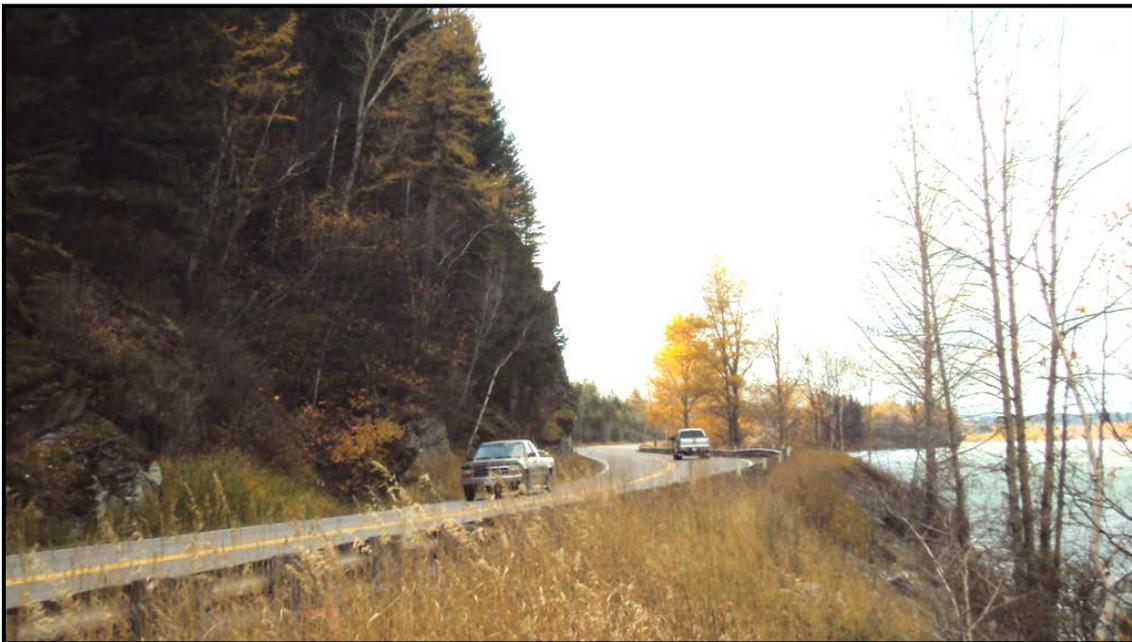
- Steep side slopes transition into the Flathead River at RP 140.3 (Sta. 30) to RP 140.7 (Sta. 60). Photos 9 to 11.
- Horizontal and vertical curves at RP 141.2 (Sta. 70) and RP 141.3 (sta. 77 to 82). Photos 27, 32, and 33.

Photo 10. West outcropping along the south side of US 2, steep slope adjacent to river on the north side, and sharp horizontal curve. RP 140.7 (Sta. 50).

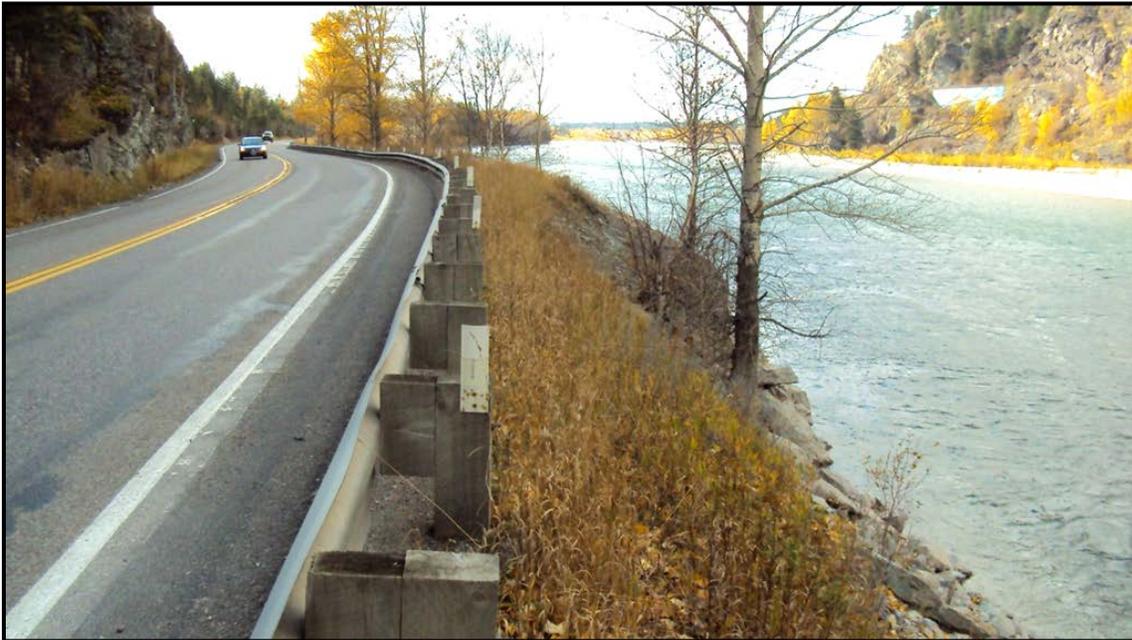
Photo 11. Steep slope adjacent to river on the north side of US 2. RP 140.7 (Sta. 50).

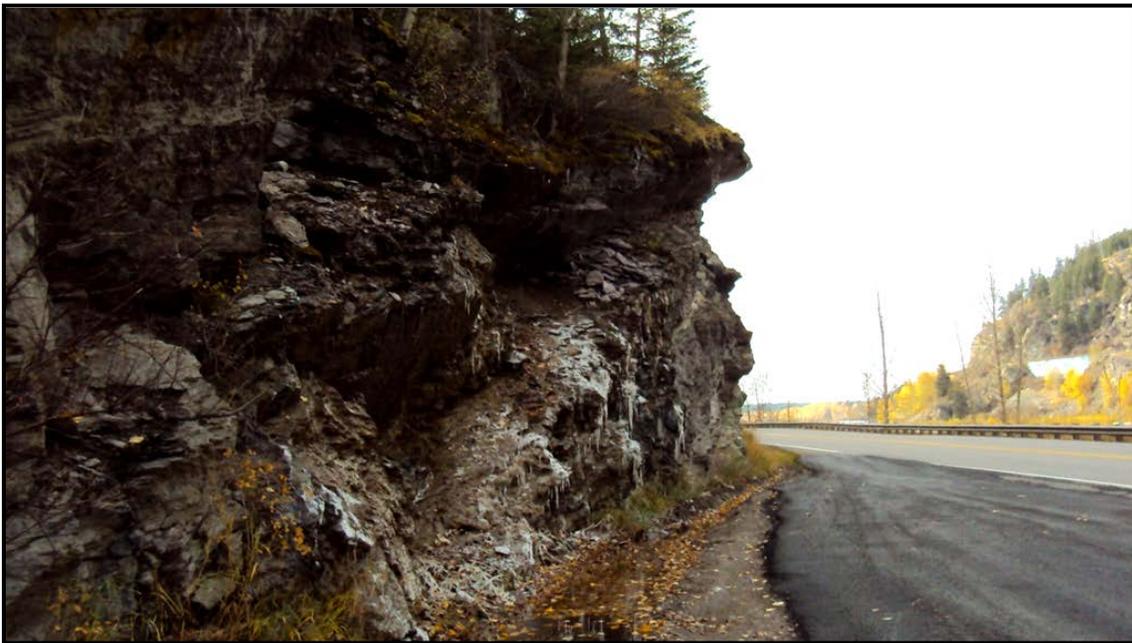
Photo 12. Icing on west outcropping on south side of US 2. RP 140.7 (Sta. 50).

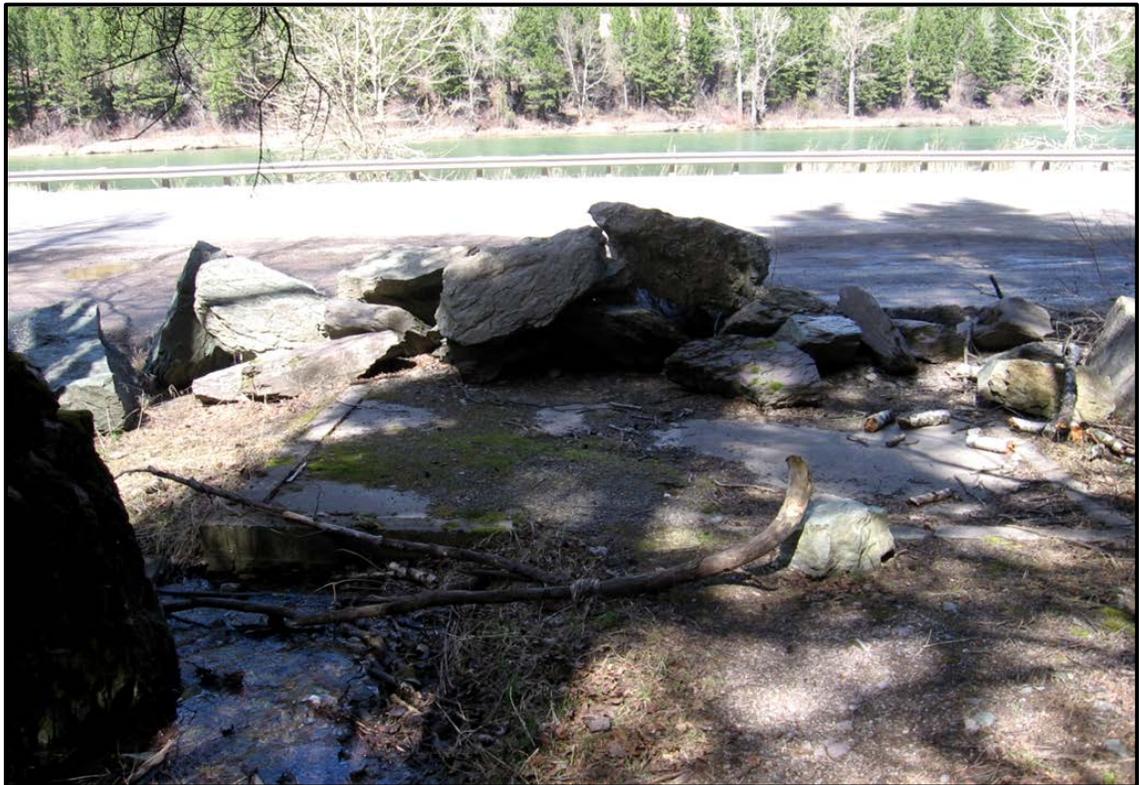
Photo 16. Looking north on the south side of US 2 at foundation for former rest area. RP 140.7 (Sta. 54).

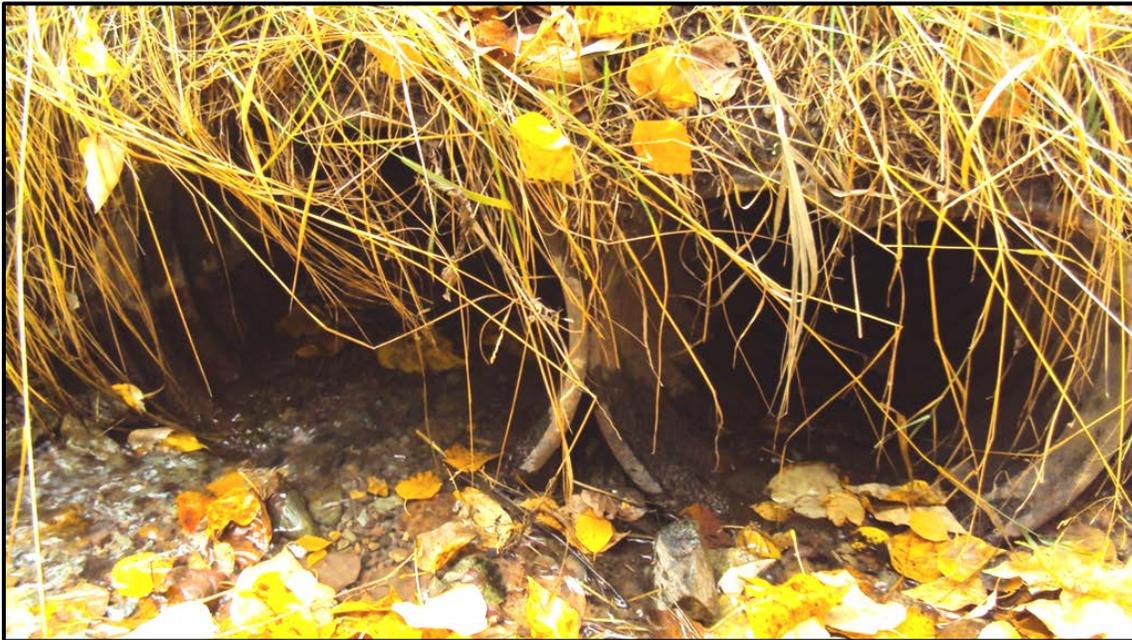
Photo 17. Two 18-inch CMP culverts south of US 2. RP 140.8 (Sta. 55).

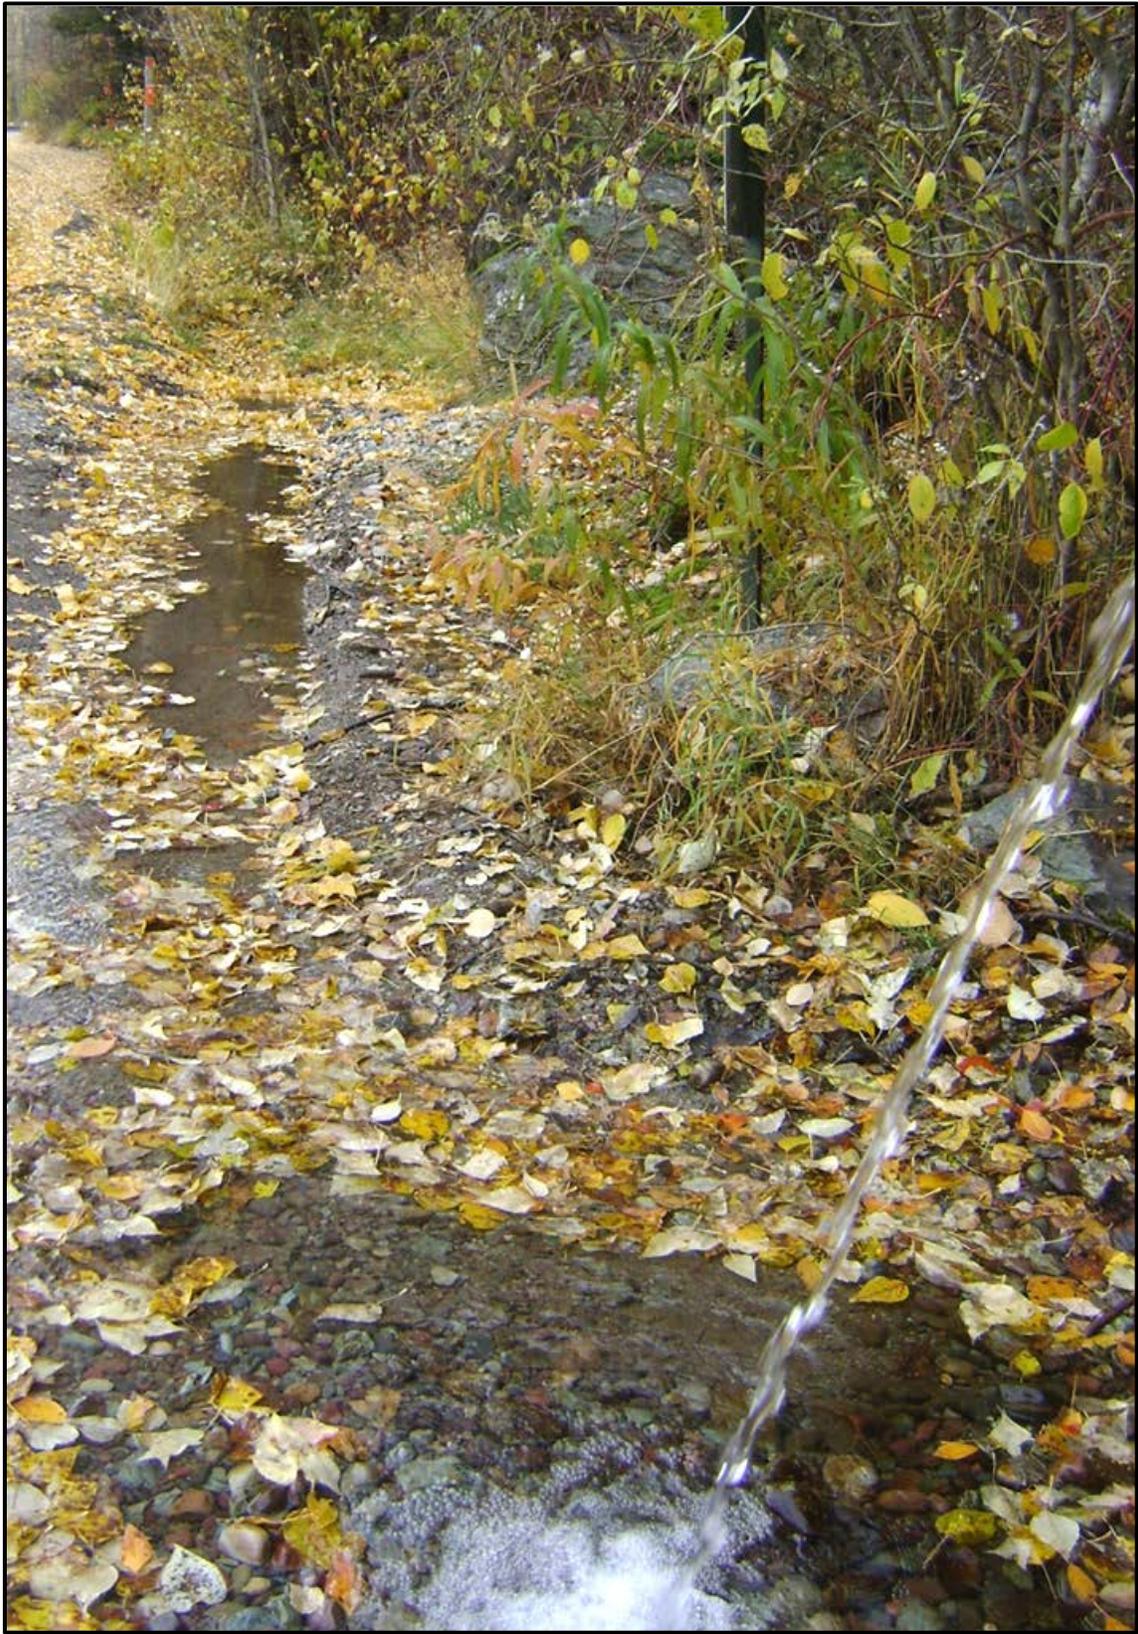
Photo 19. Drainage issues associated with Berne Memorial Park spring. RP 140.8 (Sta. 56).

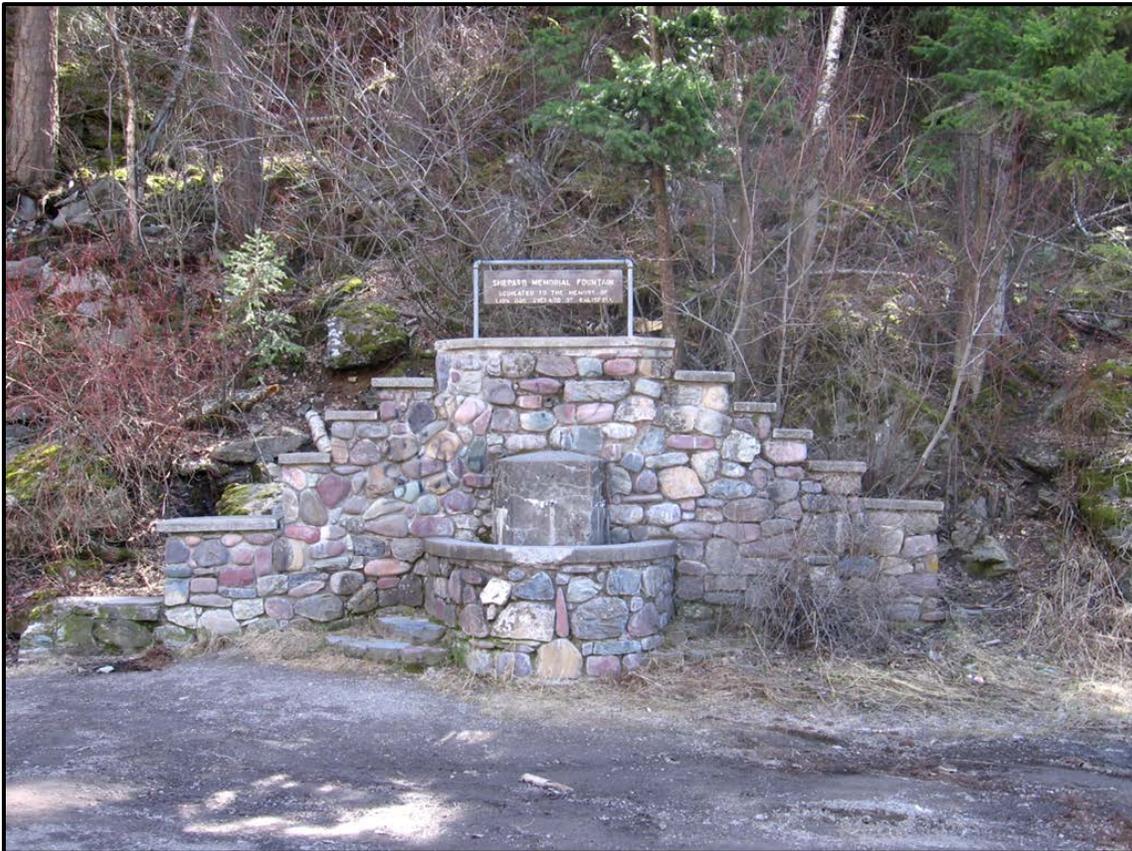
Photo 20. South of US 2 looking at original water fountain at Berne Memorial Park. Fountain is no longer in use. RP 140.8 (Sta. 56).

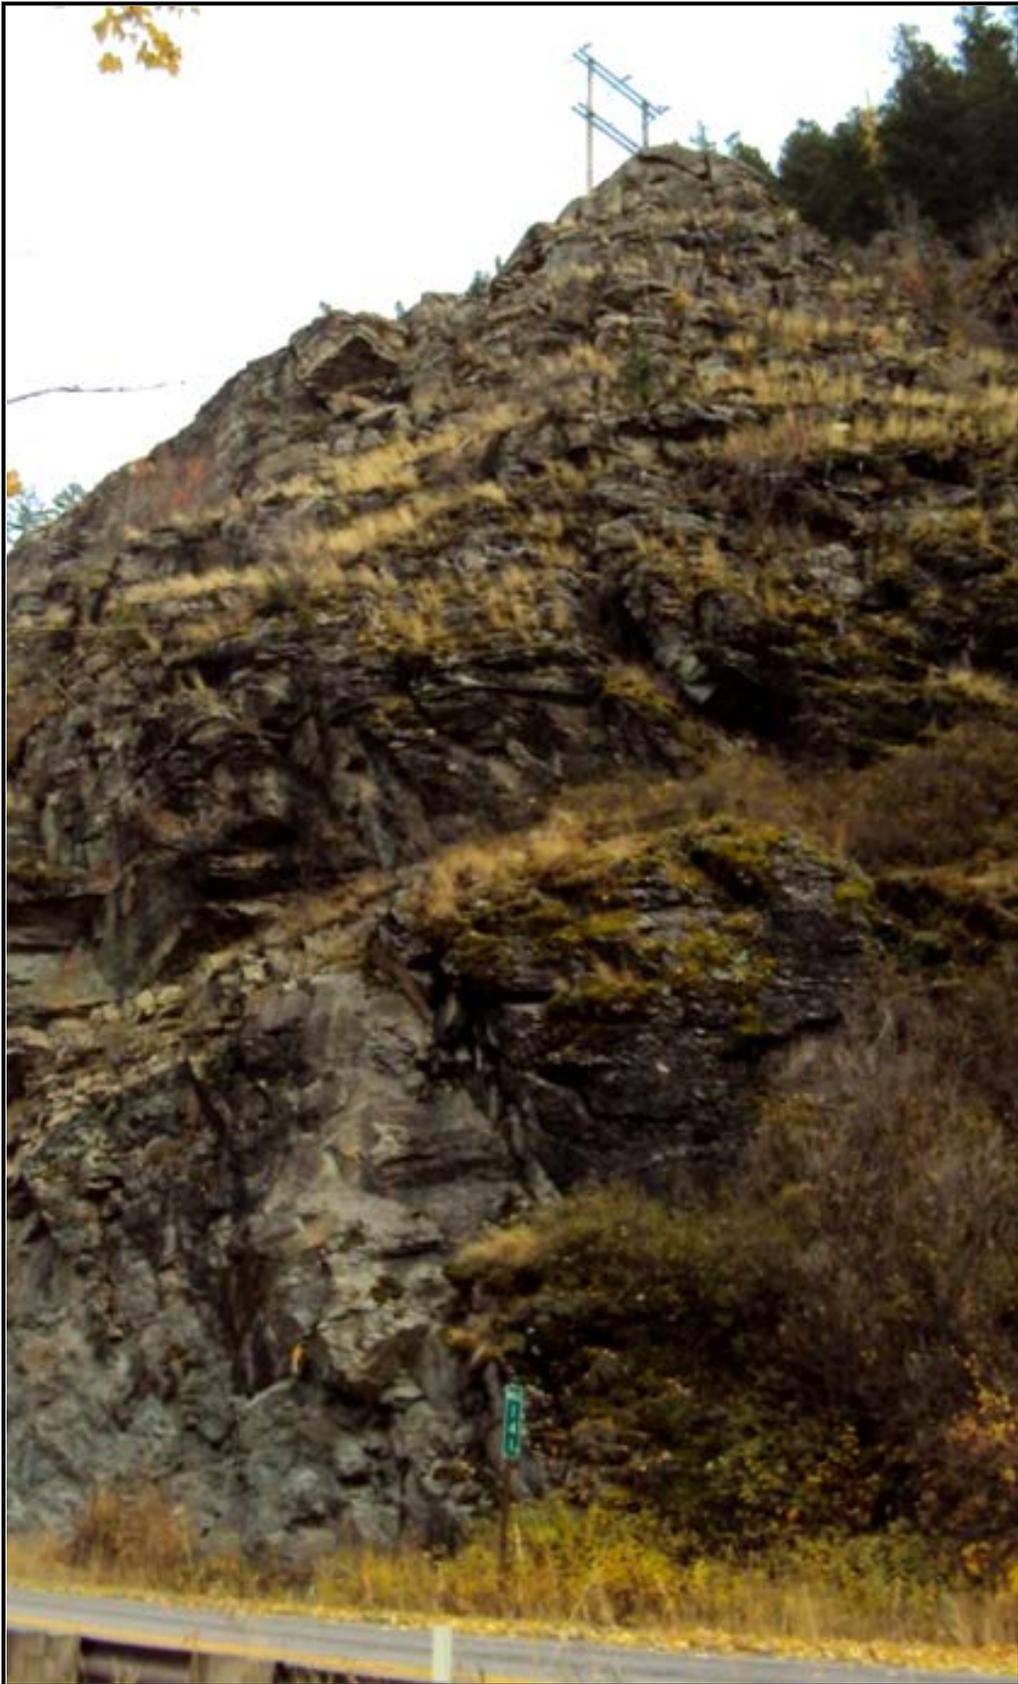
Photo 24. Reference Post 141 marker, power lines overhead, and east outcropping. Potential for falling rock. RP 141.0 (Sta. 65).

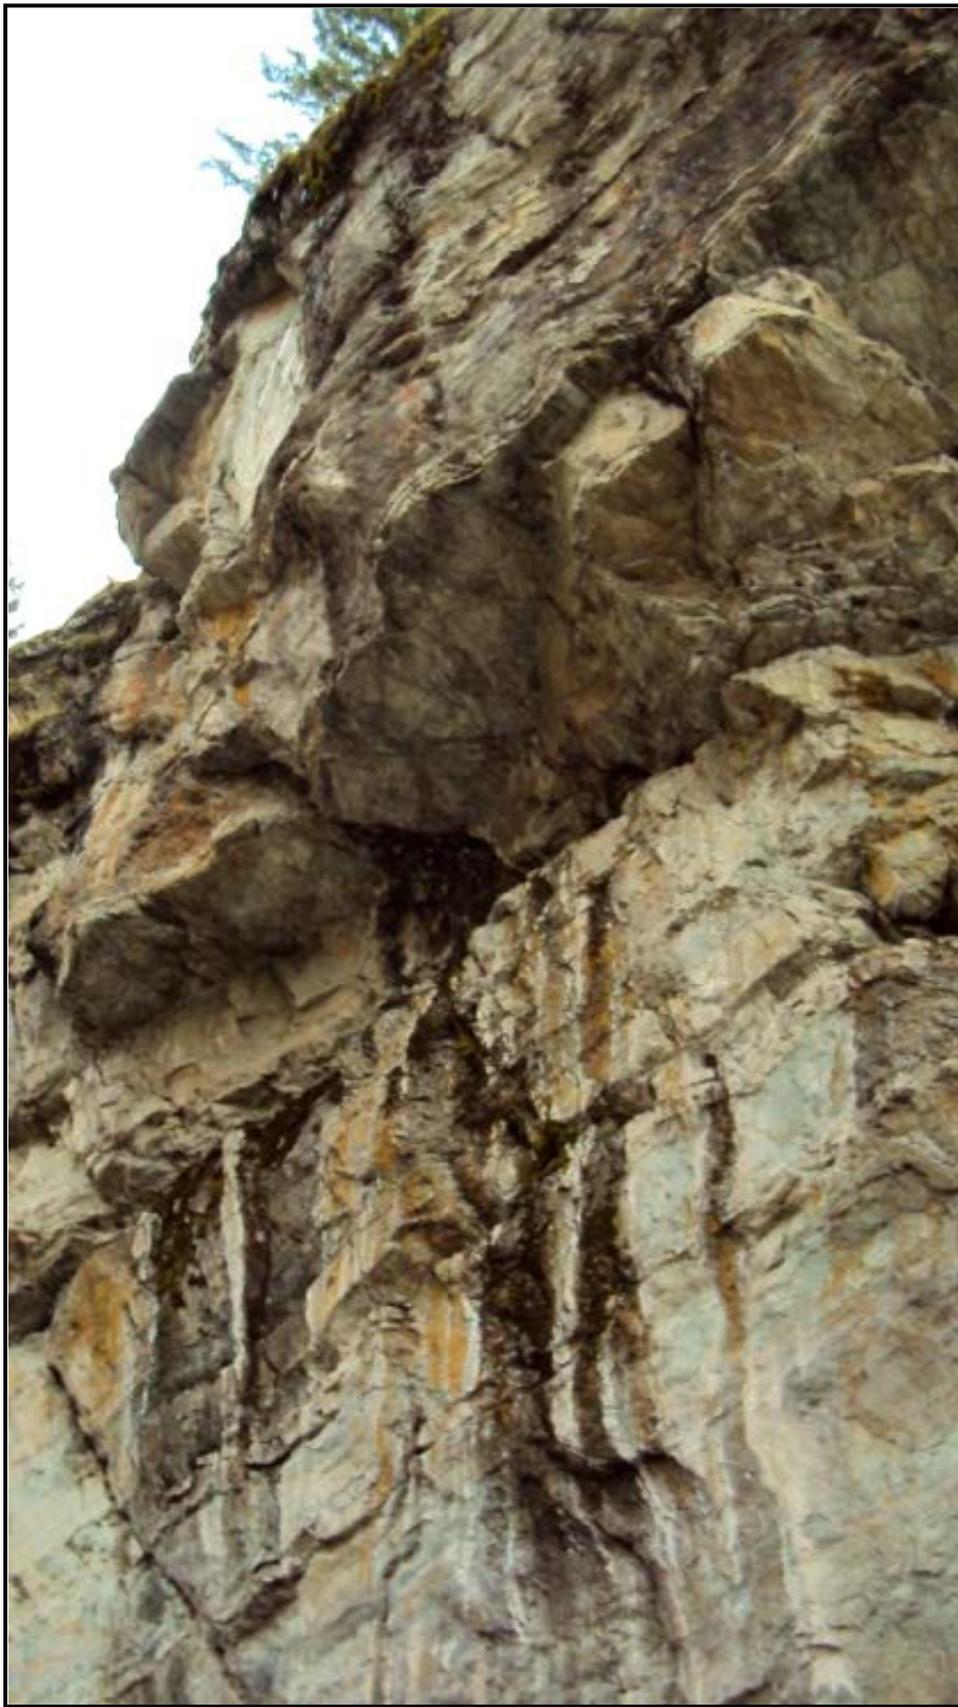
Photo 25. Evidence of water flow at east outcropping on the south side of US 2. Potential for falling rock. RP 141.1 (Sta. 67).

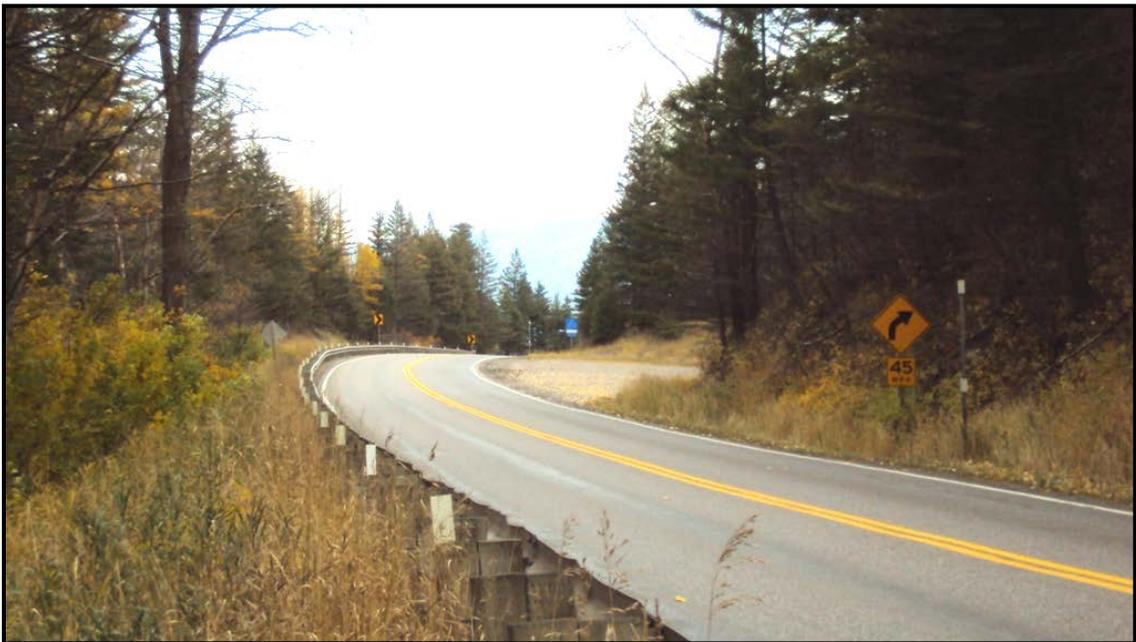
Photo 27. Looking east at a horizontal and vertical curve and a 45 mph warning sign. RP 141.2 (Sta. 70).

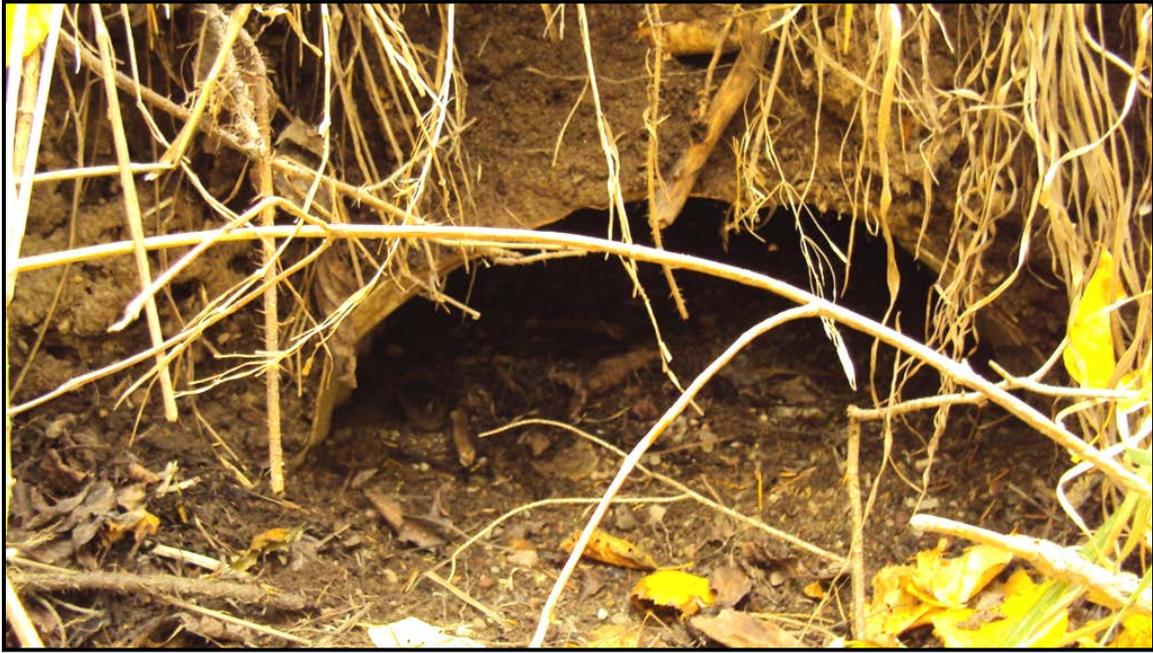
Photo 28. Single 18-inch CMP (approximately sixty percent buried) on the north side of US 2. RP 141.3 (Sta. 73).

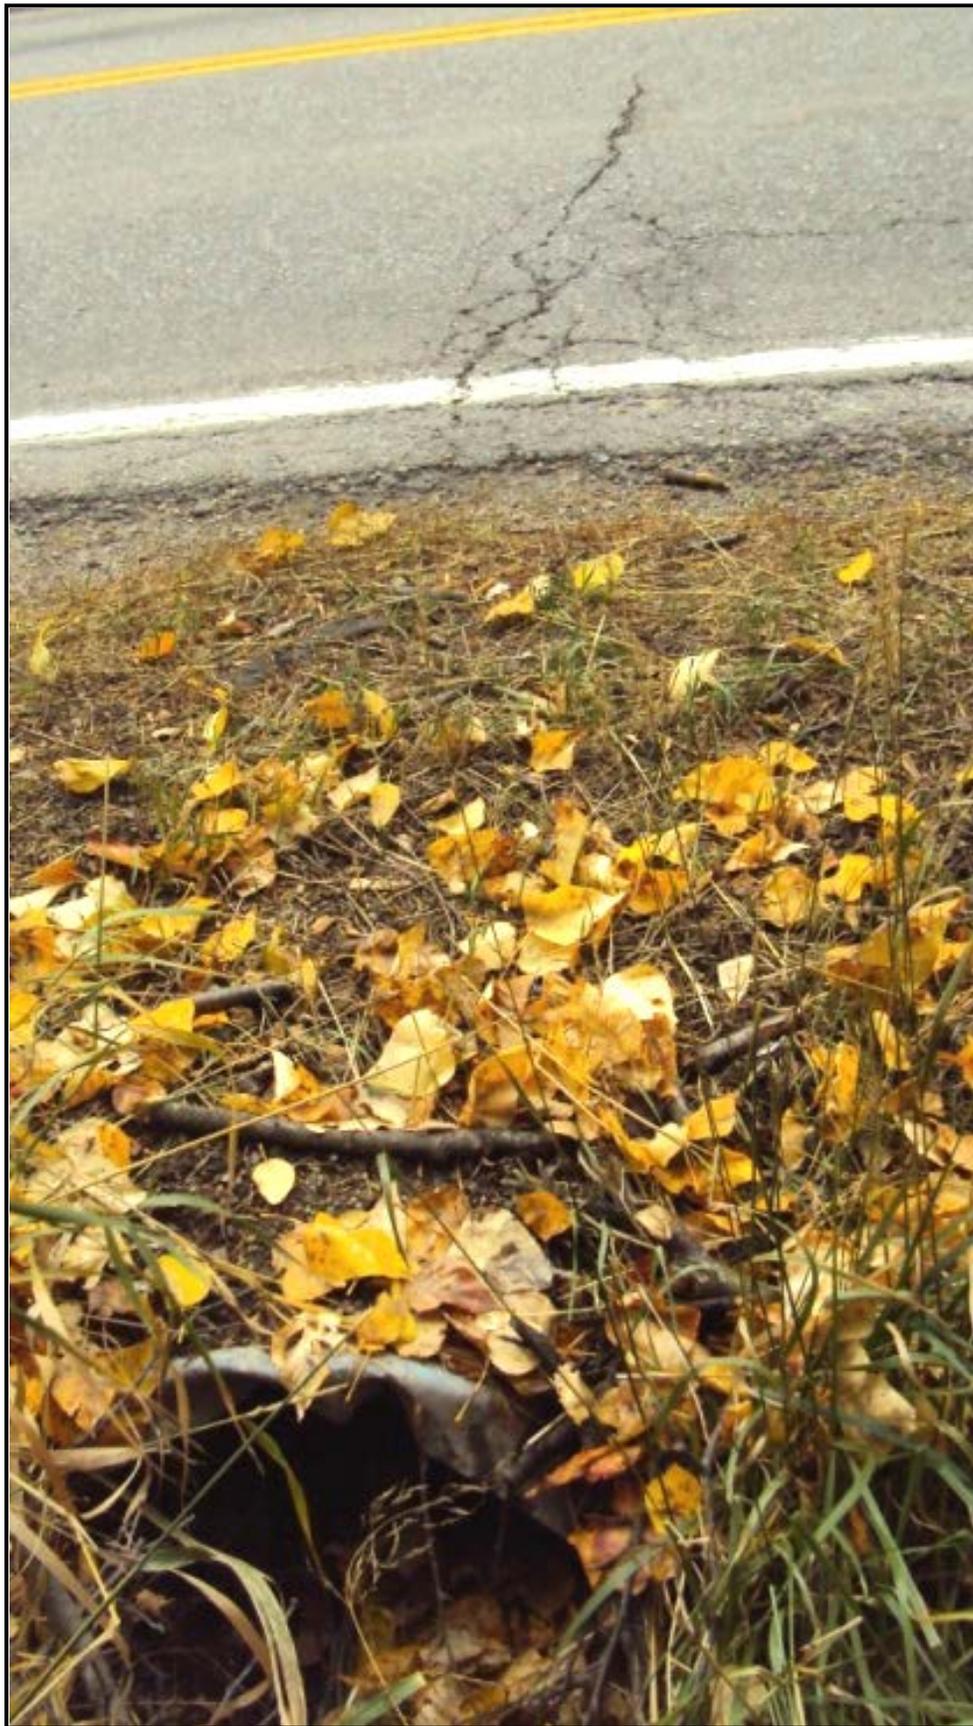
Photo 29. Single 18-inch CMP (approximately sixty percent buried) with minimal cover beneath roadbed on the south side of US 2. RP 141.3 (Sta. 73).

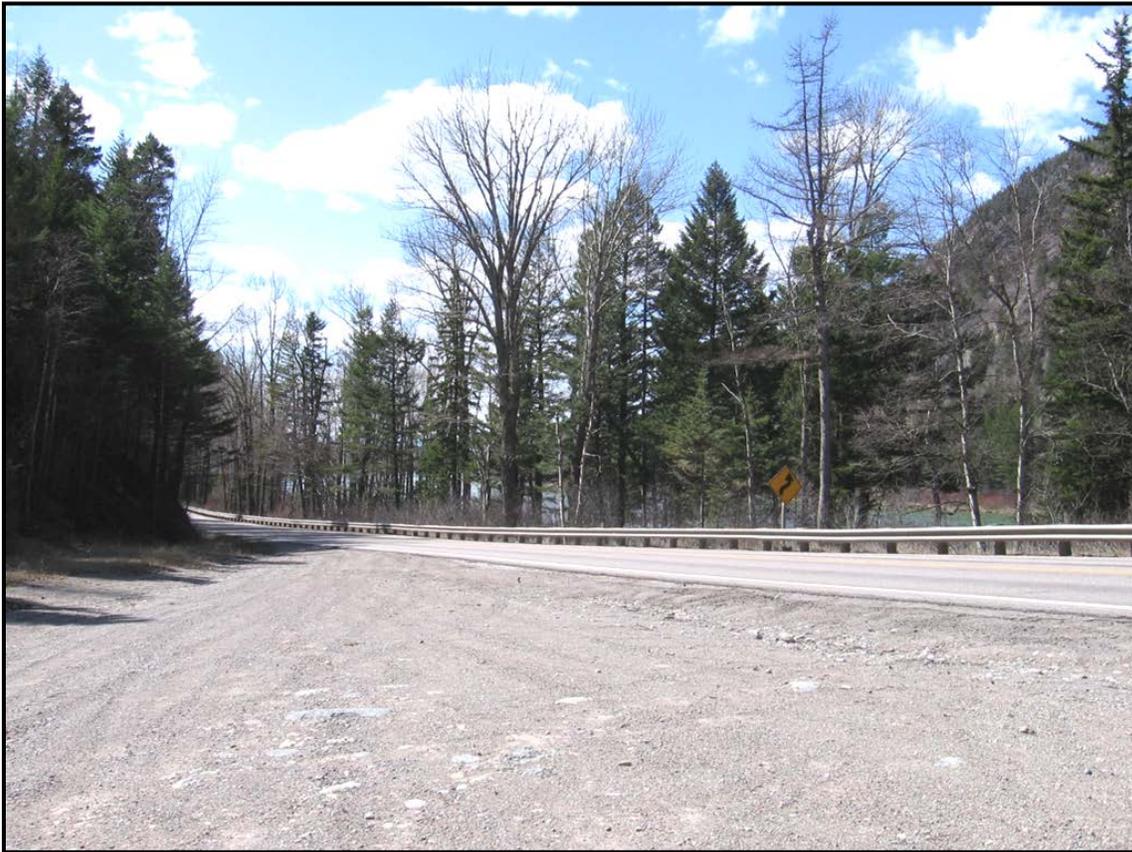
Photo 30. Looking northwest on the south side of US 2 at the east pullout. Roadside drainage issues are visible alongside the south side of the road. RP 141.3 (Sta. 75).

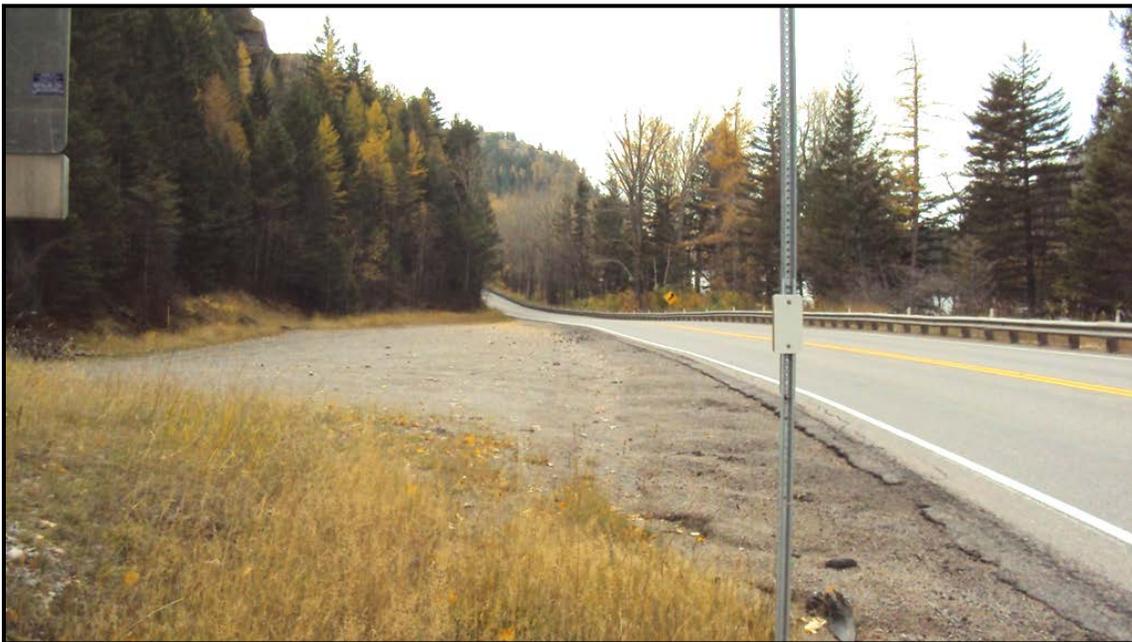
Photo 31. Roadside drainage issues along south side of US 2 looking west at the east pullout. RP 141.3 (Sta. 75).

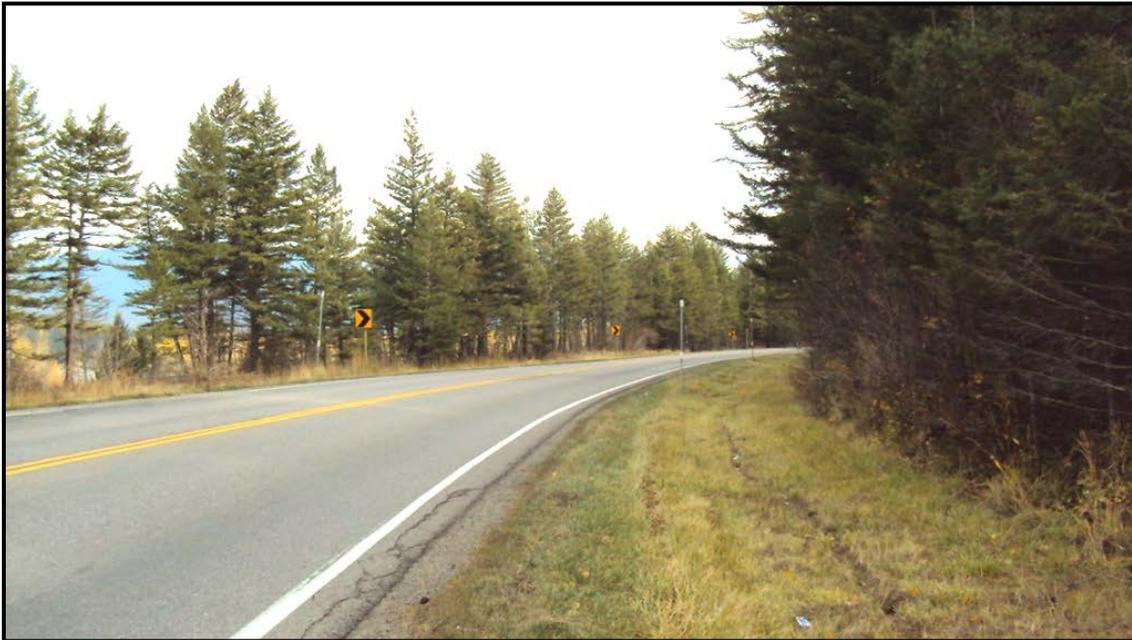
Photo 32. Horizontal curve and extended snow reflectors. RP 141.3 (Sta. 77).

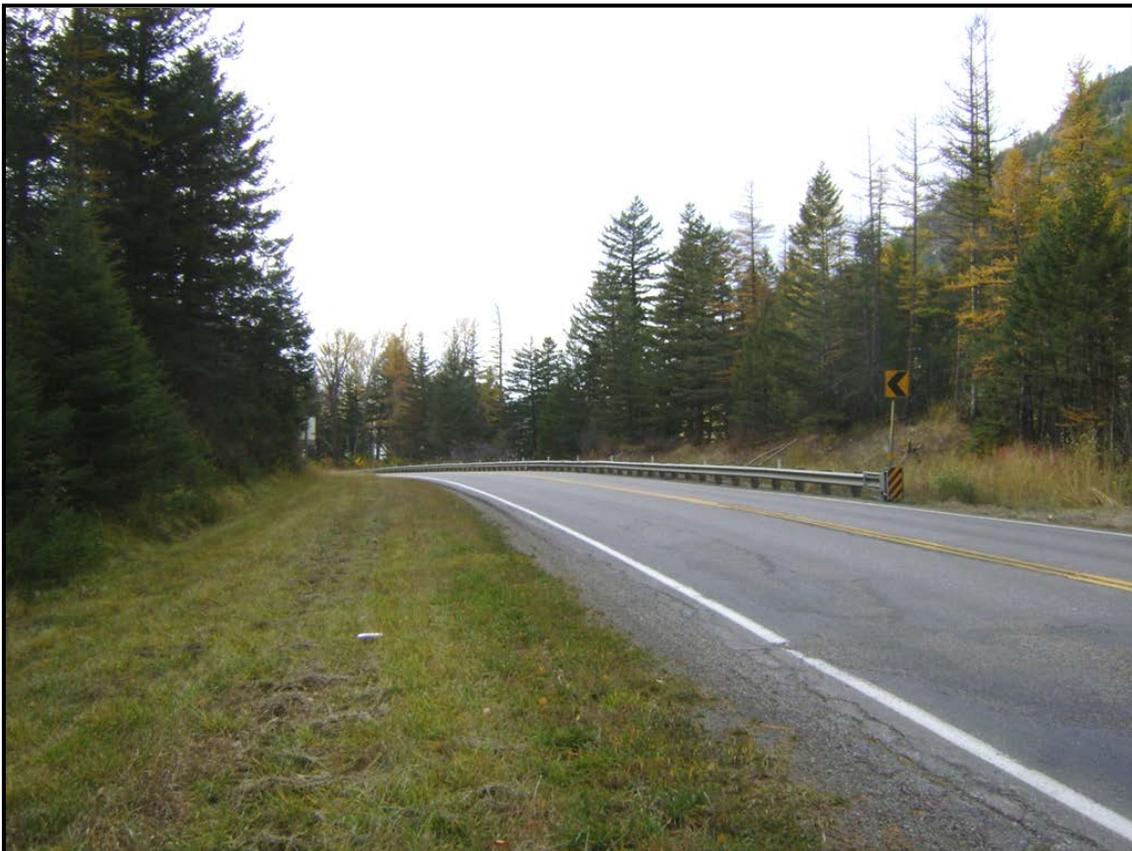
Photo 33. Looking west on the south side of US 2 at a horizontal and vertical curve. RP 141.3 (Sta. 82).

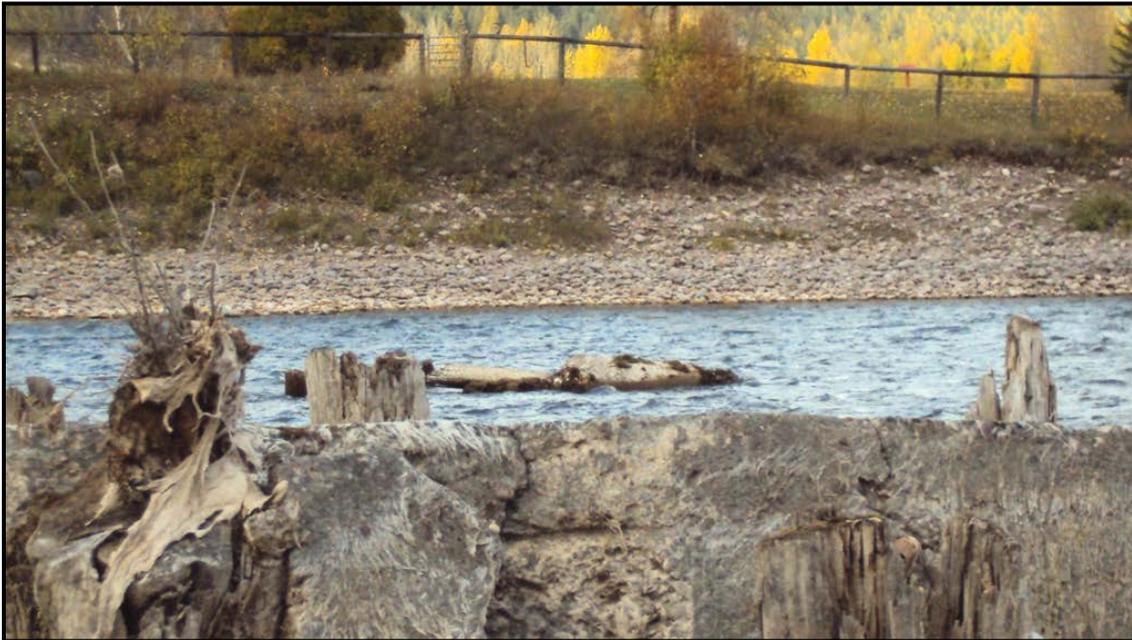
- Remnants of what appears to be a former bridge across the Flathead River. RP 141.7 (Sta. 111). Photo 36.
- Existing bridge over the South Fork of the Flathead River. Built in 1938 with a bridge deck 26 feet wide. RP 142.1 (Sta. 125). Photos 40 and 41.

Photo 36. Looking north at a former bridge crossing. The concrete foundation of the former bridge can be seen. RP 141.7 (Sta. 111).
