Appendix 1

Field Review Memorandum and Photo Log

Subject: **Summary of Field Review Conducted on October 26, 2011**
US 2 - Badrock Canyon Corridor Planning Study

PHOTO LOG

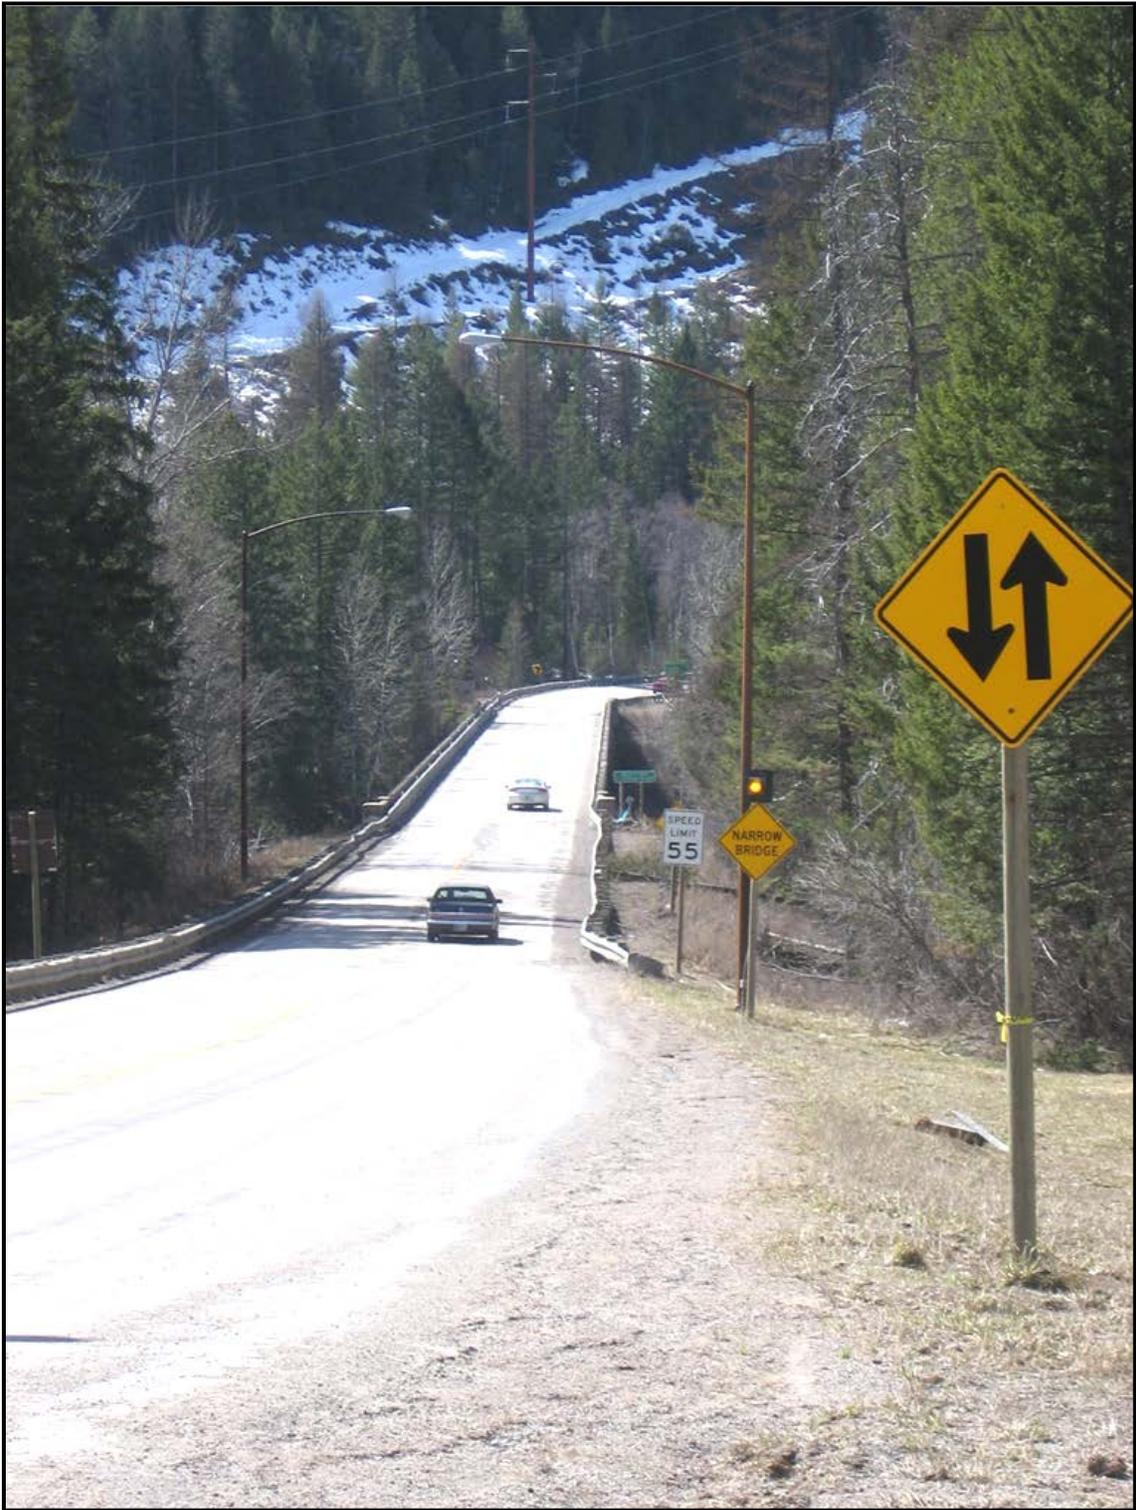
- Remnants of what appears to be a former bridge across the Flathead River. RP 141.7 (Sta. 111). Photo 36.
- Existing bridge over the South Fork of the Flathead River. Built in 1938 with a bridge deck 26 feet wide. RP 142.1 (Sta. 125). Photos 40 and 41.

Photo 40. Looking west at the narrow bridge deck over the South Fork of the Flathead River. RP 142.0 (Sta. 120).

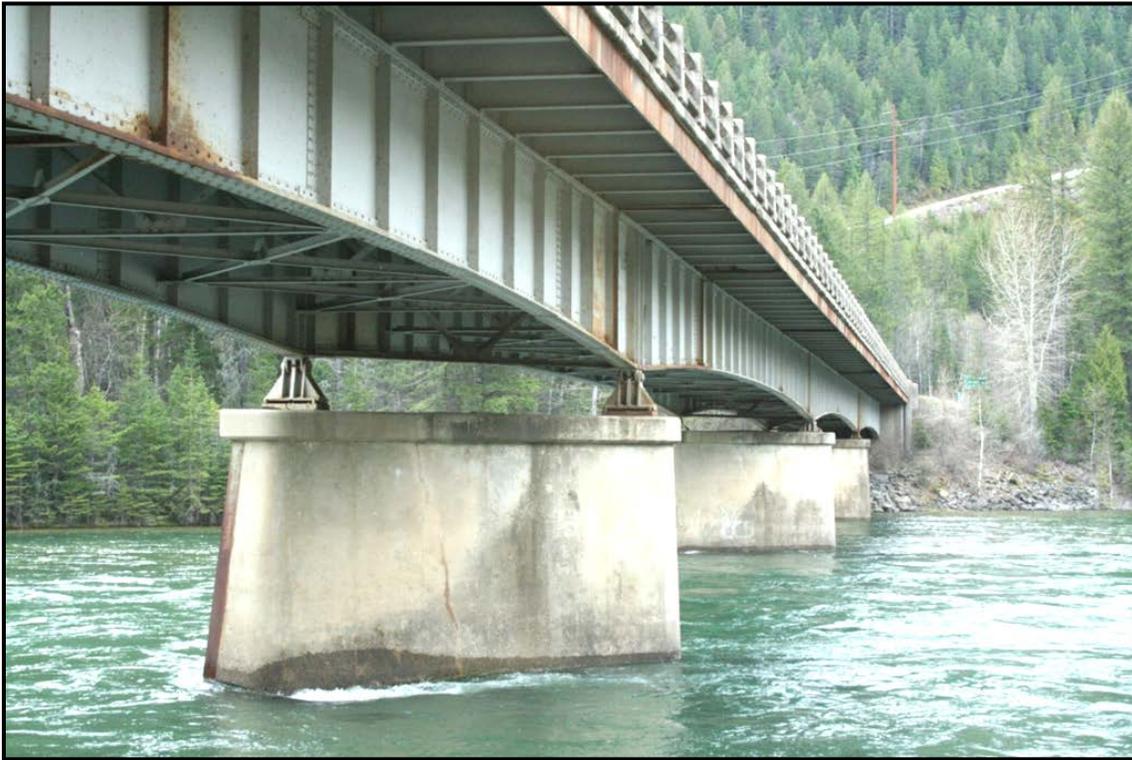
Photo 41. Looking east under the bridge over the South Fork of the Flathead River that is showing signs of corrosion. RP 142.1 (Sta. 129).
