# Bridge No. L15672000+02001

Big Fork Bridge

Condition Evaluation Report

Inspection Date: September 11, 2015

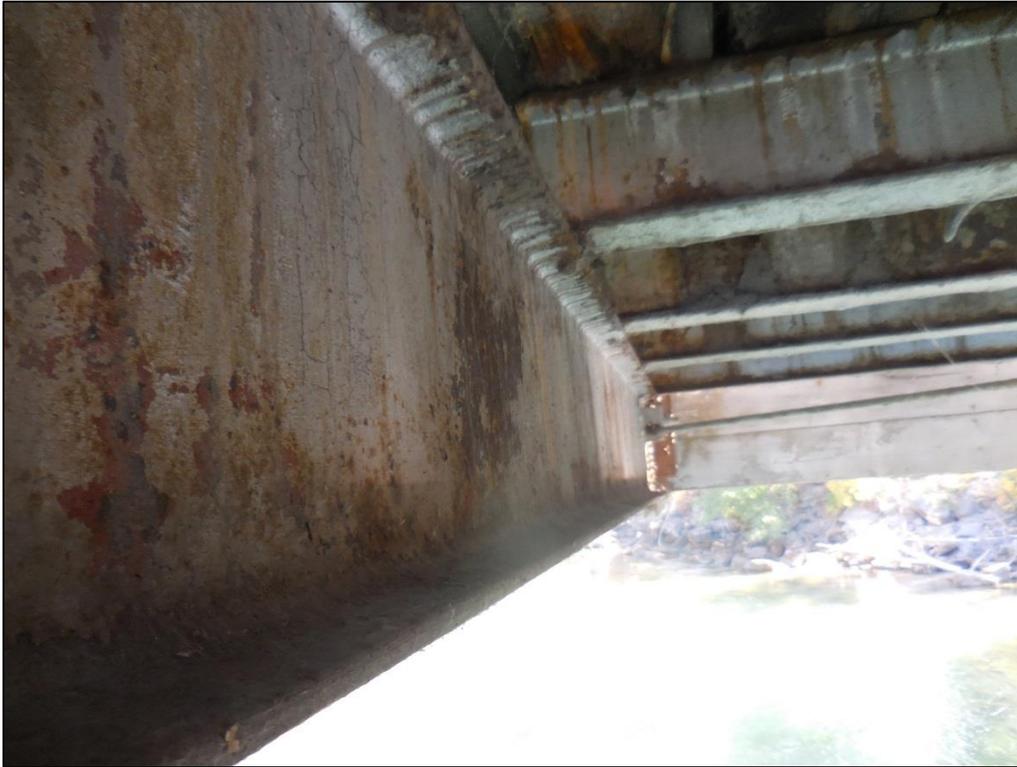
**Photo 4:** Typical floor beam with paint deterioration and moderate surface corrosion

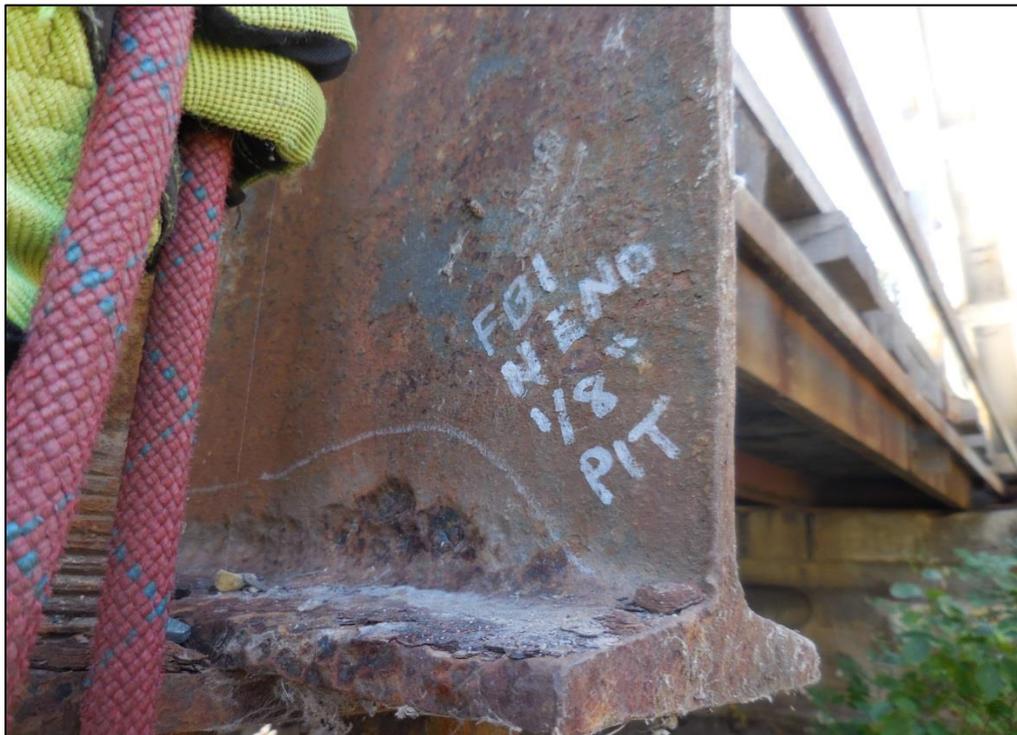
- North end of Floor Beam 1: 1/8 in. deep section loss on end 2 ft. of the beam. Section loss was 2 in. high at the web to bottom flange interface on the east face (**Photo 5**).

**Photo 5:** North end of Floor Beam 1 east face; web section loss adjacent to the bottom flange

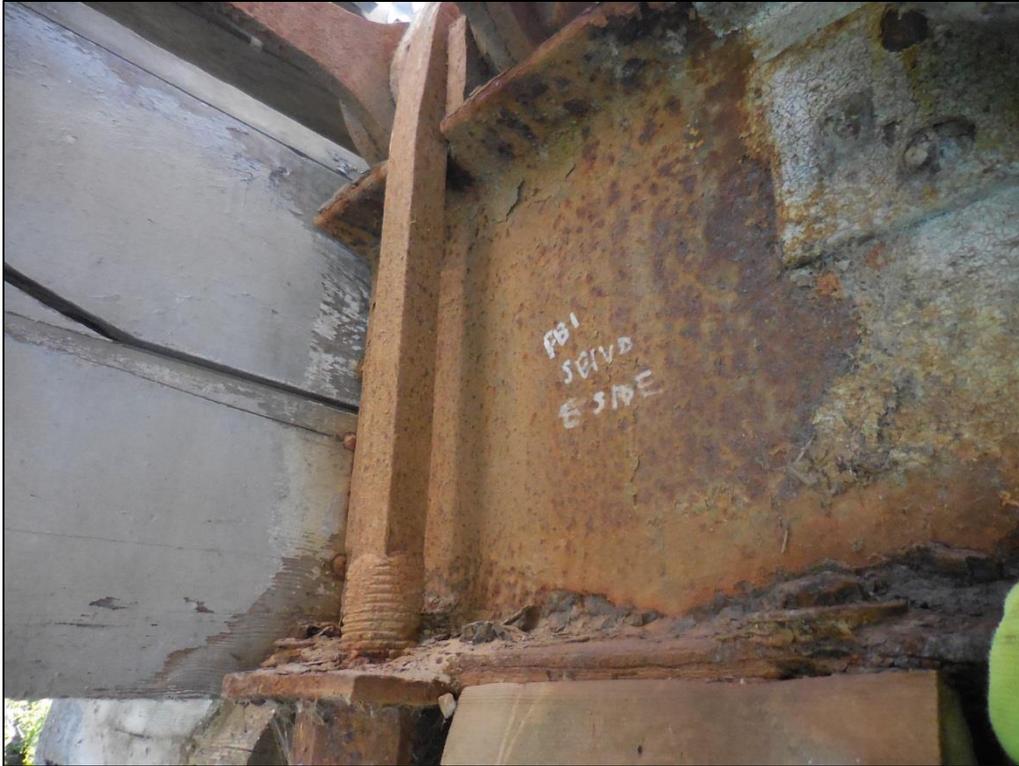
- South end of Floor Beam 1: 1/8 in. deep section loss on end 2 ft. of the beam. Section loss was 2 in. high at the web to bottom flange interface on both faces (**Photo 6**).

**Photo 6:** South end of Floor Beam 1 east face; web section loss adjacent to the bottom flange

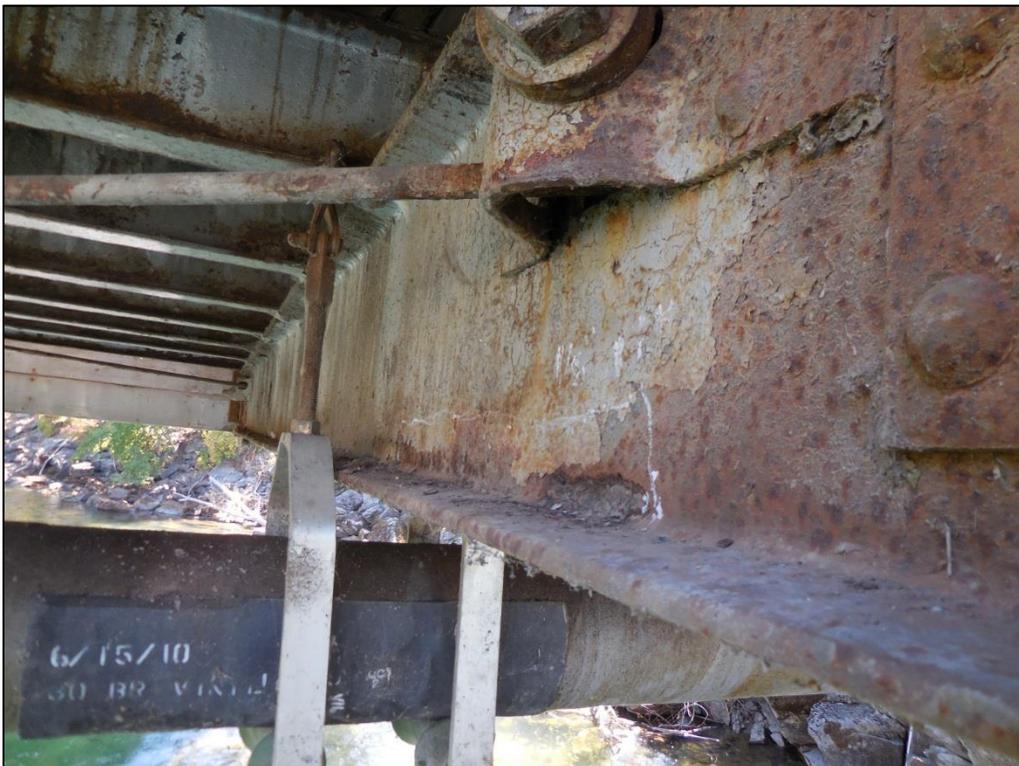
- North end of Floor Beam 2: 1/8 in. deep section loss on end 20 in. of the beam. Section loss was 2 in. high at the web to bottom flange interface on both faces (**Photo 7**).

**Photo 7:** North end of Floor Beam 2, east face; web section loss adjacent to the bottom flange

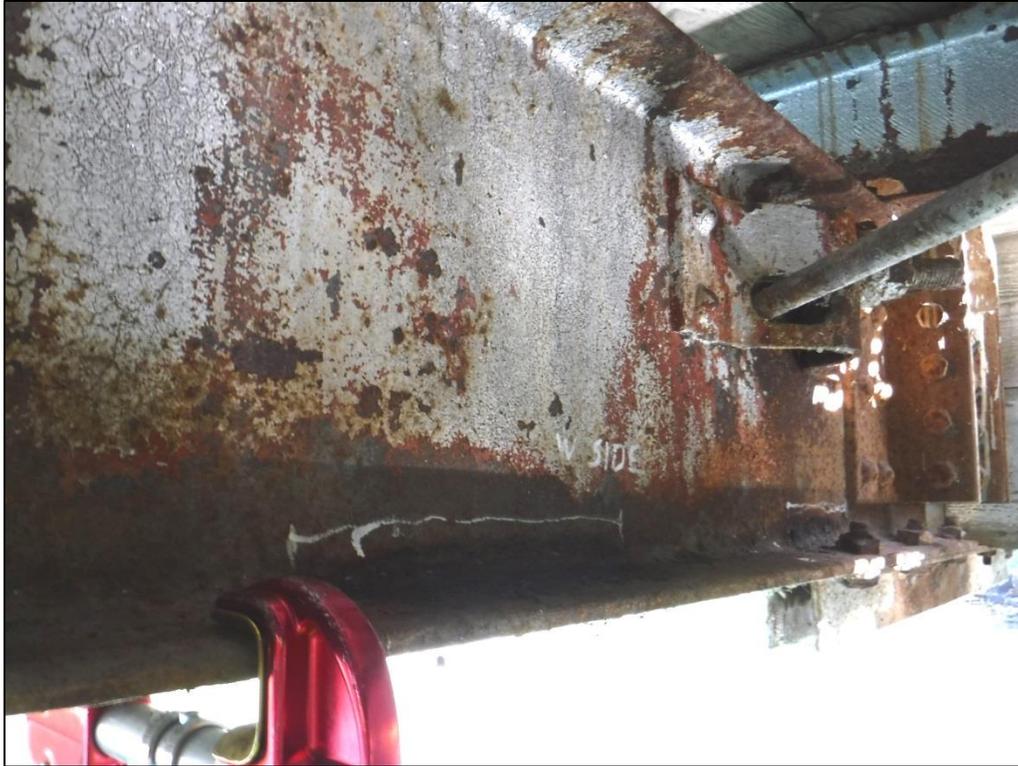
- South end of Floor Beam 2: 1/8 in. deep section loss on end 3 ft. of the beam. Section loss was 2 in. high at the web to bottom flange interface on the west face (**Photo 8**).

**Photo 8:** South end of Floor Beam 2, west face; web section loss adjacent to the bottom flange

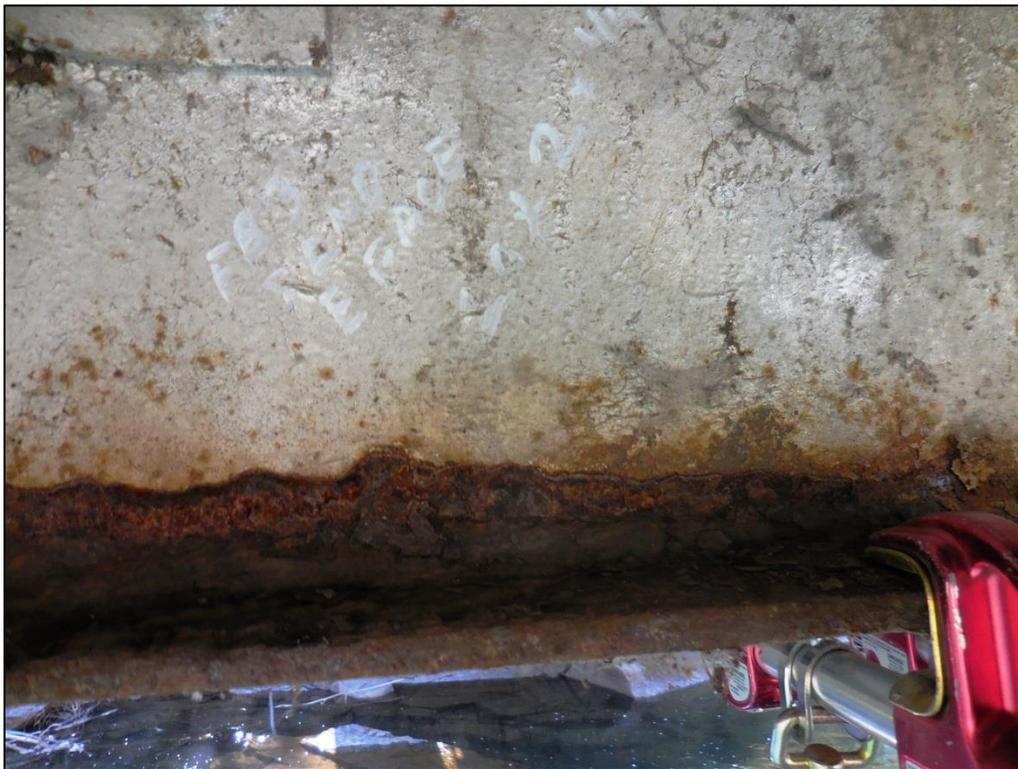
- South end of Floor Beam 3: 1/8 in. deep by 2 in. high section loss between 12 and 32 in. from the end of the west face of the beam at the bottom flange to web interface; 1/4 in. deep section loss at the same location on the east face (**Photo 9**).

**Photo 9:** South end of Floor Beam 3; web section loss adjacent to the bottom flange

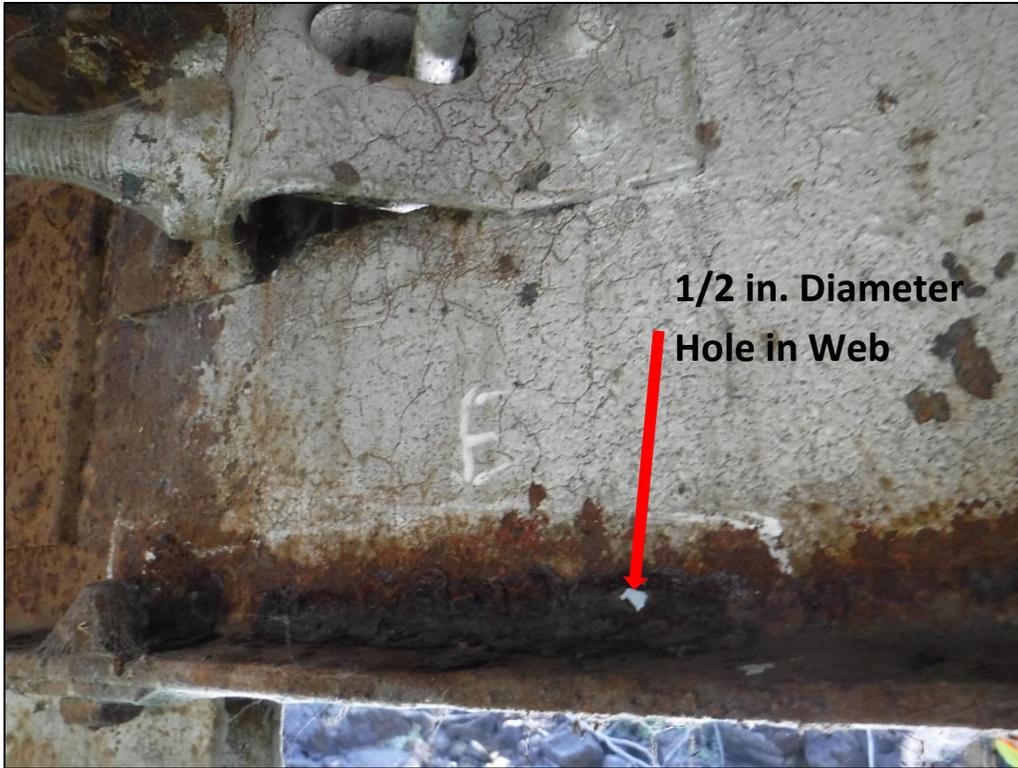
- South end of Floor Beam 3': 1/8 in. deep section loss on end 3 ft. of the beam. Section loss was 1 in. high at the web to bottom flange interface on the both faces. A 1/2 in. diameter hole was noted in the web 1 in. above the bottom flange and approximately 3

ft. from the end of the floor beam (**Photo 10**).

6. FLOOR BEAM 3': 1/8 IN. DEEP SECTION LOSS ON END 3 FT. OF THE BEAM. SECTION LOSS WAS 1 IN. HIGH AT THE WEB TO BOTTOM FLANGE INTERFACE ON BOTH FACES. A 1/2 IN. DIAMETER HOLE WAS NOTED IN THE WEB OF THE FLOOR BEAM 1 IN. ABOVE THE BOTTOM FLANGE AND APPROXIMATELY 3 FT. FROM THE END OF THE FLOOR BEAM.

**Photo 10:** South end of Floor Beam 3', east face; web section loss adjacent to the bottom flange with 1/2 in. diameter hole in web

The floor beams were found to be in fair to poor condition. The areas of heavier corrosion along the bottom edge of the floor beam webs and the hole noted in the web of Floor Beam 3' should be monitored during future fracture critical inspections. There were no signs of deflection or crushing of the floor beam webs in the areas of heavier corrosion. Since the bridge is currently posted at 3 tons, it is recommended the floor beams be monitored during future fracture critical inspections.

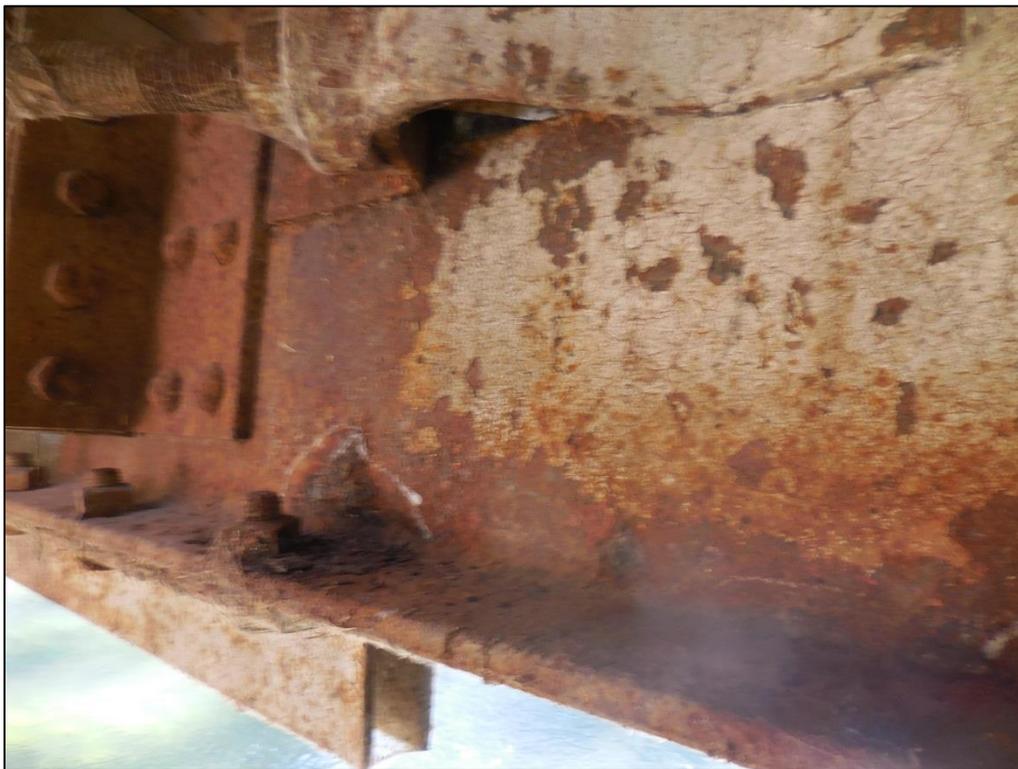
- South end of Floor Beam 2': East face of beam had an 8 in. long by 1 in. high area and a 5 in. long by 1 in. high area of 1/8 in. deep section loss. Both areas located at the bottom flange to web interface on the end 3 ft. of the beam. West face of the beam had a 5 in. long by 2 in. high area of 1/8 in. deep section loss located 20 in. from the end of the beam at the bottom flange to web interface (**Photo 11**).
- South end of Floor Beam 1': 1/8 in. deep section loss on end 2 ft. of the beam. Section loss was 1 in. high at the web to bottom flange interface on the west face (**Photo 12**).

**Photo 11:** South end of Floor Beam 2'; web section loss adjacent to the bottom flange

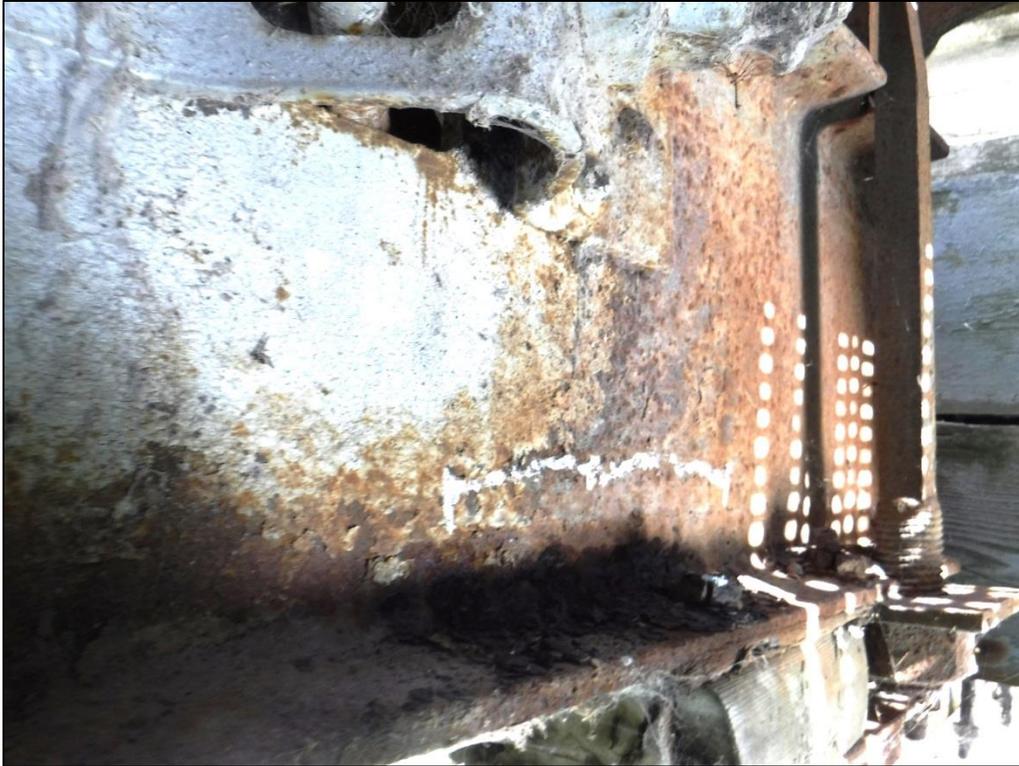
**Photo 12:** South end of Floor Beam 1', west face; web section loss adjacent to the bottom flange

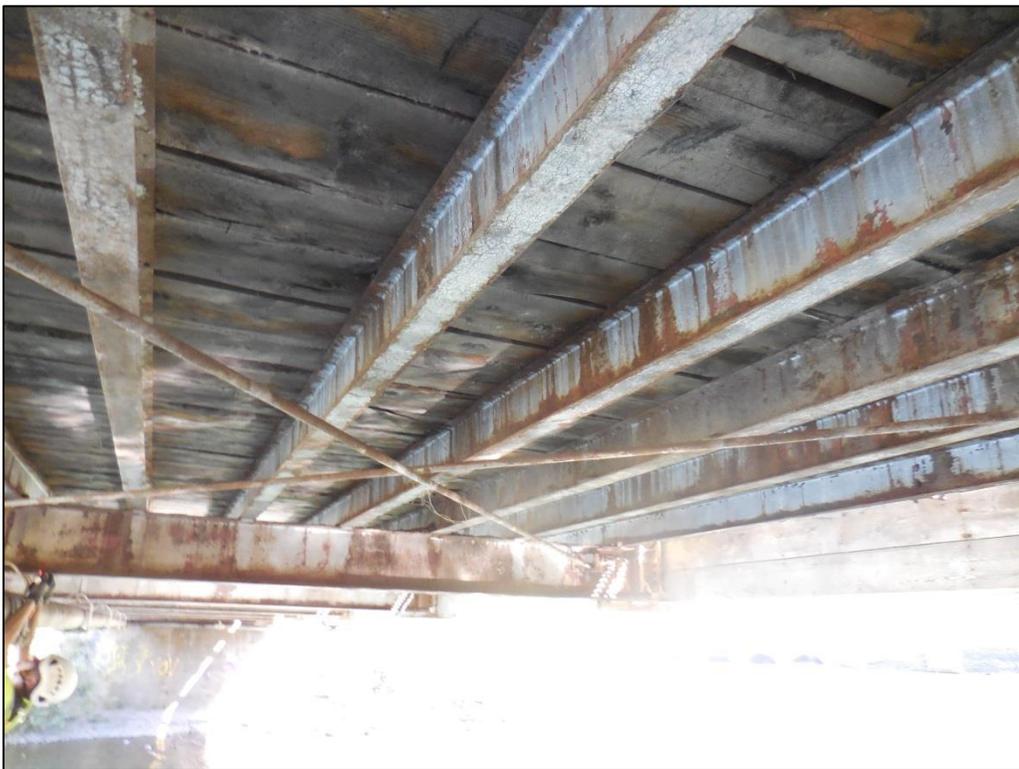
**Photo 13:** Typical stringer with paint deterioration and moderate surface corrosion

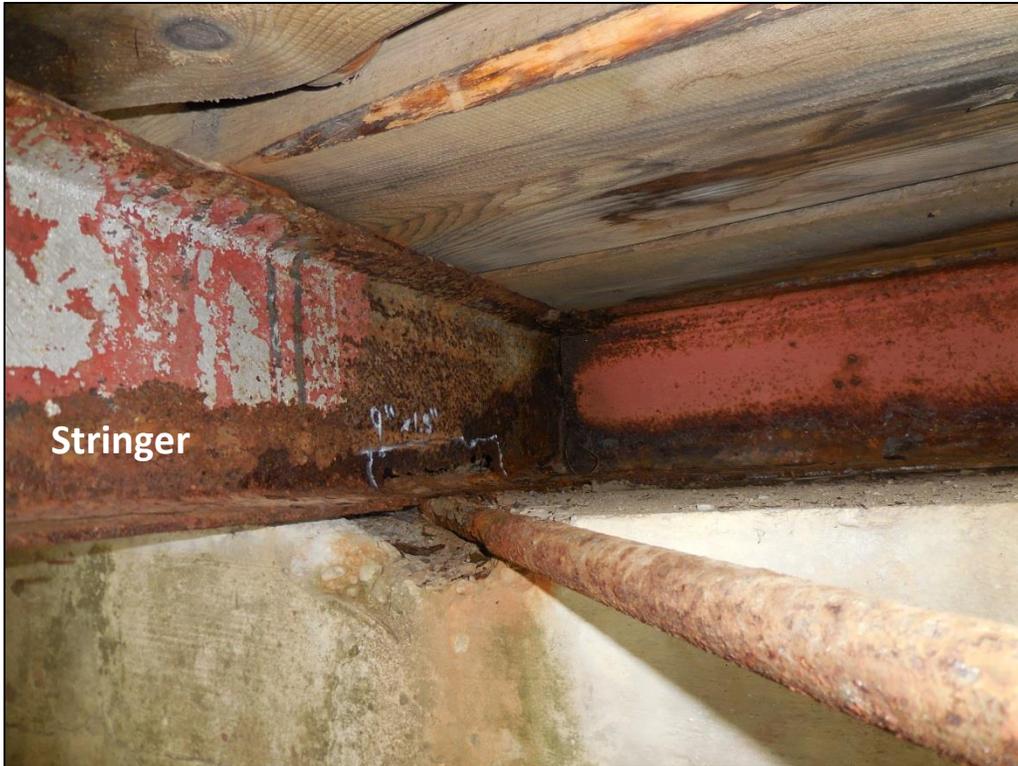
- Stringer 1 at Abutment 1: End of the stringer had a 9 in. long by 1.5 in. high hole in the stringer web adjacent to the bottom flange. The remaining end two ft. of the stringer web had D-meter readings of 0.150 in. to 0.250 in. (0.300 in. typical). The bottom flange was knife edged in this area (**Photo 14**).

**Photo 14:** View of deterioration on Stringer 1 at Abutment 1

The steel stringers were in fair to poor condition. It is recommended that the paint deterioration and corrosion be monitored during future inspections. Stringers 1 and 8 at each abutment had heavy corrosion and holes in the webs at the bearing areas. The excessive corrosion in these areas is attributed to the debris accumulation that has occurred in the past. It is recommended that these areas be cleaned during future inspections to prevent accelerated corrosion due to trapped moisture.

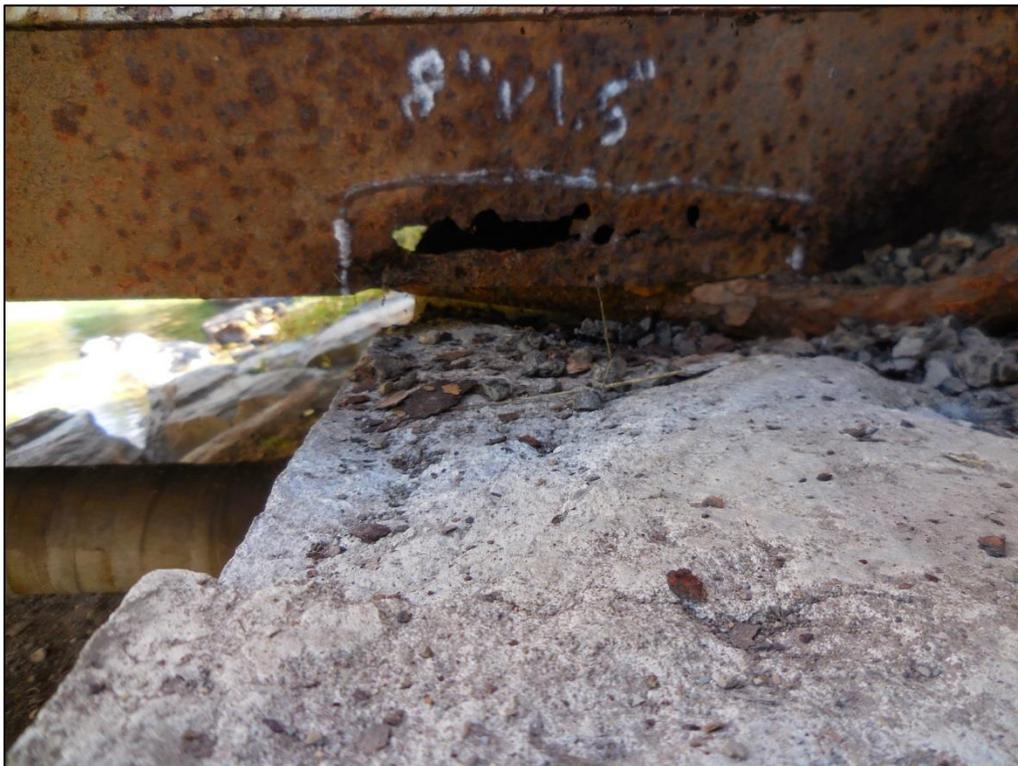
- Stringer 8 at Abutment 1: End of the stringer had an 8 in. long by 1.5 in. high hole in the stringer web adjacent to the bottom flange centered 2 ft. from the end of the stringer (**Photo 15**). A 3 in. by 3 in. hole was located at mid height at the end of the web (**Photo 16**).

**Photo 15:** View of deterioration on Stringer 8 at Abutment 1

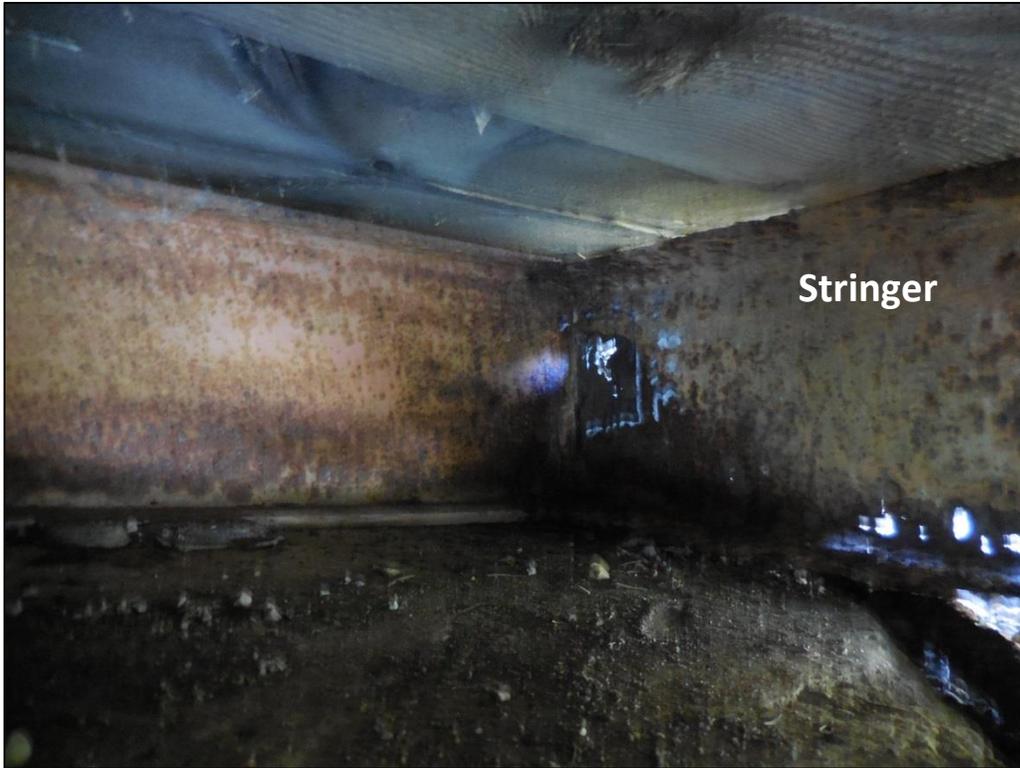
**Photo 16:** View of deterioration on Stringer 8 at Abutment 1

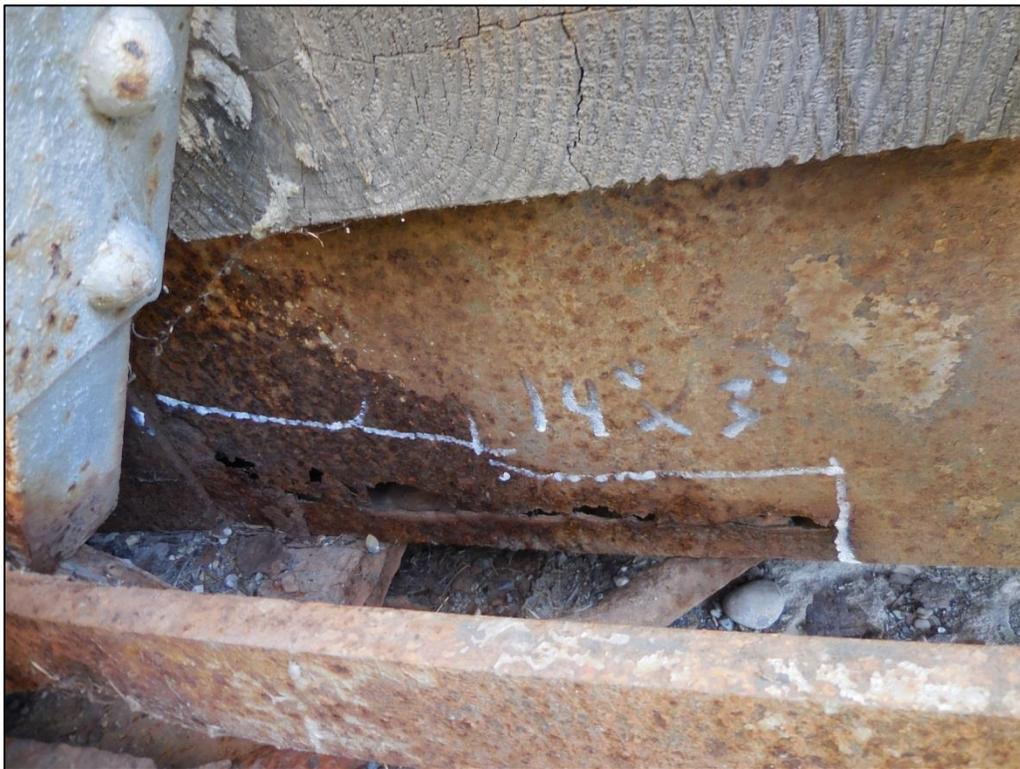
11. STRINGER 1 AT ABUTMENT 2: END OF THE STRINGER HAD A 14 IN. LONG BY 3 IN. HIGH HOLE IN THE STRINGER WEB ADJACENT TO THE BOTTOM FLANGE LOCATED AT THE END OF THE STRINGER.

**Photo 17:** View of deterioration on Stringer 1 at Abutment 2

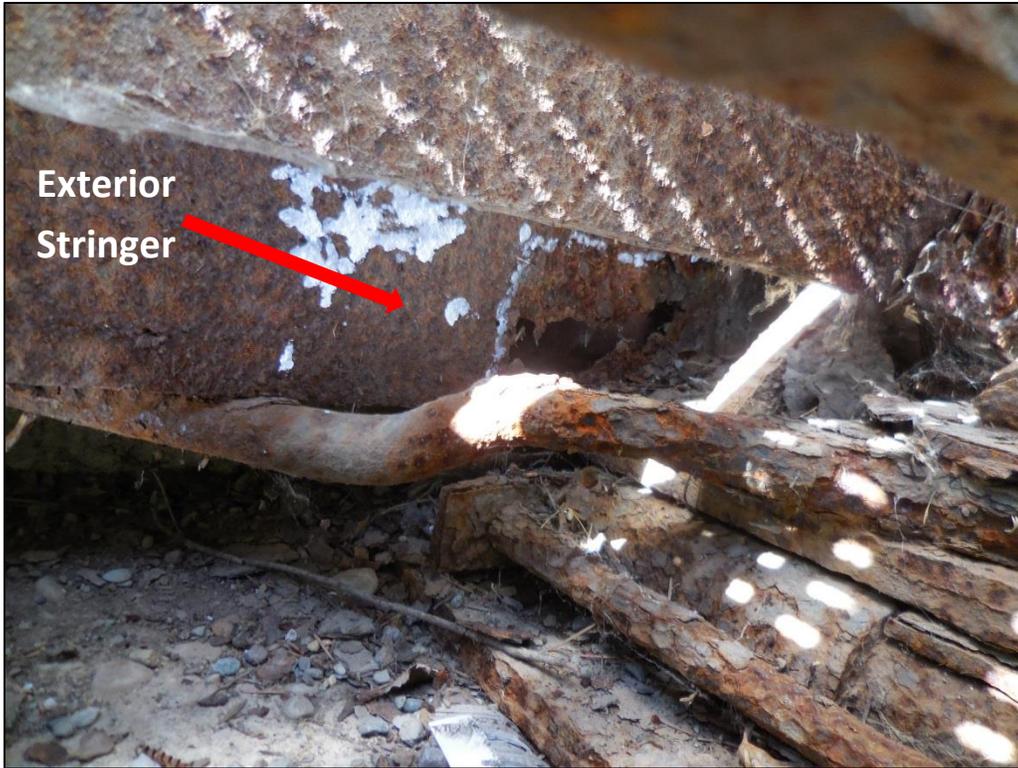
12. STRINGER 8 AT ABUTMENT 2: END OF THE STRINGER HAD A 6 IN. LONG BY 3 IN. HIGH HOLE IN THE STRINGER WEB ADJACENT TO THE BOTTOM FLANGE LOCATED AT THE END OF THE STRINGER.

**Photo 18:** View of deterioration on Stringer 8 at Abutment 2

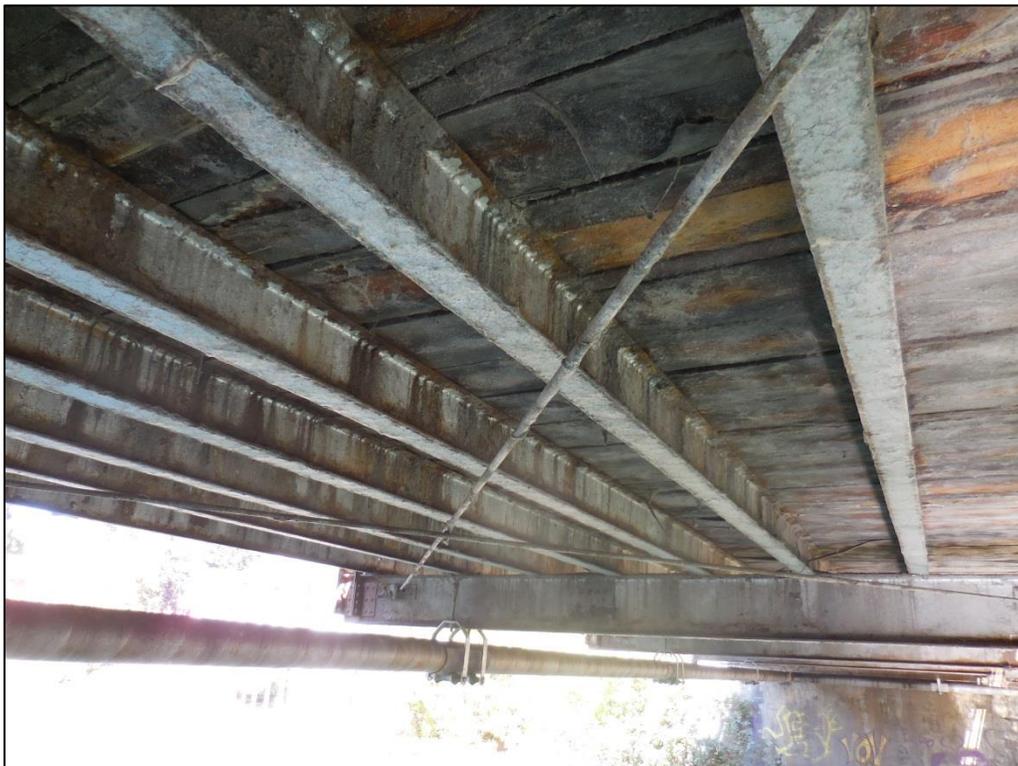
The underside of the timber deck had no coating noted. The underside of the deck had random areas of checking, splitting and signs of mold due to moisture.

**Photo 19:** View of the typical condition of the underside of the deck

The underside of the timber deck was in fair condition. It is recommended that the deck be monitored for decay and rot.

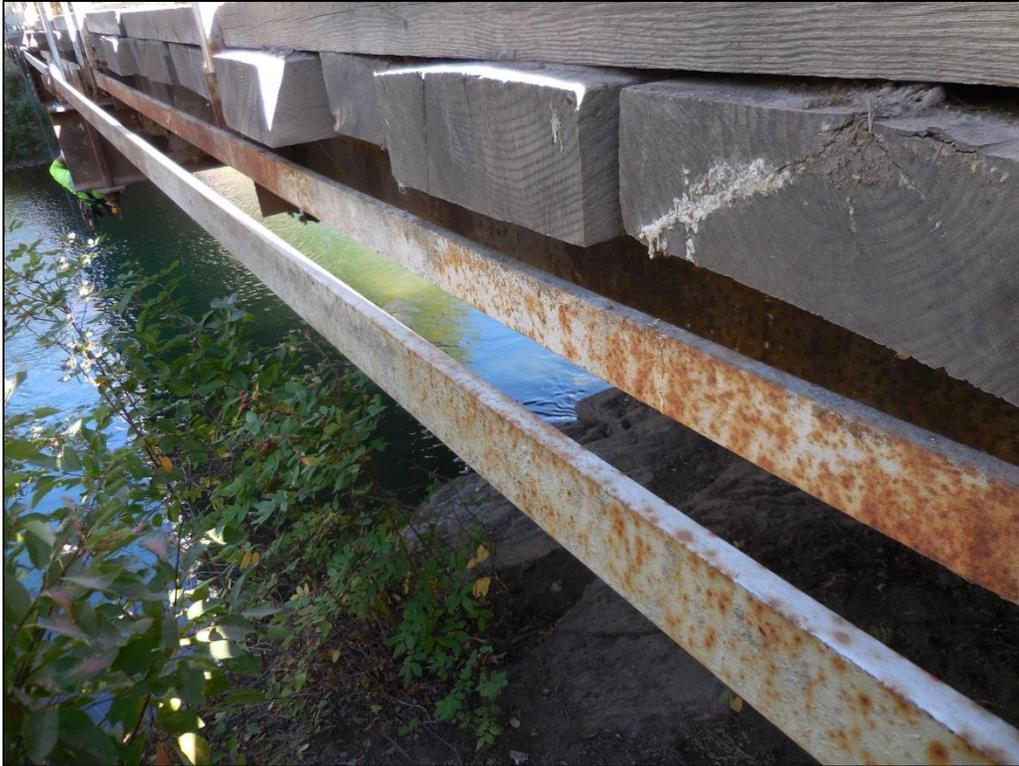
**Photo 20:** Typical lower chord with paint deterioration and moderate surface corrosion

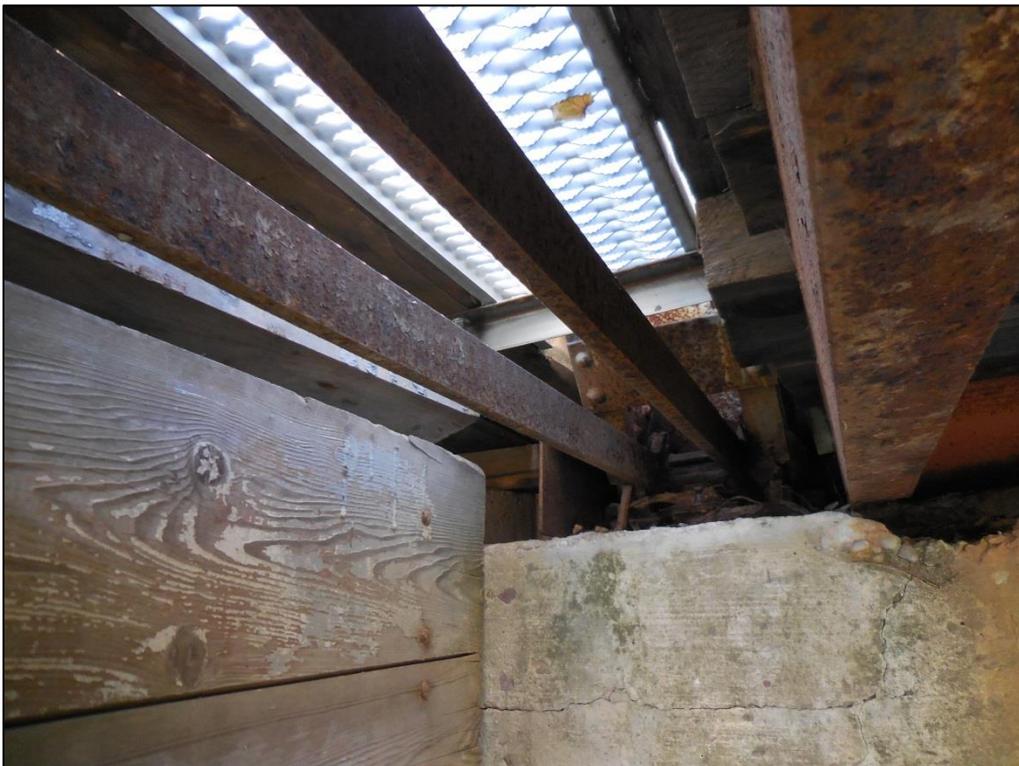
**Photo 21:** View of the pitting on the east lower chord at Abutment 1

The lower chord was found to be in fair to poor condition. It is recommended that the paint deterioration and areas of corrosion be monitored during future inspections. The areas of heavier corrosion that was noted on the lower chord connections at the bearing can be attributed to the debris accumulation that has occurred in the past. It is recommended that the bearing areas and the ends of the lower chord be cleaned during future inspections to prevent accelerated corrosion due to trapped moisture.

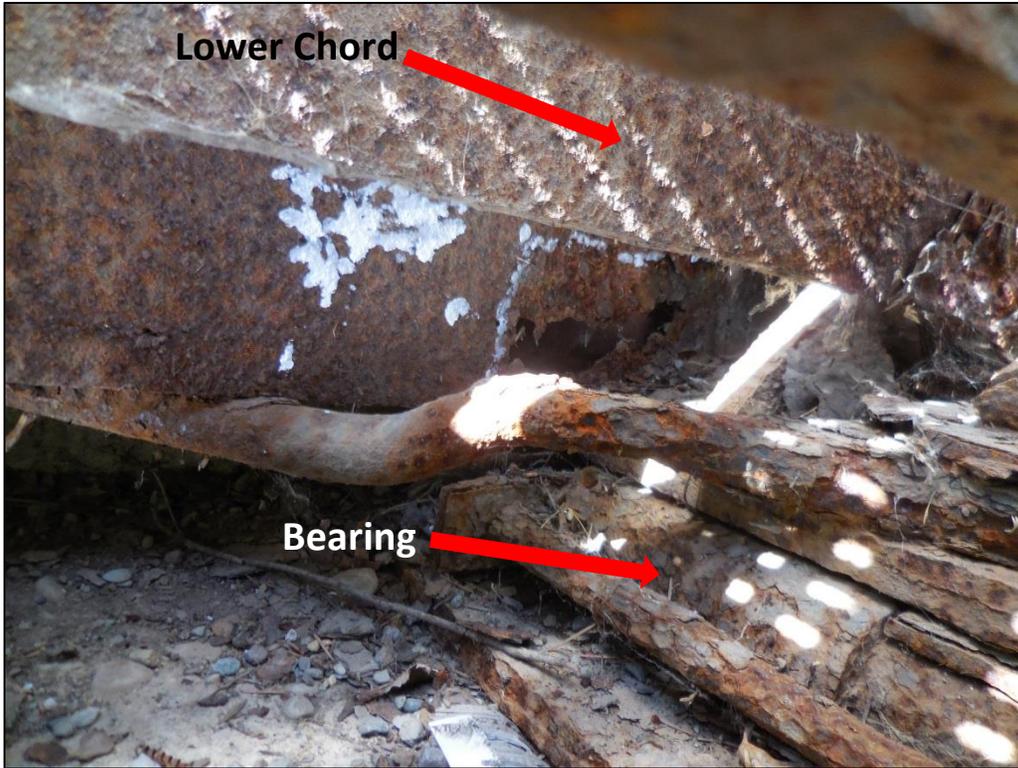
**Photo 22:** View of the pitting on the south lower chord at Abutment 2
