3.0 DEFICIENCY ANALYSIS

3.1 SHILOH INTERCHANGE

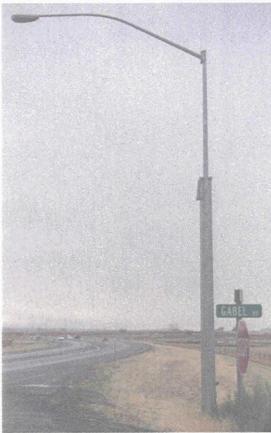
There are no existing traffic signals in the Shiloh interchange study area. Streetlight poles at all intersections have mounting brackets and were designed for future traffic signal mast arm installation.

Signal-ready pole on Zoo Drive
