# Appendix 1

## Field Review Memorandum and Photo Log

**Subject: Summary of Field Review Conducted on January 31, 2012  
MT 16 / MT 200 Glendive to Fairview Corridor Planning Study**

**MT 16 / MT 200 GLENDIVE TO FAIRVIEW  
CORRIDOR PLANNING STUDY  
PHOTO LOG**

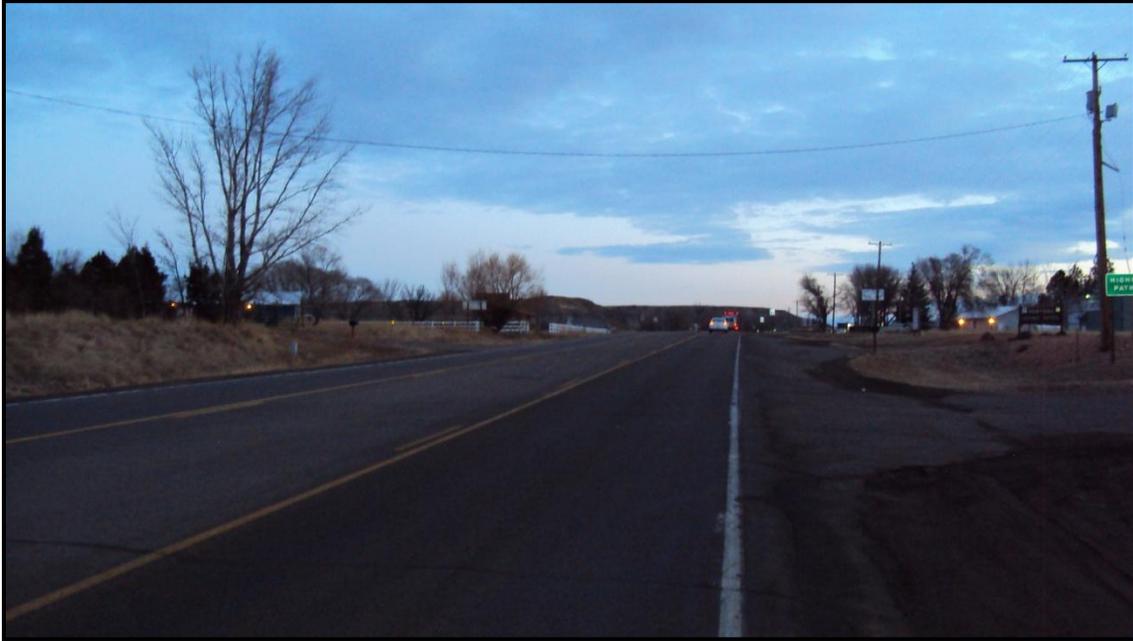
**Photo 1.** Looking north on MT 16 at a two-way left-turn lane north of Glendive. RP 0.7.

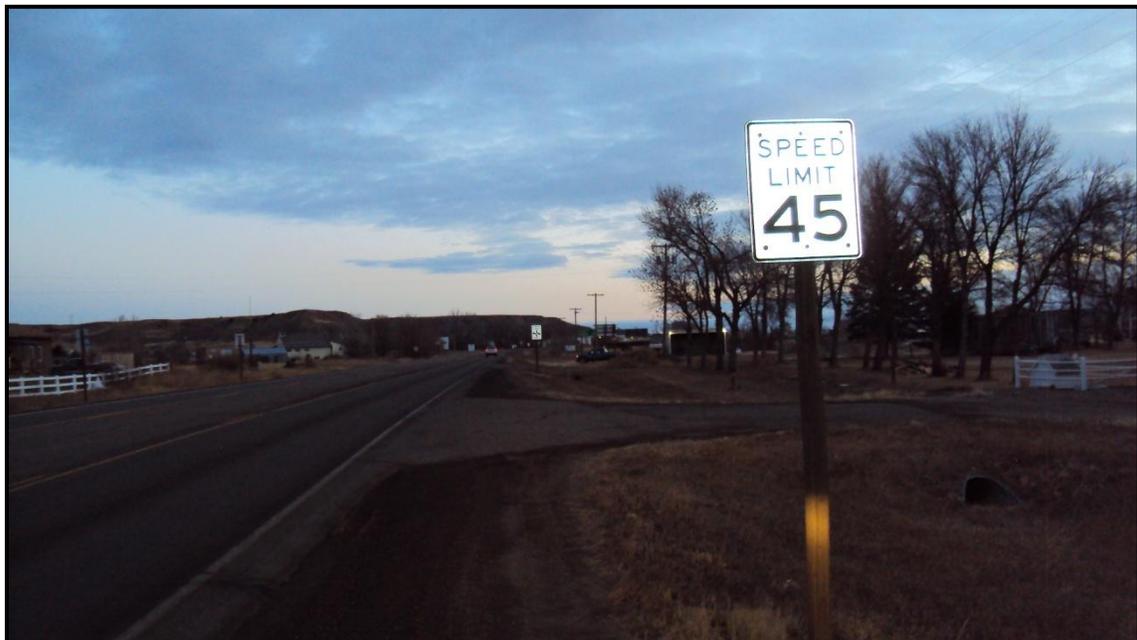
**Photo 2.** Looking north on MT 16 at 45 mile per hour (mph) sign north of Glendive. RP 0.7.

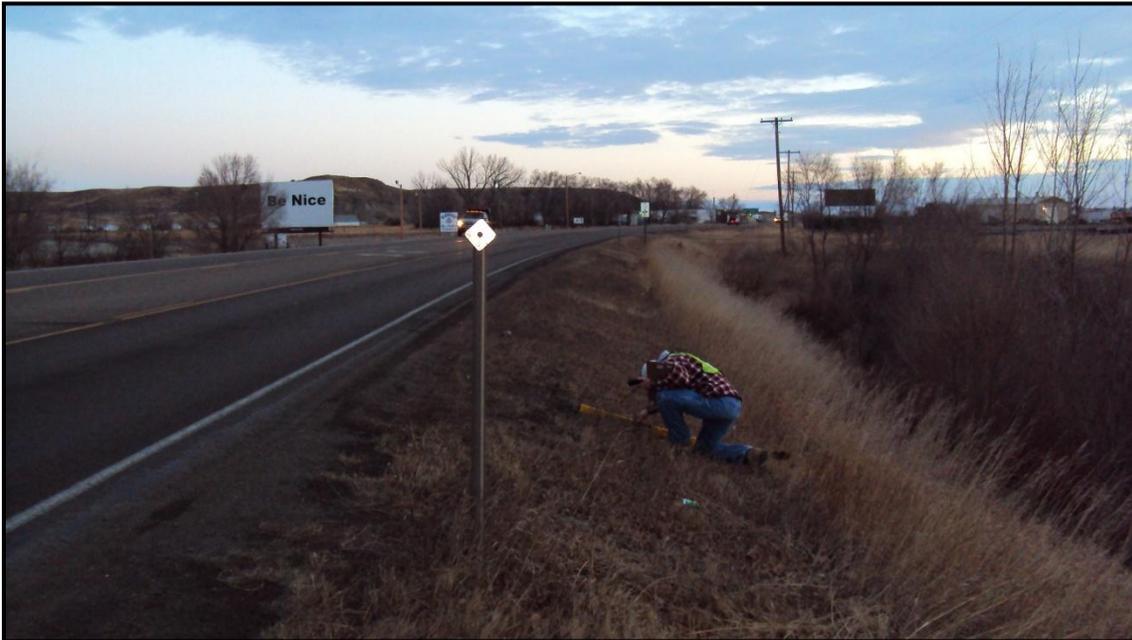
**Photo 3.** Looking north on MT 16. East side slope transitions from 3:1 to 2:1 approximately 13 feet from northbound travel lane. RP 1.1.

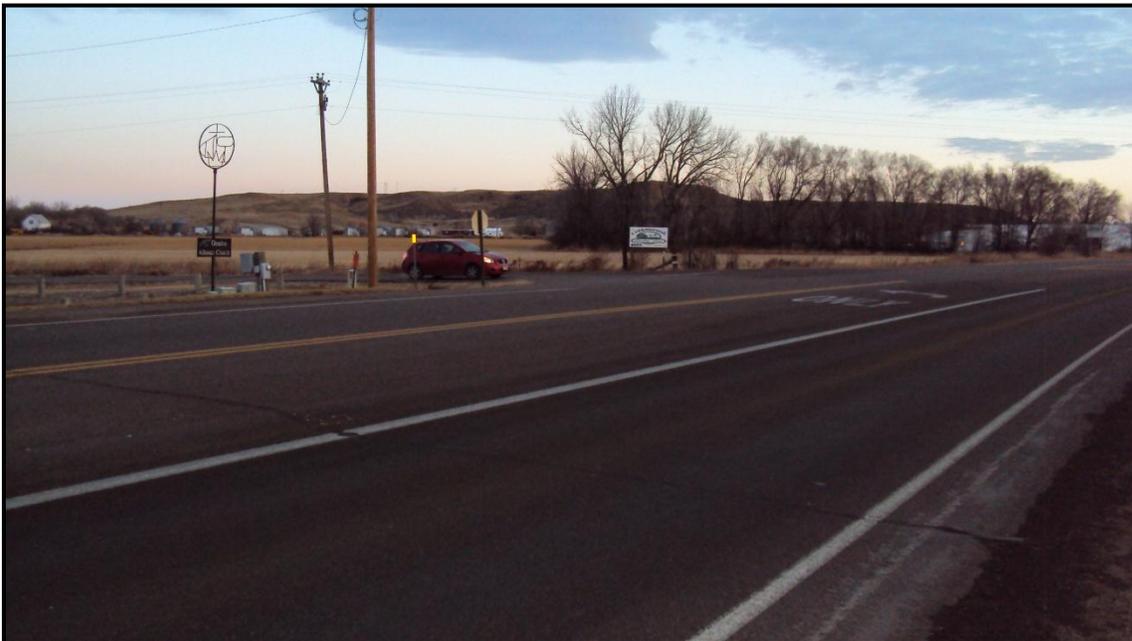
**Photo 4.** Looking northwest at intersection of Highland Park Road and MT 16 northbound left-turn lane. RP 1.2.

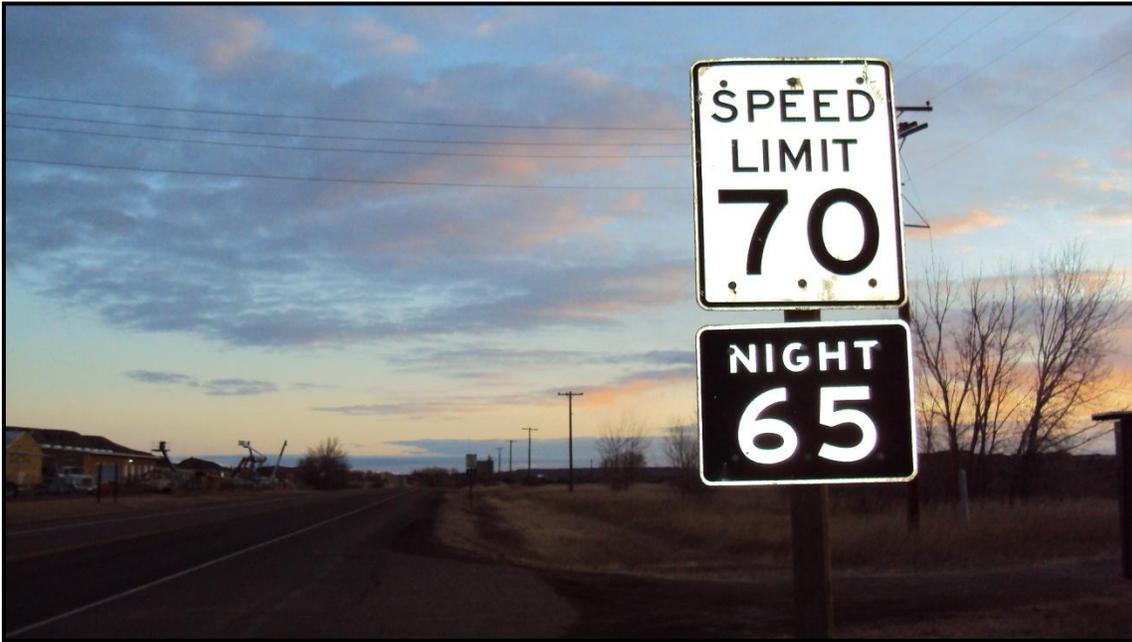
**Photo 5.** Looking north on MT 16 at the beginning of a 70 mph zone. RP 1.3.

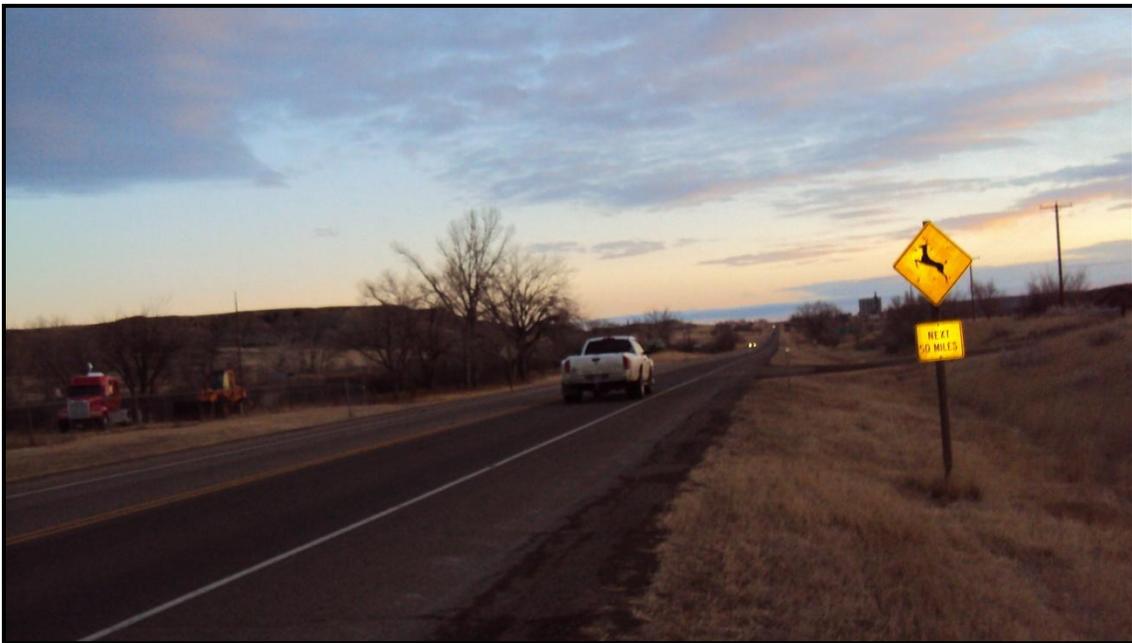
**Photo 6.** Looking north on MT 16 at deer crossing sign. RP 1.4.

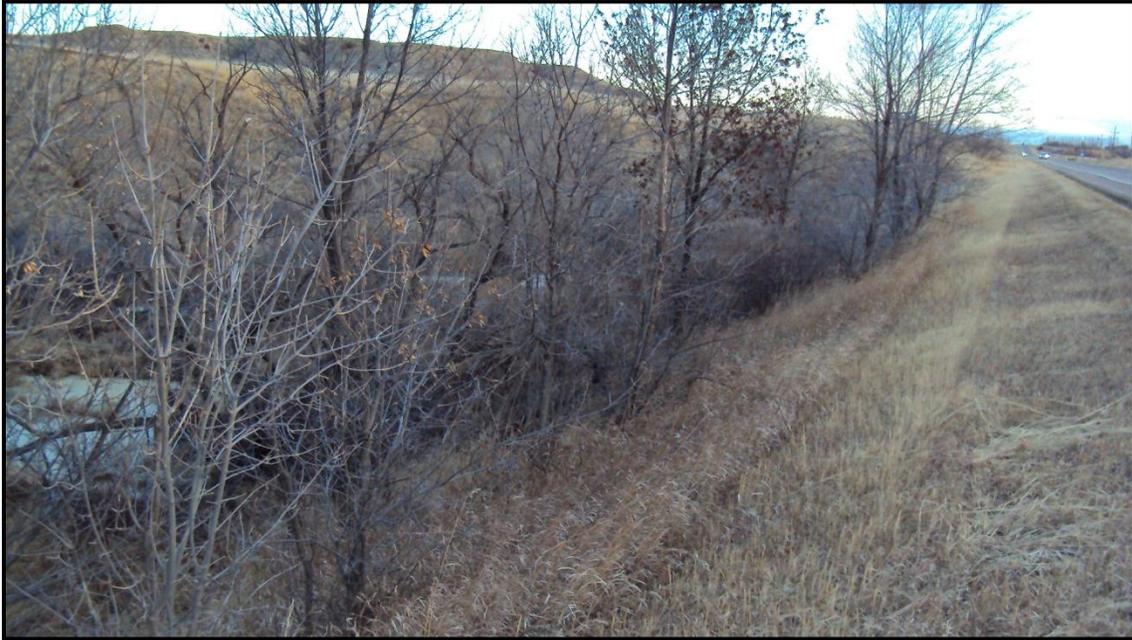
**Photo 7.** Looking north on the west side slope of MT 16. West side slope transitions from 4:1 to 2:1 approximately 20 feet from southbound travel lane. Areas exhibiting wetland characteristics observed west of MT 16. RP 1.7.

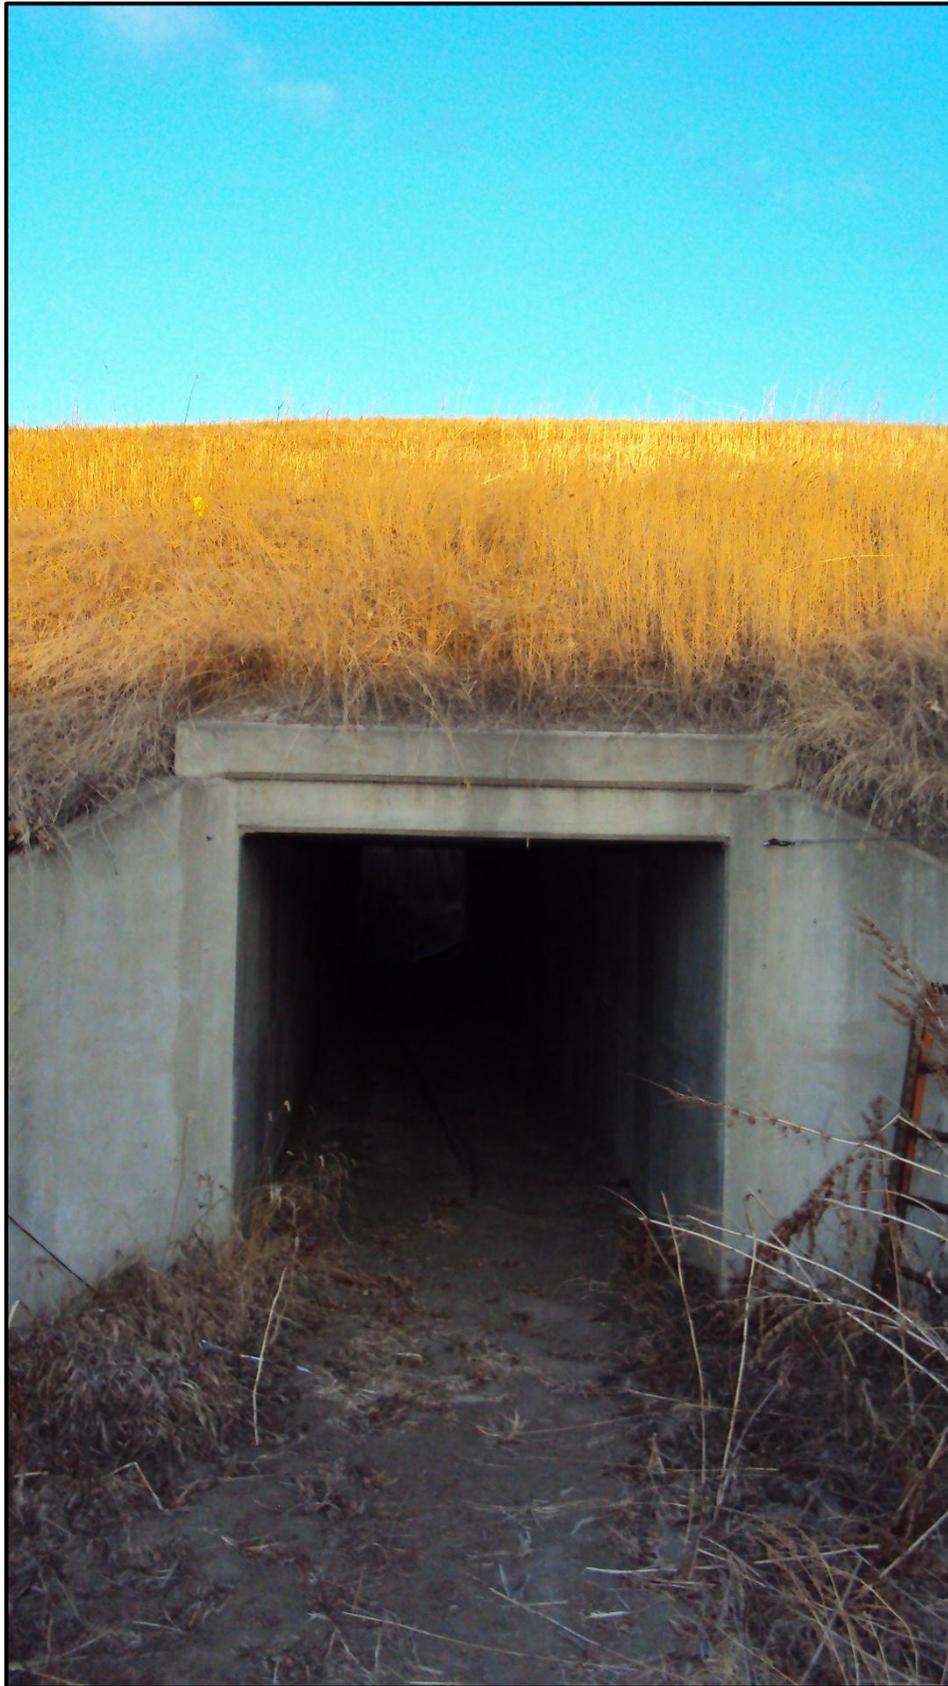
**Photo 8.** Looking west at a box culvert/wildlife underpass under MT 16. East side slope transitions from 4:1 to 2:1 approximately 18 feet from northbound travel lane. RP 2.4.

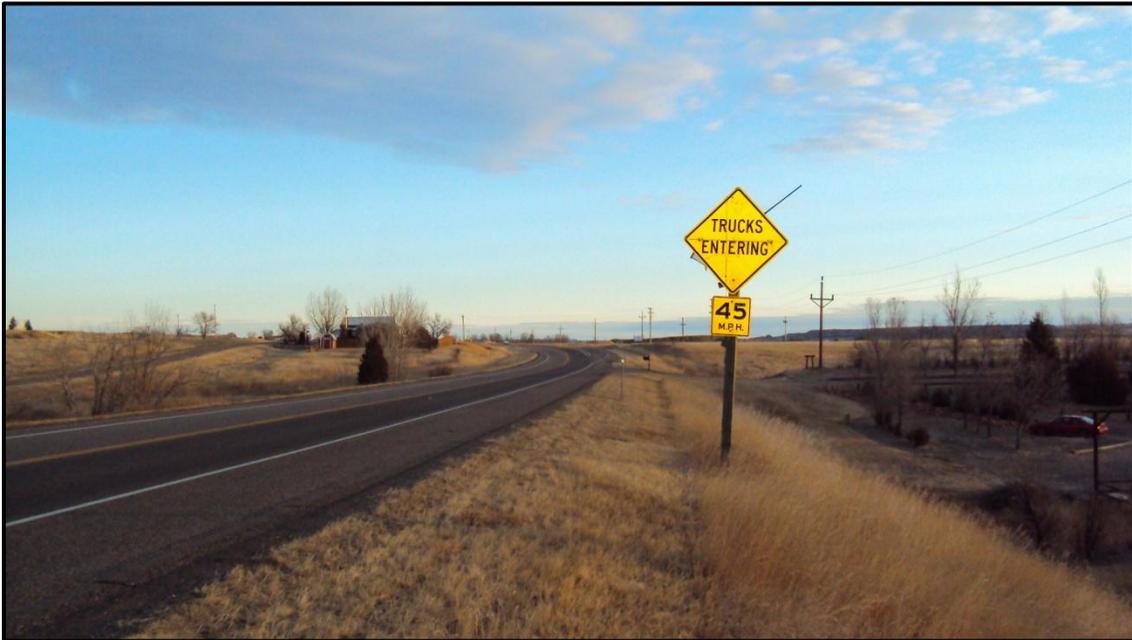
**Photo 9.** Looking north on MT 16 at trucks entering 45 mph advisory sign. East side slope transitions from 5:1 to 2:1 approximately 18 feet from northbound travel lane. RP 2.8.

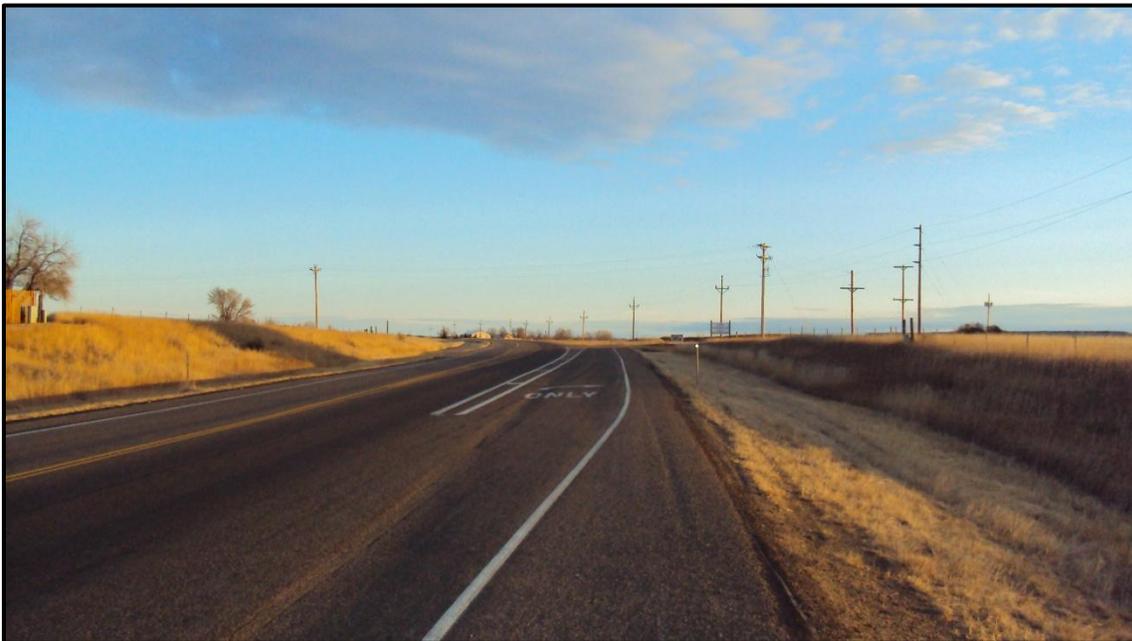
**Photo 10.** Looking north on MT 16 at northbound right-turn lane. RP 3.1.

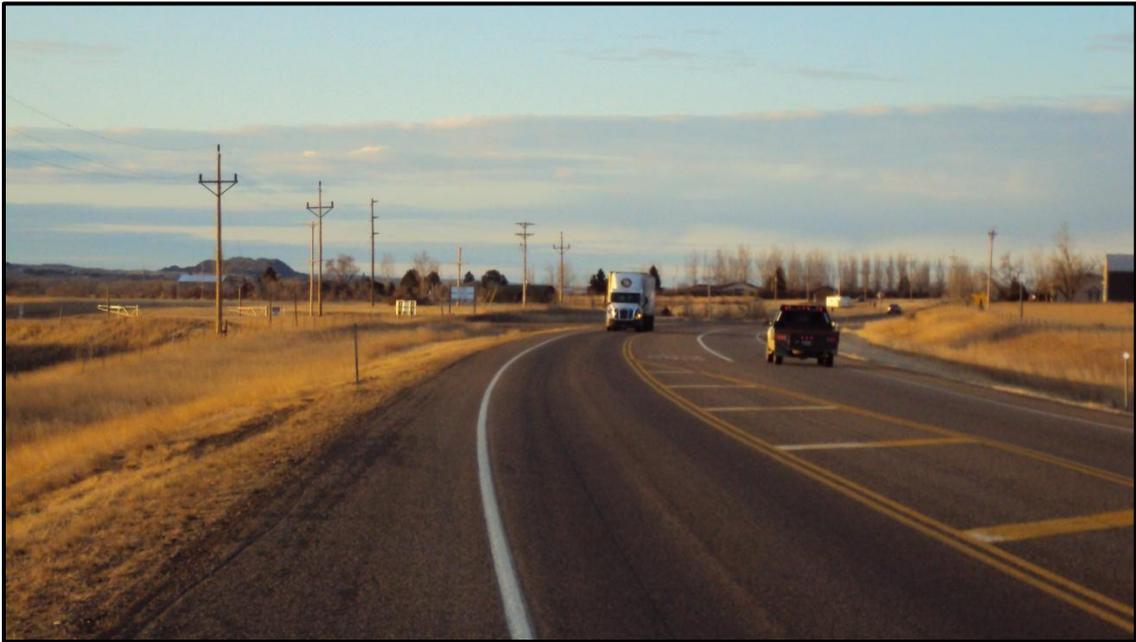
**Photo 11.** Looking south on MT 16 southbound left-turn lane. RP 3.1.

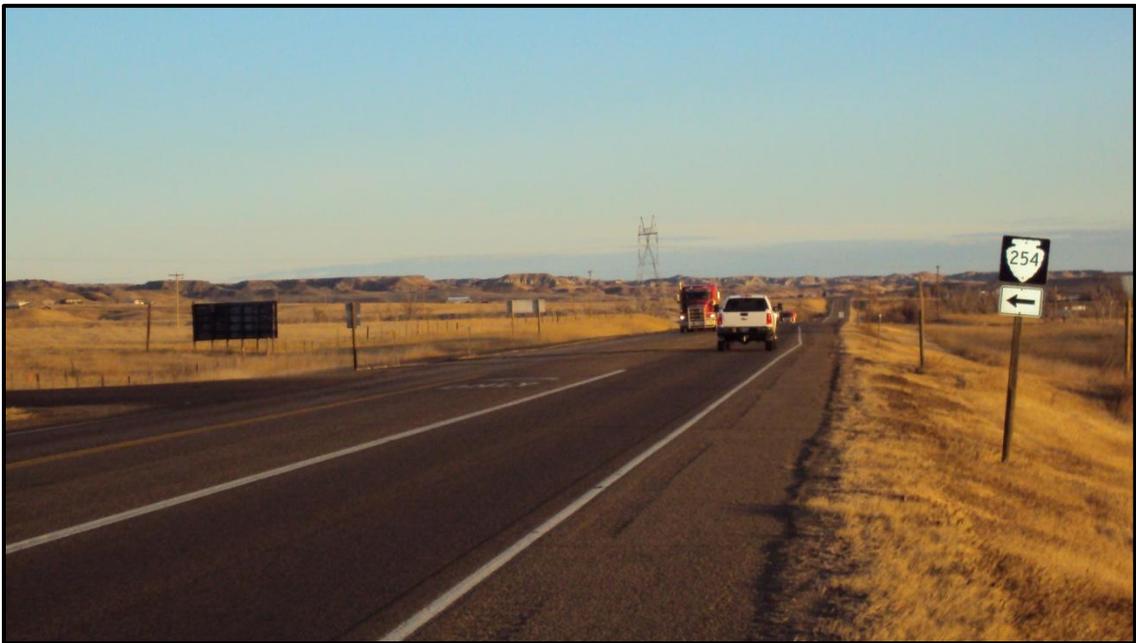
**Photo 12.** Looking north on MT 16 at intersection of MT 16 and County Road 254 northbound left-turn lane. RP 3.7.

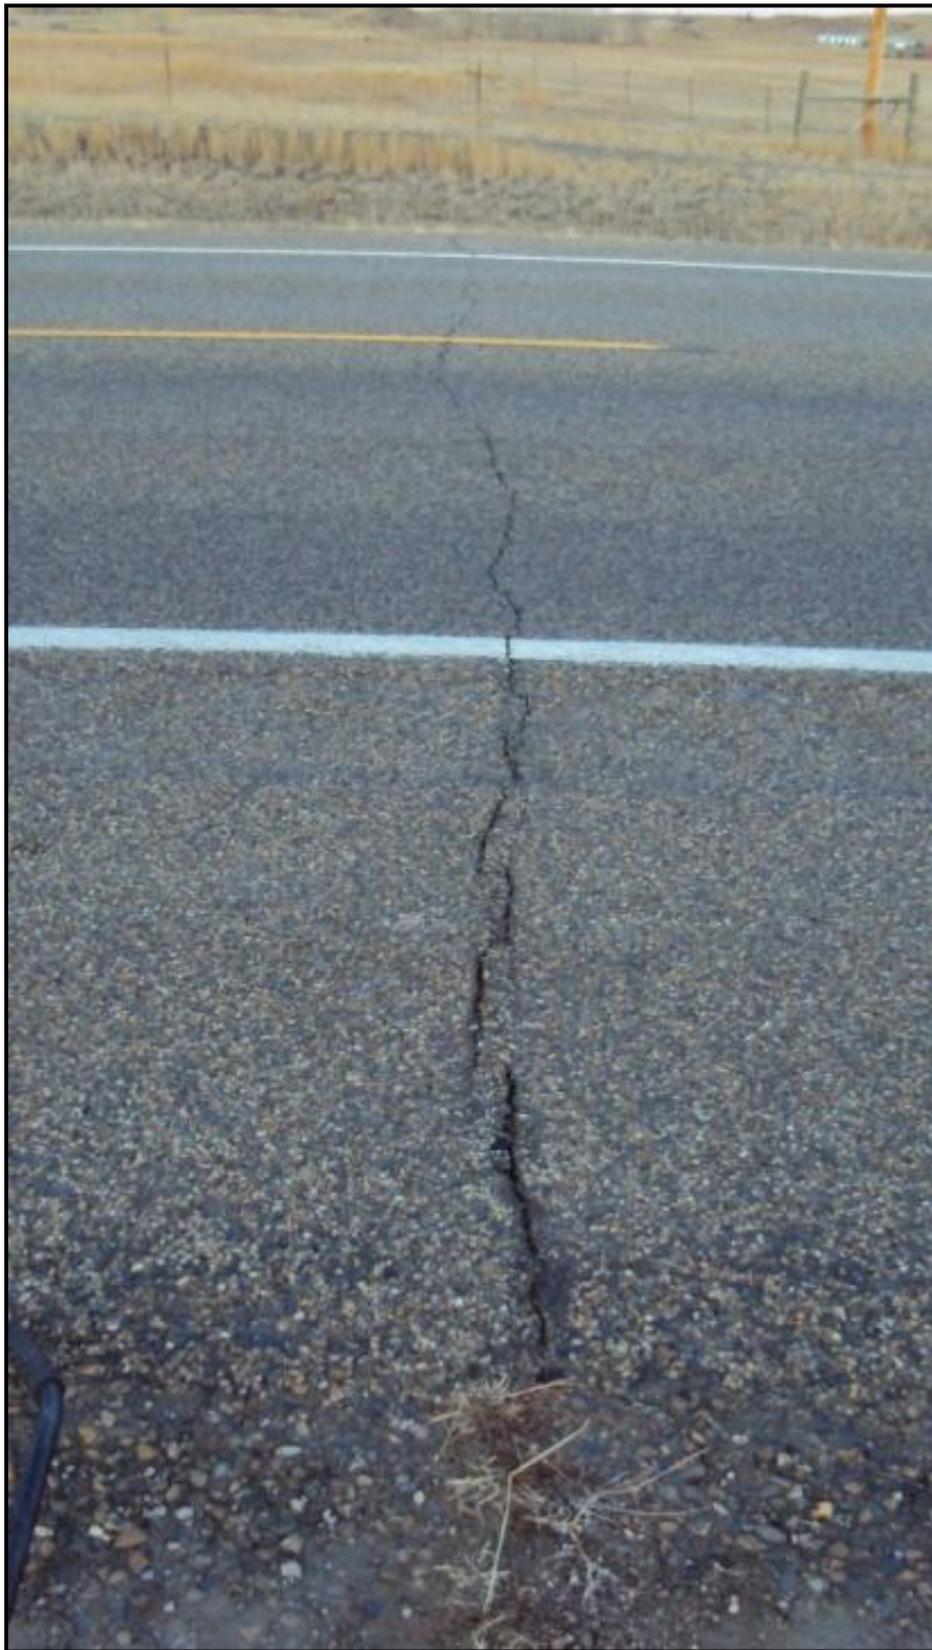
- Transverse pavement cracking within the travel way measured approximately 0.25 inches in width, approximately every 85 feet. Transverse pavement cracking within the shoulder was observed approximately every 15 feet. No measurable pavement rutting was observed within the travel way at RP 5.4. Photo 13.

**Photo 13.** Looking across MT 16 at transverse pavement cracking. Pavement cracking within the travel way measured approximately 0.25 inches in width, approximately every 85 feet. RP 5.4.

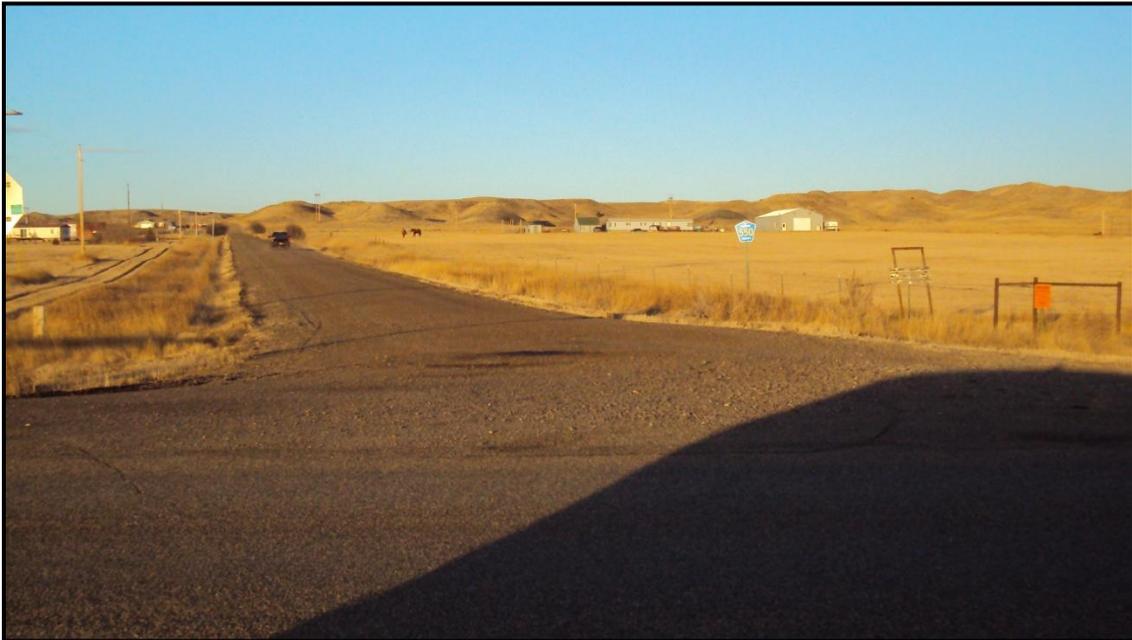
**Photo 14.** Looking west at the intersection of MT 16 and County Road 550. County Road 550 is unpaved. RP 5.6.

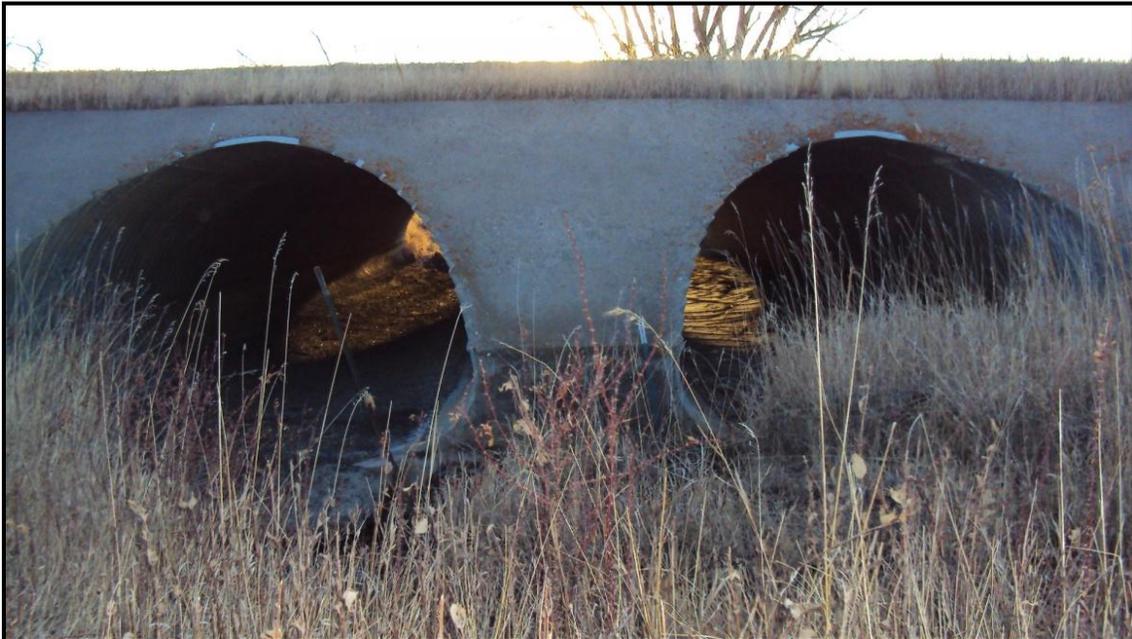
**Photo 15.** Looking east at 96-inch double arch culverts under MT 16. West side slope was measured at 4:1 to approximately 21 feet from northbound travel lane. RP 7.0.

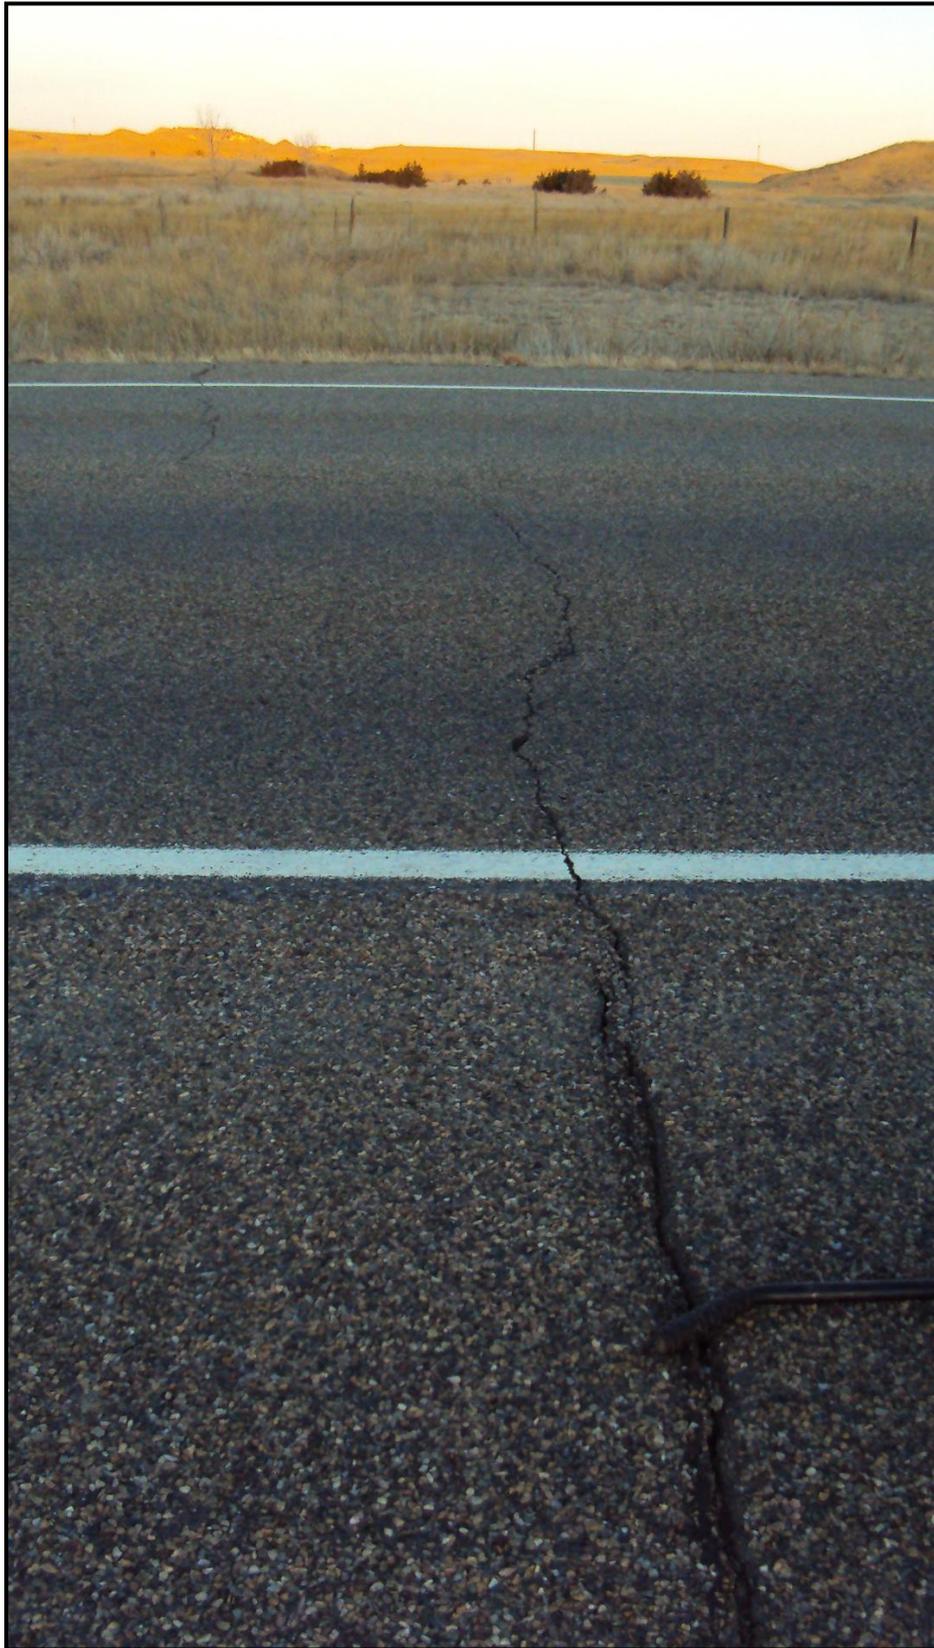
- Transverse pavement cracking within the travel way measured approximately 0.125 inches in width. Transverse pavement cracking within the shoulder measured approximately 0.75 inches in width. Pavement rutting within the travel way measured approximately 0.5 centimeters in depth at RP 8.3. Photo 16.

**Photo 16.** Looking across MT 16 at transverse pavement cracking. Pavement cracking within the travel way measured approximately 0.125 inches, approximately every 50 feet. Pavement rutting measured at approximately 0.5 centimeters. RP 8.3.

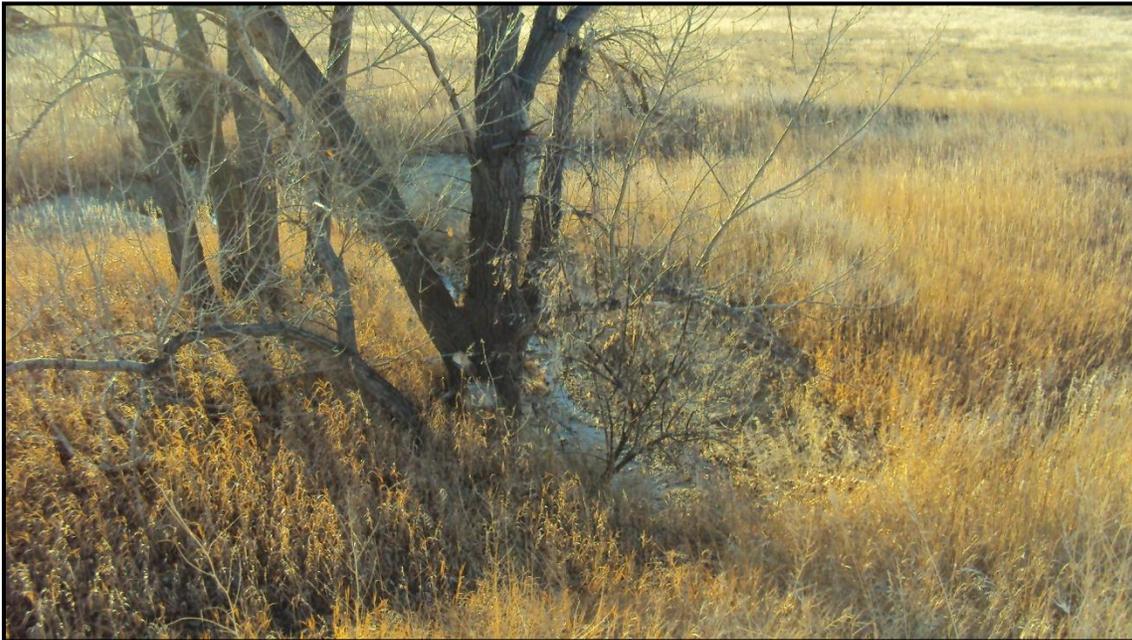
**Photo 17.** Looking at areas exhibiting wetland characteristics observed east of MT 16. East side slope transitions from 4:1 to 2:1 approximately 18 feet from northbound travel lane. RP 8.4.

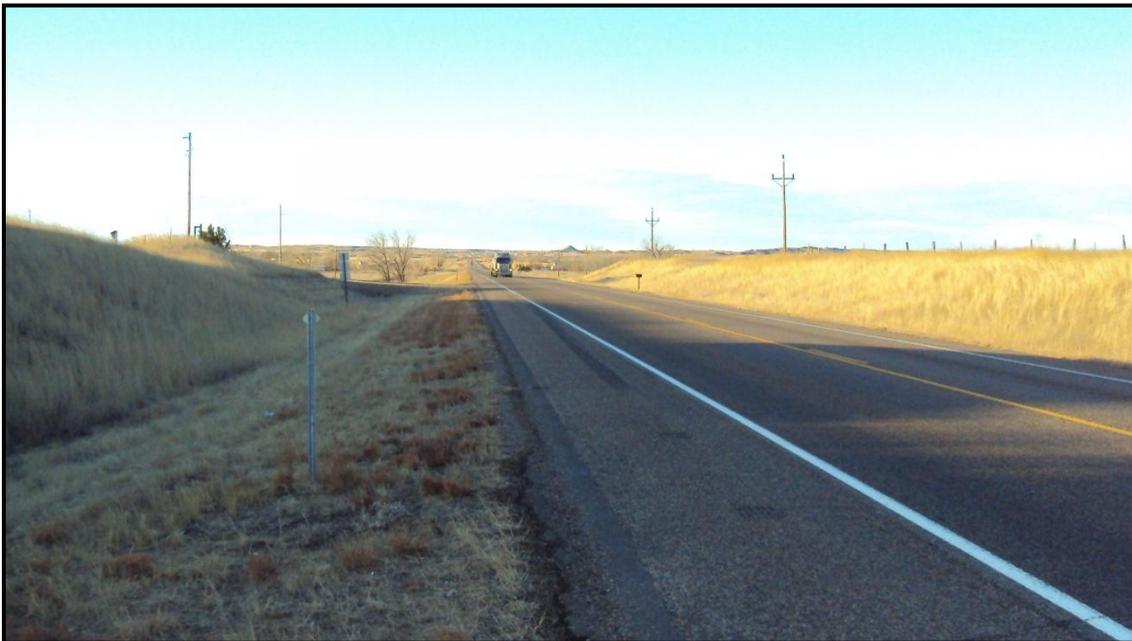
**Photo 18.** Looking south on MT 16 at tire skid marks. RP 8.7.

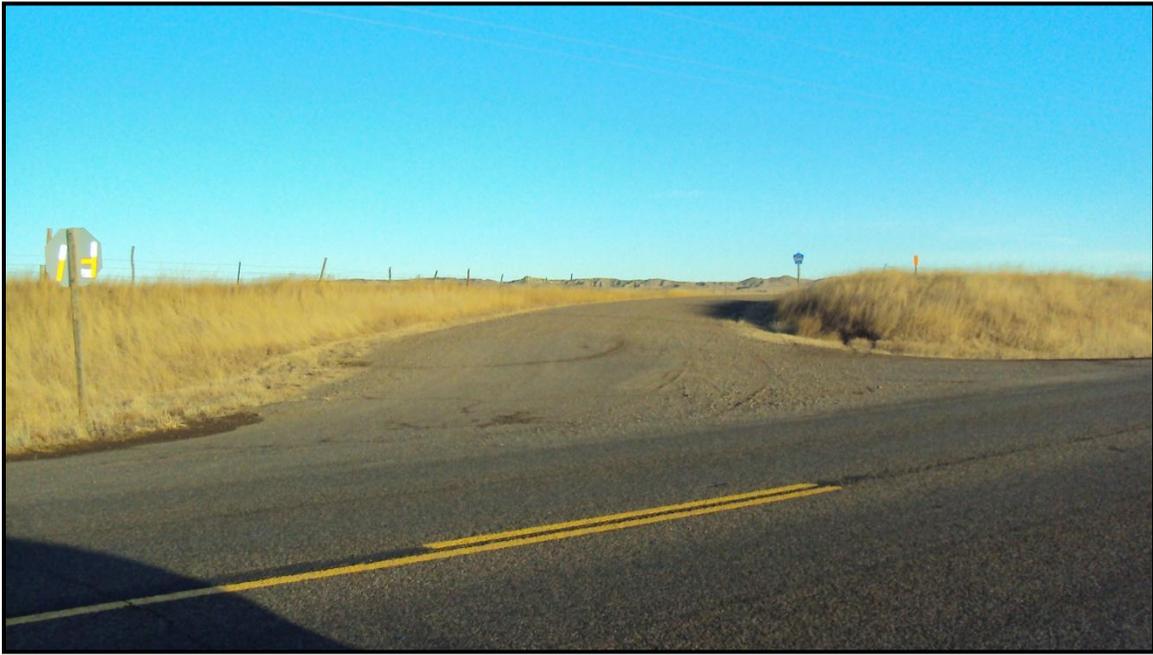
**Photo 19.** Looking west at intersection of MT 16 and County Road 544. County Road 544 is unpaved. RP 8.7.

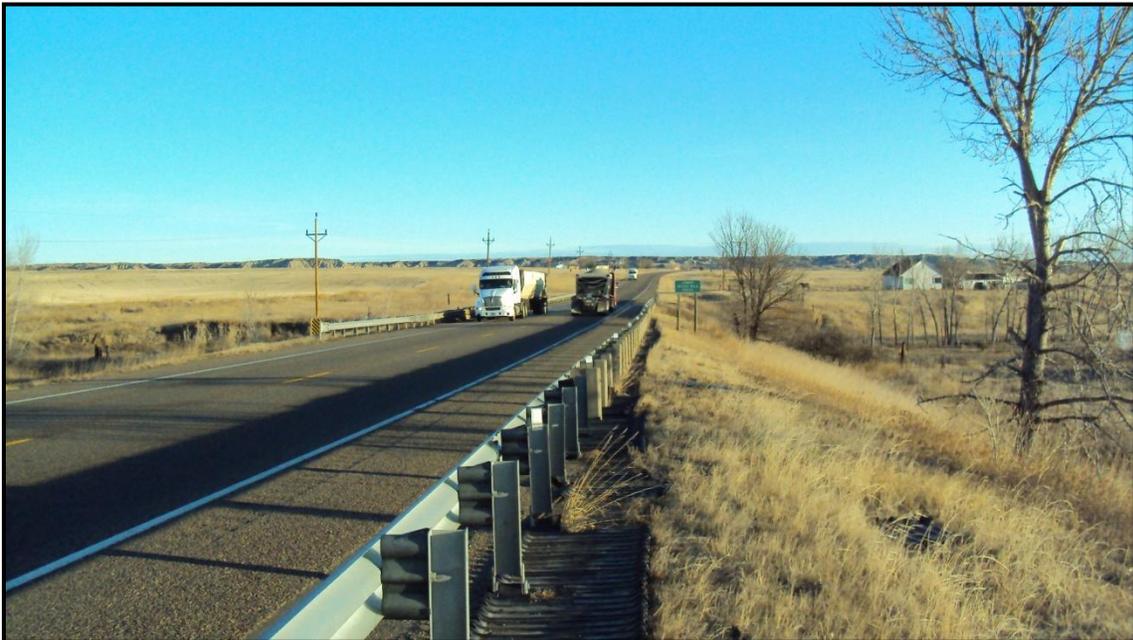
**Photo 20.** Looking south on MT 16 at Lower Seven Mile Creek. East side slope transitions from 4:1 to 2:1 approximately 15 feet from the northbound travel lane. RP 10.1.

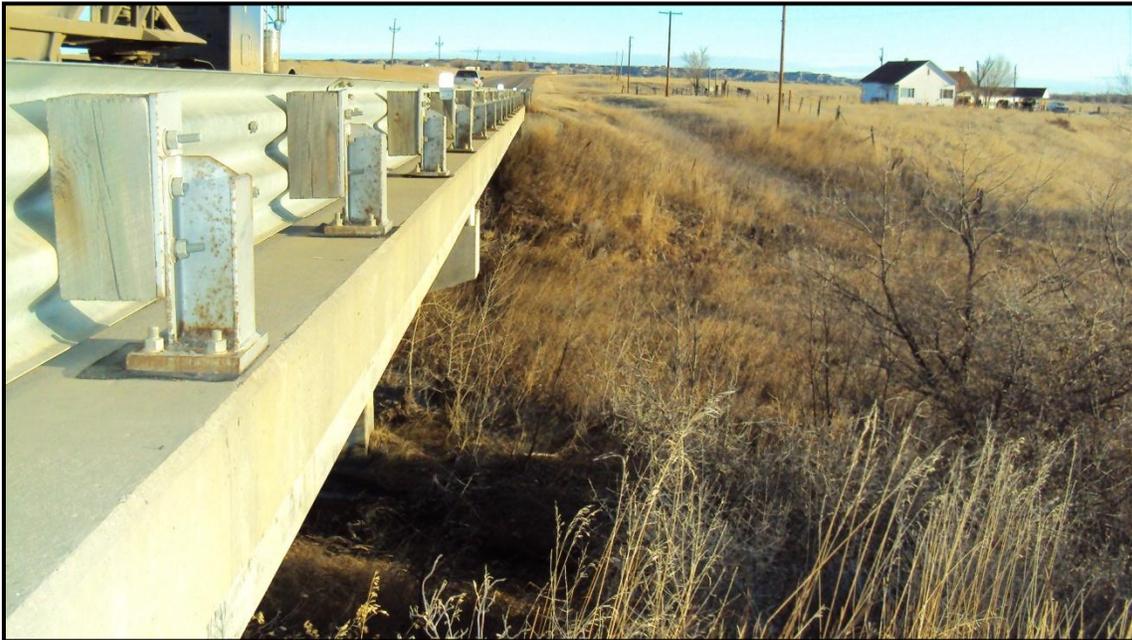
**Photo 21.** Looking north on MT 16 at Lower Seven Mile Creek bridge undercrossing. RP 10.1.

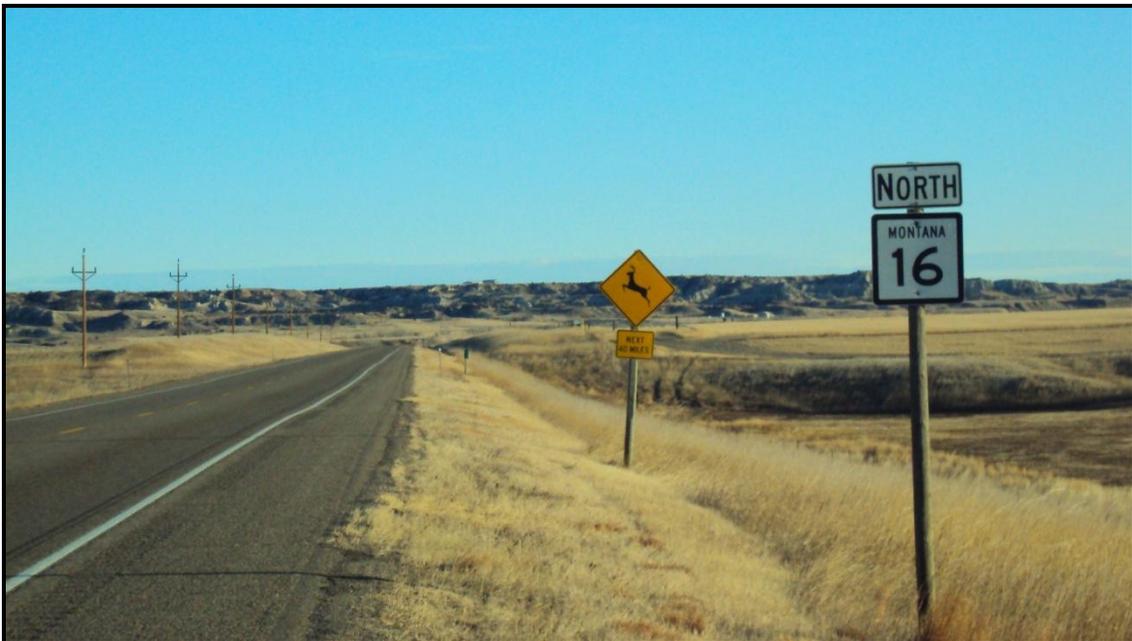
**Photo 22.** Looking north on MT 16 at deer crossing sign. RP 10.9.

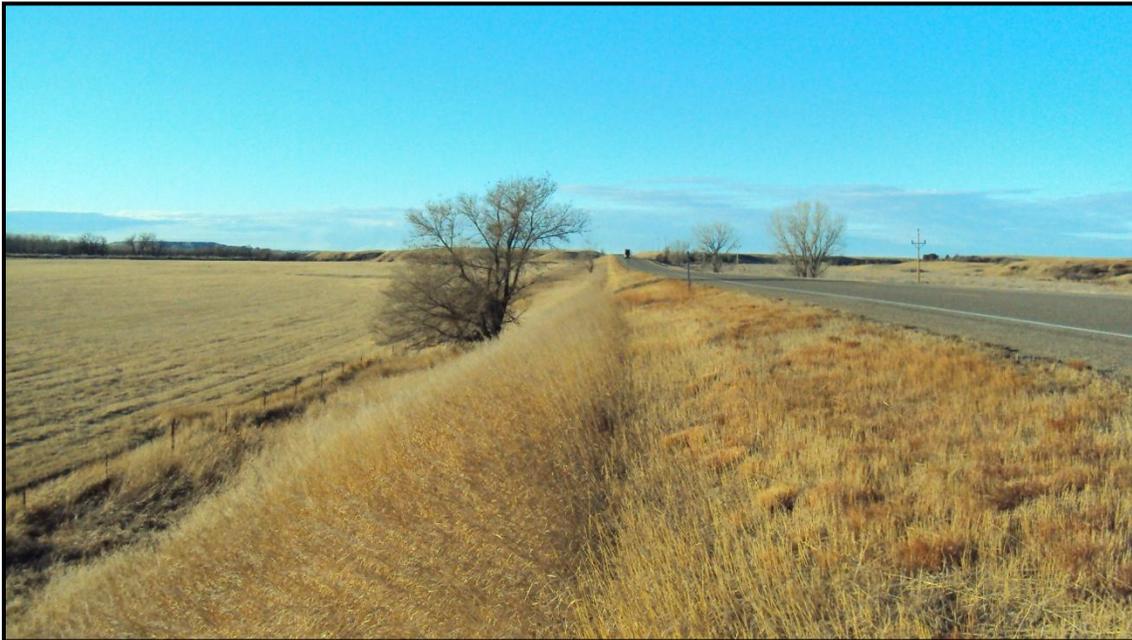
**Photo 23.** Looking south on MT 16. West side slope transitions from 4:1 to 2:1 approximately 17 feet from southbound travel lane. RP 12.0.

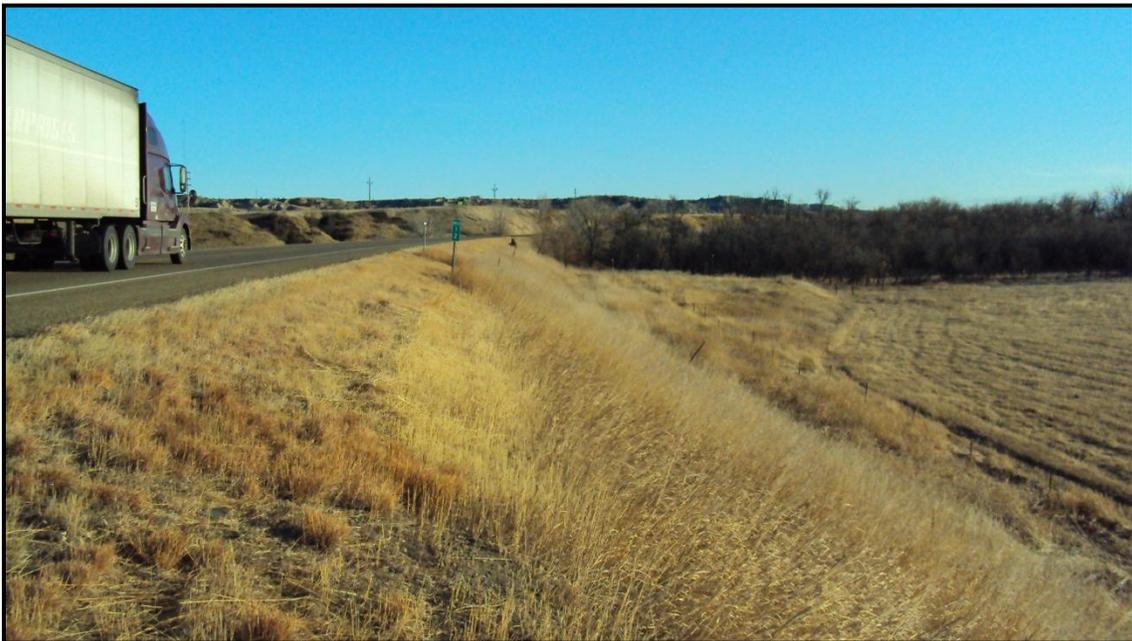
**Photo 24.** Looking north on MT 16. East side slope transitions from 4:1 to 2:1 approximately 17 feet from northbound travel lane. RP 12.0.

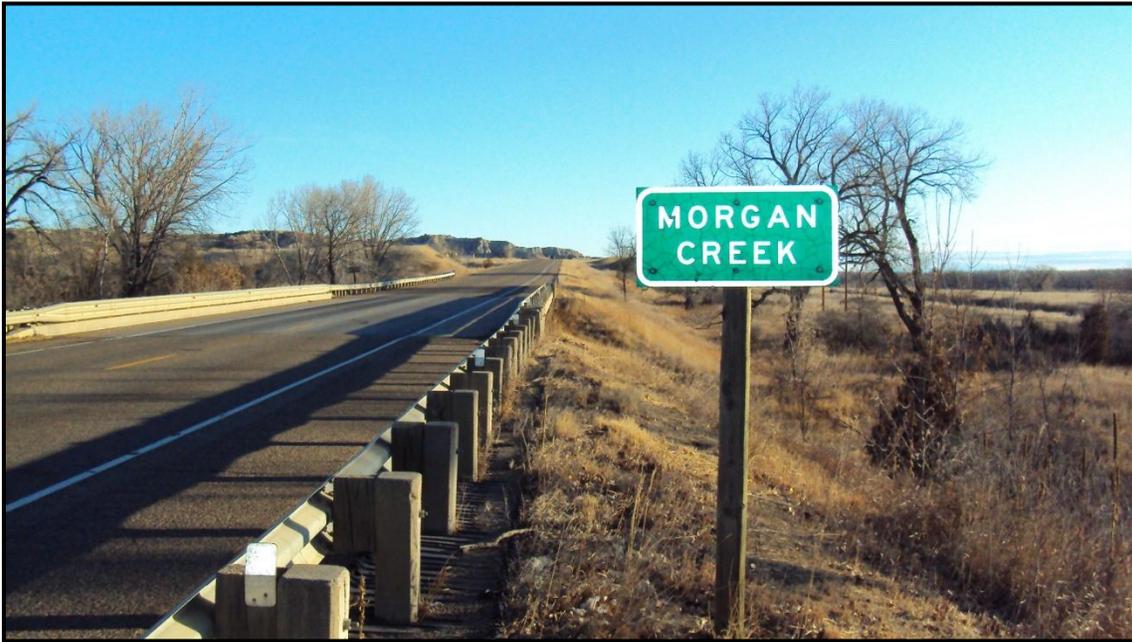
**Photo 25.** Looking north on MT 16 at Morgan Creek. RP 12.5.

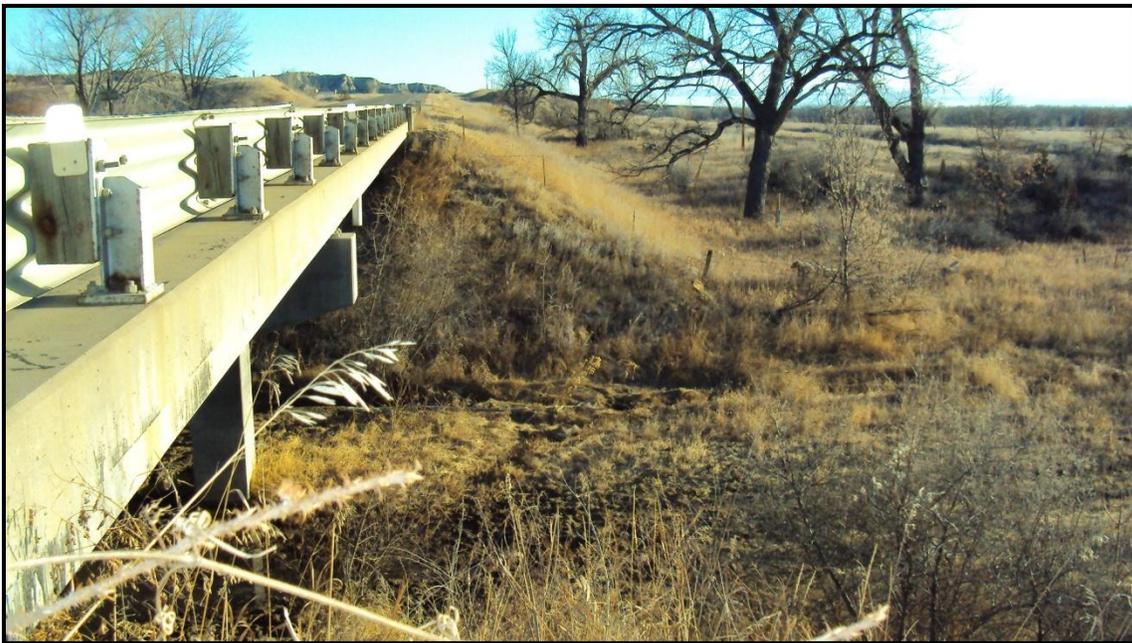
**Photo 26.** Looking north on MT 16 at Morgan Creek bridge undercrossing. RP 12.5.

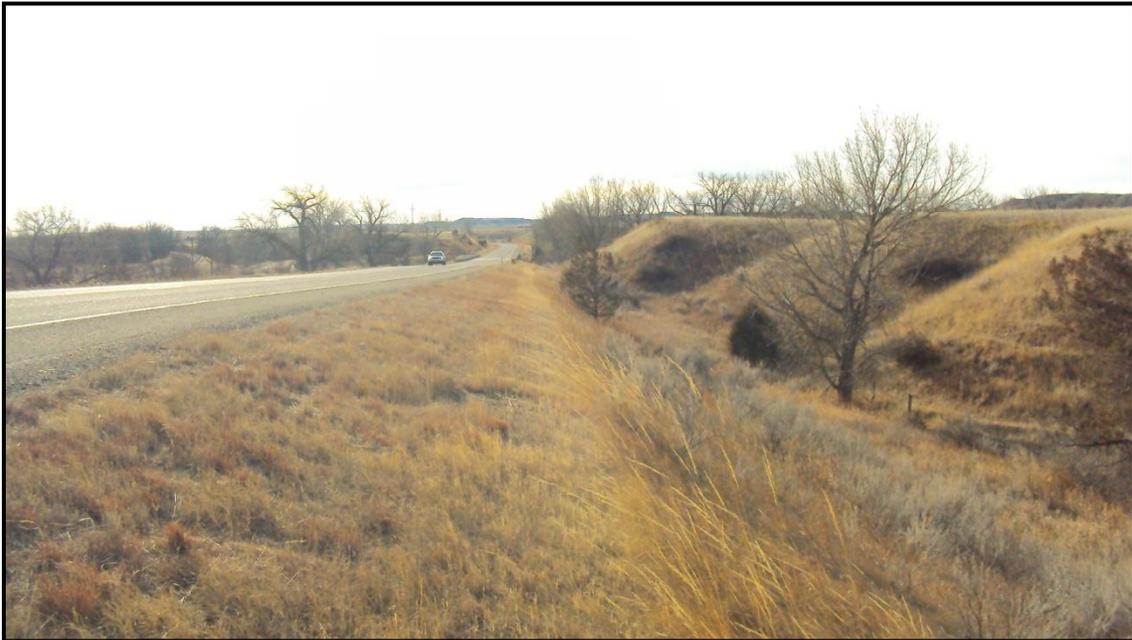
**Photo 27.** Looking north on MT 16. East side slope transitions from 4:1 to 2:1 approximately 20 feet from northbound travel lane. RP 12.7.
