# Appendix 1

## Field Review Memorandum and Photo Log

**Subject: Summary of Field Review Conducted on January 31, 2012  
MT 16 / MT 200 Glendive to Fairview Corridor Planning Study**

**MT 16 / MT 200 GLENDIVE TO FAIRVIEW  
CORRIDOR PLANNING STUDY  
PHOTO LOG**

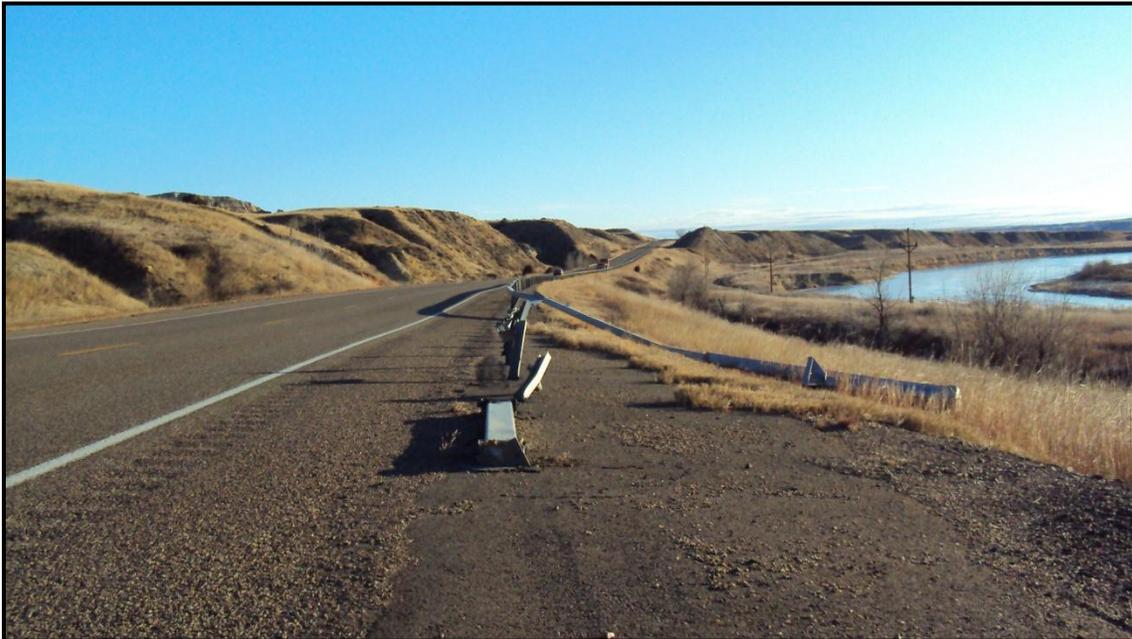
**Photo 28.** Looking north on MT 16 at damaged guardrail. East side slope transitions from 4:1 to 5:1 approximately 23 feet from northbound travel lane. RP 13.6.

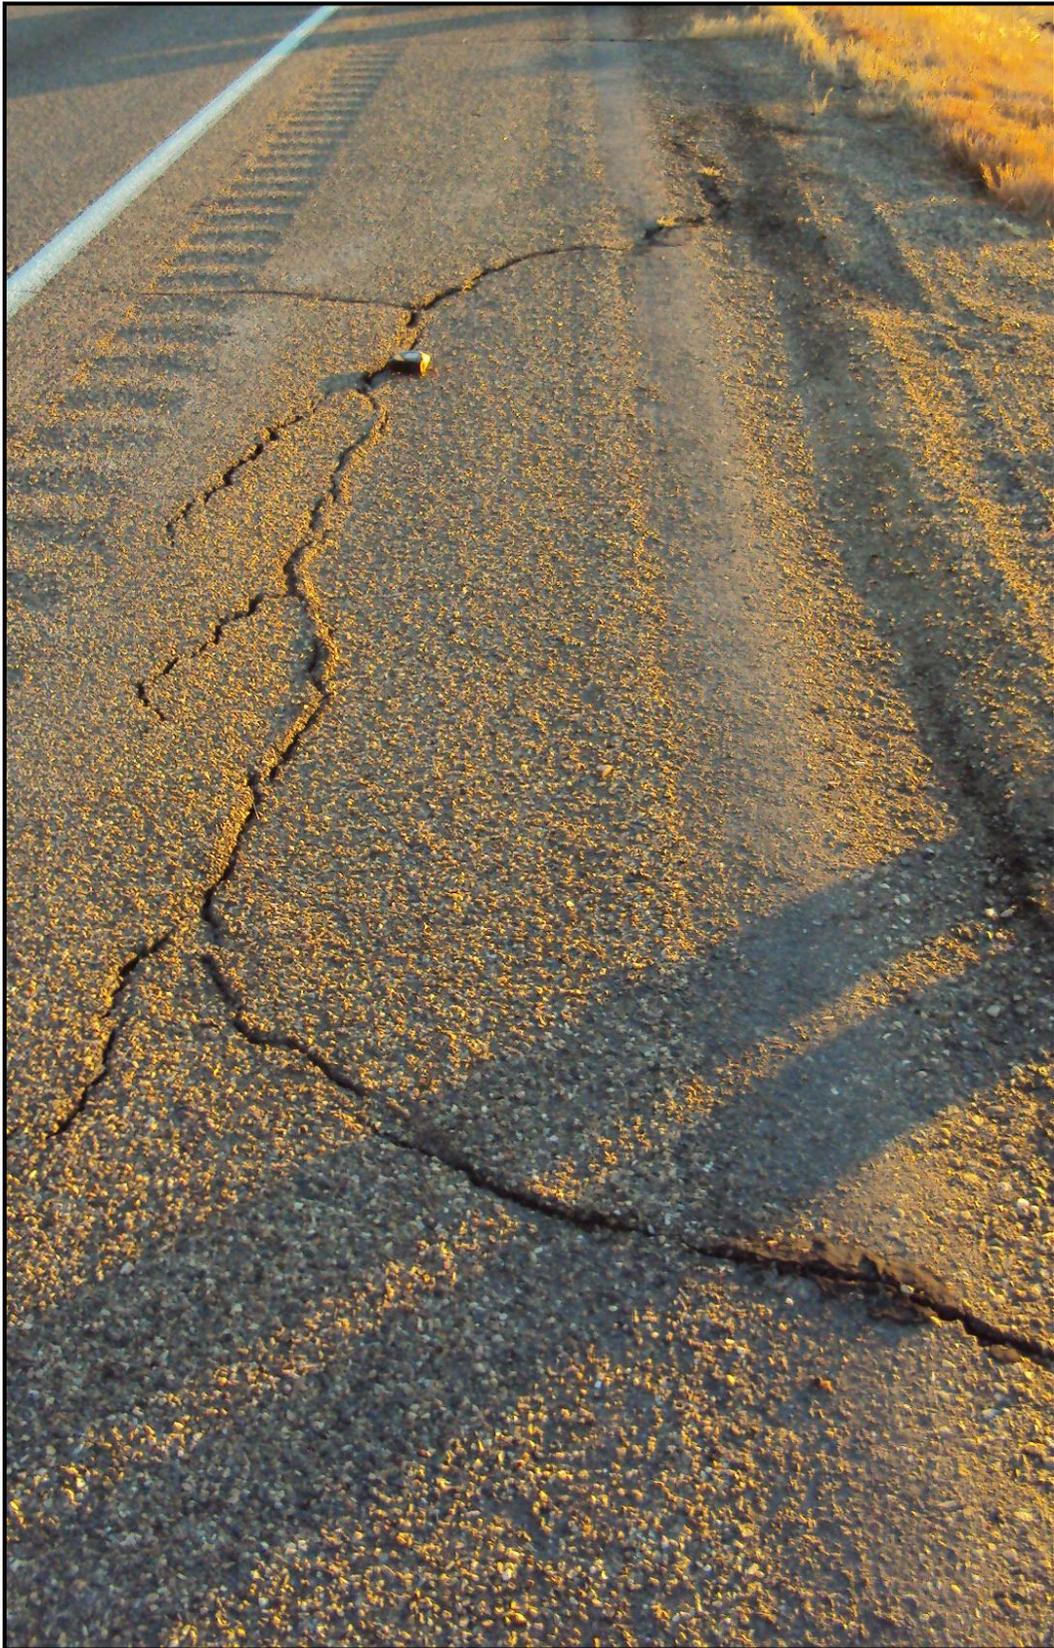
- Transverse pavement cracking within the travel way measured approximately 0.5 inches in width, approximately every 45 feet. Transverse pavement cracking within the shoulder was observed approximately every 15 feet. A pavement depression was observed within the shoulder. No measurable pavement rutting was observed within the travel way at RP 14.1. Photo 29.

**Photo 29.** Looking across MT 16 at transverse pavement cracking. Pavement cracking within the travel way measured approximately 0.5 inches in width, approximately every 45 feet. RP 14.1.

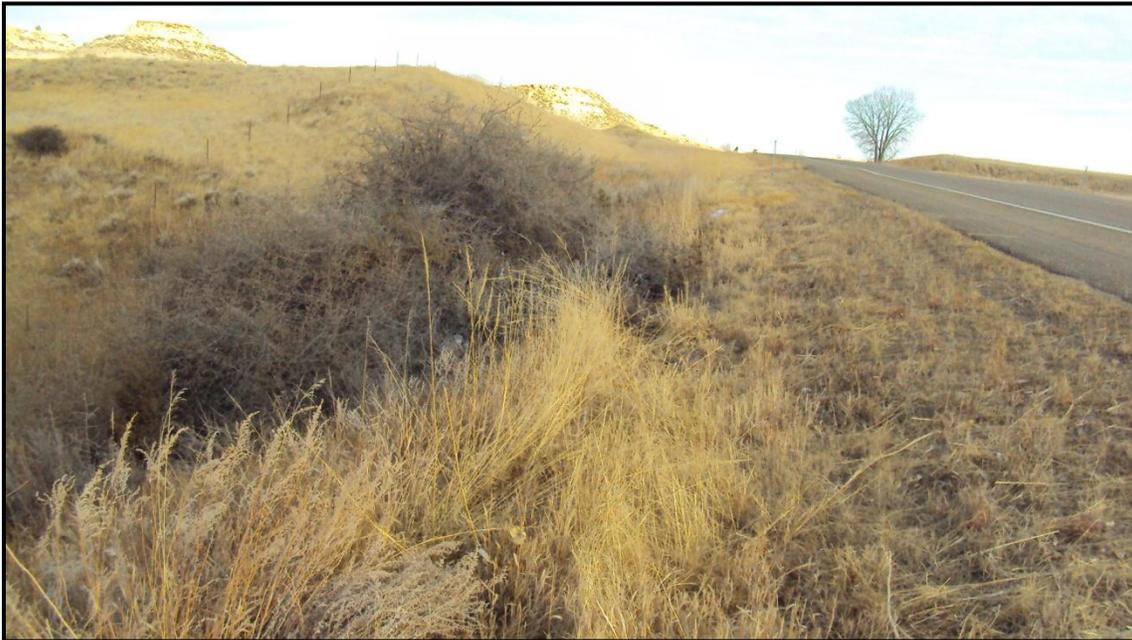
**Photo 30.** Looking south on MT 16. West side slope transitions from 4:1 to 2:1 approximately 20 feet from northbound travel lane. RP 14.4.

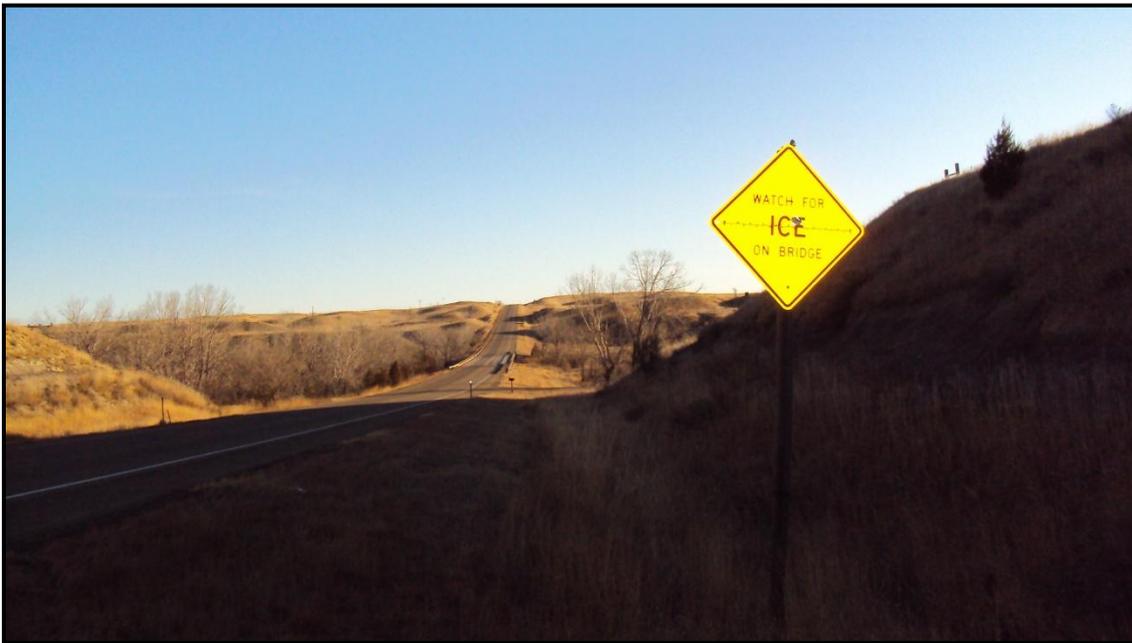
**Photo 31.** Looking south on MT 16 at watch for ice on bridge sign. RP 14.7.

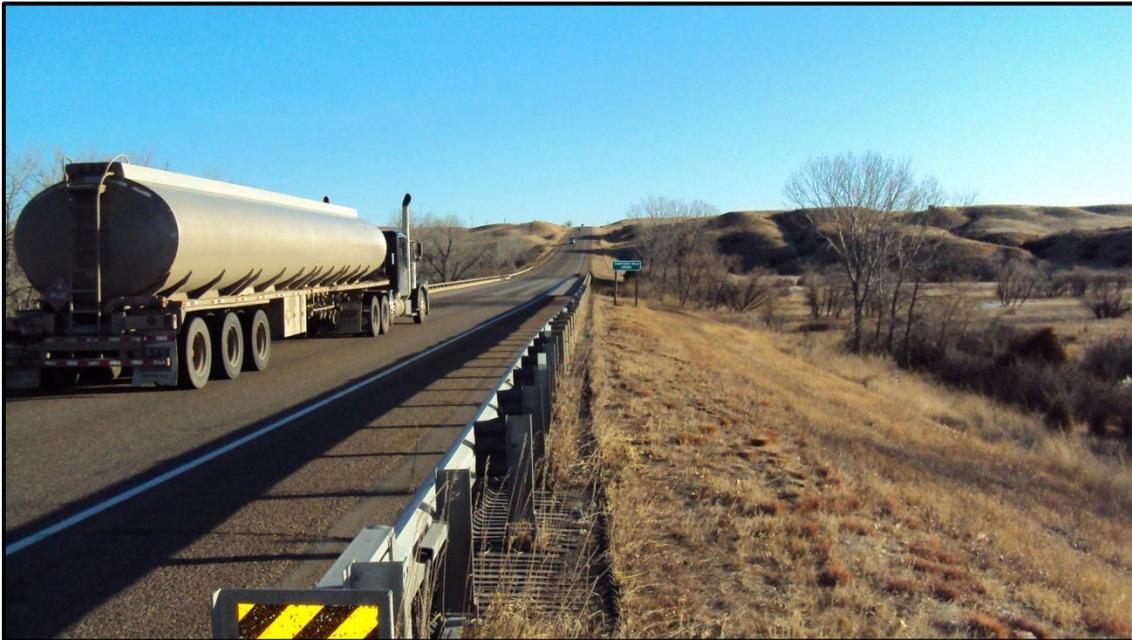
**Photo 32.** Looking north on MT 16 at Thirteen Mile Creek. RP 15.5.

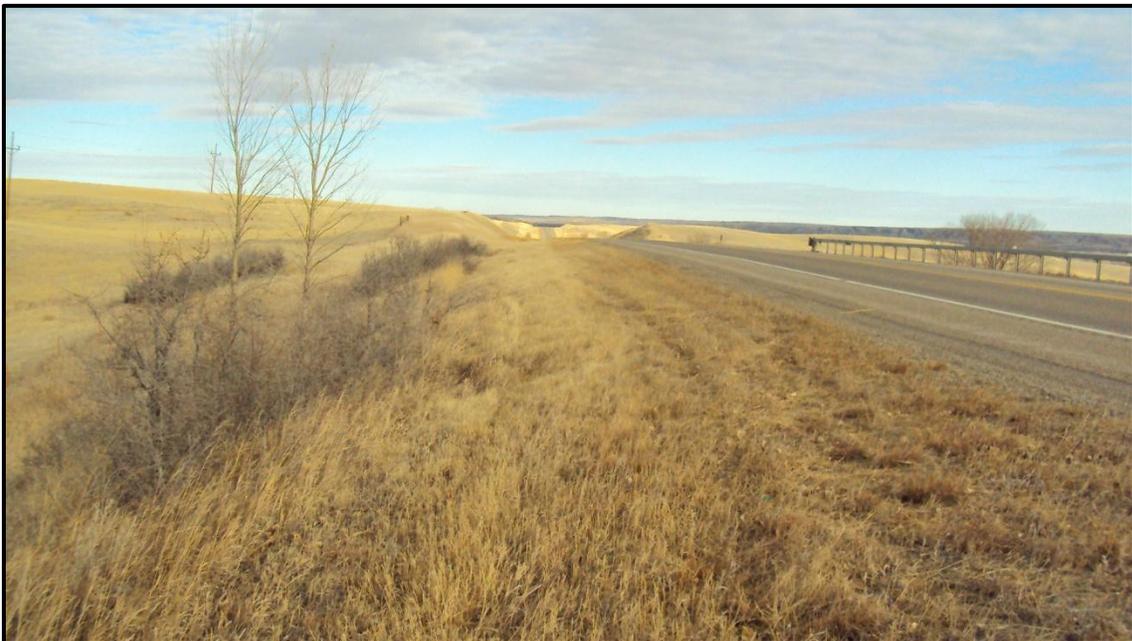
**Photo 33.** Looking north on MT 16. West side slope transitions from 5:1 to 3:1 approximately 17 feet from southbound travel lane. RP 16.4.

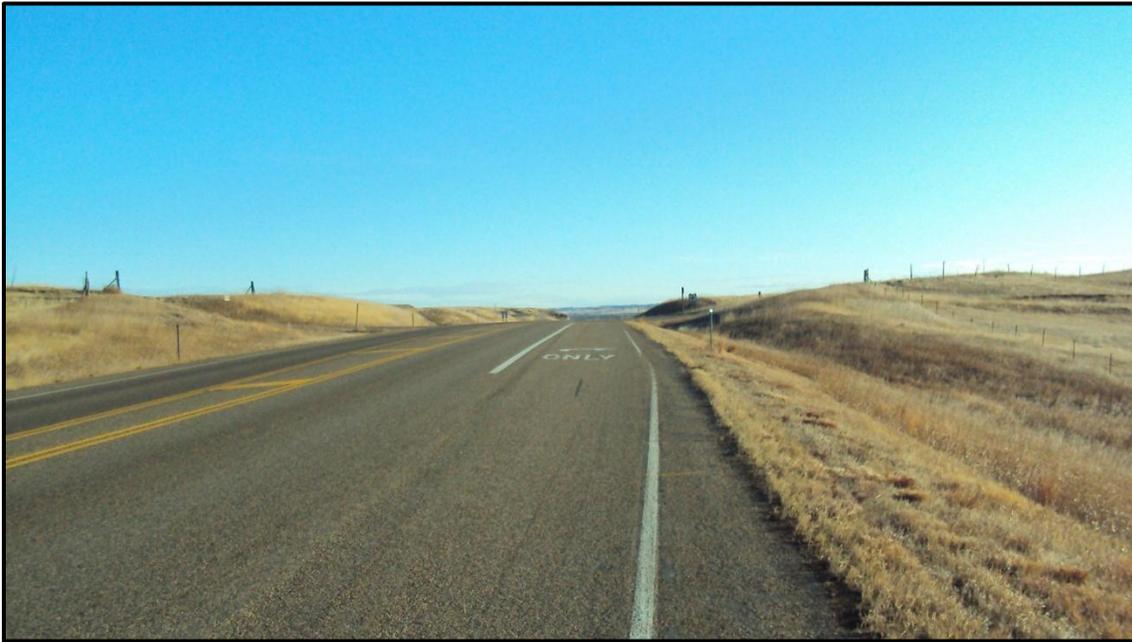
**Photo 34.** Looking north on MT 16 at northbound right-turn lane at Intake fishing access. RP 17.1.

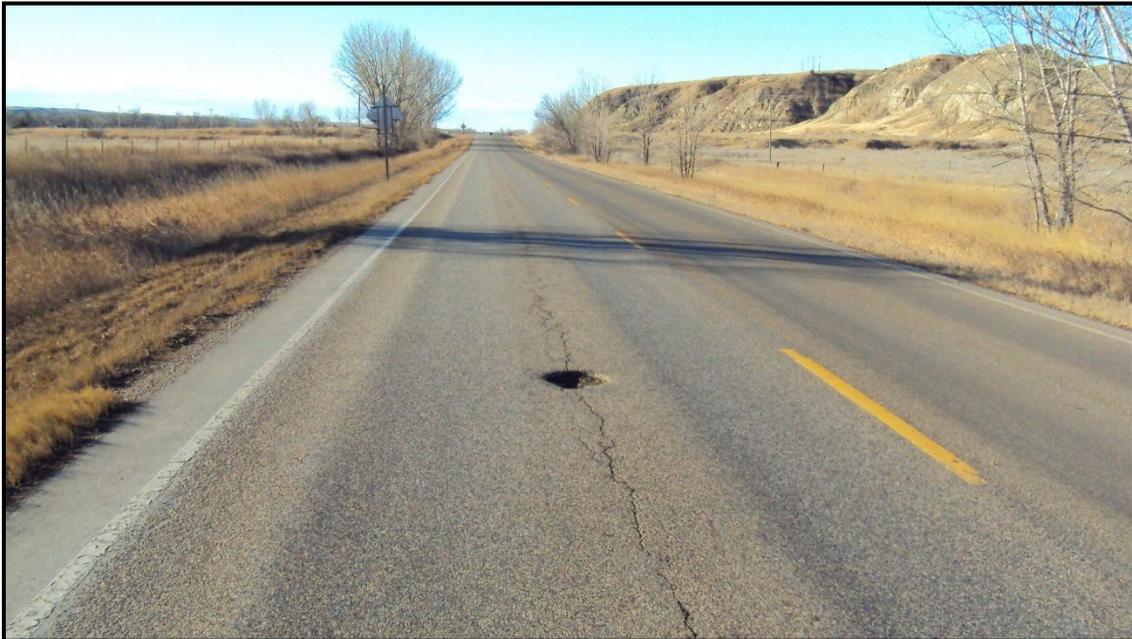
- Transverse pavement cracking within the travel way measured approximately 0.5 inches in width. Longitudinal and pavement cracking was observed, as well as a large pothole within the travel way. Pavement rutting within the travel way measured approximately 0.5 inches in depth at RP 19.3. Photos 35 and 36.

**Photo 35.** Looking south on MT 16 at longitudinal pavement cracking and pothole. RP 19.3.

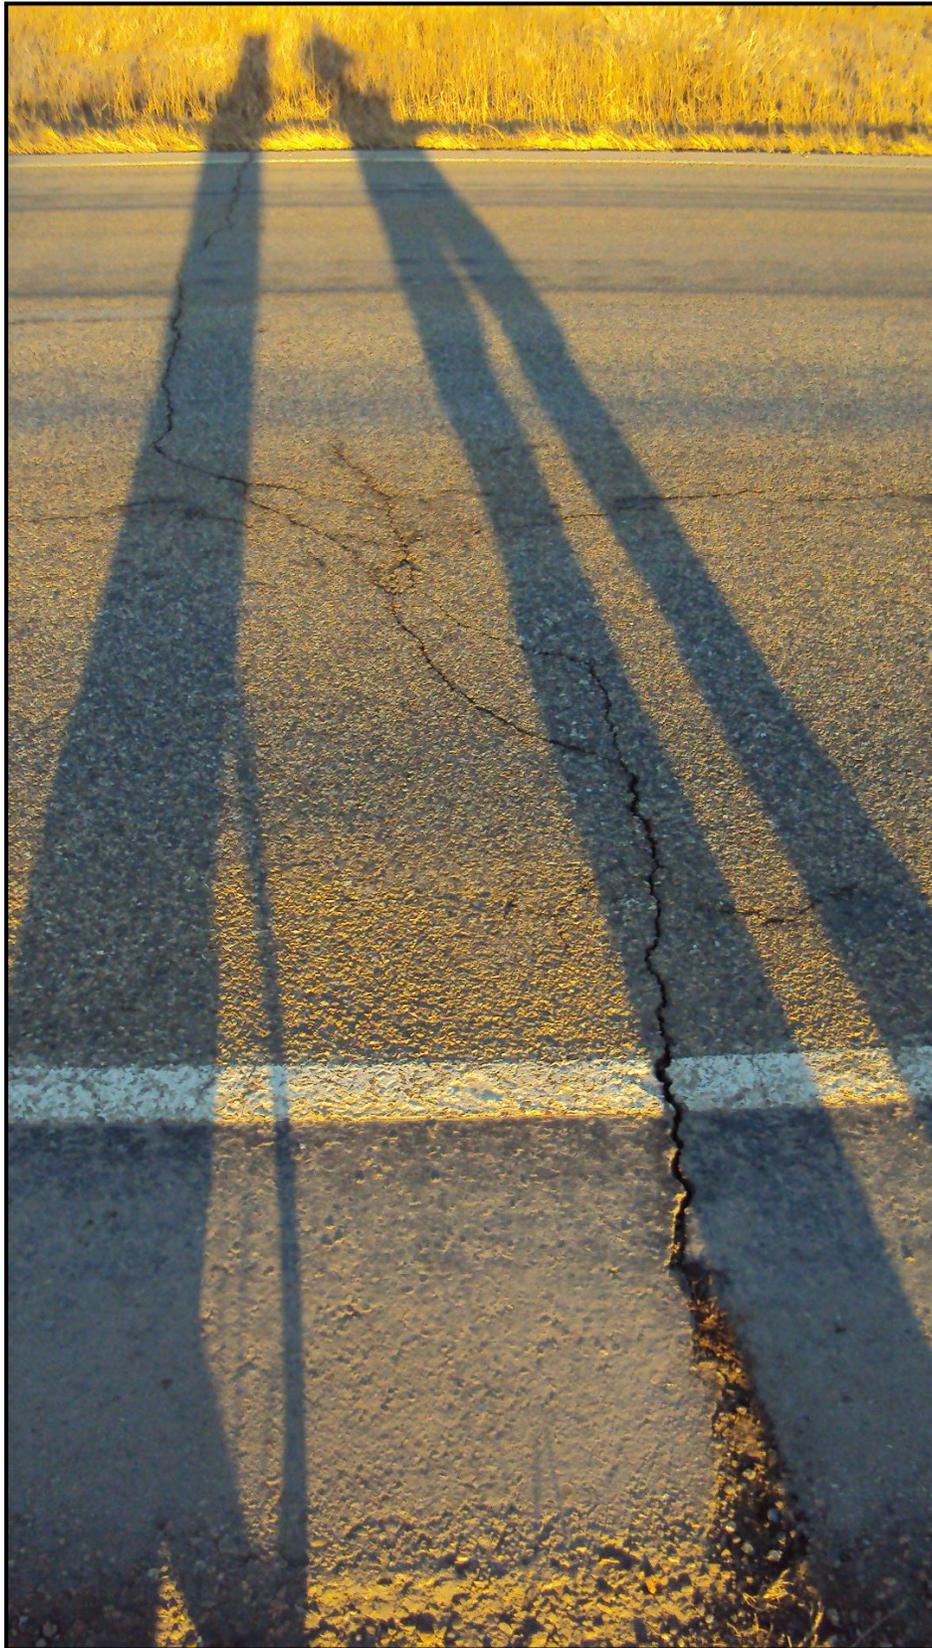
**Photo 36.** Looking across MT 16 at transverse pavement cracking. Pavement cracking within the travel way measured approximately 0.5 inches in width, approximately every 30 feet. Pavement rutting measured approximately 0.5 inches in depth. RP 19.3.

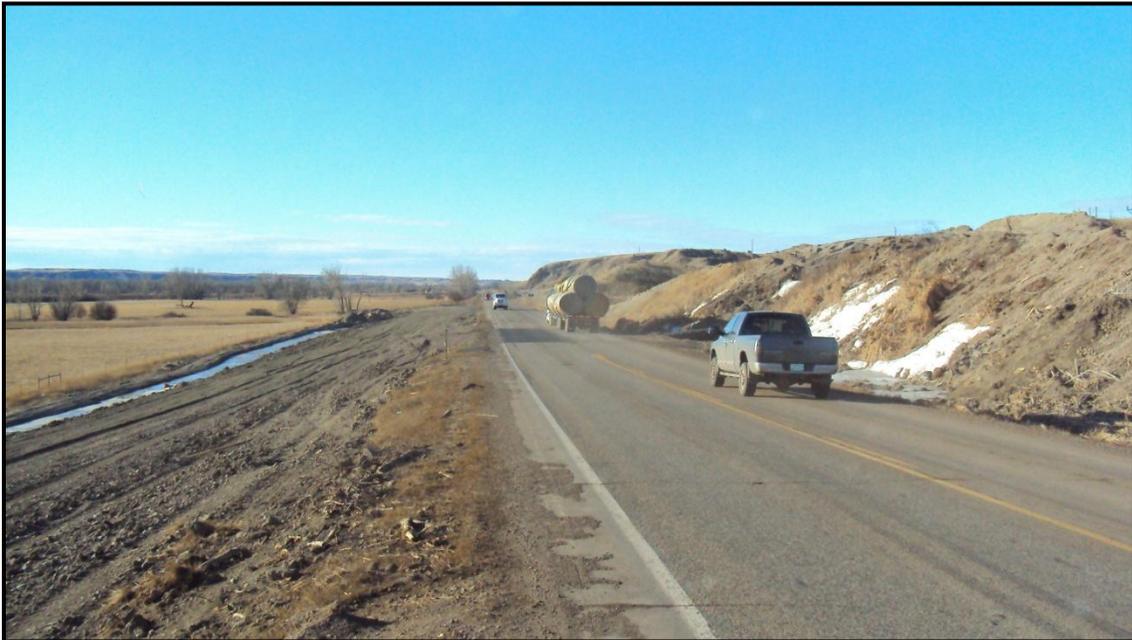
**Photo 37.** Looking south on MT 16 at narrow shoulder widths, longitudinal pavement cracking, and spot resurfacing. RP 19.6.

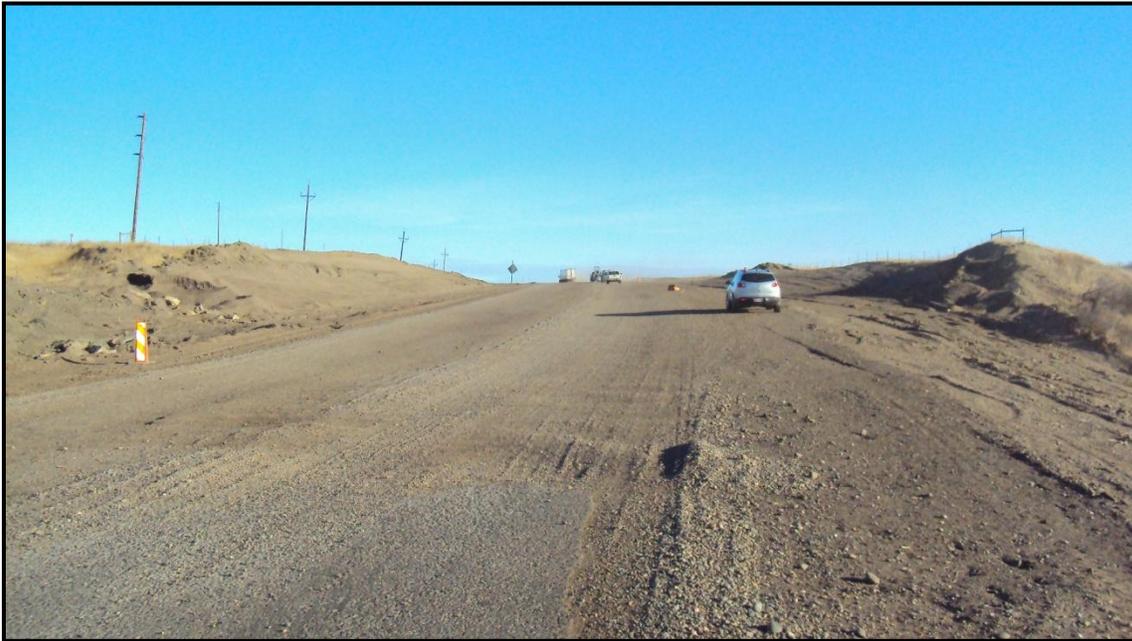
**Photo 38.** Looking north on MT 16 at roadway reconstruction and re-graded side slopes. RP 19.7.

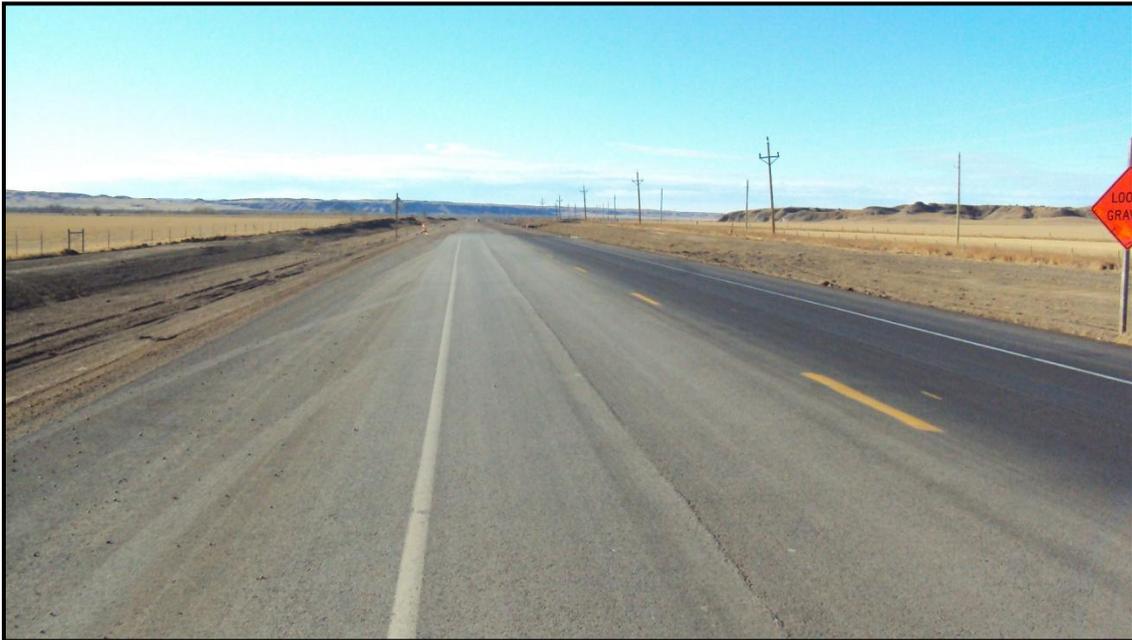
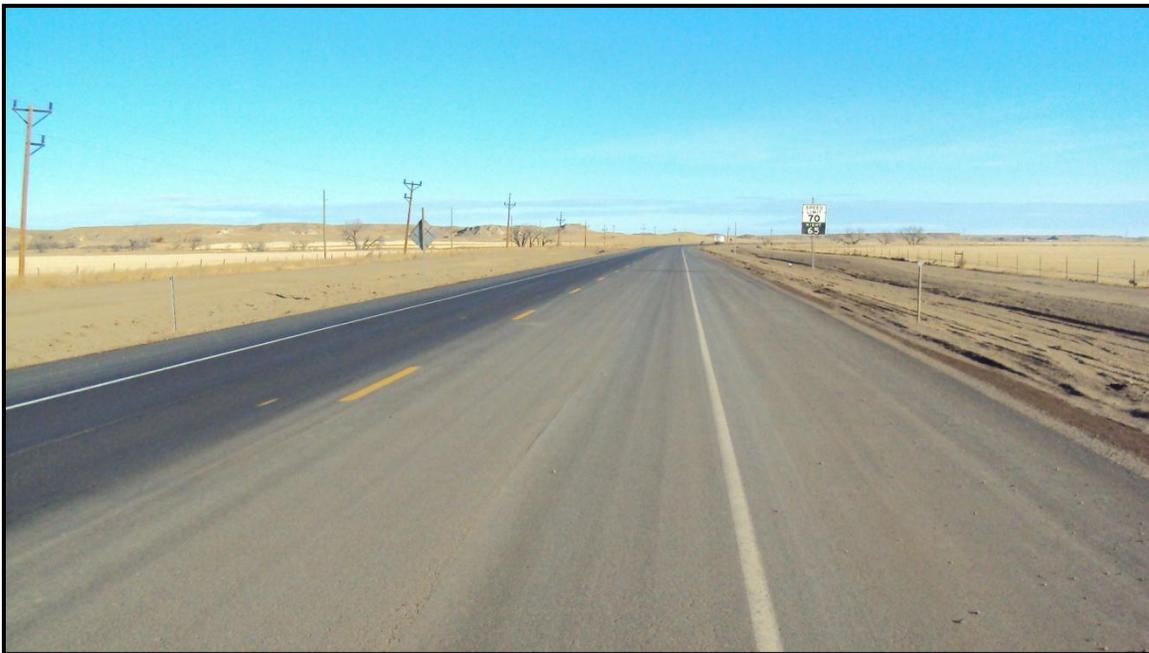
**Photo 39.** Looking south at reconstructed portion of MT 16. RP 20.4.

**Photo 40.** Looking south at reconstructed portion of MT 16. RP 20.4.

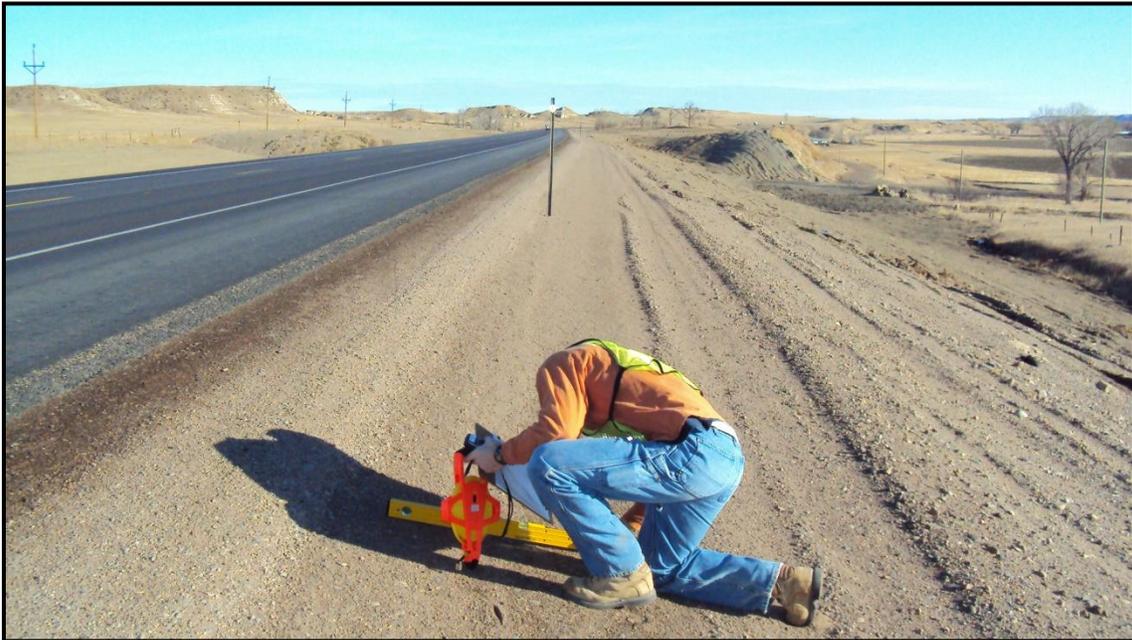
**Photo 41.** Looking north on MT 16. East side slope transitions from 5:1 to 3:1 approximately 28 feet from northbound travel lane. RP 22.5.

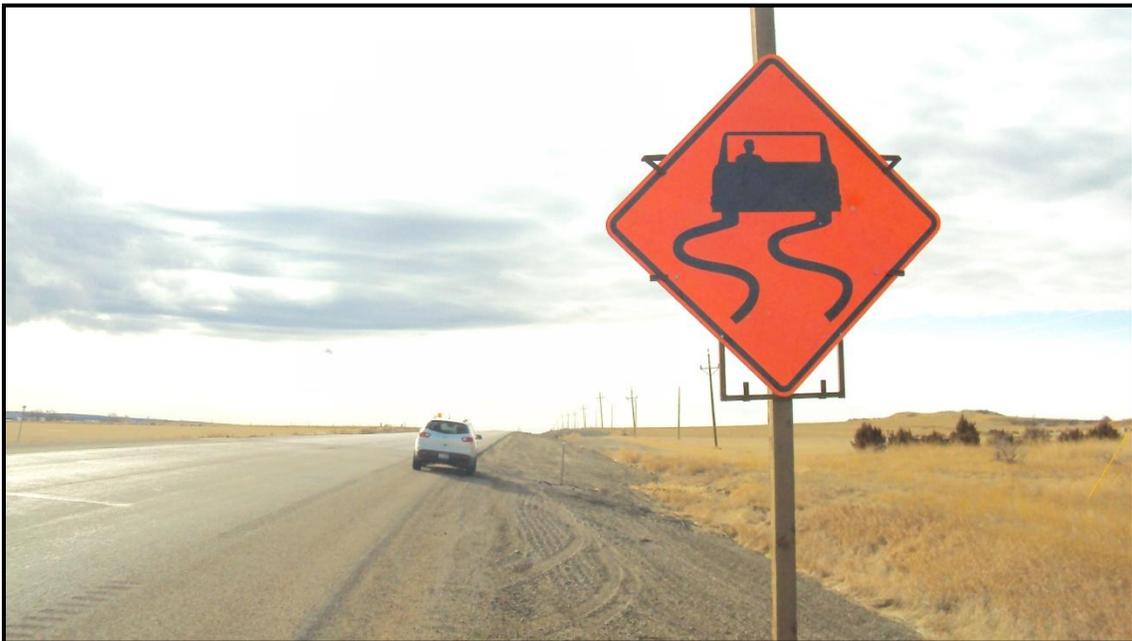
**Photo 42.** Looking south on MT 16 at slippery when wet sign. RP 24.6.

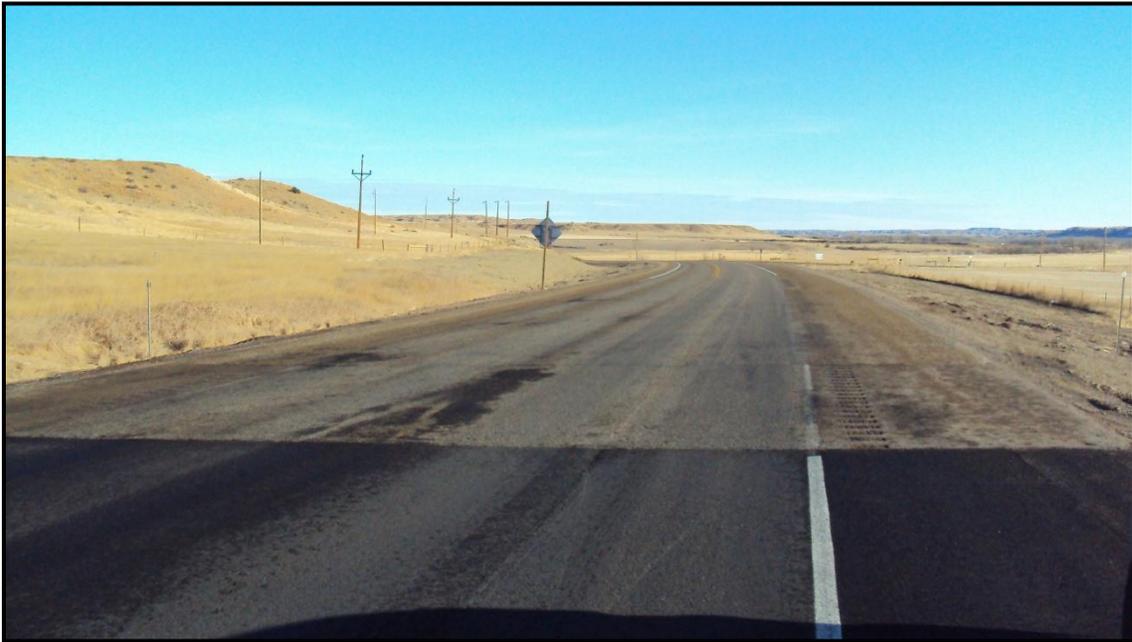
**Photo 43.** Looking north on MT 16 at end of reconstructed section. RP 24.7.

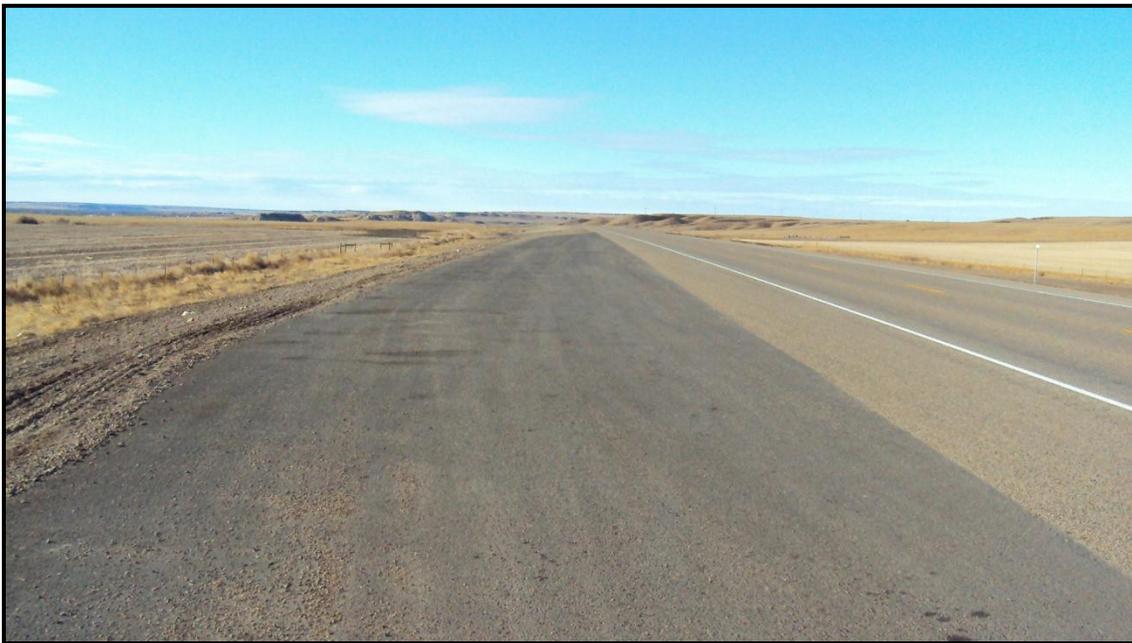
**Photo 44.** Looking south on MT 16 at a paved vehicle pullout. RP 26.4.

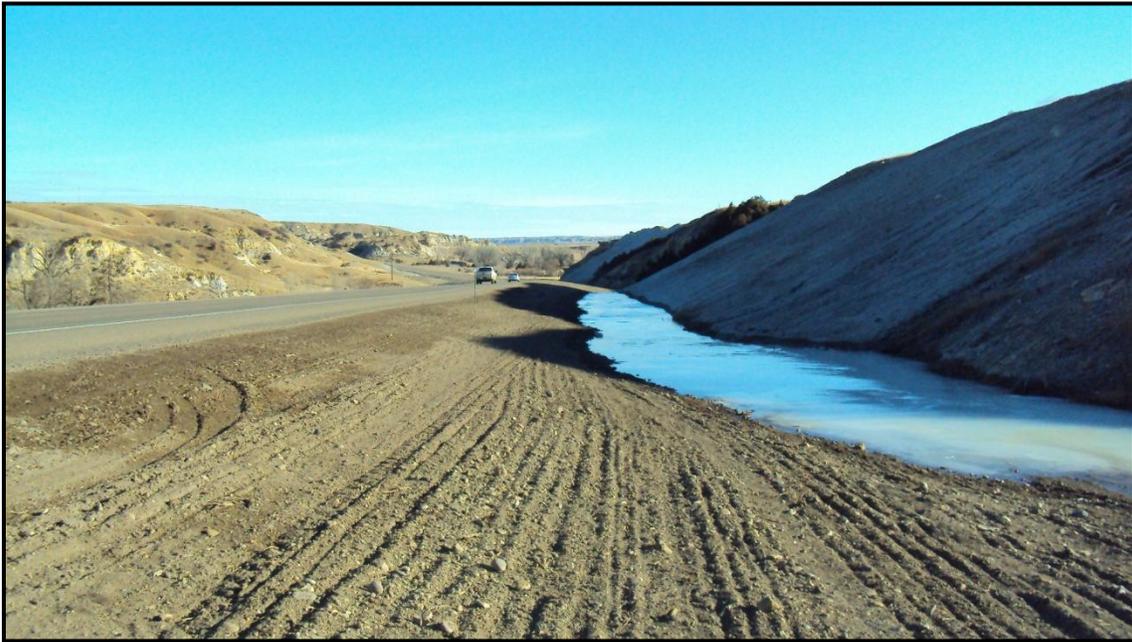
**Photo 45.** Looking north on MT 16 at unvegetated side slope. RP 27.5.

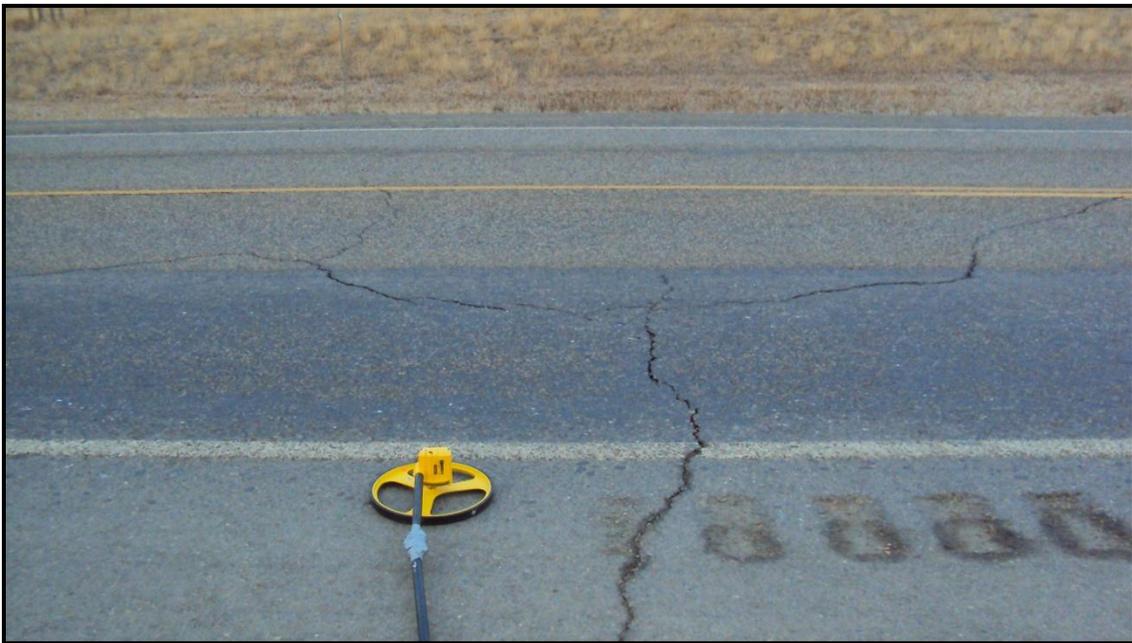
**Photo 46.** Looking across MT 16 at continuous transverse pavement cracking. Pavement cracking within the travel way measured approximately 0.5 inches in width, approximately every 35 feet. RP 29.0.

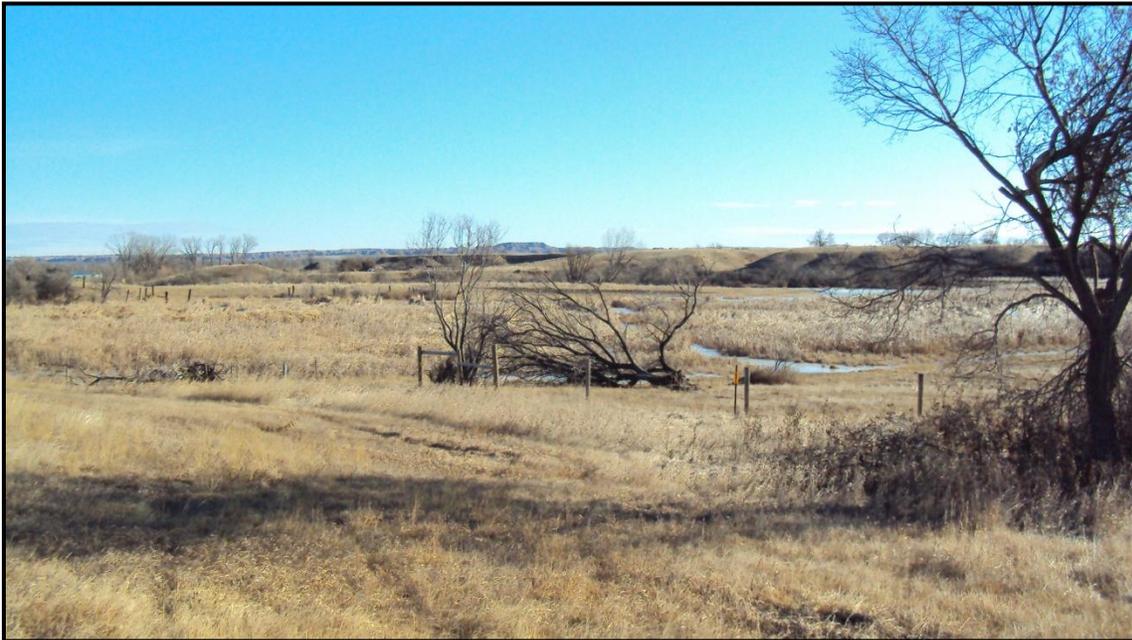
**Photo 47.** Looking east of MT 16 at areas exhibiting wetland characteristics. RP 29.2.

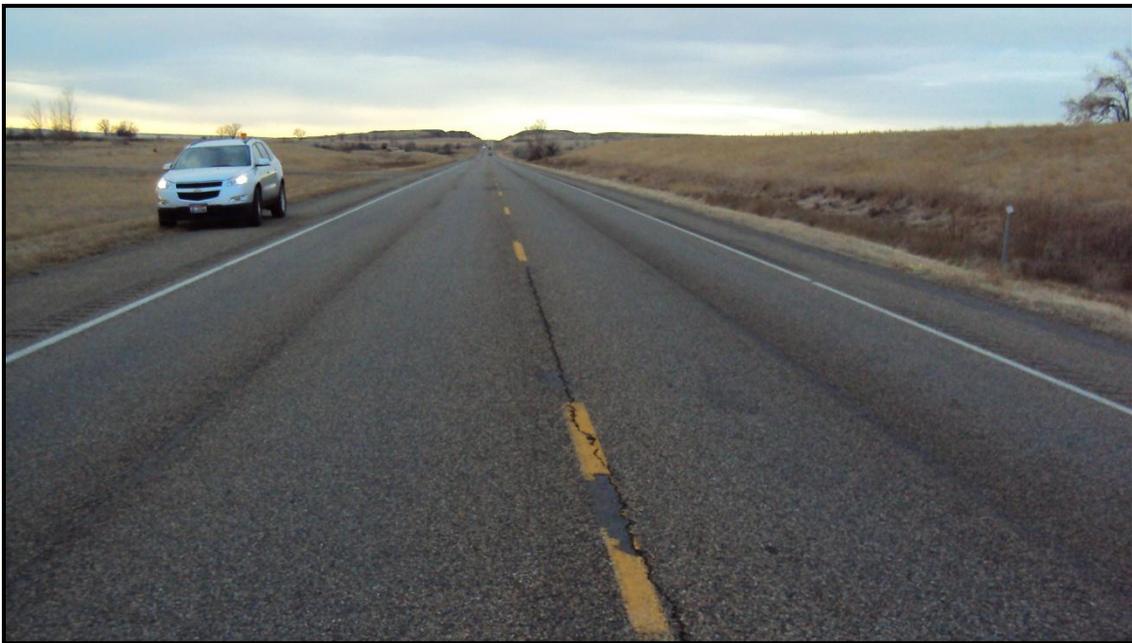
- Transverse pavement cracking within the travel way measured approximately 0.5 inches in width, approximately every 45 feet. Longitudinal pavement cracking was observed within the travel way. No measurable pavement rutting was observed within the travel way at RP 29.5. Photo 48.

**Photo 48.** Looking north on MT 16 at continuous longitudinal pavement cracking. Pavement cracking within the travel way measured approximately 0.5 inches in width. RP 29.5.

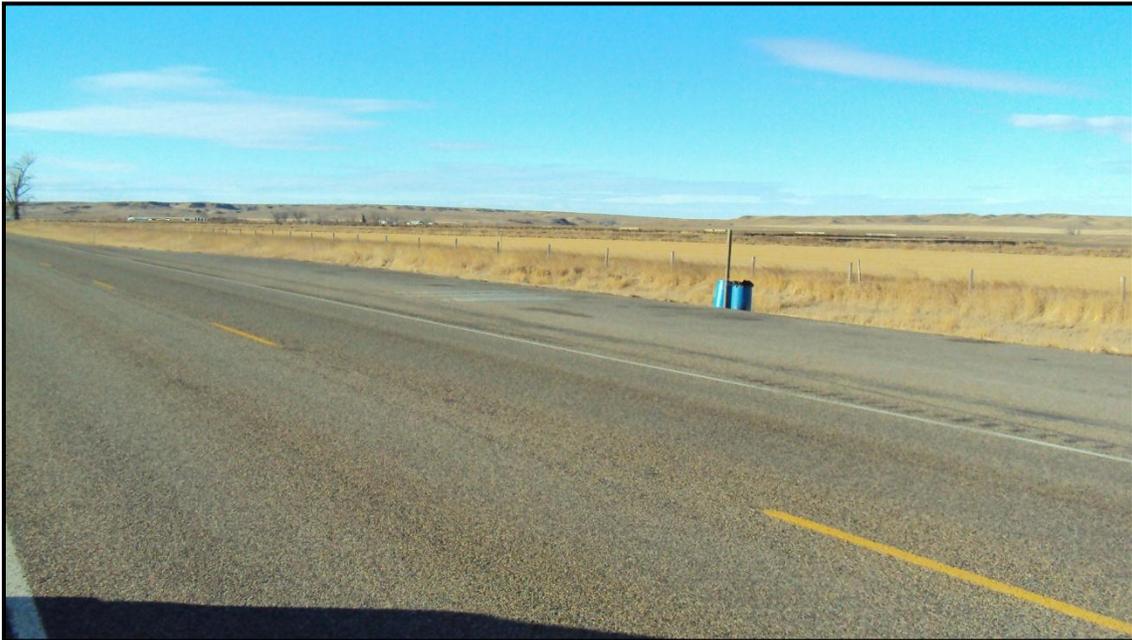
**Photo 49.** Looking south on MT 16 at a paved vehicle pullout. RP 30.4.

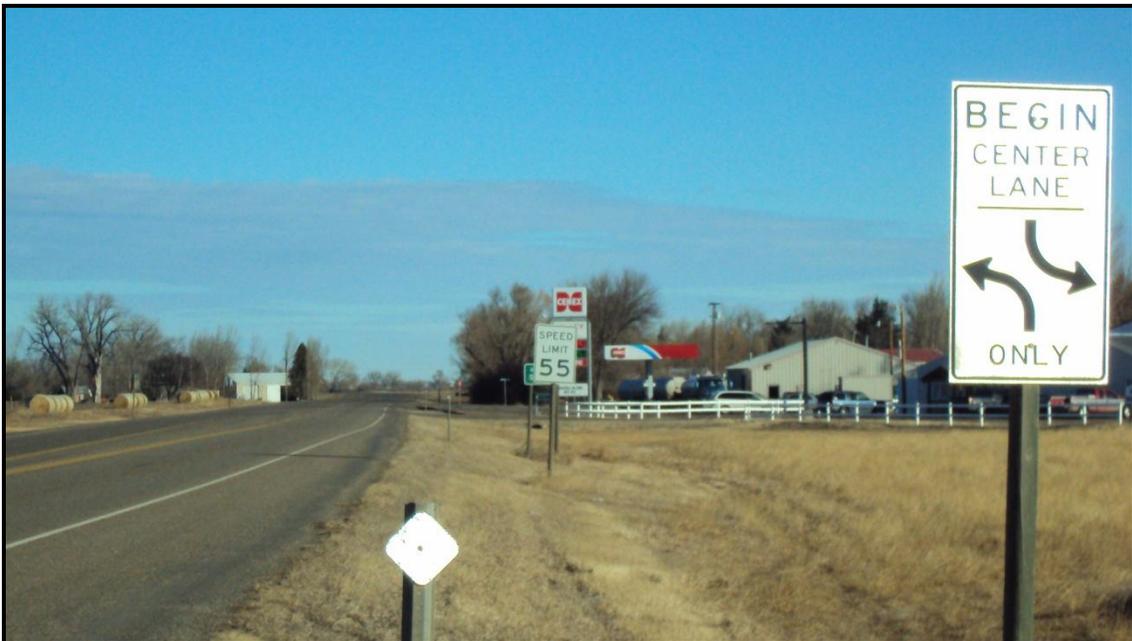
**Photo 50.** Looking north on MT 16 at beginning of two-way left-turn lane and reduced posted speed limit (55 mph for all vehicles) through Savage, MT. RP 31.5.

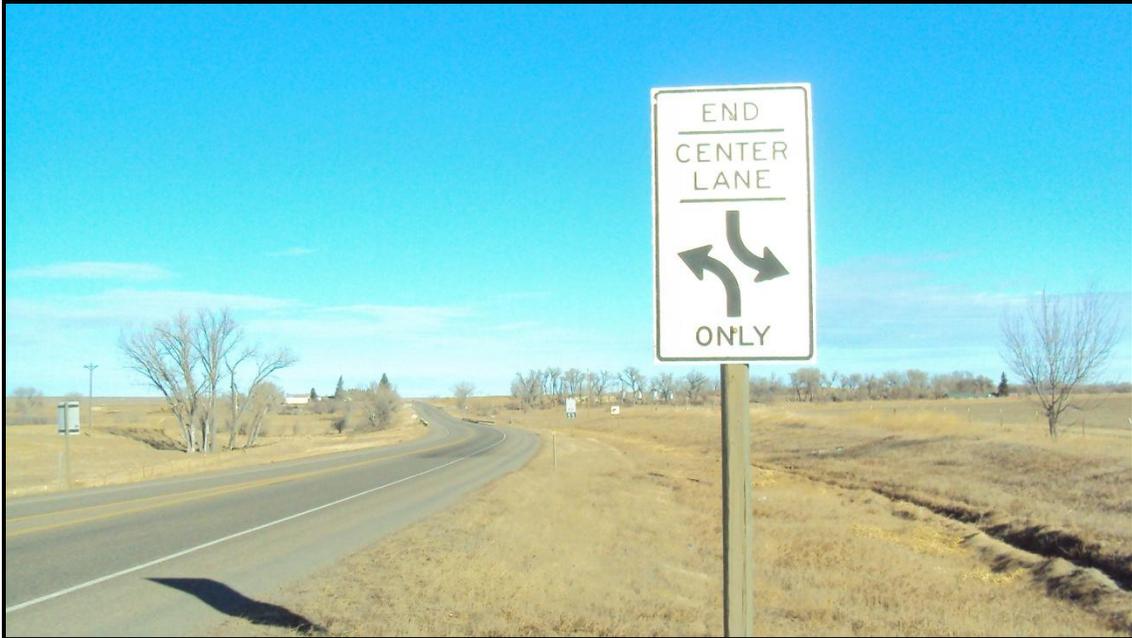
**Photo 51.** Looking north on MT 16 at end of two-way left-turn lane and restored posted speed limits (60 mph for trucks, 70 mph for vehicles). RP 32.3.

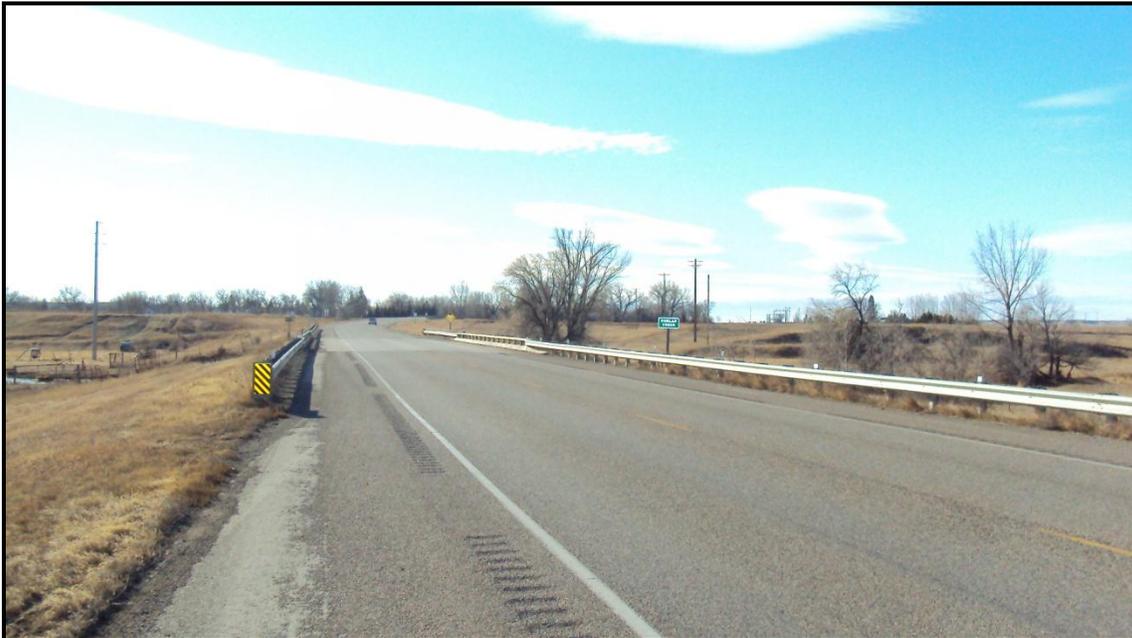
**Photo 52.** Looking south on MT 16 at Dunlap Creek. RP 32.6.

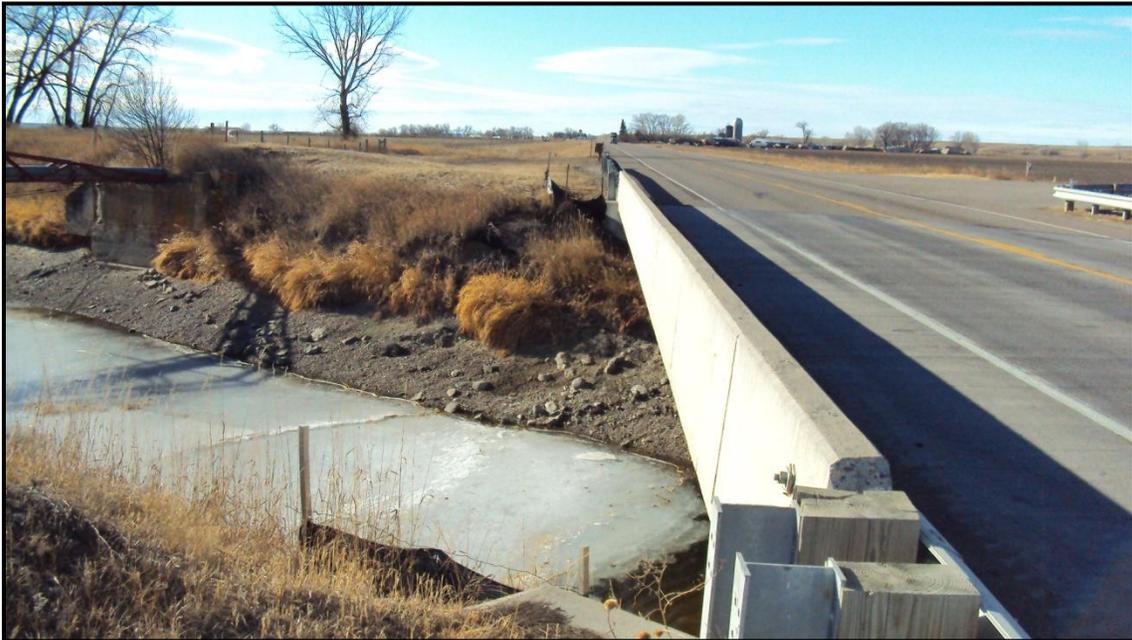
**Photo 53.** Looking south on MT 16 at Irrigation Canal. RP 37.5.

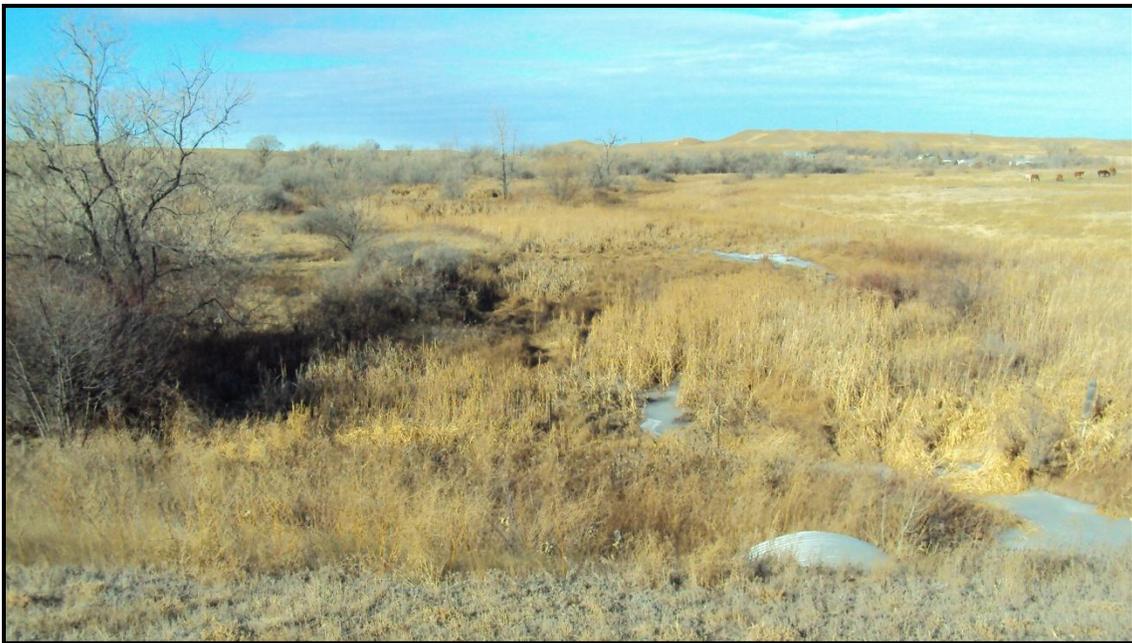
**Photo 54.** Looking east of MT 16 at areas exhibiting wetland characteristics. RP 37.7.
