# Appendix 1

## Field Review Memorandum and Photo Log

**Subject: Summary of Field Review Conducted on January 31, 2012  
MT 16 / MT 200 Glendive to Fairview Corridor Planning Study**

**MT 16 / MT 200 GLENDIVE TO FAIRVIEW  
CORRIDOR PLANNING STUDY  
PHOTO LOG**

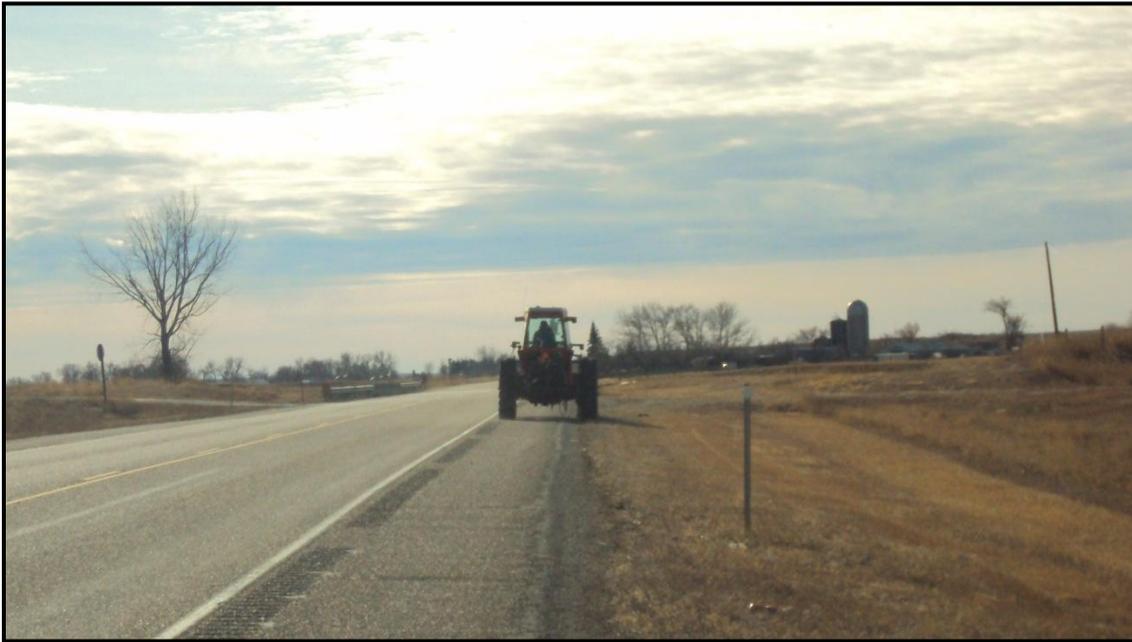
**Photo 55.** Looking south on MT 16 at slow moving tractor. RP 38.4.

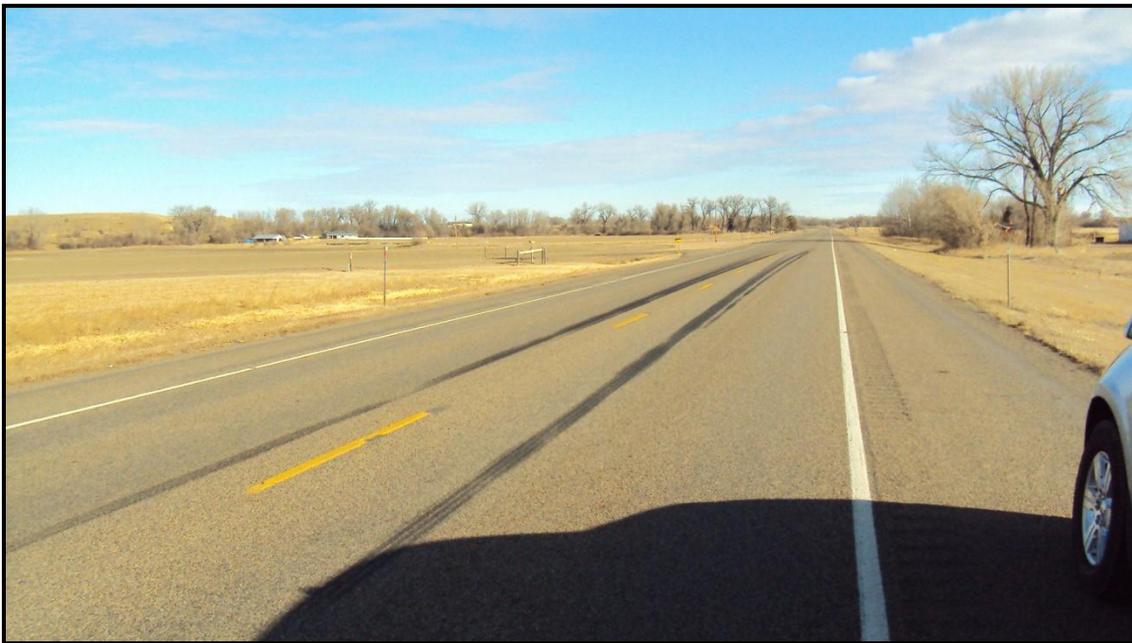
**Photo 56.** Looking north on MT 16 at tire skid marks. RP 40.4.

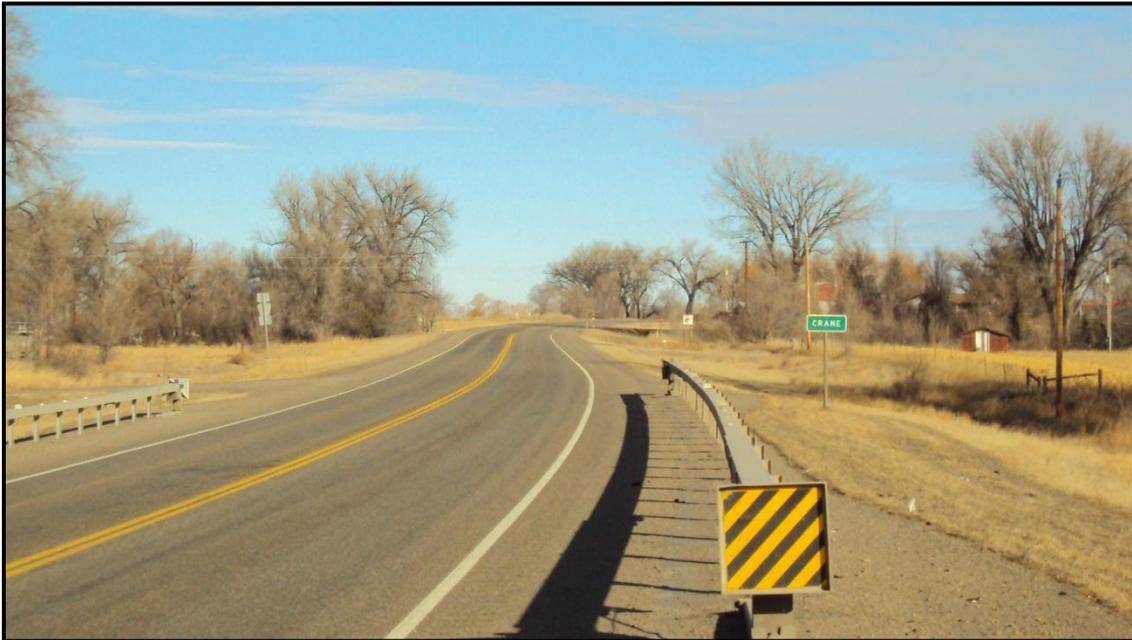
**Photo 57.** Looking north on MT 16 at entrance to Crane, MT. Speed limits are not reduced through Crane, MT. RP 41.4.

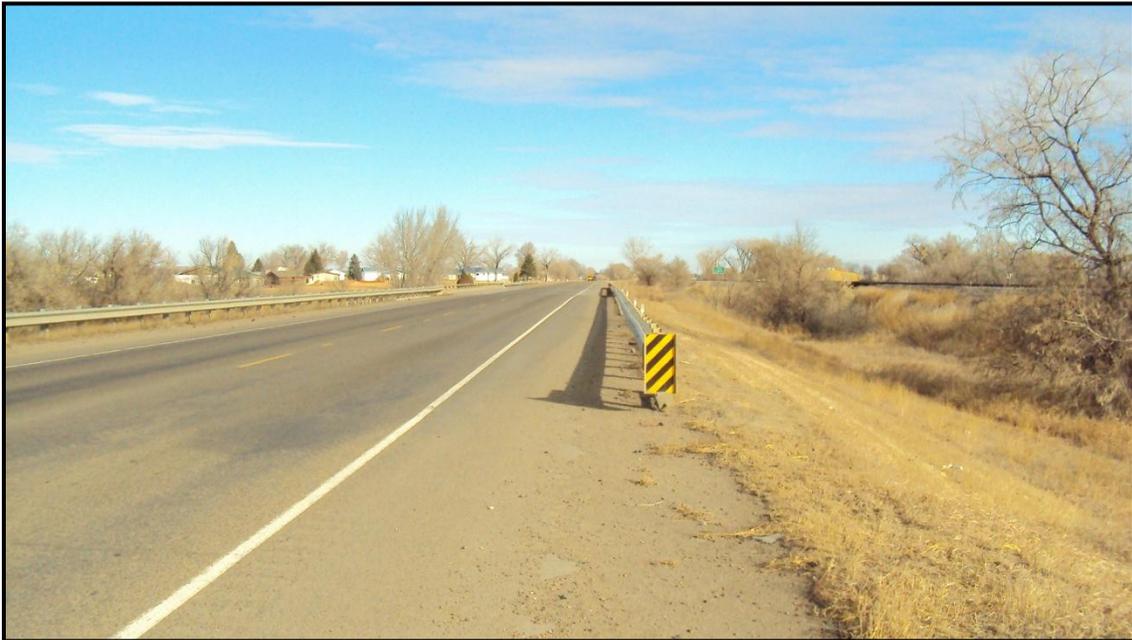
**Photo 59.** Looking north on MT 16 at Fox Creek. RP 46.7.

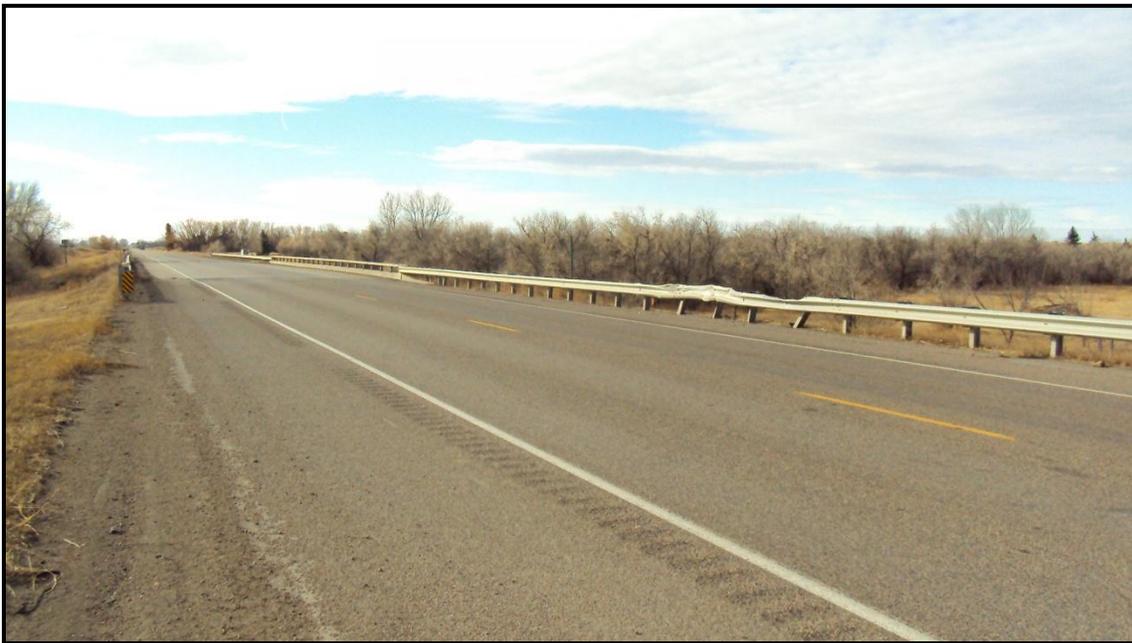
**Photo 60.** Looking south on MT 16 at damaged guardrail. RP 46.7.

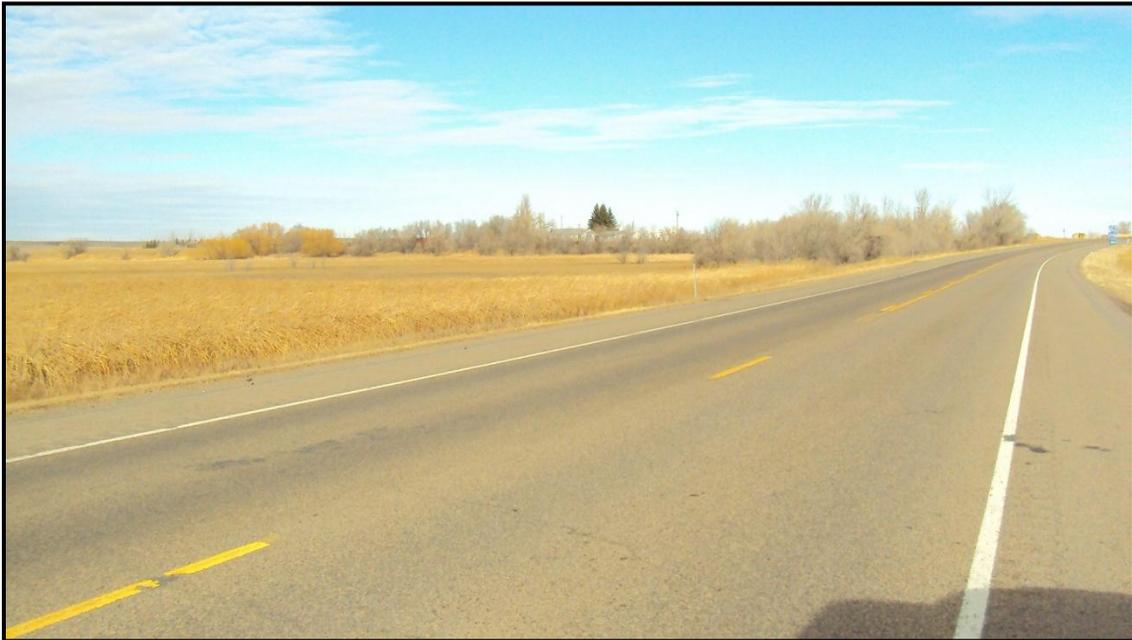
**Photo 61.** Looking northwest of MT 16 at areas exhibiting wetland characteristics observed approximately 32 feet from southbound travel lane. RP 47.8.

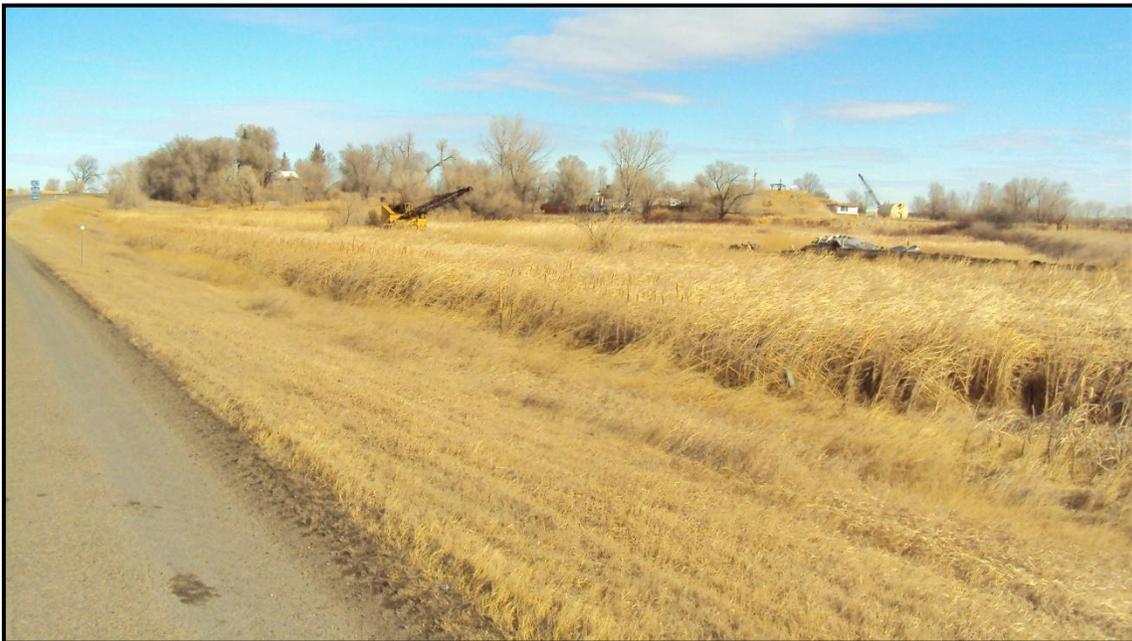
**Photo 62.** Looking northeast of MT 16 at areas exhibiting wetland characteristics observed approximately 32 feet from northbound travel lane. RP 47.8.

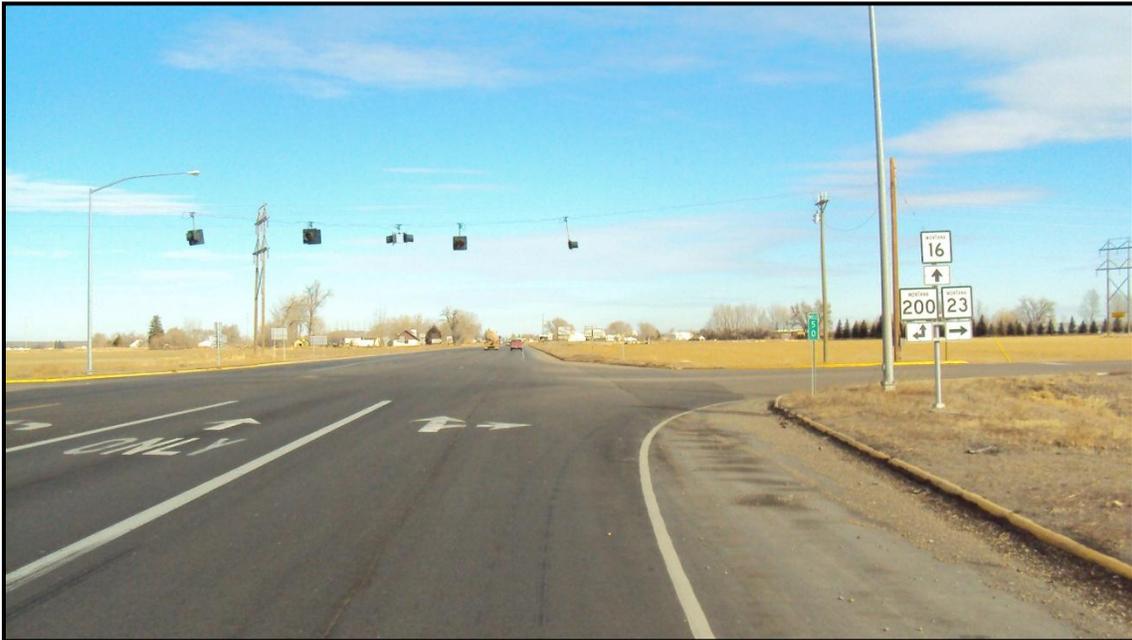
**Photo 63.** Looking north on MT 16 at intersection of MT 16 / MT 200 and MT 200 / MT 23. RP 50.0.

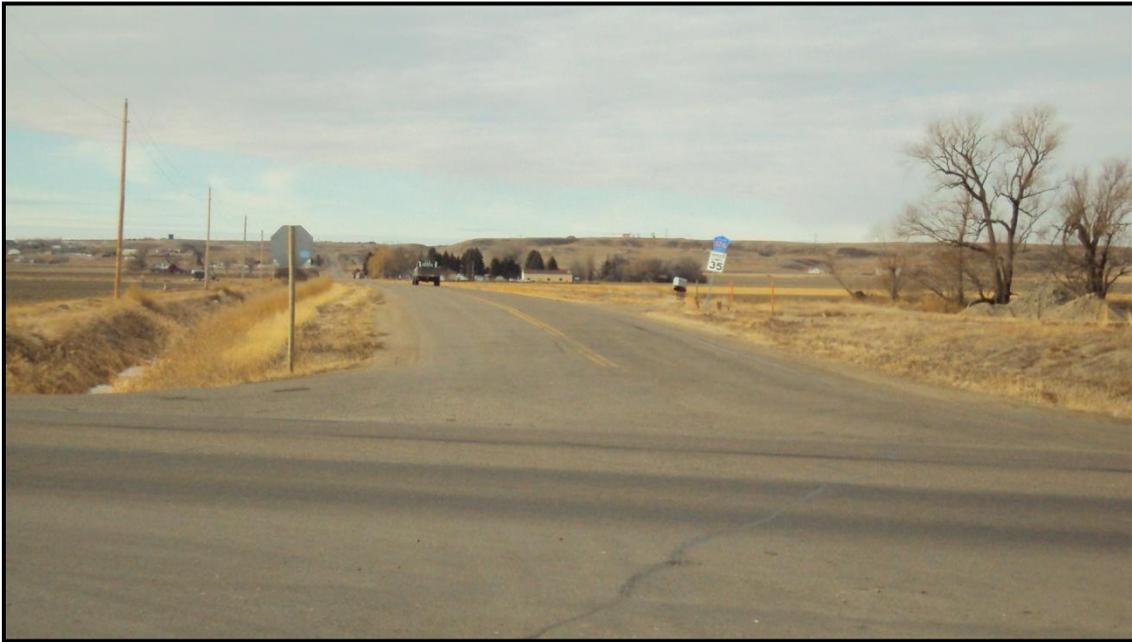
**Photo 65.** Looking at paved intersection of MT 200 and County Road 126. RP 53.6.

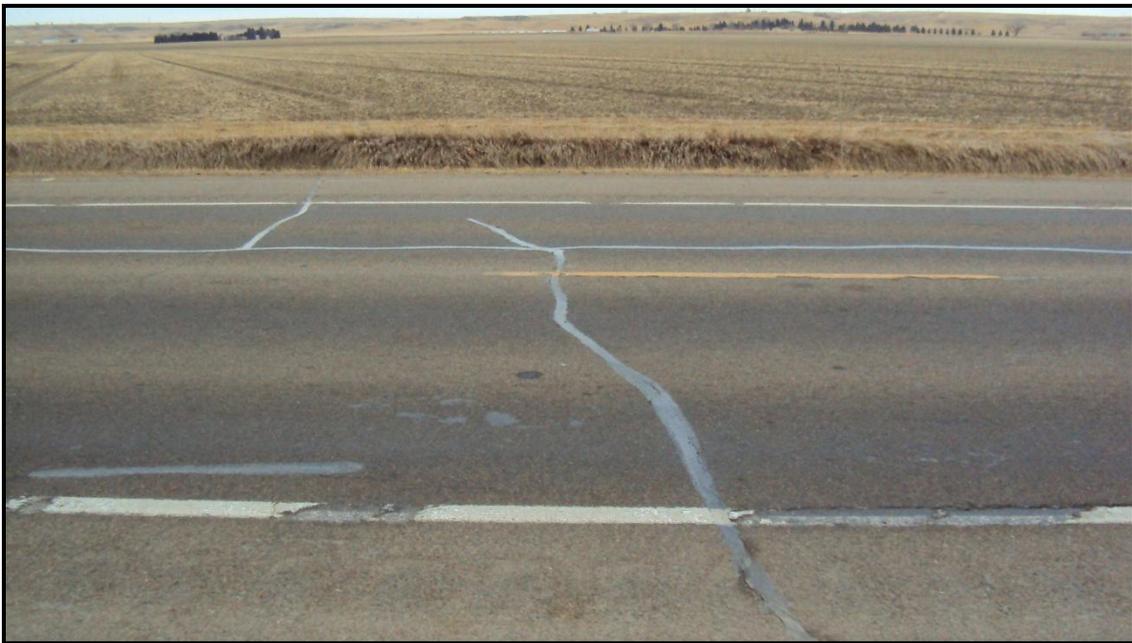
**Photo 66.** Looking at transverse sealed pavement cracking 0.25 inches in width, approximately every 30 feet. Chip seal peeling was observed on the travel way white line. No measurable pavement rutting was observed within the travel way. RP 54.0.

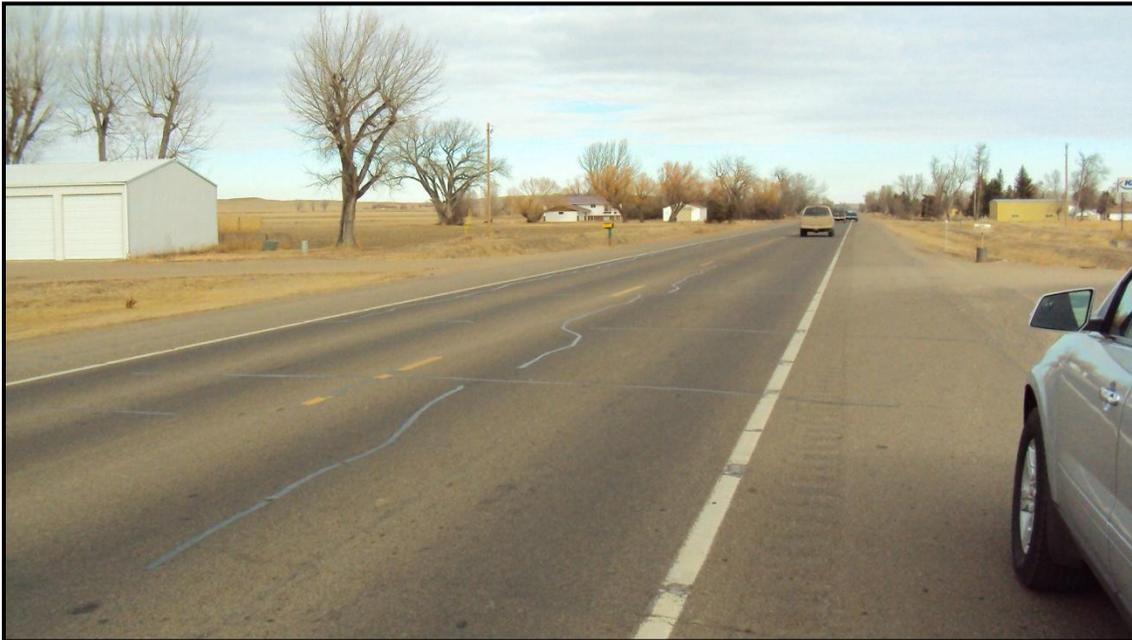
**Photo 67.** Looking north on MT 200 at transverse and longitudinal pavement crack sealing. RP 56.0.

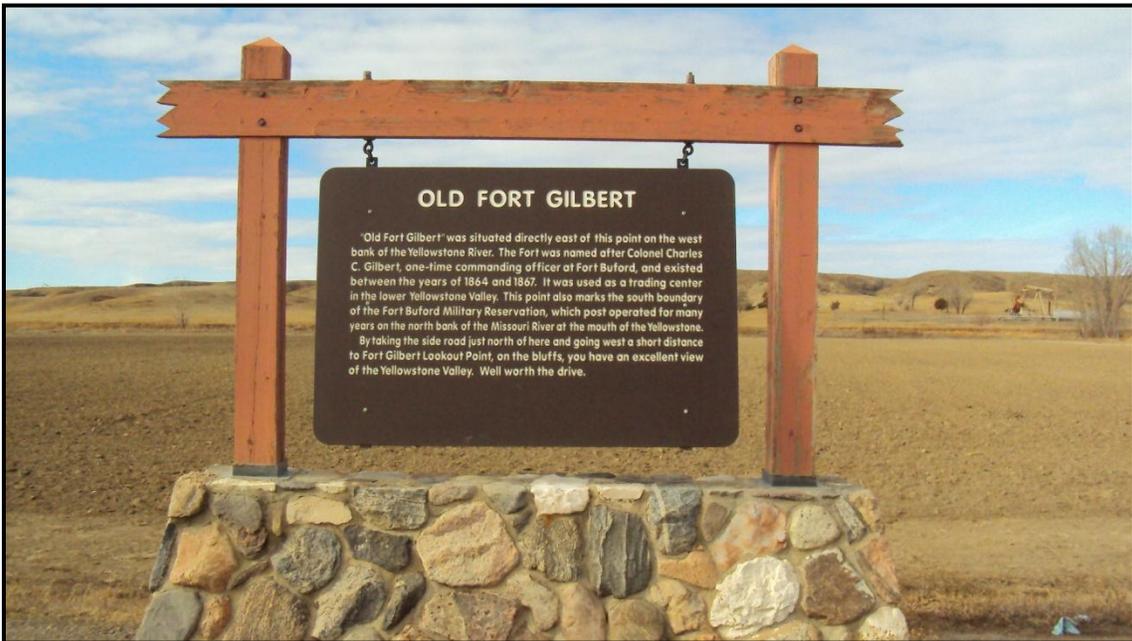
**Photo 68.** Old Fort Gilbert sign. RP 57.7.

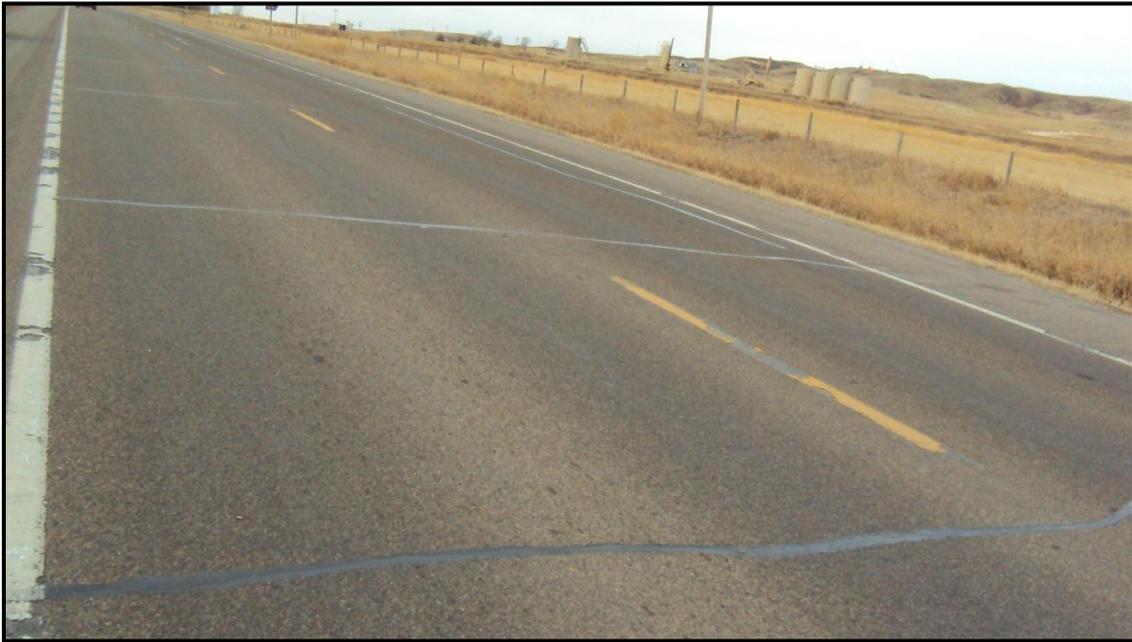
**Photo 69.** Looking across MT 16 at continuous longitudinal and transverse pavement crack sealing. Pavement cracking within the travel way measured approximately 1.5 inches in width, approximately every 30 feet. RP 58.4.

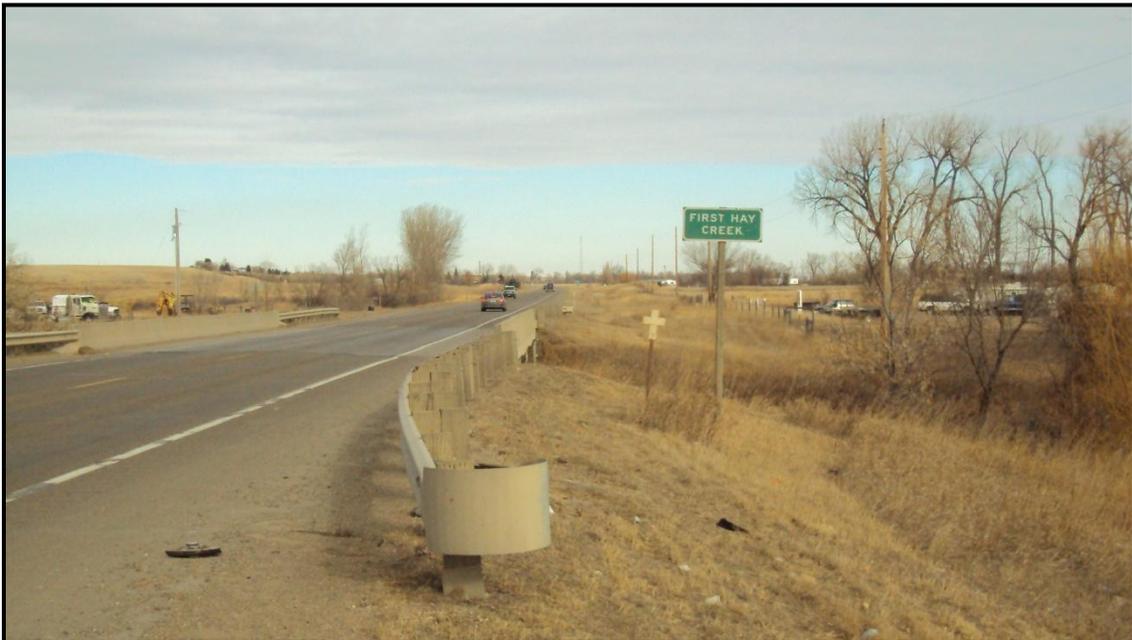
**Photo 70.** Looking north on MT 200 at First Hay Creek. RP 59.5.

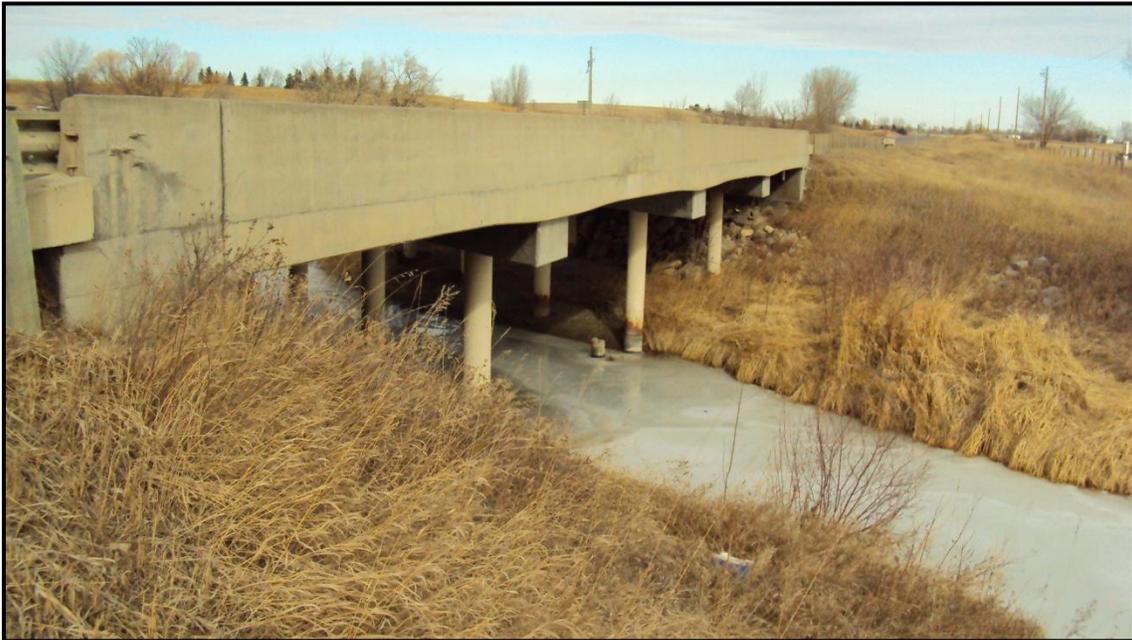
**Photo 71.** Looking north on MT 200 at First Hay Creek Bridge undercrossing. RP 59.5.

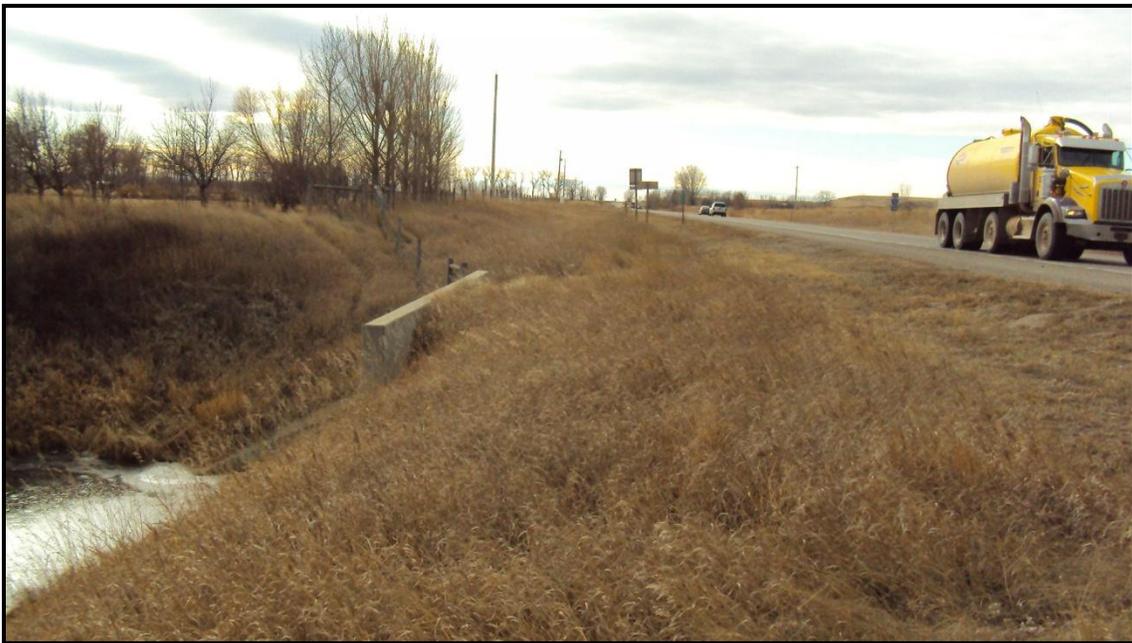
**Photo 72.** Looking south on MT 200 at Second Hay Creek. Distance from the northbound travel lane to concrete wall is approximately 40 feet. RP 60.1
