STRUCTURE INSPECTION REPORT

Structure # 03719
BITTERROOT RIVER 010 - W MISSOULA

Rope Access Climbing Bridge Inspection Report

Asset #: 03719

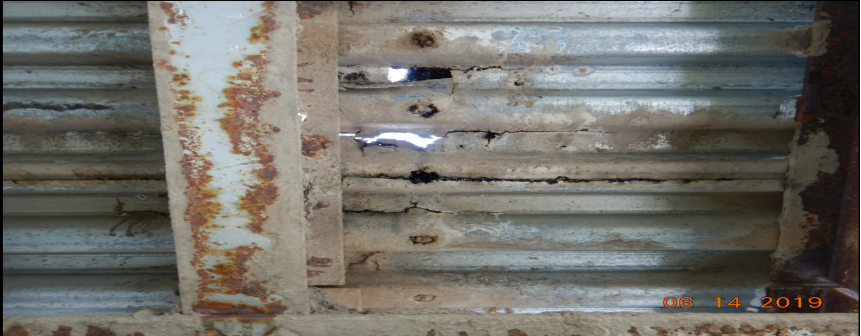
<p>Photo #:Span 1 Hole and cracking in deck west of FB3' above S3</p> <p>Location:</p> <p>Comments:</p> <p>Element:30 - Steel Corrugated or Orthotropic Deck (SF) Thru-Truss</p>			 					
--	--	--	---	--	--	--	--	--

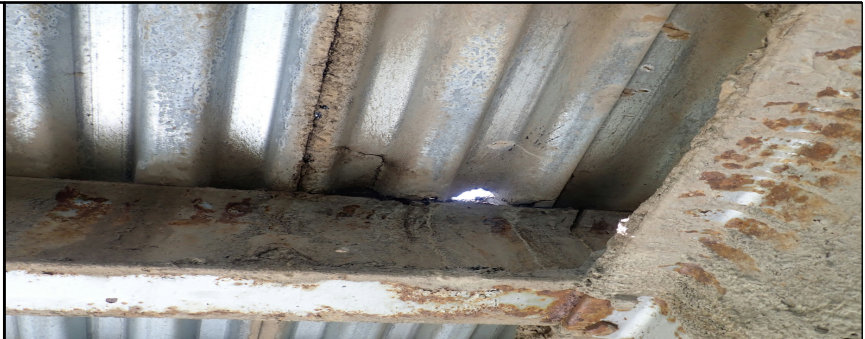
Photo #:Span 1 Hole and cracking in corrugated steel deck above S6 at FB 2'

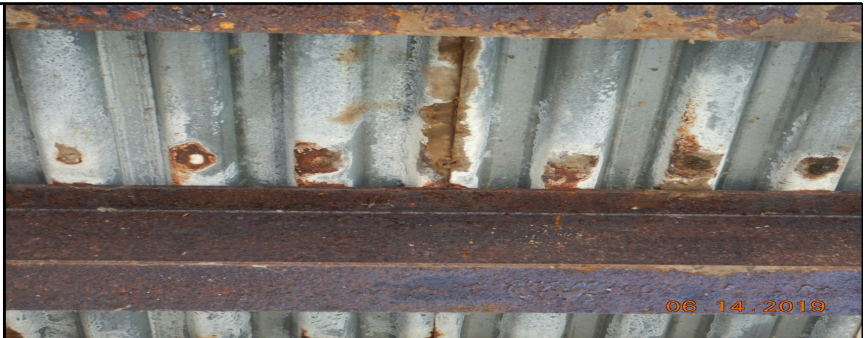
The underside of the deck was in fair condition. The underside of Spans 1 and 2 consisted of galvanized, corrugated stay-in-place formwork that had welding burn through holes throughout with minor surface corrosion and negligible section loss to the burn hole edges. The welding burn through holes allowed debris to fall through the stay-in-place formwork onto the floor beams. The underside of the deck in Spans 3 and 4 consisted of top flanges of tee beams with isolated areas of efflorescence seeping through the construction joints and superficial cracking, but no notable deficiencies.

Photo #:Areas of welding burn-through in corrugated deck, Looking Up

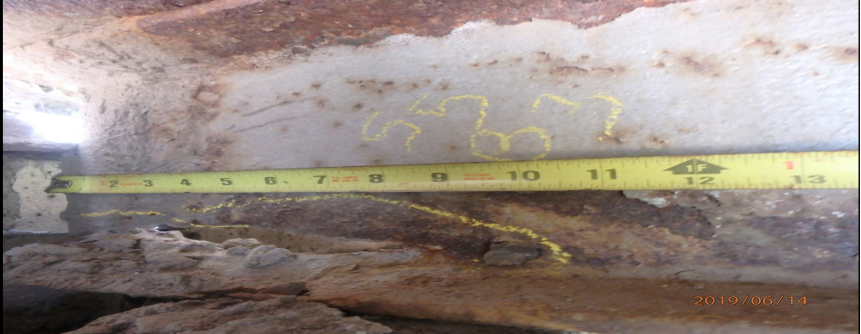
Element #	Parent Element	Name	Unit	Quantity	%CS 1	%CS 2	%CS 3	%CS 4
<p>Photo #:Span 2 Stringer 5 Bent 3 corrosion hole</p> <p>Location:</p> <p>Comments:</p> <p>Element:113 - Steel Stringer (LF) Pony Truss</p>

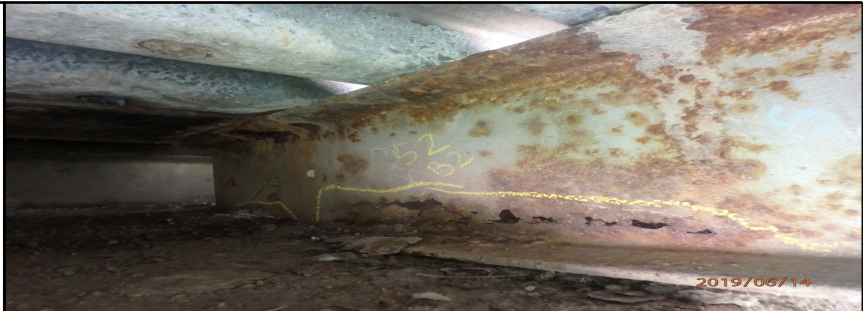
Photo #:Span 2 Stringer 2 Bent 2 hole

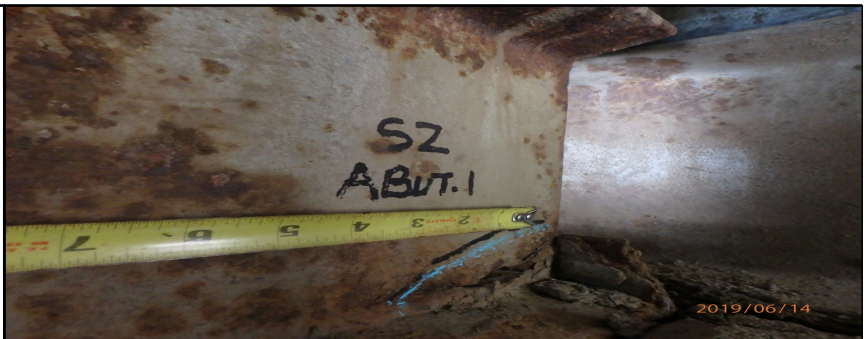
Photo #:Span 1 Stringer 2 Abut 1 corrosion hole

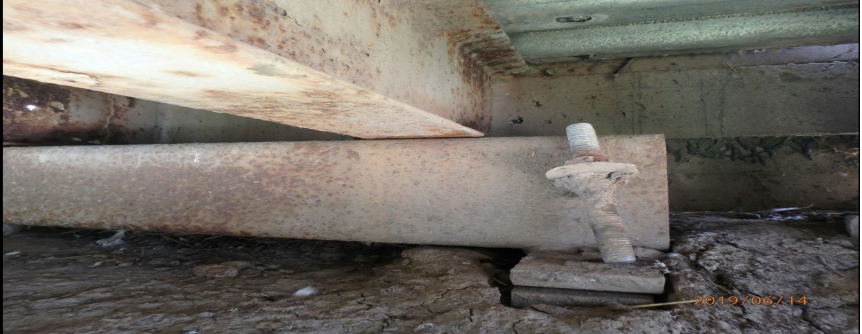
Element #	Parent Element	Name	Unit	Quantity	%CS 1	%CS 2	%CS 3	%CS 4
<p>Photo #: Bent 3 stringer bearing tube broken anchor rod</p> <p>Location:</p> <p>Comments:</p> <p>Element: 113 - Steel Stringer (LF) Pony Truss</p>

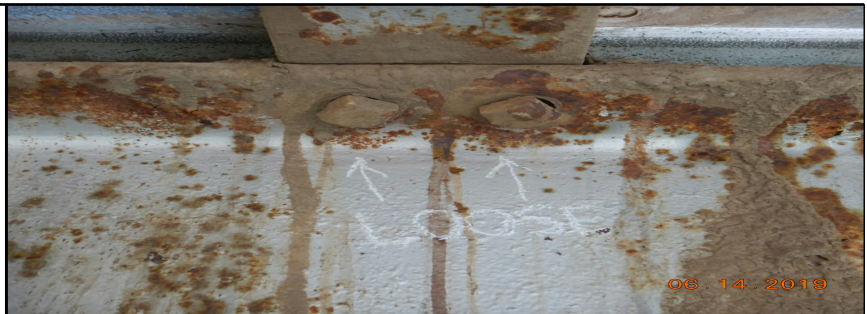
Photo #:Span 1 Two loose bolts S5 to FB3

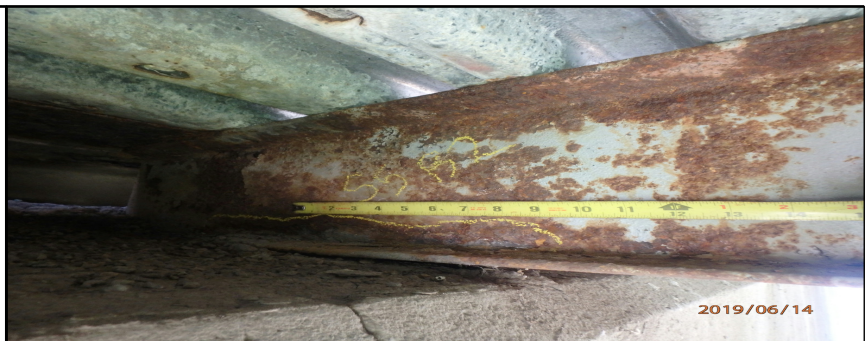
Photo #:Span 2 Stringer 5 Bent 2 corrosion and delamination

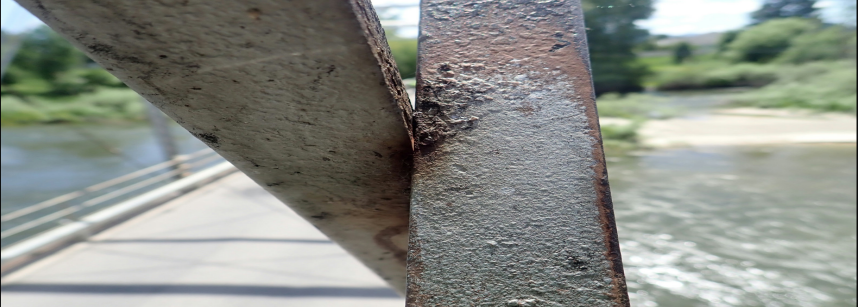
Element #	Parent Element	Name	Unit	Quantity	%CS 1	%CS 2	%CS 3	%CS 4
Photo #:Wear at intersection of diagonals L4'S-U4S and L4S-U4'S Location: Comments: Element:120 - Steel Truss (LF) Thru-Truss

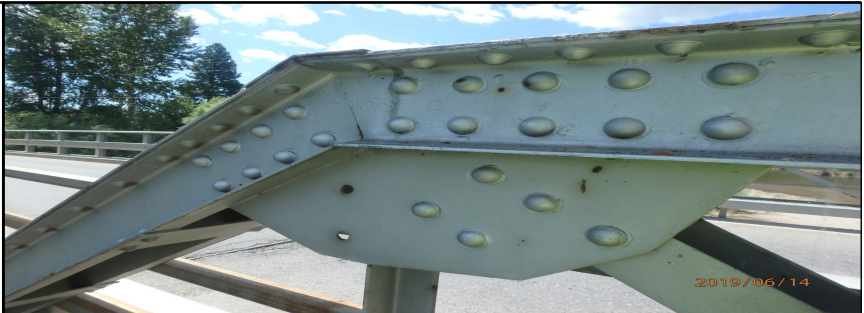
Photo #:Span 2 Misdrilled holes in ext plate at U1'N

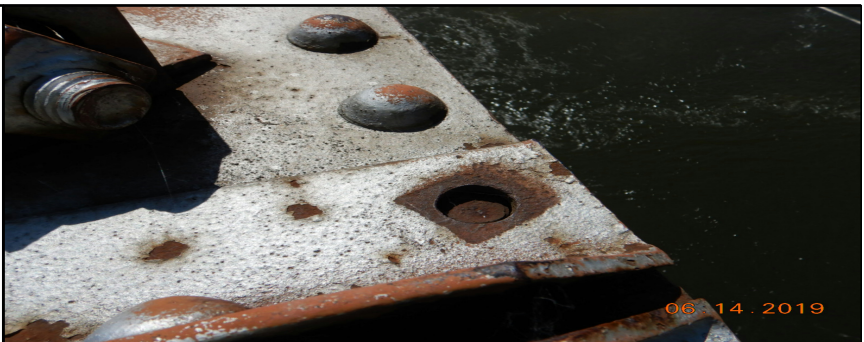
Photo #:Span 1 Sheared Bolt U4S upper horizontal strut

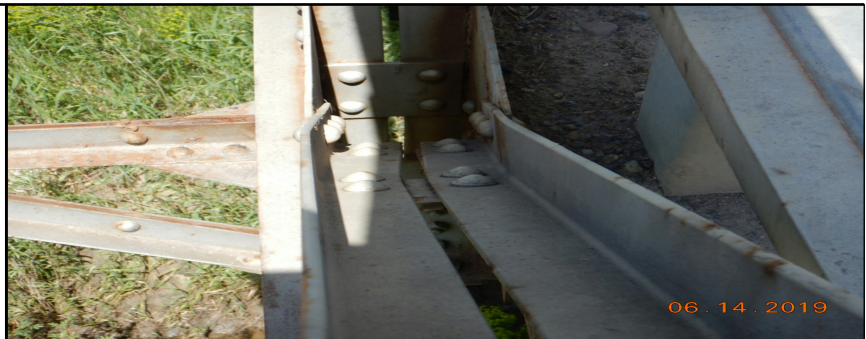
Photo #:Diagonal L2'-U1' S Truss
distortion at U1'S

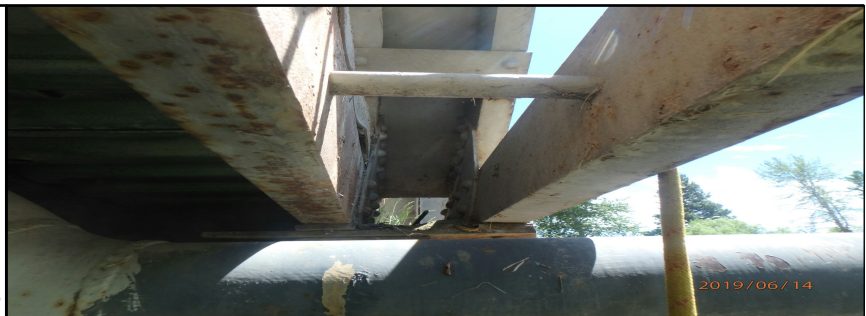
Photo #:Lower Chord L1'-L0'S Span 2
Distortion at L0'S

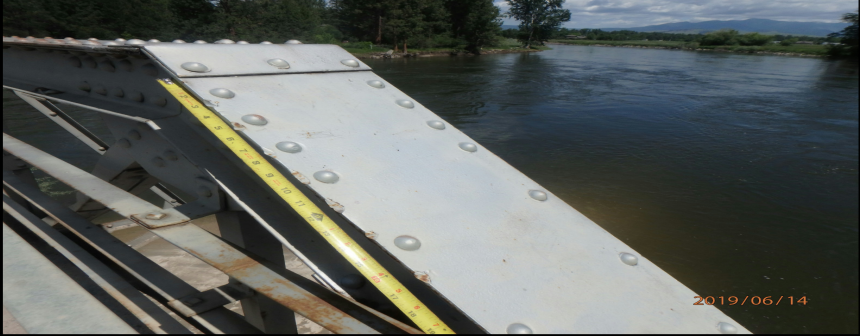
Element #	Parent Element	Name	Unit	Quantity	%CS 1	%CS 2	%CS 3	%CS 4
Photo #:Imp Dam to End Post U1'-L0' N Truss Span 2 Location: Comments: Element:120 - Steel Truss (LF) Pony Truss

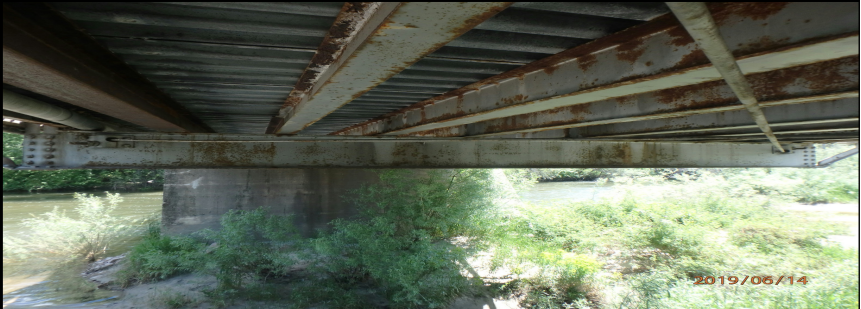
Element #	Parent Element	Name	Unit	Quantity	%CS 1	%CS 2	%CS 3	%CS 4
Photo #:Typ FB Span 2 Location: Comments: Element:152 - Steel Floor Beam (LF) Pony Truss

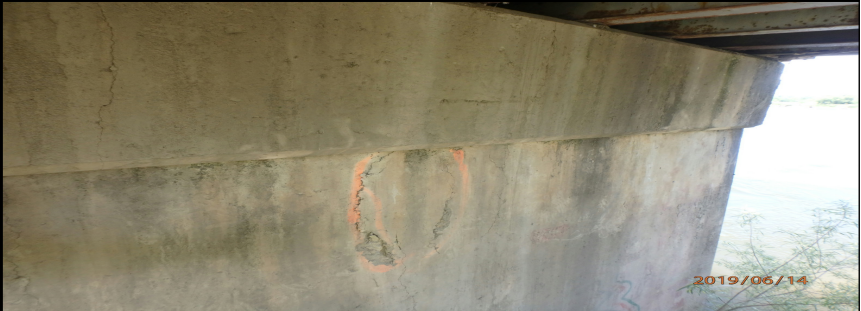
Element #	Parent Element	Name	Unit	Quantity	%CS 1	%CS 2	%CS 3	%CS 4
Photo #:Bent 2 Delamination on east face Location: Comments: Element:210 - Reinforced Concrete Pier Wall (LF) Bent 2

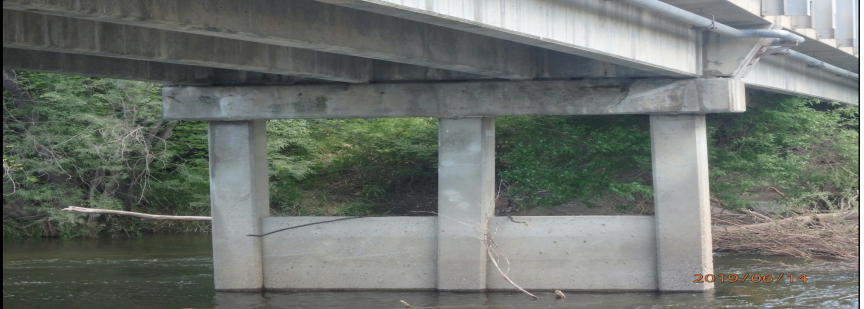
Bent 4 exhibited a 3 ft. wide by 2 ft. high spall with exposed reinforcing steel on the west face of the bent cap. The exposed reinforcing steel had moderate corrosion with negligible section loss.

Element #	Parent Element	Name	Unit	Quantity	%CS 1	%CS 2	%CS 3	%CS 4
Photo #:Bent 4 Spall on west face of cap Location: Comments: Element:234 - Reinforced Concrete Cap (LF) Bent 2

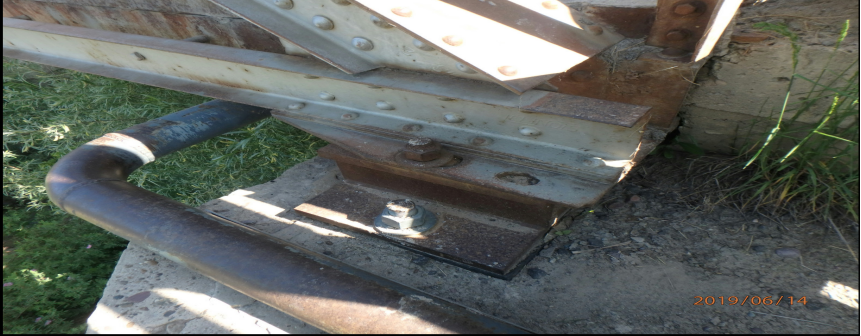
The North and South Truss sliding bearings at Bent 3 were unpainted and had moderate corrosion with pitting up to 1/16 in. deep. The top plates were displaced 1-1/2 in. at the north bearing and 1-7/8 in. at the south bearing to the east (in expansion) in relation to the upper flanges of the bearings.

Element #	Parent Element	Name	Unit	Quantity	%CS 1	%CS 2	%CS 3	%CS 4
<p>Photo #:Span 2 South Truss slider bearing corrosion and minor pitting</p> <p>Location:</p> <p>Comments:</p> <p>Element:311 - Movable Bearing (roller, sliding, etc.) (EA)</p>

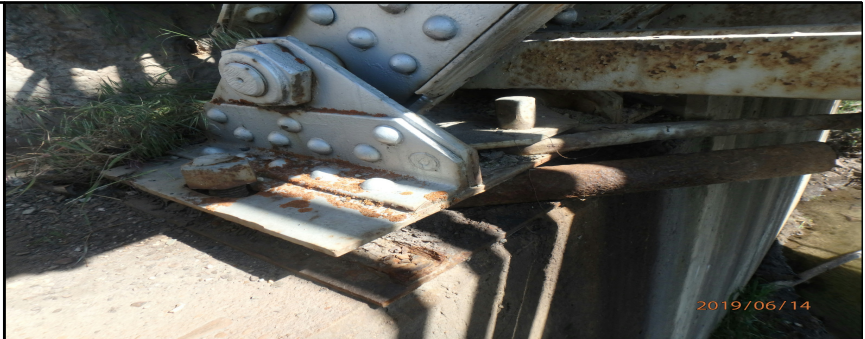
The South Truss roller bearing keeper at Abutment 1 had broken away from the bearing due to heavy corrosion and was pushed against the abutment backwall. Half of the rollers were still within the bearing but were not fully in contact with the bearing plates. The top plate was displaced 1-1/2 in. to the west (in expansion) in relation to the bottom plate.

Photo #:Span 1 South moveable bearing rollers slid out

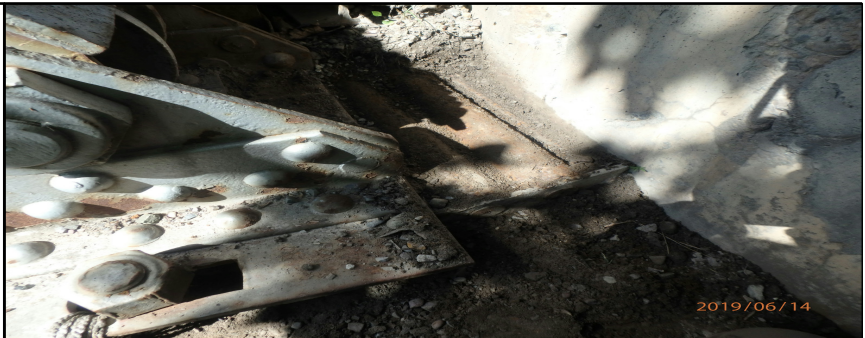
The North Truss roller bearing at Abutment 1 had two rollers along with a portion of the keeper that had worked out from underneath the truss to the west of the bearing and one roller was sticking out from underneath the bearing to the east of the bearing. The anchor rods exhibited up to 25 percent section loss at the concrete interface due to heavy corrosion. The top plate was displaced 1-3/4 in. to the west (in expansion) in relation to the bottom plate.

Photo #:Span 1 North moveable bearing rollers slid to west

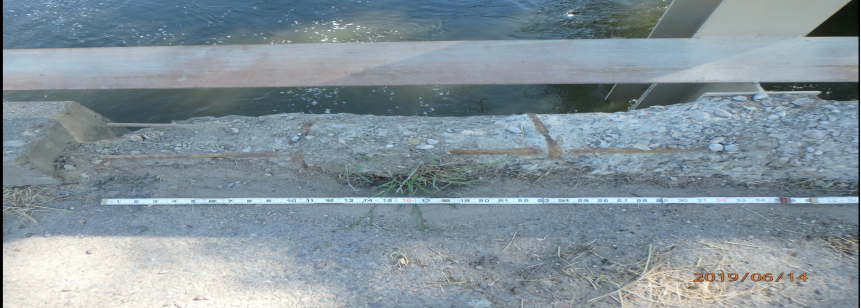
Element #	Parent Element	Name	Unit	Quantity	%CS 1	%CS 2	%CS 3	%CS 4
Photo #:Span 4 spall north curb near Bent 4 Location: Comments: Element:330 - Steel Bridge Rail (LF)

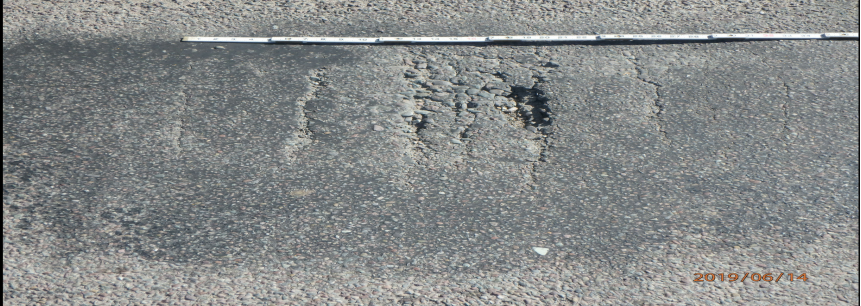
Element #	Parent Element	Name	Unit	Quantity	%CS 1	%CS 2	%CS 3	%CS 4
Photo #:Cracking in Asphalt Patch at W End Location: Comments: Element:510 - Wearing Surfaces (SF)
