# STRUCTURE INSPECTION REPORT

Structure # 03719  
BITTERROOT RIVER 010 - W MISSOULA

## Bridge Inspection Date: 06/21/2021

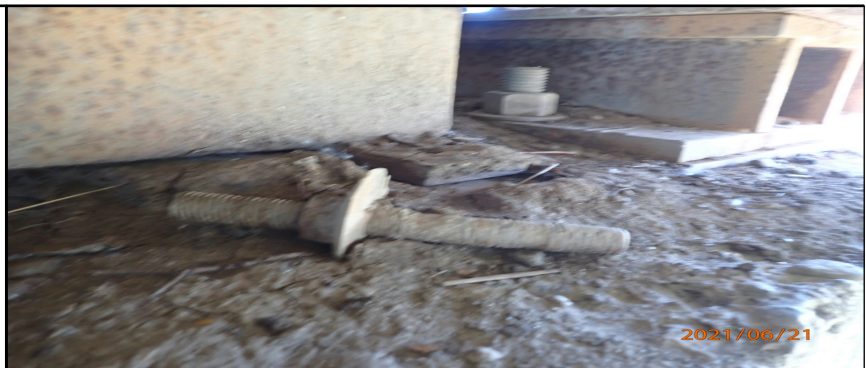
Photo #:Span 2 Bent 3 Broken Bearing Tube Anchor Rod at Stringer 8, Looking SE

Span 2: The stringers had failed paint along their entire length with minor surface corrosion.  
 Span 2: The east anchor rod at Stringer 4 at the west anchor rod at Stringer 8, which secure the hollow bearing tube to Bent 3, were sheared. The west anchor rod at Stringer 3 exhibited up to 50% loss of section. The hollow tube moved up to 1/2 in. under live load. Stringers 4, 5, 7 and 8 had gaps between the bottom flange and the stringer bearing tube at Bent 3. See video of movement uploaded to Inspection Documents. (8 LF CS3)  
 Span 2: Stringer 2 at Bent 2 and Stringers 5, 7, and 8 at Bent 3 exhibited heavy corrosion in the webs with through holes at the bearing locations. See 2021 Fracture Critical Inspection Report, Table 3, for specific locations and extents. (8 LF CS4)  
 Span 2 Stringers 2, 4, and 5 at Bent 2 and Stringer 3 at Bent 3 exhibited delamination up to 1/4 in. thick on the webs at the bearing locations. See 2021 Fracture Critical Inspection Report, Table 3, for specific locations and extents. (8 LF CS3)

Repair Suggestions:					
Repair ID	Date Requested	Type	Status	Priority	Comments
#Error	08-09-2021	Repair suggestion	Open	High	Replace the broken stringer bearing tube and anchor rod at the south end of Bent 3 (see Span 2 Stringer Connection Defect for photos).
#Error	08-09-2021	Repair suggestion	Open	Low	Replace the seal in the Bent 3 compression joint (see Compression Joint Seal Damage Defect for photos).
#Error	08-09-2021	Repair suggestion	Open	Low	Both moveable bearings at Abutment 1 should be replaced/reset (see Main Span Moveable Bearing Defects for photos).
#Error	08-09-2021	Repair suggestion	Open	High	Shim the stringers/bearing tube at Abutment 1 and Bent 3 to reduce movement when loads pass above (see Span 2 Stringer Settlement Defect for photos).

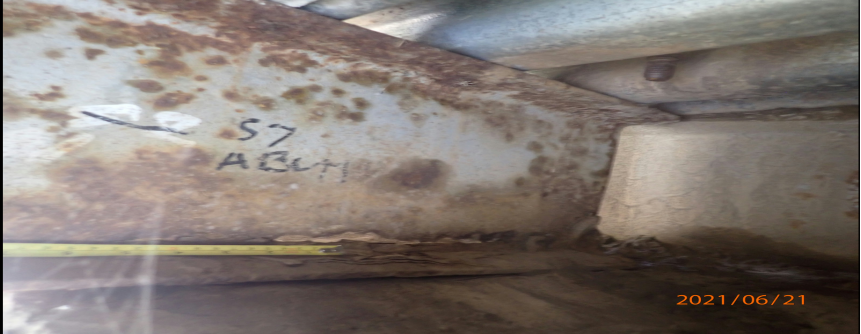
Element #	Parent Element	Name	Unit	Quantity	%CS 1	%CS 2	%CS 3	%CS 4
Photo #:Span 1 Stringer 7 at Abutment 1 Corrosion, Looking SW  Location:  Comments:  Element:113 - Steel Stringer (LF) Pony Truss

CS3/CS4 Stringers 2 and 5 over Bent 2 and Stringers 2, 5, 7, and 8 over Bent 3 had heavy corrosion with areas of through corrosion. See 2019 FC Inspection Report for table of measurements. (CS3 - 8 LF, CS4 - 6 LF) Condition State 3 : 2.55  
The unpainted stringer had minor to moderate corrosion with negligible section loss. Condition State 2 : 100  
The stringers had failed paint along their entire length with minor surface corrosion and negligible section loss.  
Condition State 2 : 94.59  
The stringer bearing tube at Bent 3 had a broken anchor rod at the south end. Condition State 3 : .32  
Stringers 4, 5, and 7 had gaps between the bottom flange and the stringer bearing tube at Bent 3. When vehicles drove over the bridge, the bearing tube was observed typically moving up to 1/4 in. and up to 1/2 in. at the south end. Condition State 3 : .64  
CS3/CS4 Stringers 2 and 5 over Bent 2 and Stringers 2, 5, 7, and 8 over Bent 3 had heavy corrosion with areas of through corrosion. See 2019 FC Inspection Report for table of measurements. (CS3 - 8 LF, CS4 - 6 LF) Condition State 4 : 1.91

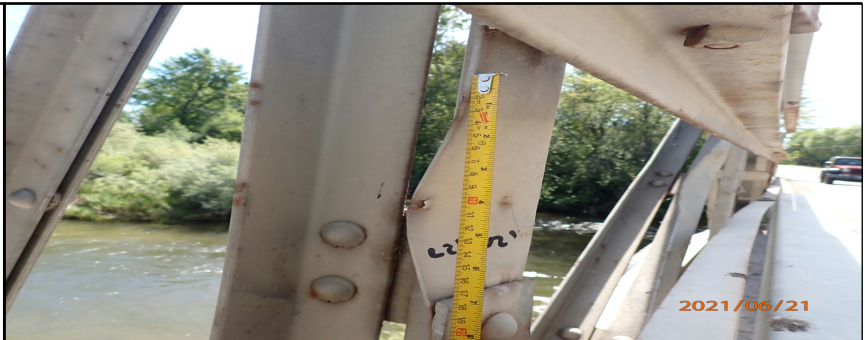
Photo #:Span 2 L2'U2'N Impact Damage, Looking E

Span 2: Vertical L2'-U2' N interior flange was bent 1 in. out of plane over a 6 in. height. (1 LF CS2 - Overlaps with CS3 Corrosion.)

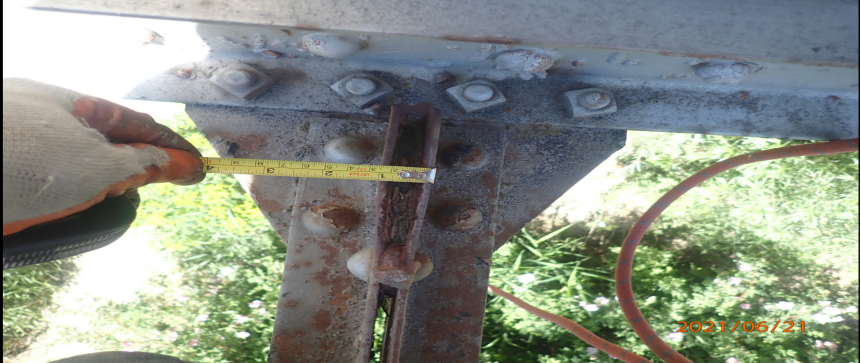
Element #	Parent Element	Name	Unit	Quantity	%CS 1	%CS 2	%CS 3	%CS 4
<p>Photo #:Span 2 L2'S Typical Pack Rust at Sway Brace Frame Lower Strut, Looking N</p> <p>Location:</p> <p>Comments:</p> <p>Element:120 - Steel Truss (LF) Pony Truss</p>

Span 2: Panel Points L2N, L2'N, L2S, and L2'S exhibited pack rust up to 3/4 in. thick between the lower strut angles of the outboard sway brace frames and pack rust up to 1/4 in. thick between the lower chord and both the inboard and outboard gusset plates. (16 LF CS3)

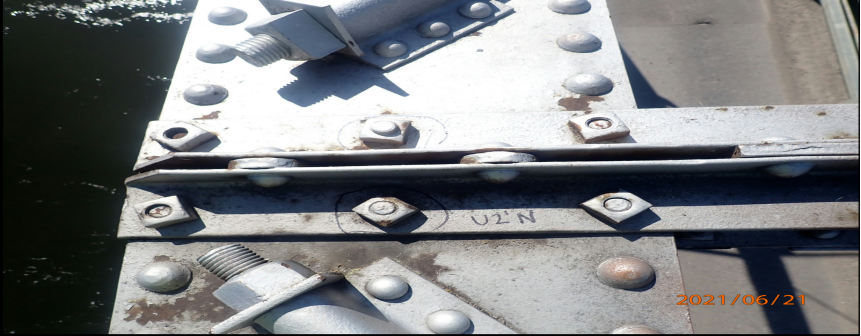
Element #	Parent Element	Name	Unit	Quantity	%CS 1	%CS 2	%CS 3	%CS 4
<p>Photo #:Span 1 Upper Strut U2'N Loose Bolts, Looking E</p> <p>Location:</p> <p>Comments:</p> <p>Element:120 - Steel Truss (LF) Pony Truss</p>

(2) bolts were loose at the upper horizontal strut to top connection plate at U2'N. Condition State 2 : .83

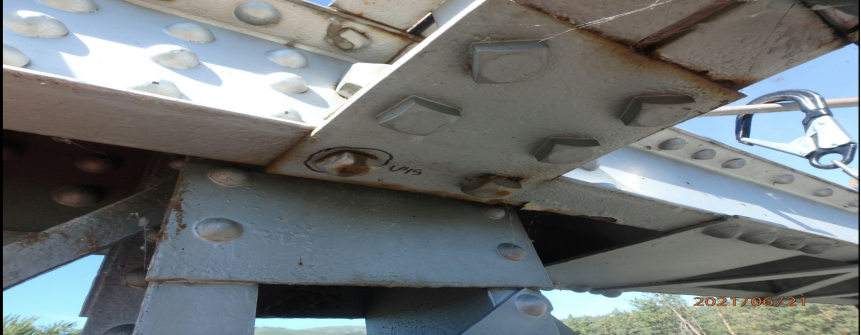
Element #	Parent Element	Name	Unit	Quantity	%CS 1	%CS 2	%CS 3	%CS 4
<p>Photo #:Span 1 U4S Loose Bolt at Upper Sway Brace Underside Connection, Looking S</p> <p>Location:</p> <p>Comments:</p> <p>Element:120 - Steel Truss (LF) Thru-Truss</p>

(1) bolt was loose at the upper horizontal strut to top connection plate at both U2S and U4S.

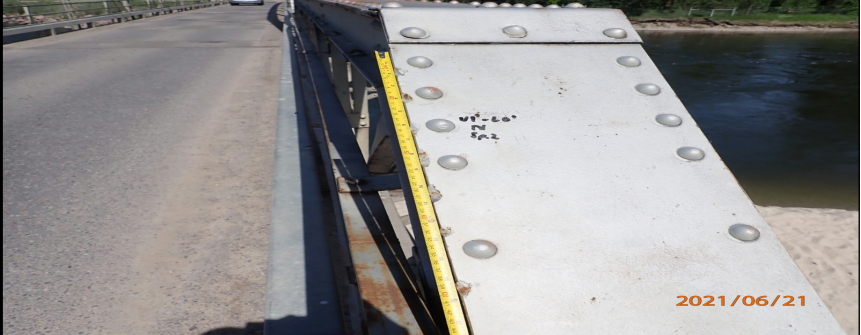
Element #	Parent Element	Name	Unit	Quantity	%CS 1	%CS 2	%CS 3	%CS 4
Photo #:Span 2 U1'L0'N Impact Damage, Looking W  Location:  Comments:  Element:120 - Steel Truss (LF) Pony Truss

Span 2: Diagonal U1'-L0' N had 7 areas of impact damage up to 1/4 in. out of plane and 3/4 in. long over a 15 in. length. (2 LF CS2)
