# STRUCTURE INSPECTION REPORT

Structure # 03719  
BITTERROOT RIVER 010 - W MISSOULA

## Bridge Inspection Date: 08/08/2017

Bridge No. L32101000+01001  
Missoula, Montana  
Condition Evaluation Report:  
Routine and Fracture Critical Inspection  
Inspection Date: August 8 and 10, 2017

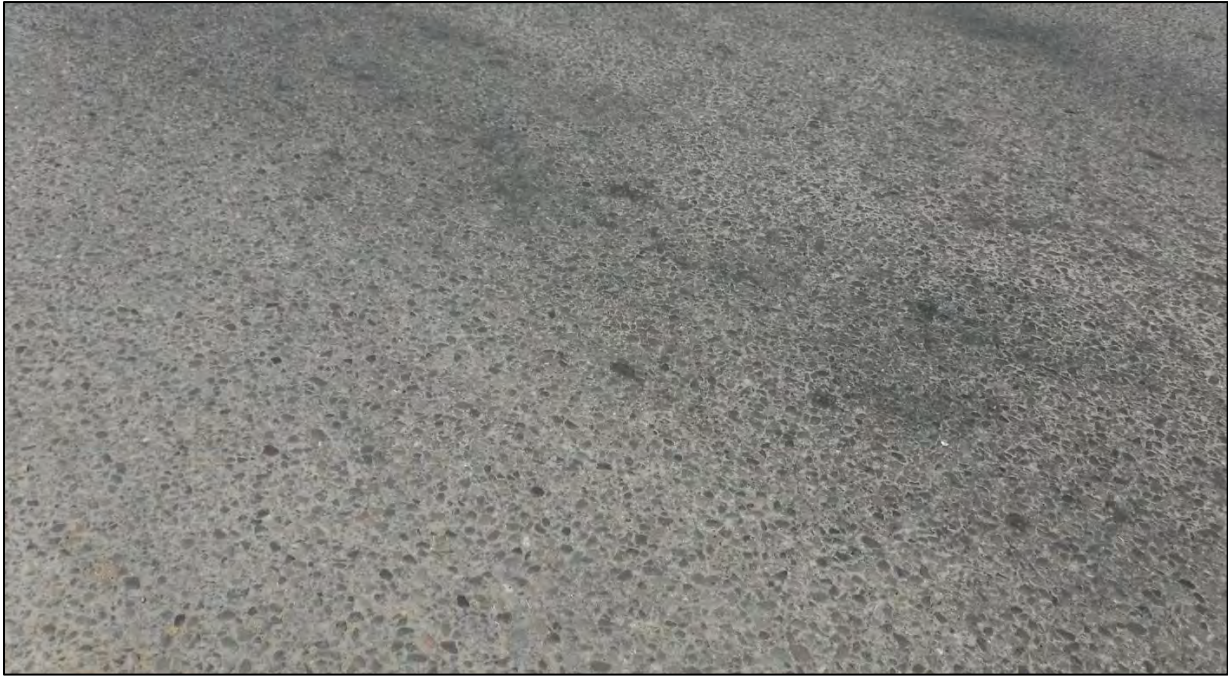
**Photo 18:** Minor wear to West Approach. Similar condition on East Approach

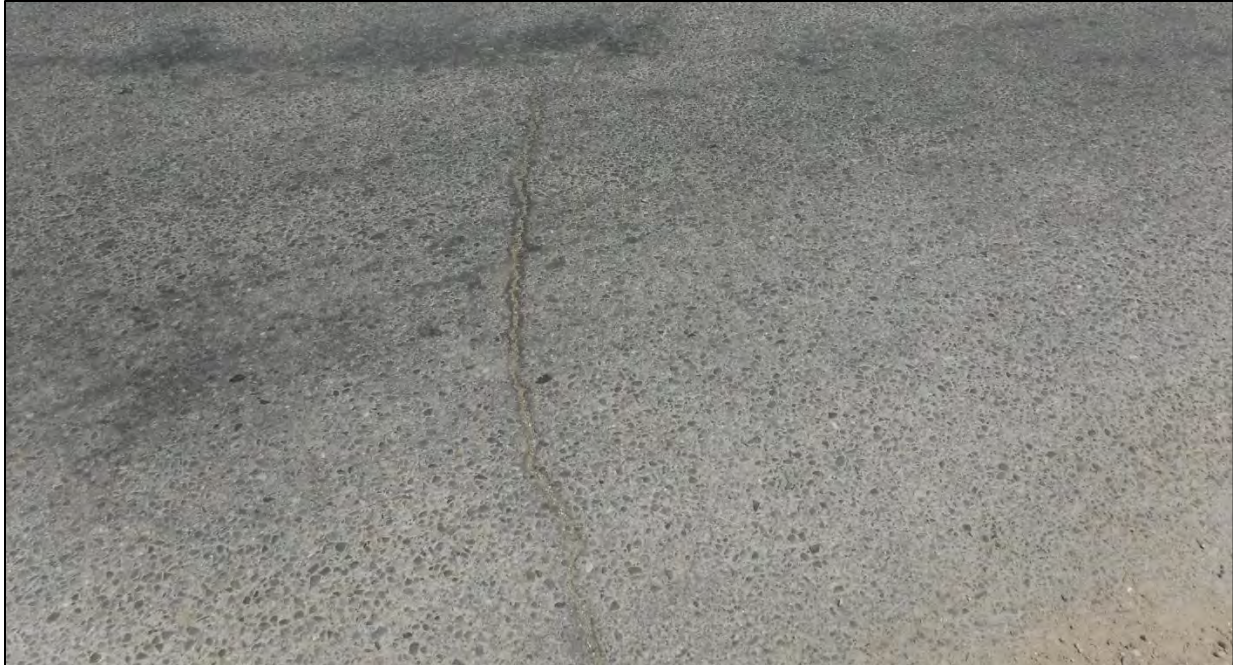
**Photo 20:** 1/4 in. wide transverse crack located 18 ft. from the West Transition

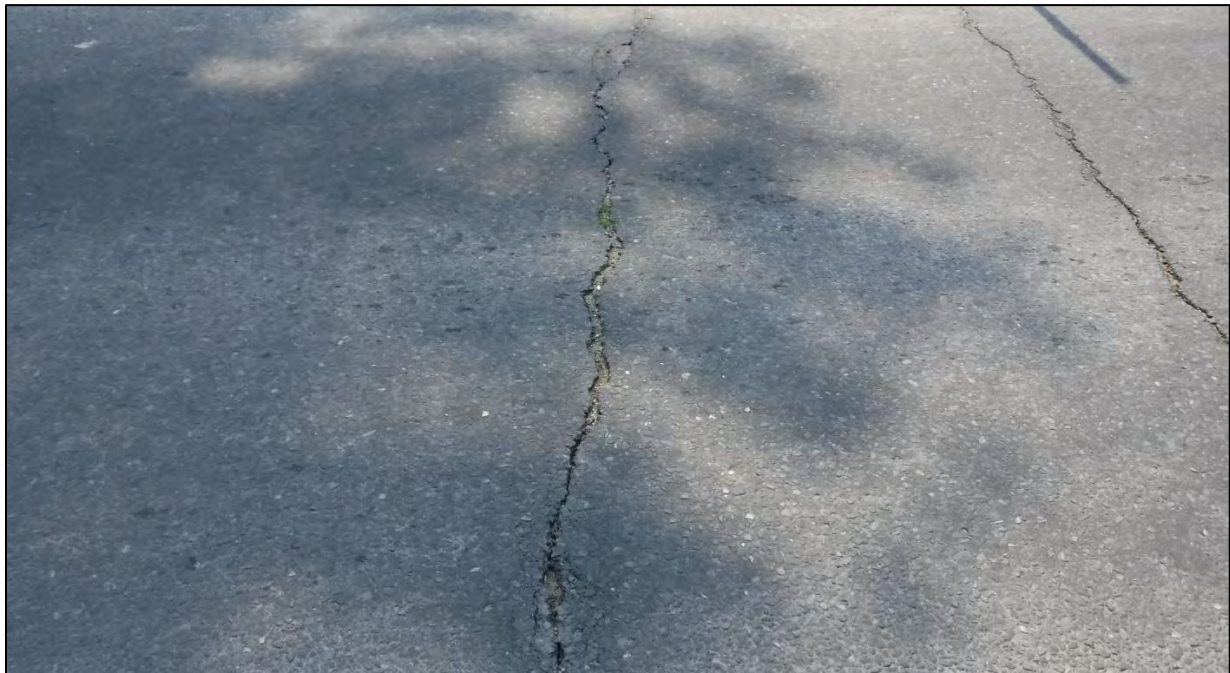
**Photo 21:** 1/2 in. wide transverse crack located 4 ft. from the East Transition

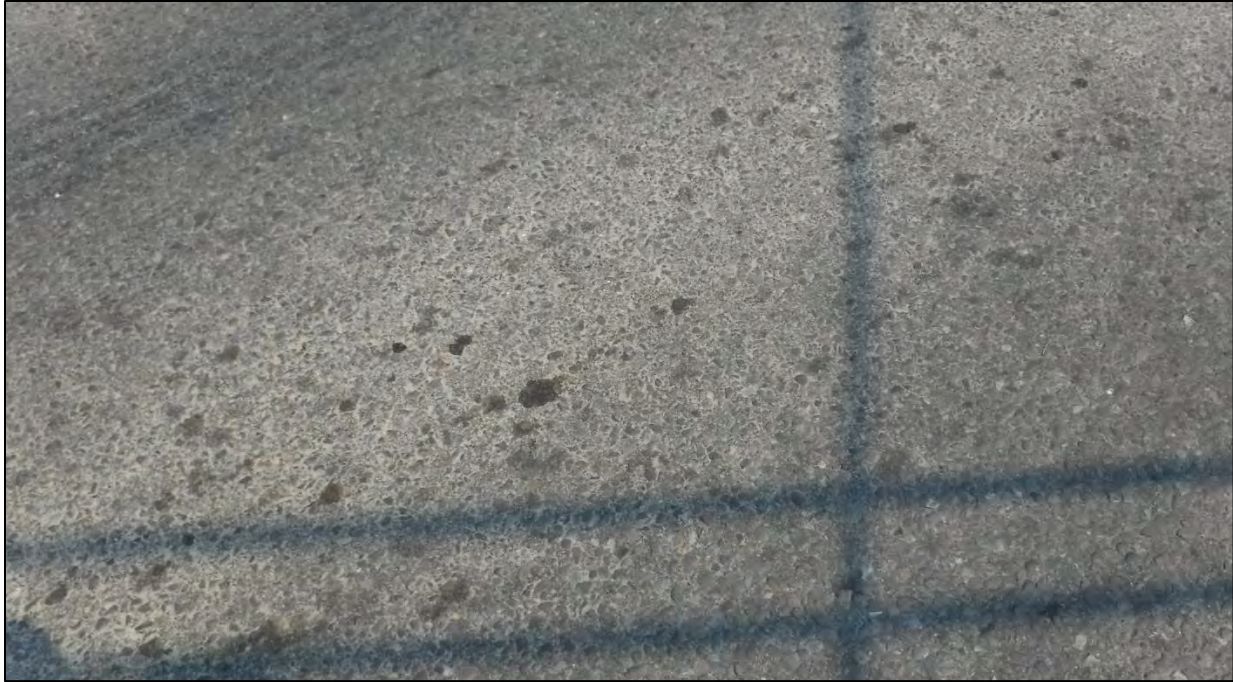
**Photo 22:** Typical minor wear on Span 1 bituminous overlay

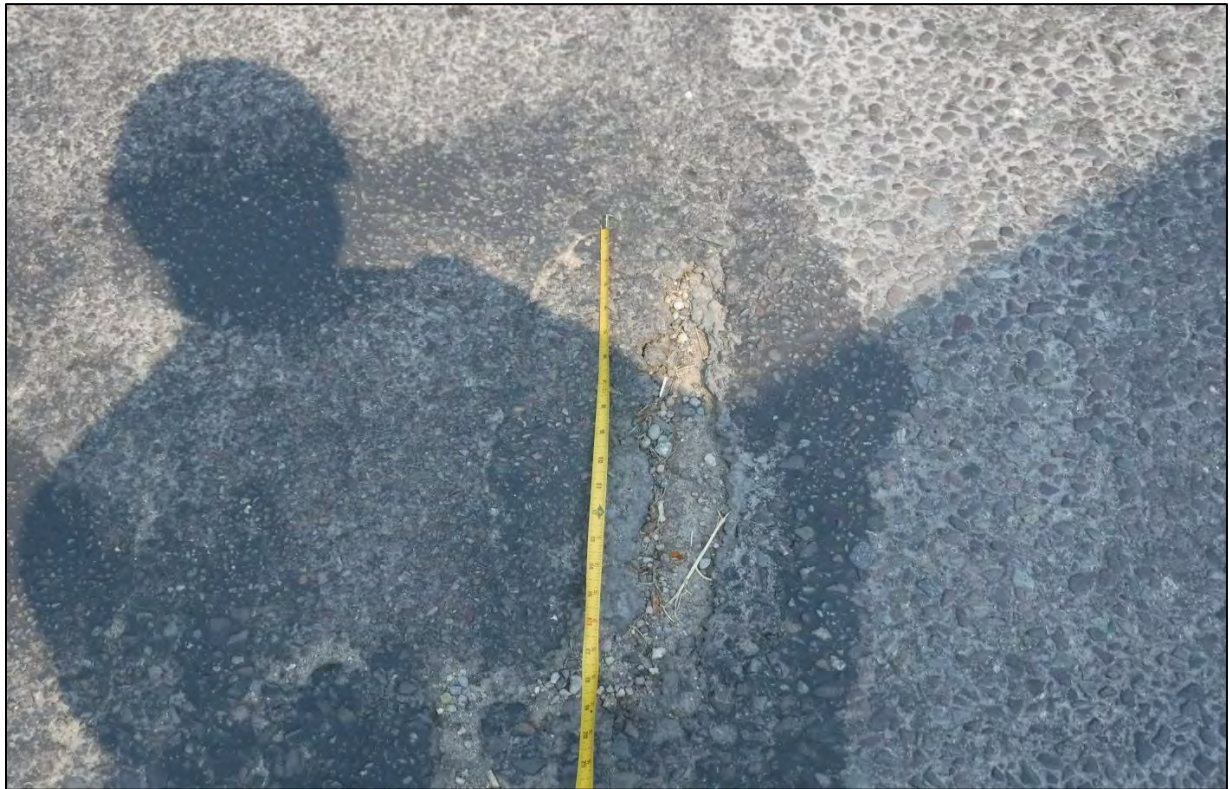
**Photo 23:** Typical minor wear on Span 1 bituminous overlay

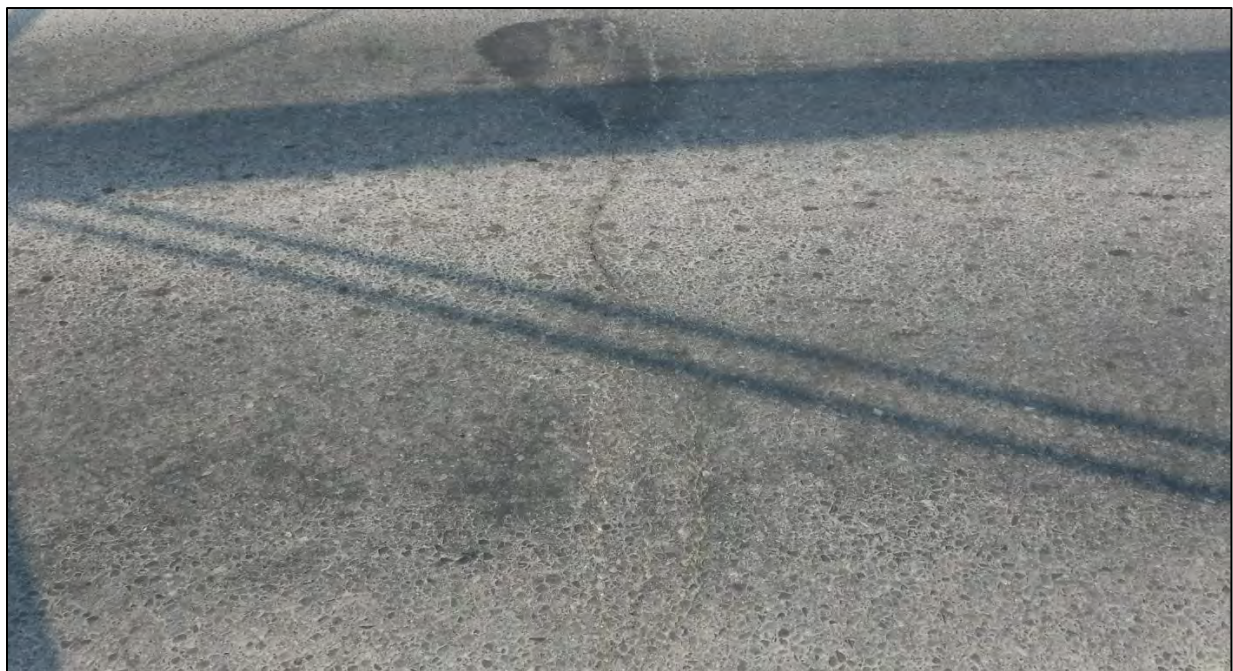
**Photo 25:** Typical 1/8 in. wide transverse crack located above each floor beam

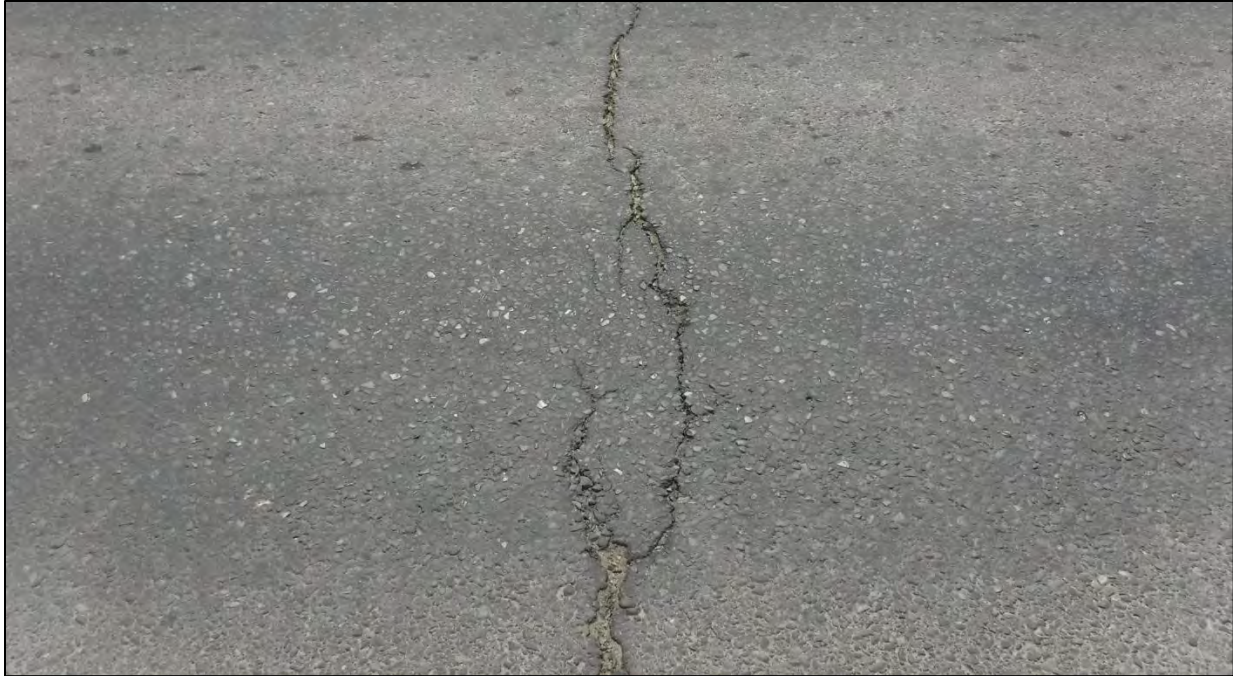
**Photo 26:** Transverse crack up to 1/2 in. wide over Bent 4

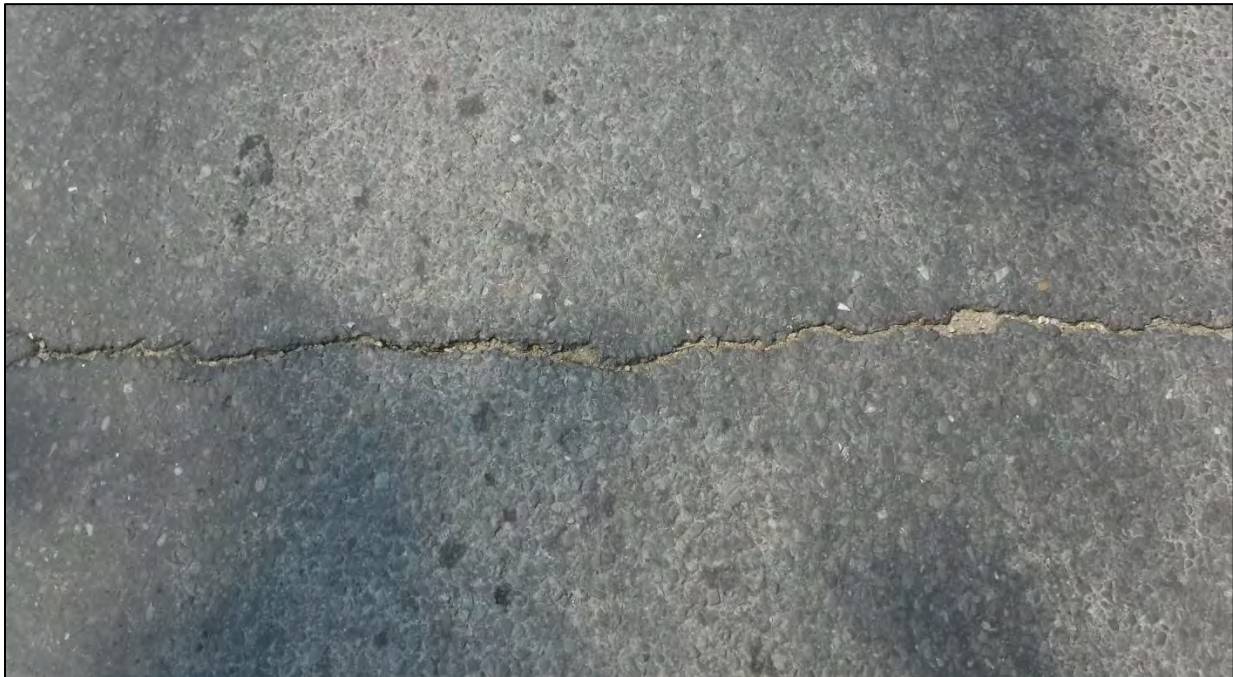
**Photo 27:** Transverse crack up to 1/2 in. wide over Abutment 5

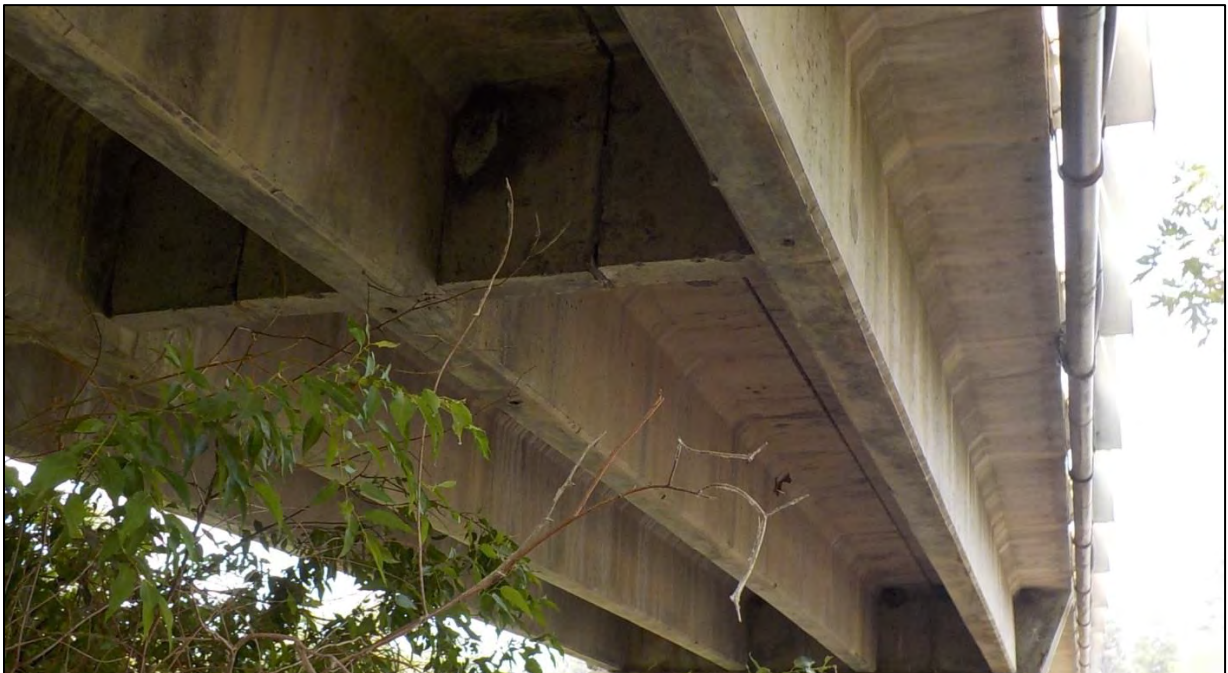
**Photo 29:** Typical underside of Span 3 deck

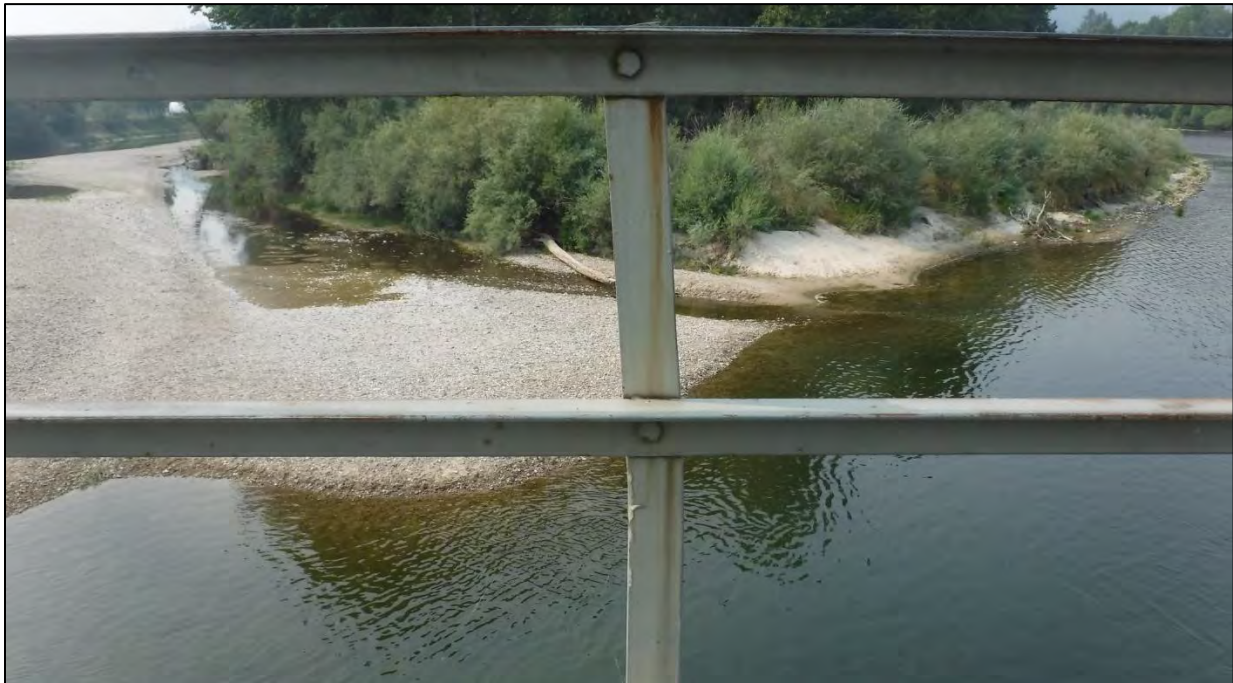
**Photo 33:** The vertical angle on the South Rail between Panel Point 4' and 3' was bent 1-1/2 in. over a 2 ft. length due to impact damage

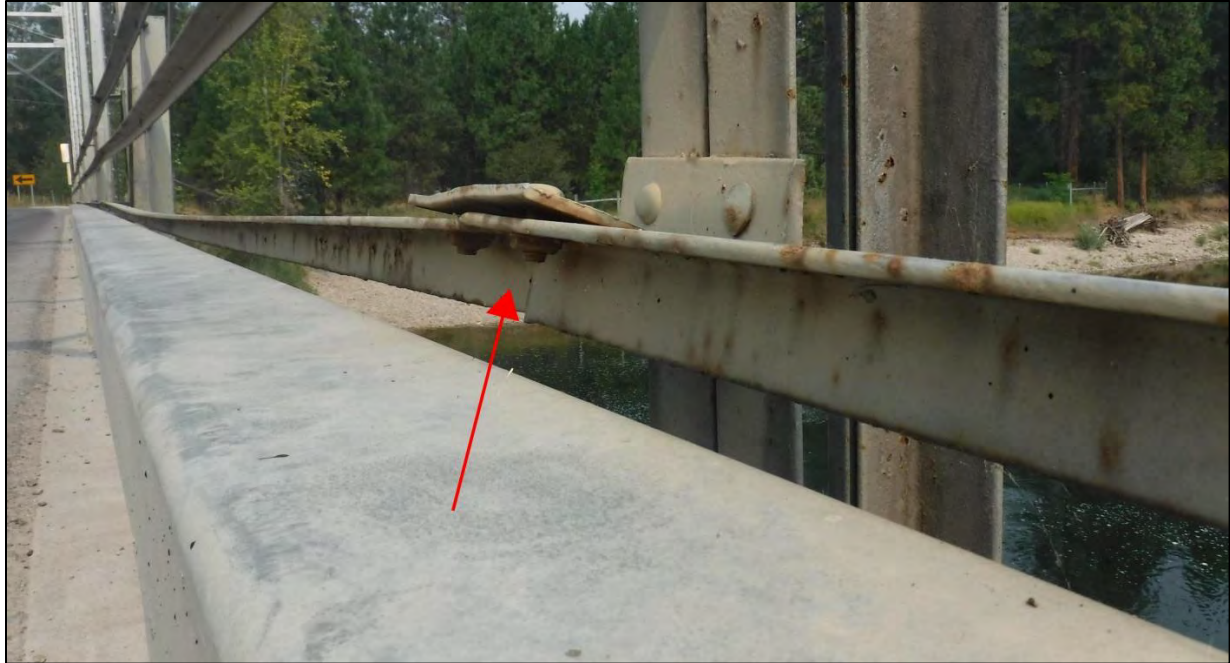
**Photo 34:** North Rail, Panel Point 1': The bottom angle was bent 3/4 in. upwards

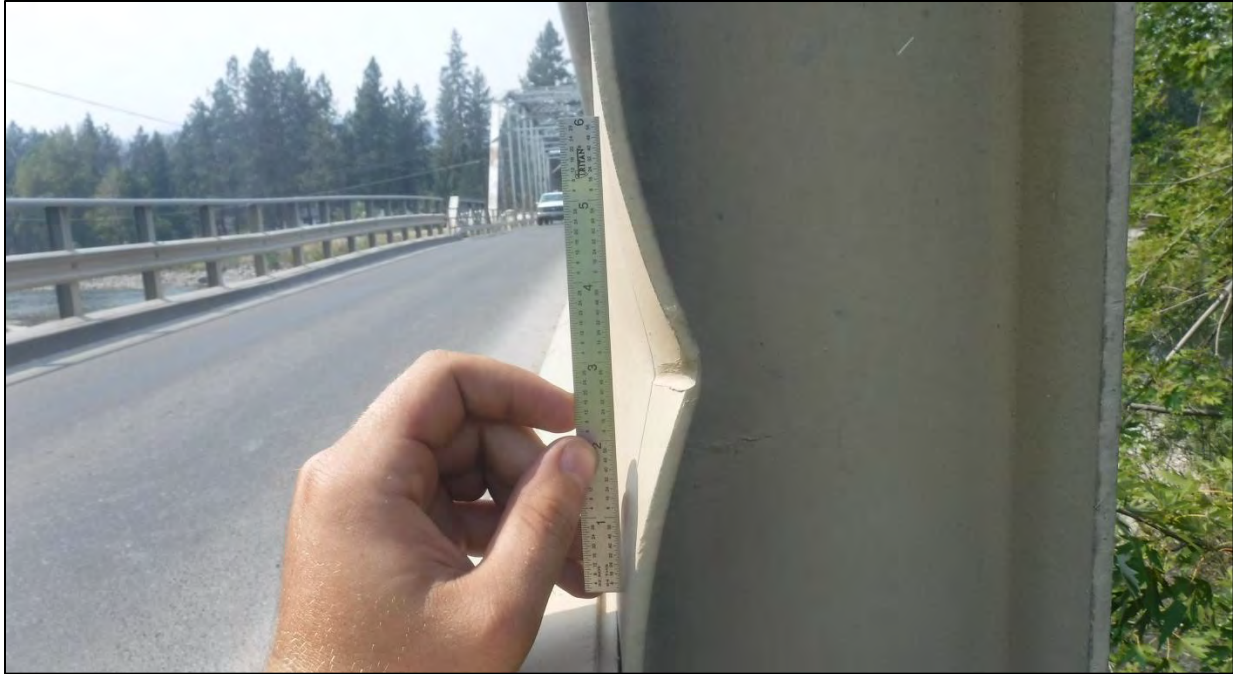
**Photo 36:** Three vertical members had impact damage that bent the interior flange 3/4 in. over a 6 in. length on the North Rail near the East Approach

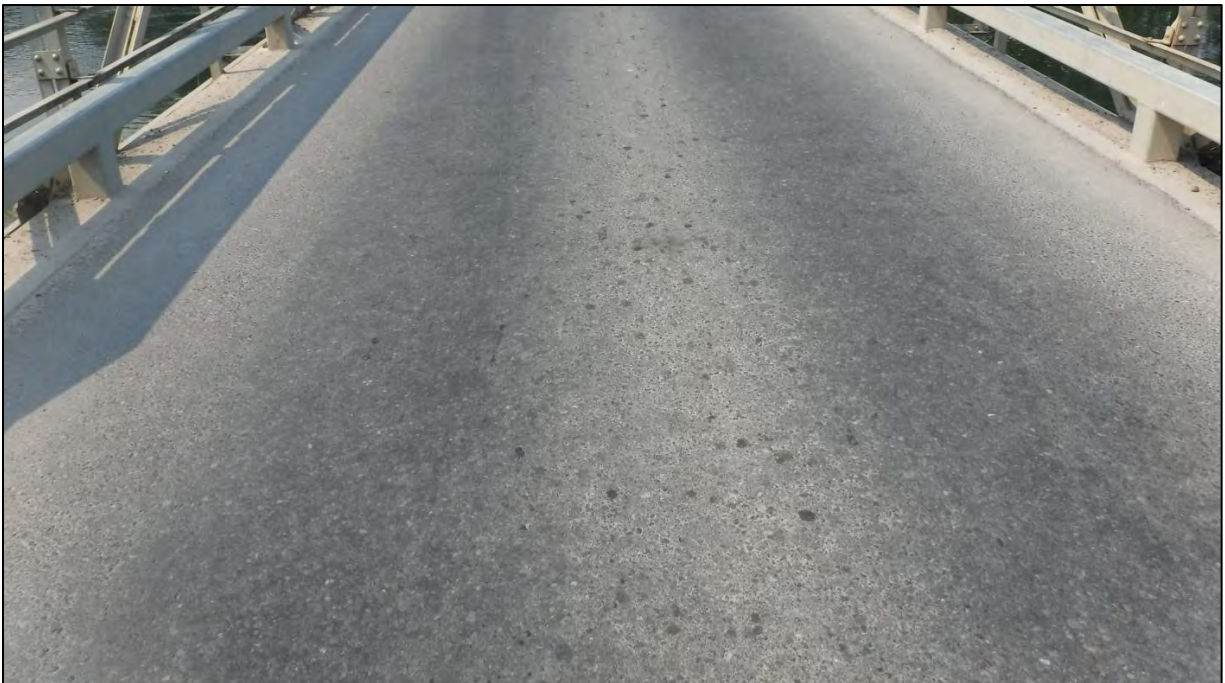
**Photo 37:** Typical minor wear on Span 2 bituminous overlay

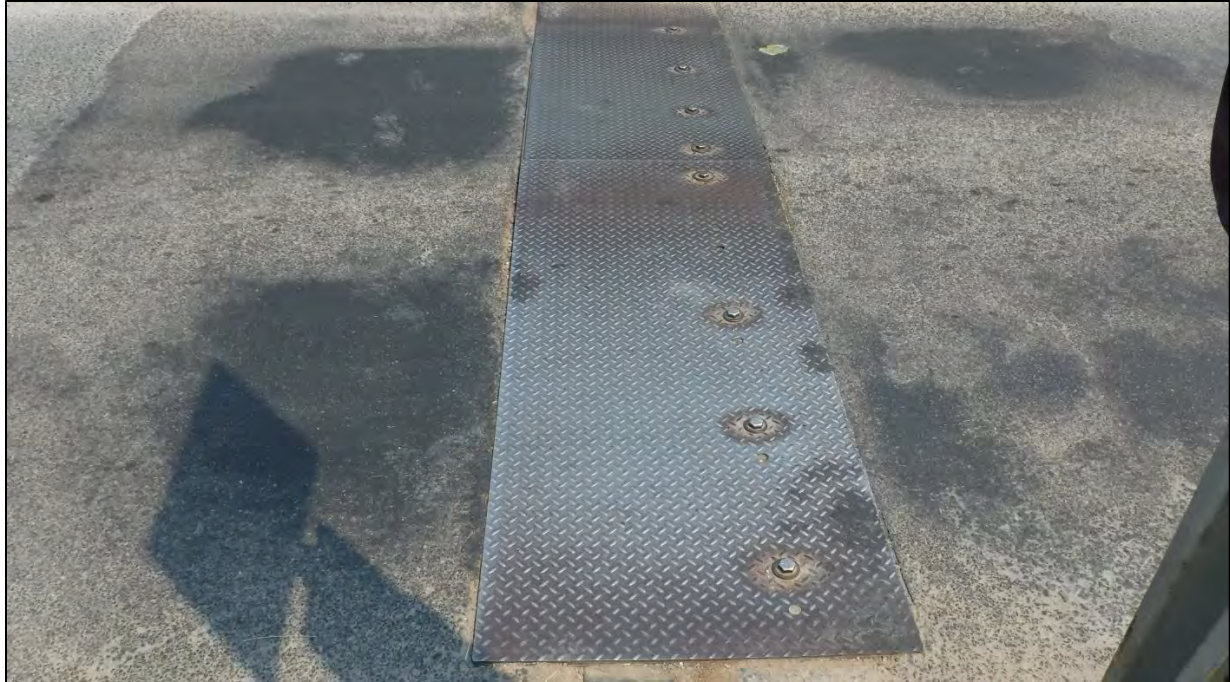
Joint 1 over Abutment 1 was a 11 ft. long by 30 in. wide metal plate bolted to the bridge deck on the east side of the joint (**Photo 38**).

**Photo 38:** Joint 1 over Abutment 1 looking north at joint

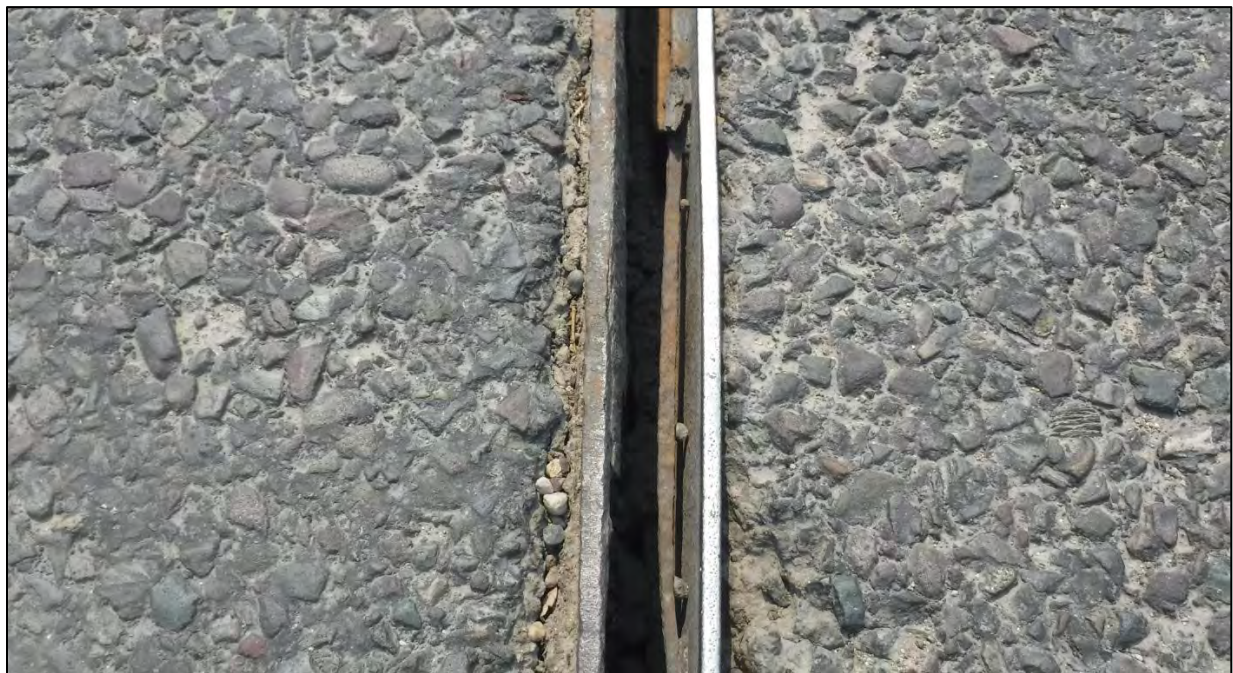
**Photo 41:** Joint 3 over Bent 3 with seal deterioration which was typical over 90 percent of the length

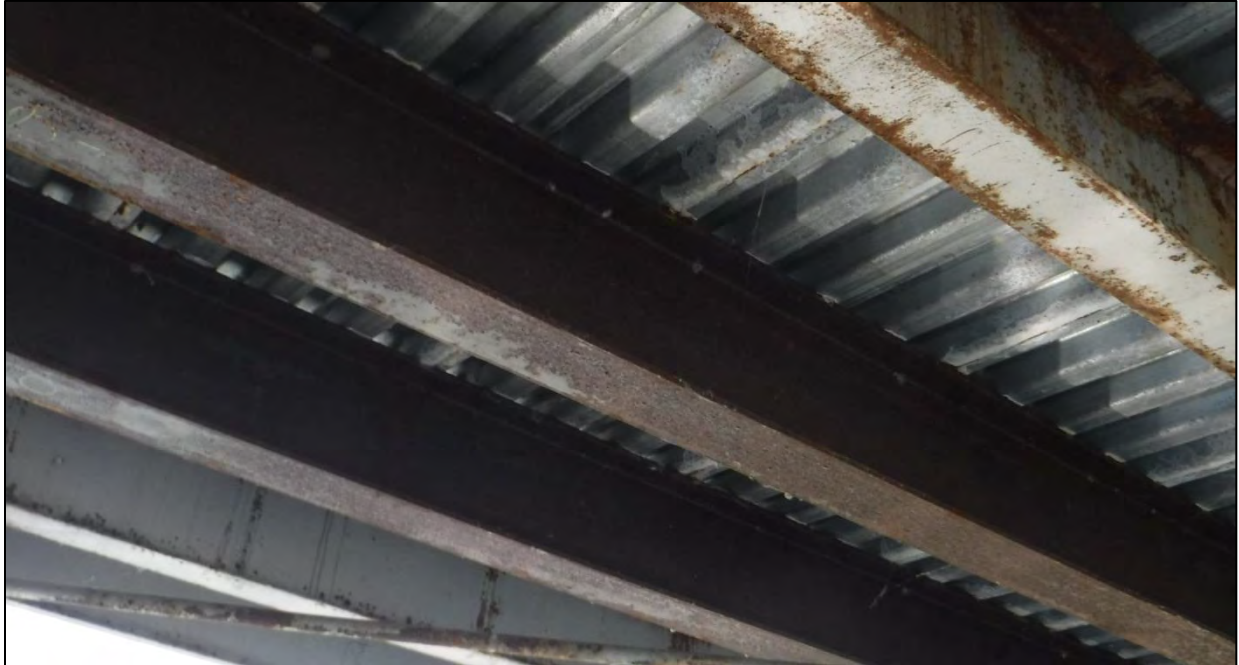
**Photo 44:** Typical unpainted stringers with minor to moderate corrosion and negligible section loss

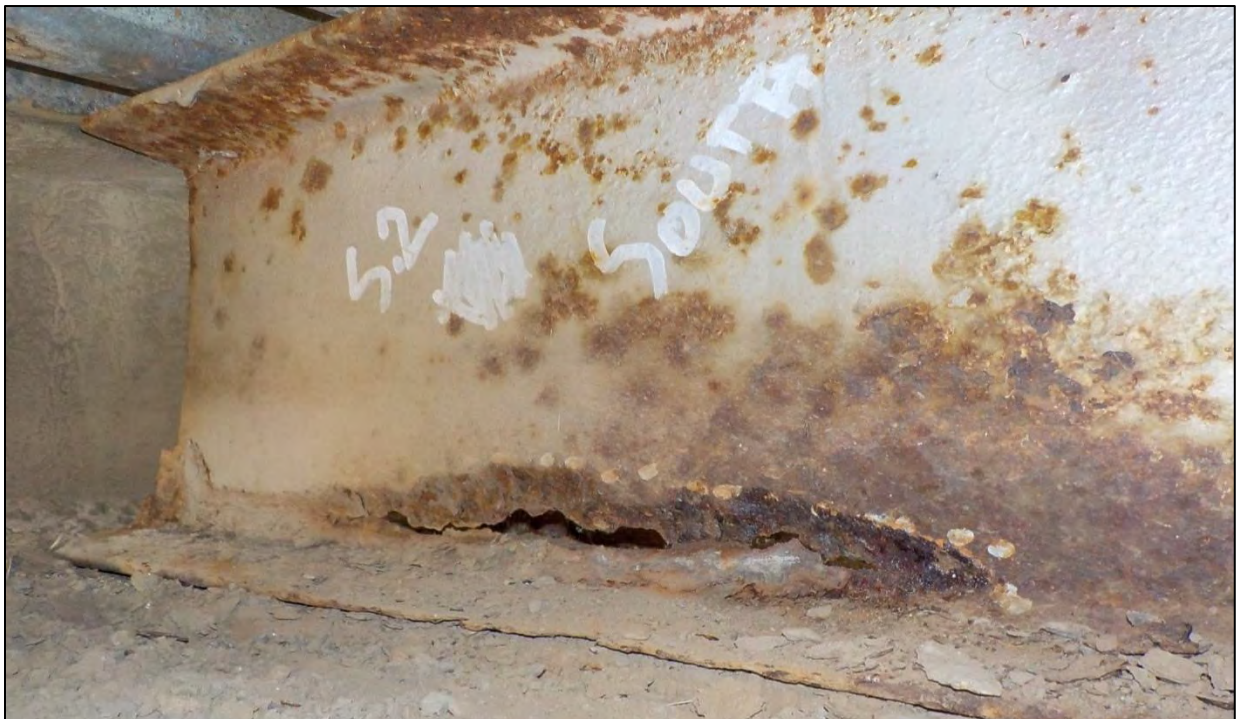
Stringers 2, 5, and 7 over Abutment 1 heavy corrosion over the end 2 ft. with areas of through corrosion. See 2017 FC Inspection Report for table of defects.

**Photo 45:** Span 1, Abutment 1, Stringer 2: the stringer web had heavy corrosion and section loss over a 17 in. long by 2 in. high area with a 1 in. diameter hole center 10 in. from the stringer end

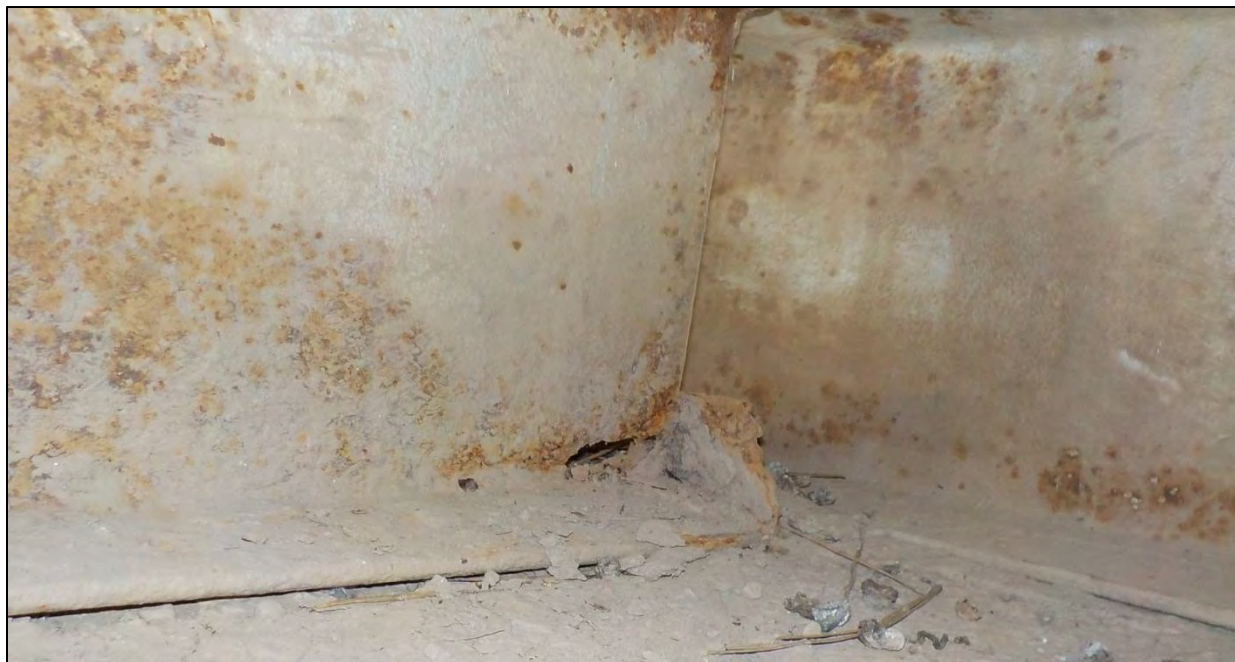
**Photo 47:** Span 1, Abutment 1, Stringer 7: the stringer web had heavy corrosion and section loss over a 14 in. long by 2 in. high area with a 2 in. long by 1/2 in. high hole center 2 in. from the stringer end

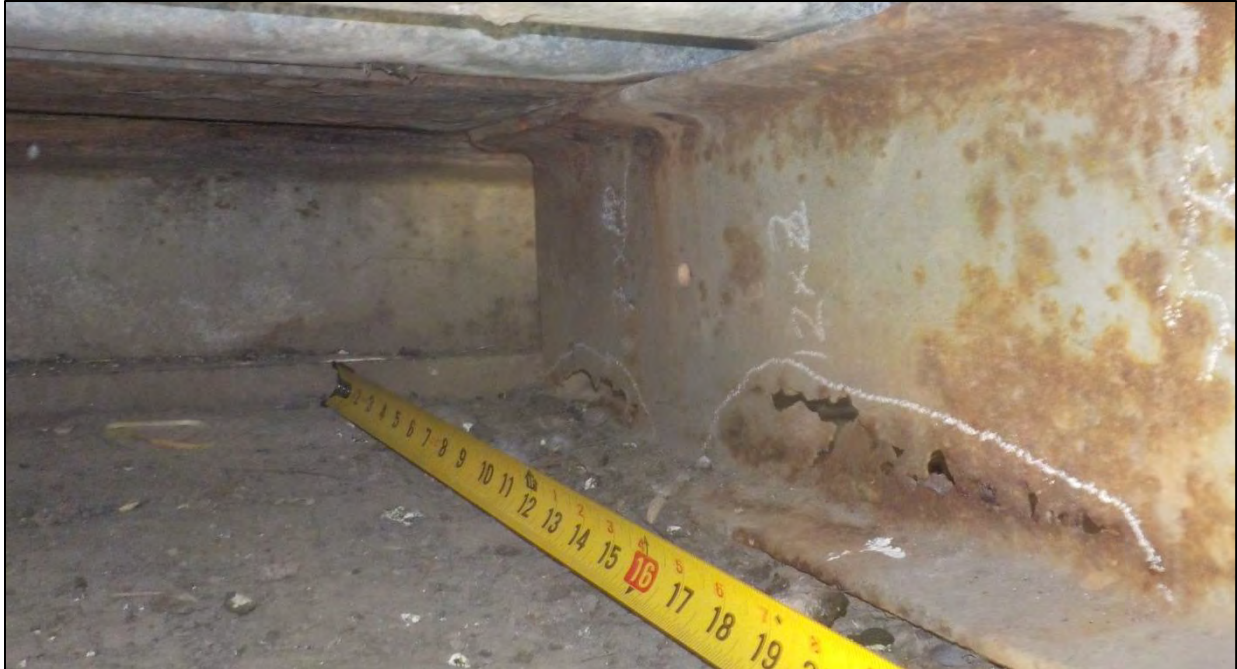
**Photo 48:** Span 2, Bent 2, Stringer 2: the stringer web had heavy corrosion and section loss with two holes; 7 in. long by 1 in. high and 6 in. long by 2 in. high centered 16 in. from the stringer end

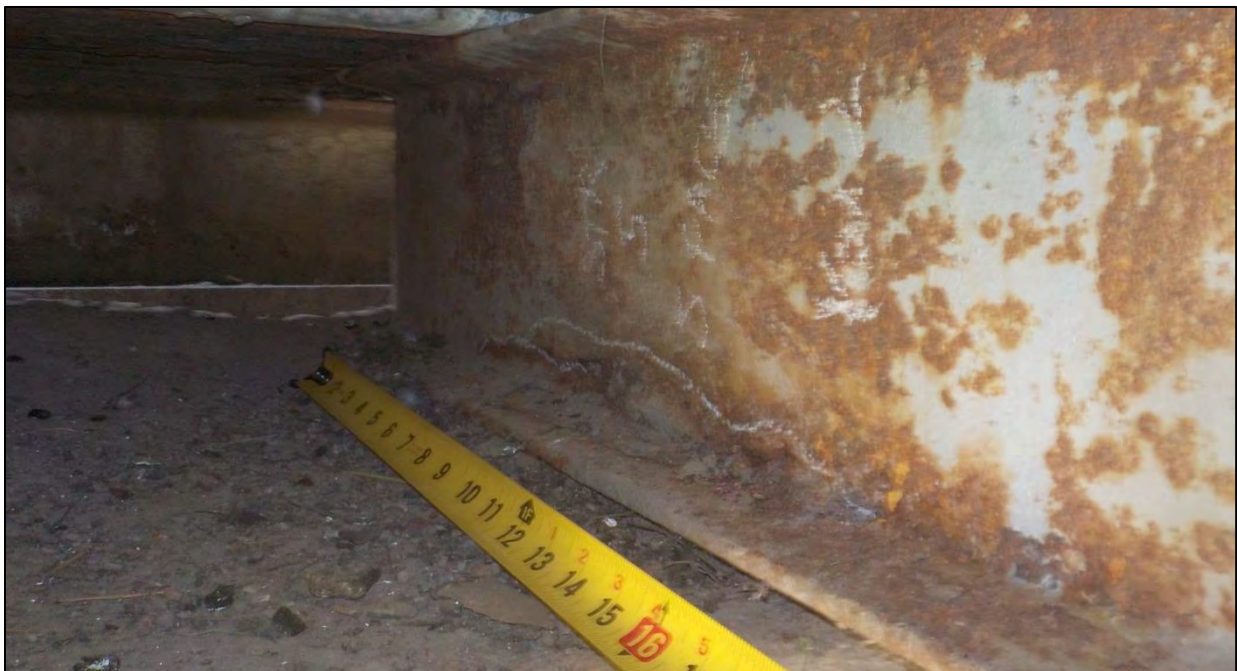
**Photo 49:** Span 2, Bent 2, Stringer 5: the south face had a 16 in. long by 2 in. tall area of pack rust up to 1/4 in. thick on the bottom of the web located 12 in. from the end of the stringer

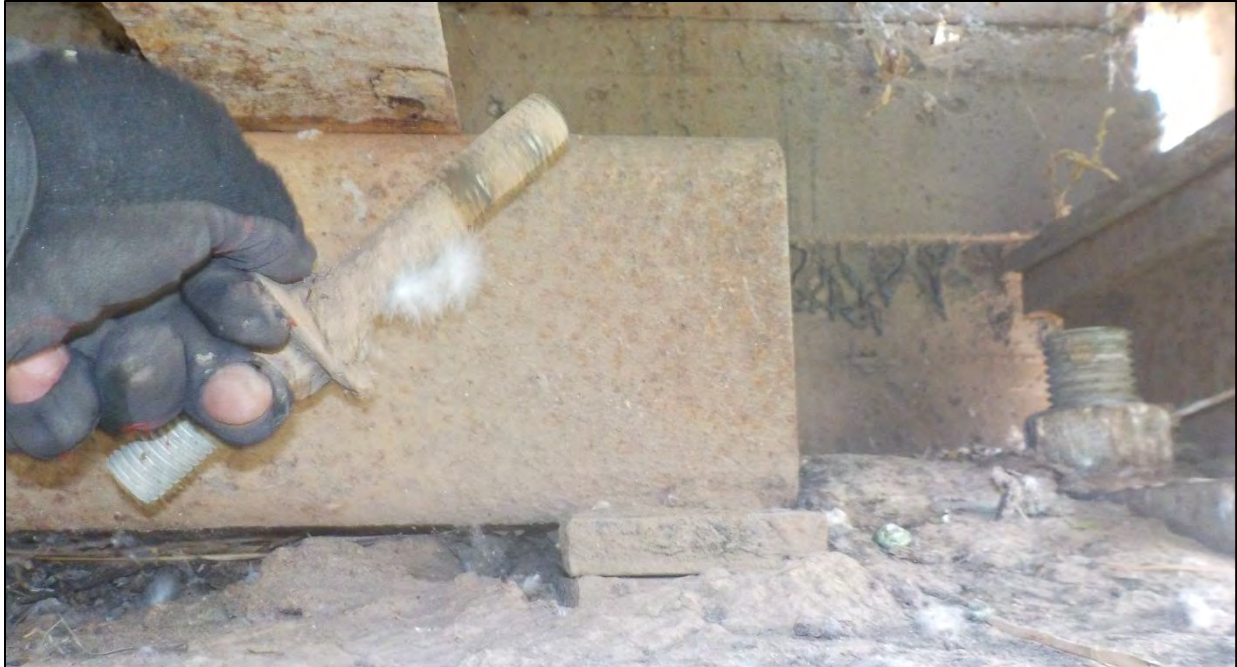
**Photo 50:** Span 2, Bent 3, All Stringers: the hollow pipe that the stringers were bearing on had vertical movement up to 1/4 in. when vehicles passed. The south anchor rod for the south pipe had failed and this edge of the pipe had movement up to 1/2 in. when vehicles passed

Repair Suggestions:					
Repair ID	Date Requested	Type	Status	Priority	Comments
#Error	10-17-2017	Repair suggestion	Open	High	Both movable bearings on Abutment 1 need to be replaced.
#Error	11-09-2017	Repair suggestion	Open	Low	Patch potholes in asphalt wearing surface.
#Error	11-09-2017	Repair suggestion	Open	Low	Replace joint seal above Bent 3
#Error	11-09-2017	Repair suggestion	Open	Low	Repair spalls with exposed steel reinforcement on curbs and bents.
#Error	11-09-2017	Repair suggestion	Open	High	Shim stringer ends on Span 2 Bent 3 to prevent vertical movement.

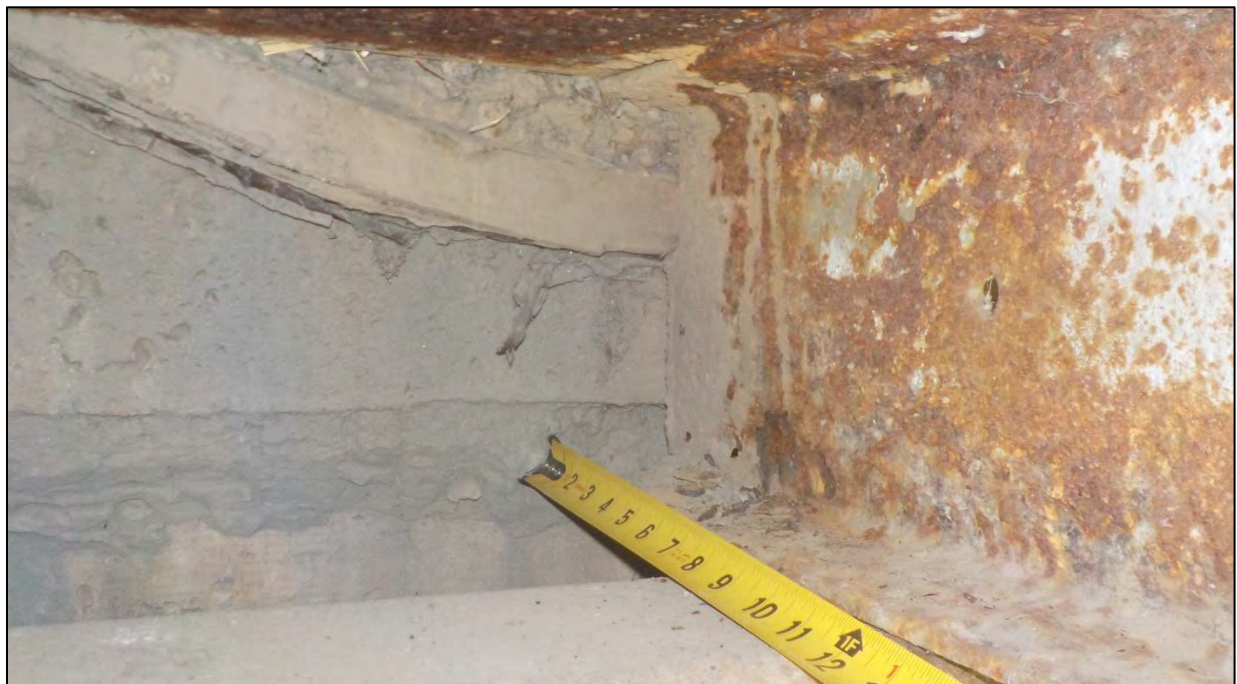
**Photo 51:** Span 2, Bent 3, Stringer 2: the stringer web had heavy corrosion with up to 1/8 in. thick rust scale on both sides of the stringer web at the web to lower flange interface adjacent to the stringer end

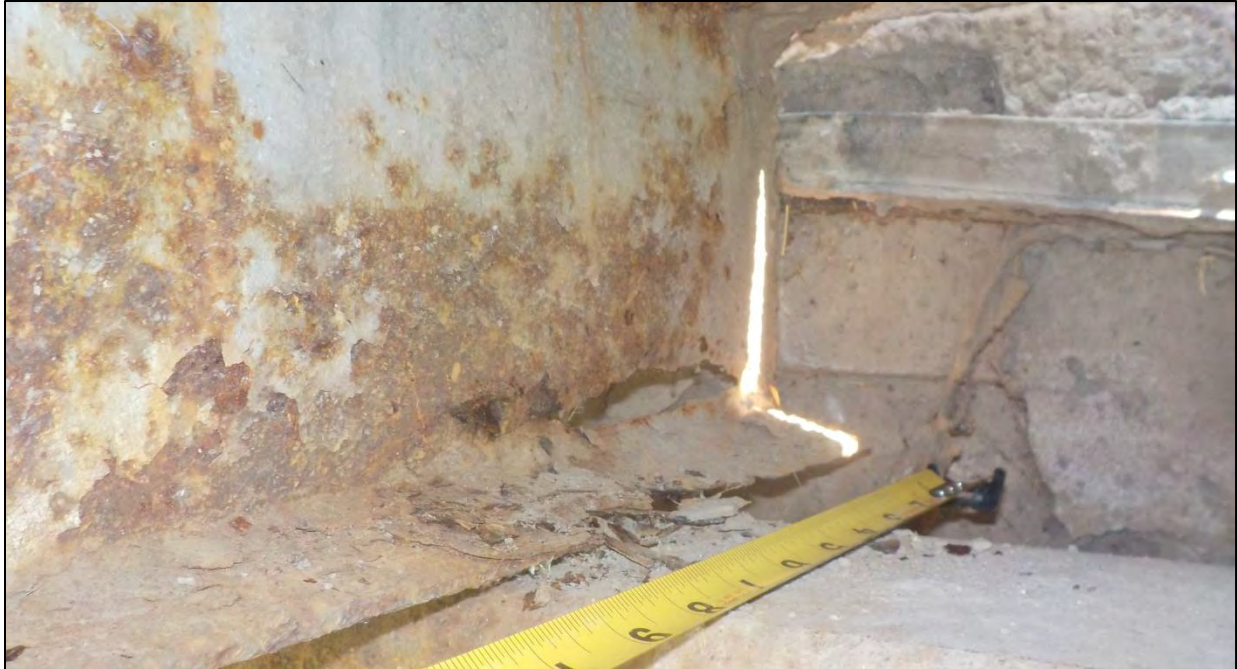
**Photo 52:** Span 2, Bent 3, Stringer 4: the stringer web had heavy corrosion and section loss with a 5 in. long by 1 in. high through hole near the stringer end. The bottom flange was knife edges in this area

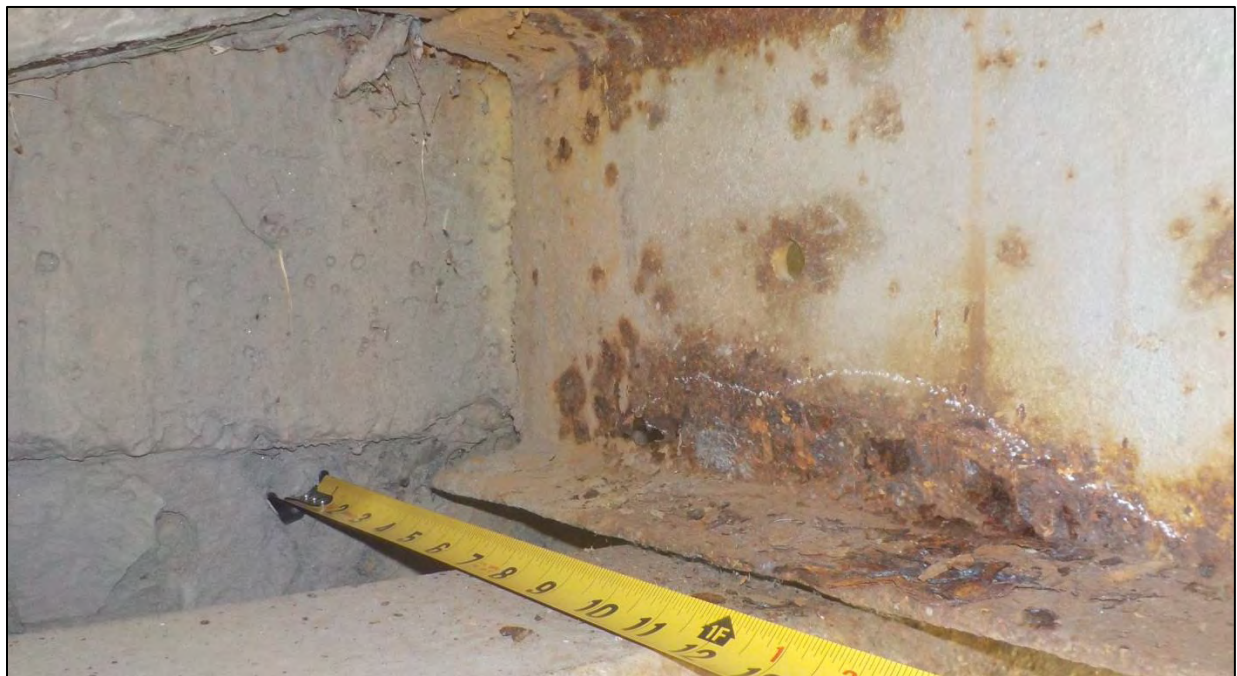
**Photo 53:** Span 2, Bent 3, Stringer 7: the stringer web had heavy corrosion with up to 50 percent section loss over a 6 in. long by 2 in. high adjacent to the stringer end that had a 1/2 in. diameter hole 6 in. from the stringer end at the web to lower flange interface

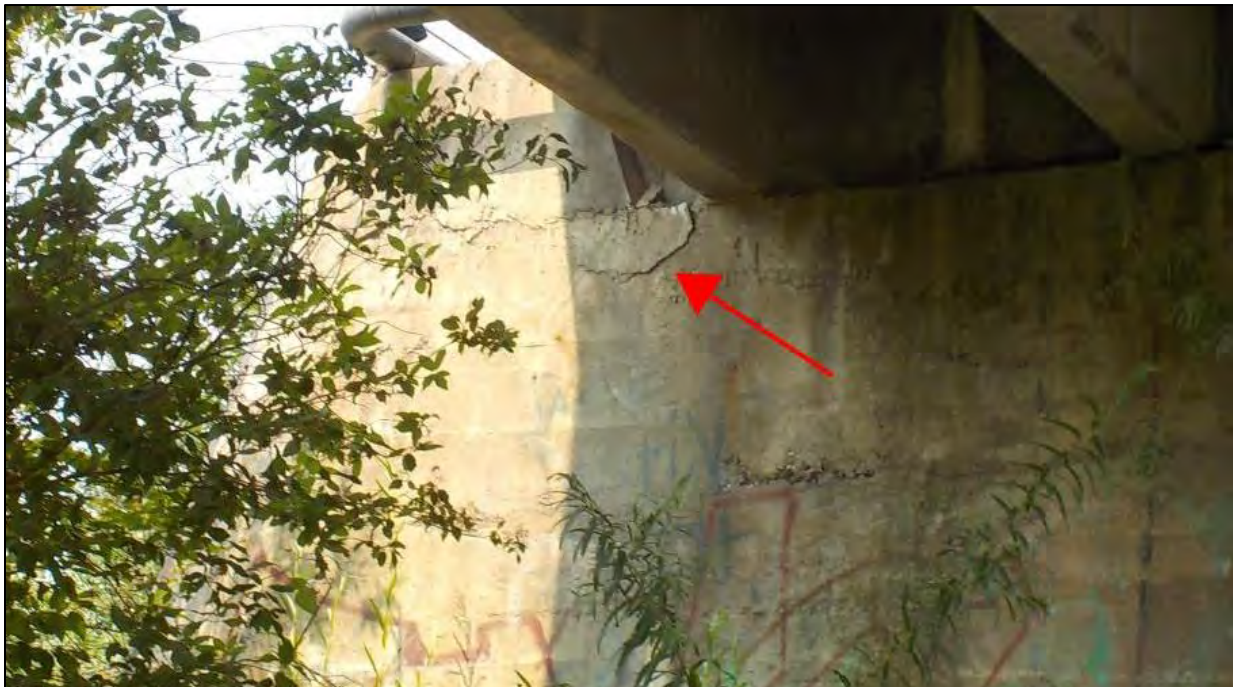
**Photo 57:** Bent 3 had a 12 in. wide by 10 in. high area of delamination on the top, southeast corner of the bent

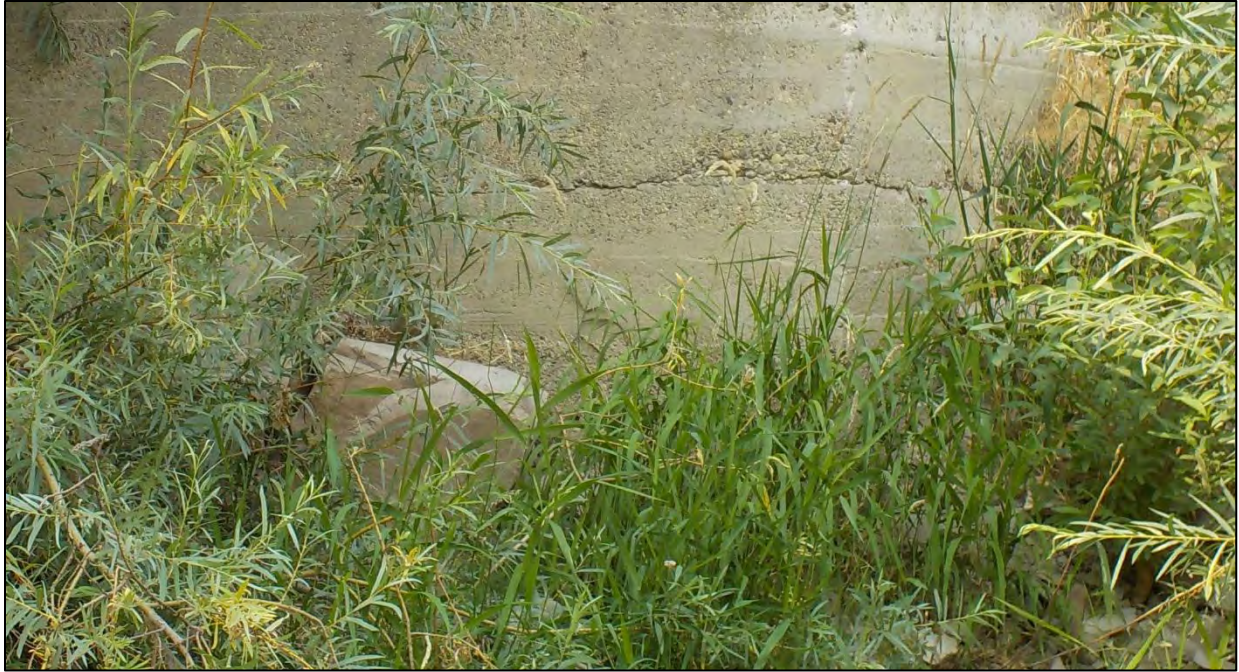
A 5 ft. long horizontal crack up to 1/16 in. wide was located near the bottom, northeast corner.

**Photo 58:** Bent 3 had a 5 ft. long horizontal crack up to 1/16 in. wide was located near the bottom, northeast corner
