# STRUCTURE INSPECTION REPORT

Structure # 03719  
BITTERROOT RIVER 010 - W MISSOULA

## Bridge Inspection Date: 08/08/2017

Bridge No. L32101000+01001  
Missoula, Montana  
Condition Evaluation Report:  
Routine and Fracture Critical Inspection  
Inspection Date: August 8 and 10, 2017

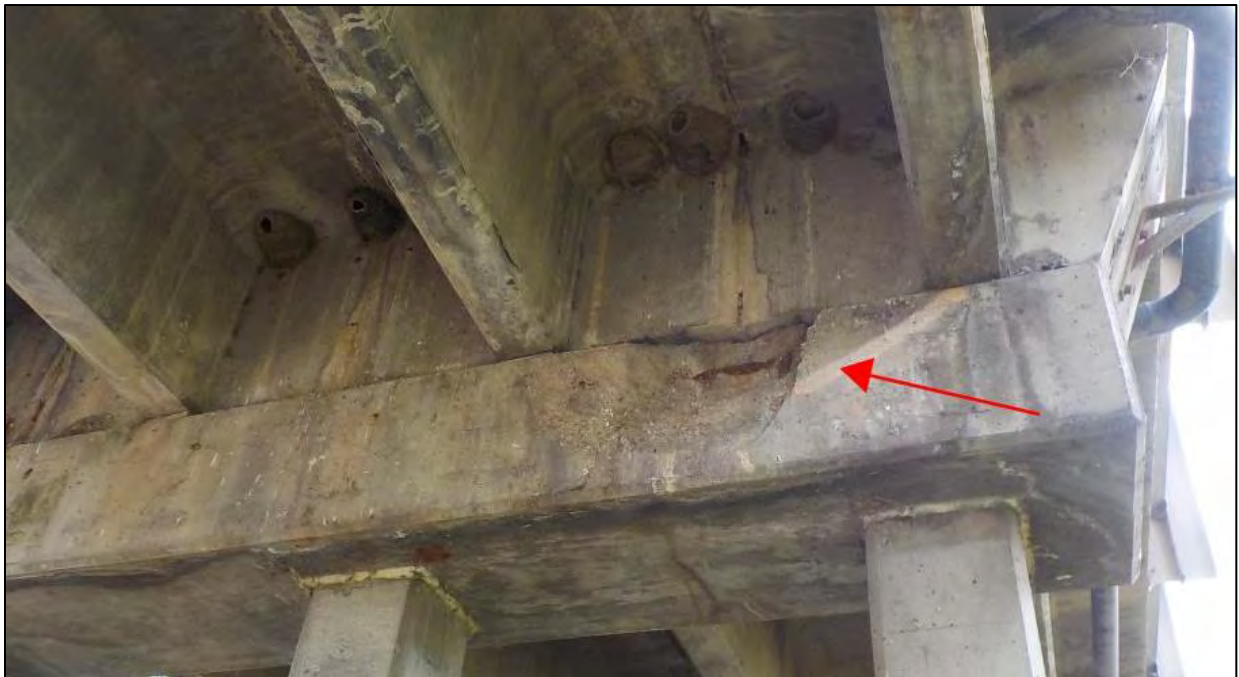
**Photo 59:** Bent 4 had a 3 ft. wide by 2 ft. high spall with exposed reinforcing steel on the west face of the bent cap. The exposed reinforcing steel had moderate corrosion with negligible section loss

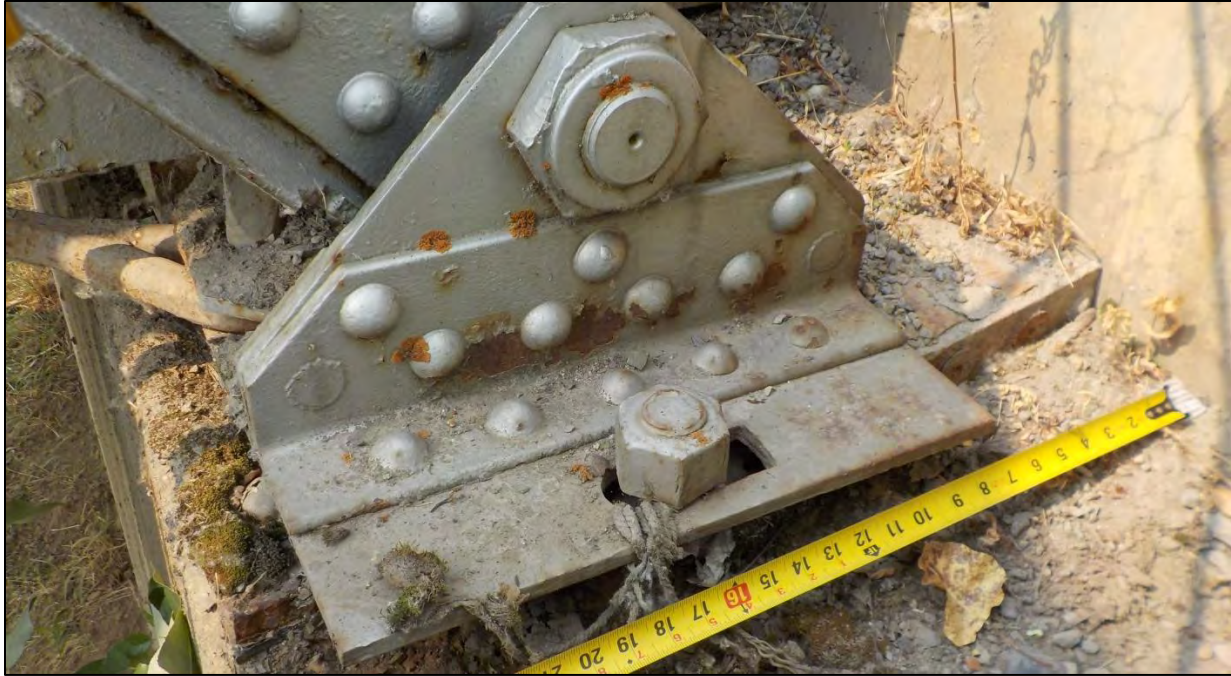
Abutment 1, North Truss roller bearing (**Photo 60**) had a failed painted coating on approximately 25 percent of the surface area with moderate corrosion and pitting up to 1/16 in. to the steel underneath, 10 percent had failed with exposed primer underneath, and the remaining paint was chalking. The heavy corrosion was under the rollers and roller keeper (**Photo 61**). The roller keeper had split due to heavy corrosion and the nested roller assembly had failed. Two of the rollers along with a portion of the keeper were out from underneath the truss to the west of the bearing and one roller was sticking out from underneath the bearing to the east of the bearing (**Photo 62**). The anchor rods had up to 25 percent section loss at the concrete interface due to heavy corrosion. The top plate was displaced 1-7/8 in. to the west (in expansion) in relation to the bottom plate.

**Photo 60:** Abutment 1, North Truss roller bearing

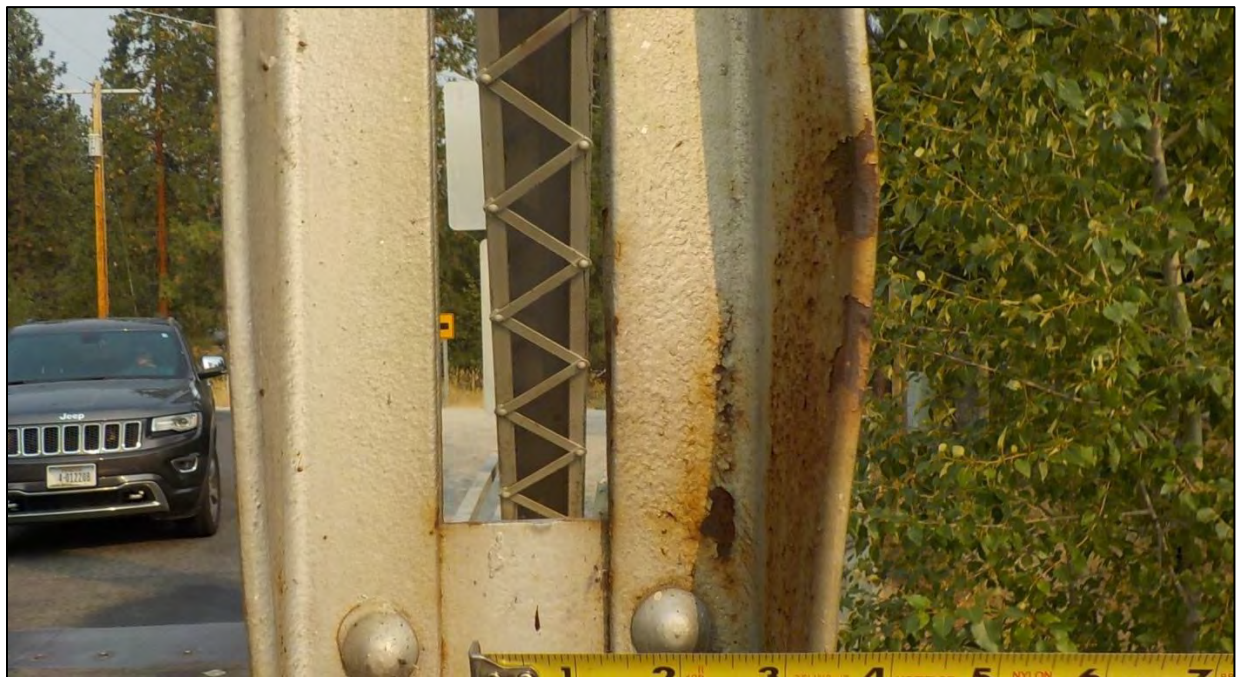
Span 1, North Truss, Vertical L1-U1: the exterior flange of the vertical was bent 1 in. to the north due to impact damage approximately 5 ft. above the bridge deck.  
The truss members had minor to moderate surface corrosion throughout.  
Span 1, South Truss, Top Chord at U4: one bolt was sheared off on the horizontal brace to top chord connection plate.

**Photo 71:** Span 1, North Truss, Vertical U1-L1: the exterior flange of the vertical was bent 1 in. to the north due to impact damage approximately 5 ft. above the bridge deck

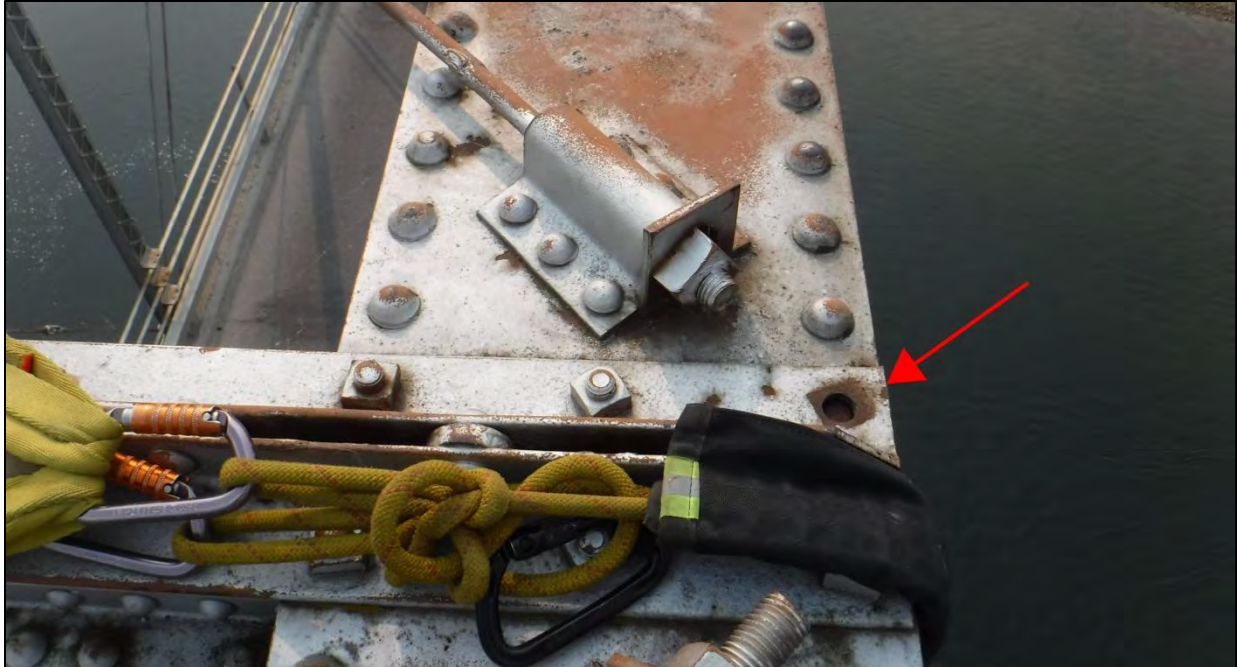
**Photo 72:** Span 1, South Truss, Top Chord at U4: one bolt was sheared off on the horizontal brace to top chord connection plate

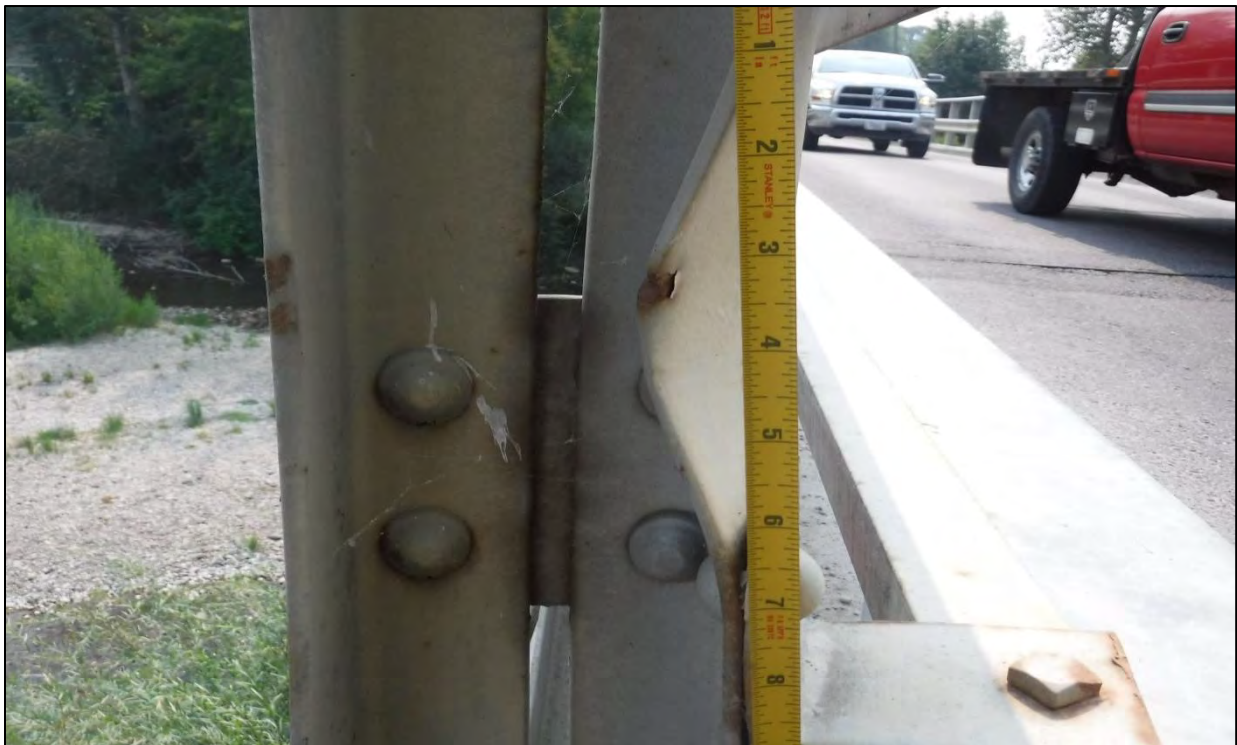
**Photo 73:** Span 2, North Truss, Vertical L2'-U2': the interior flange of the vertical was bent 1 in. over a 6 in. length due to impact damage

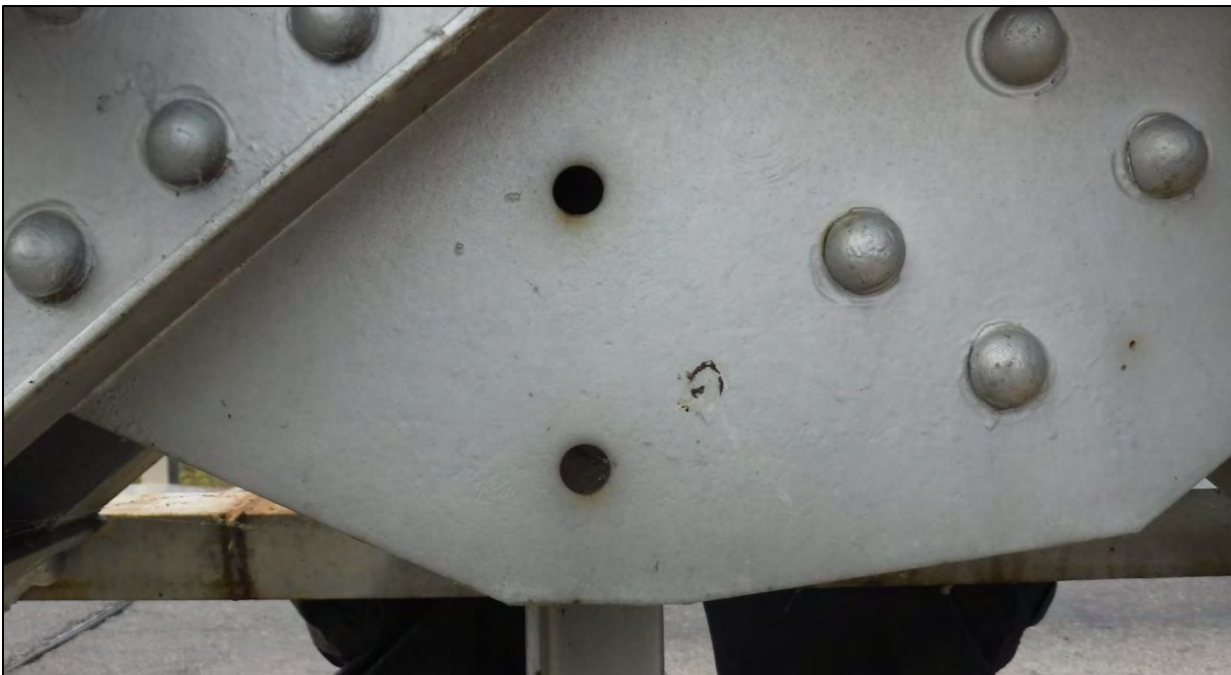
**Photo 75:** Span 2, North Truss, Gusset Plate U1': the exterior gusset plate had two misdrilled 3/4 in. diameter holes
