**RE: Phase III Geotechnical/Hydrogeological Site Evaluation and Monitoring
Stone Creek North, NH 49-1(25)9, UPN 7931000 – Summary Report**

Summary Report for the Stone Creek North Geotechnical/ Hydrogeological Site Evaluation and Monitoring

Stone Creek North, Highway 41 (N-49)
North of Dillon, Montana

[For Work Performed from April 2016 through May 2018]

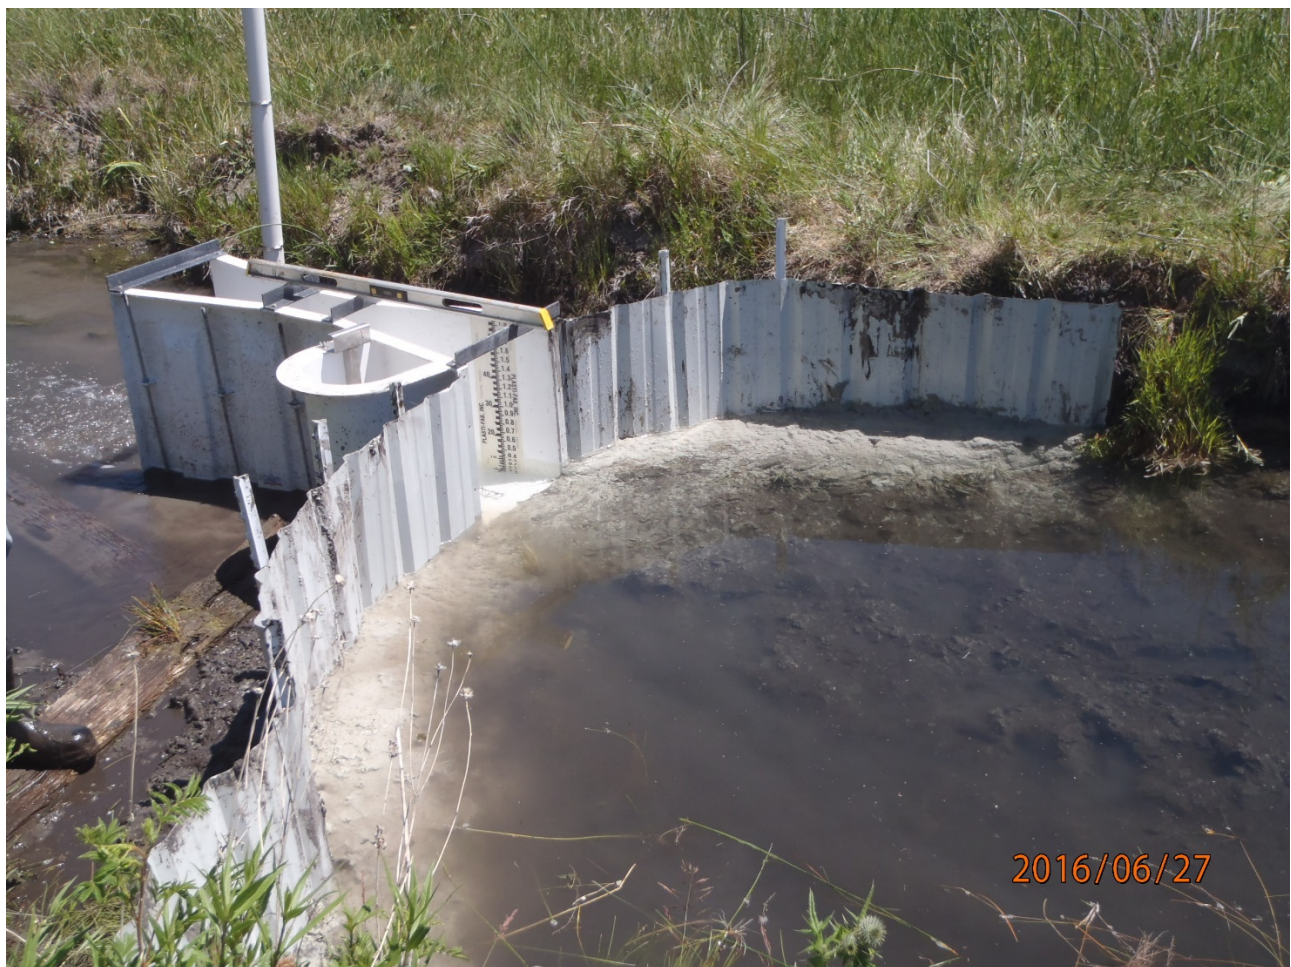
Site challenges mostly related to wildlife and livestock caused some loss of data in some locations and led to modifications to the monitoring network. Muskrats continuously burrowed beneath the 6-inch Parshall flume on the WSD until it was removed in fall 2016 and reinstalled at a downstream location by R.E. Miller and Sons, which is a firm that specializes in flume installations (Photograph 1 and Photograph 2). The primary reason for relocating the 6-inch Parshall flume to a downstream location was because the POR Ranch believed that groundwater was at times upwelling into the WSD downstream of the original flume location. Based on this information, Pioneer recommended that the flume be moved approximately 650 feet downstream to ensure that the flow data from the flume represented the entire flow of upwelling groundwater from the Warm Springs.

Photograph 1. Original Installation of 6-inch Parshall Flume

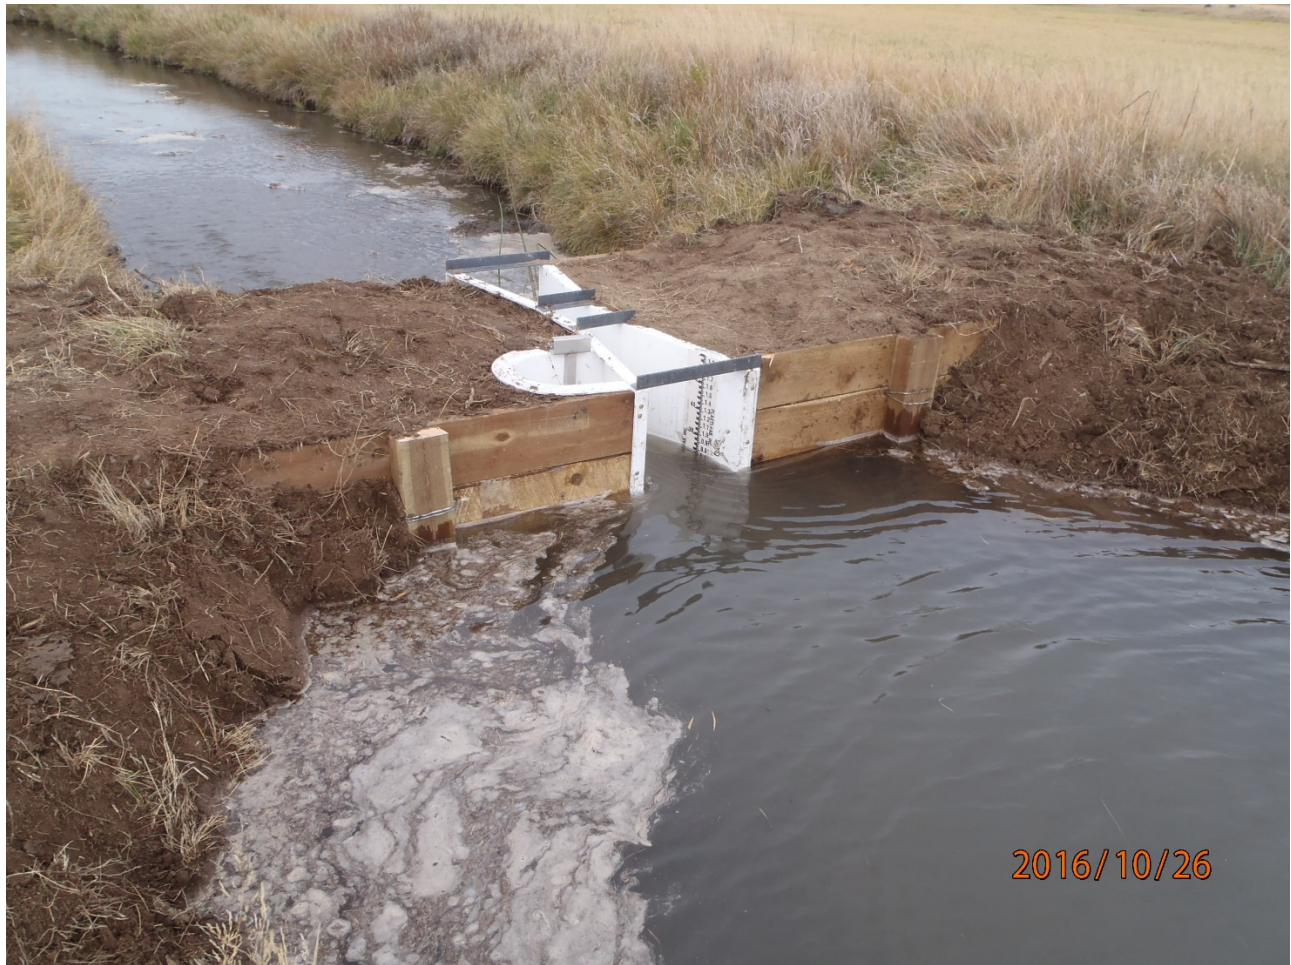
Photograph 2. Re-installation of 6-inch Parshall Flume by R.E. Miller and Sons

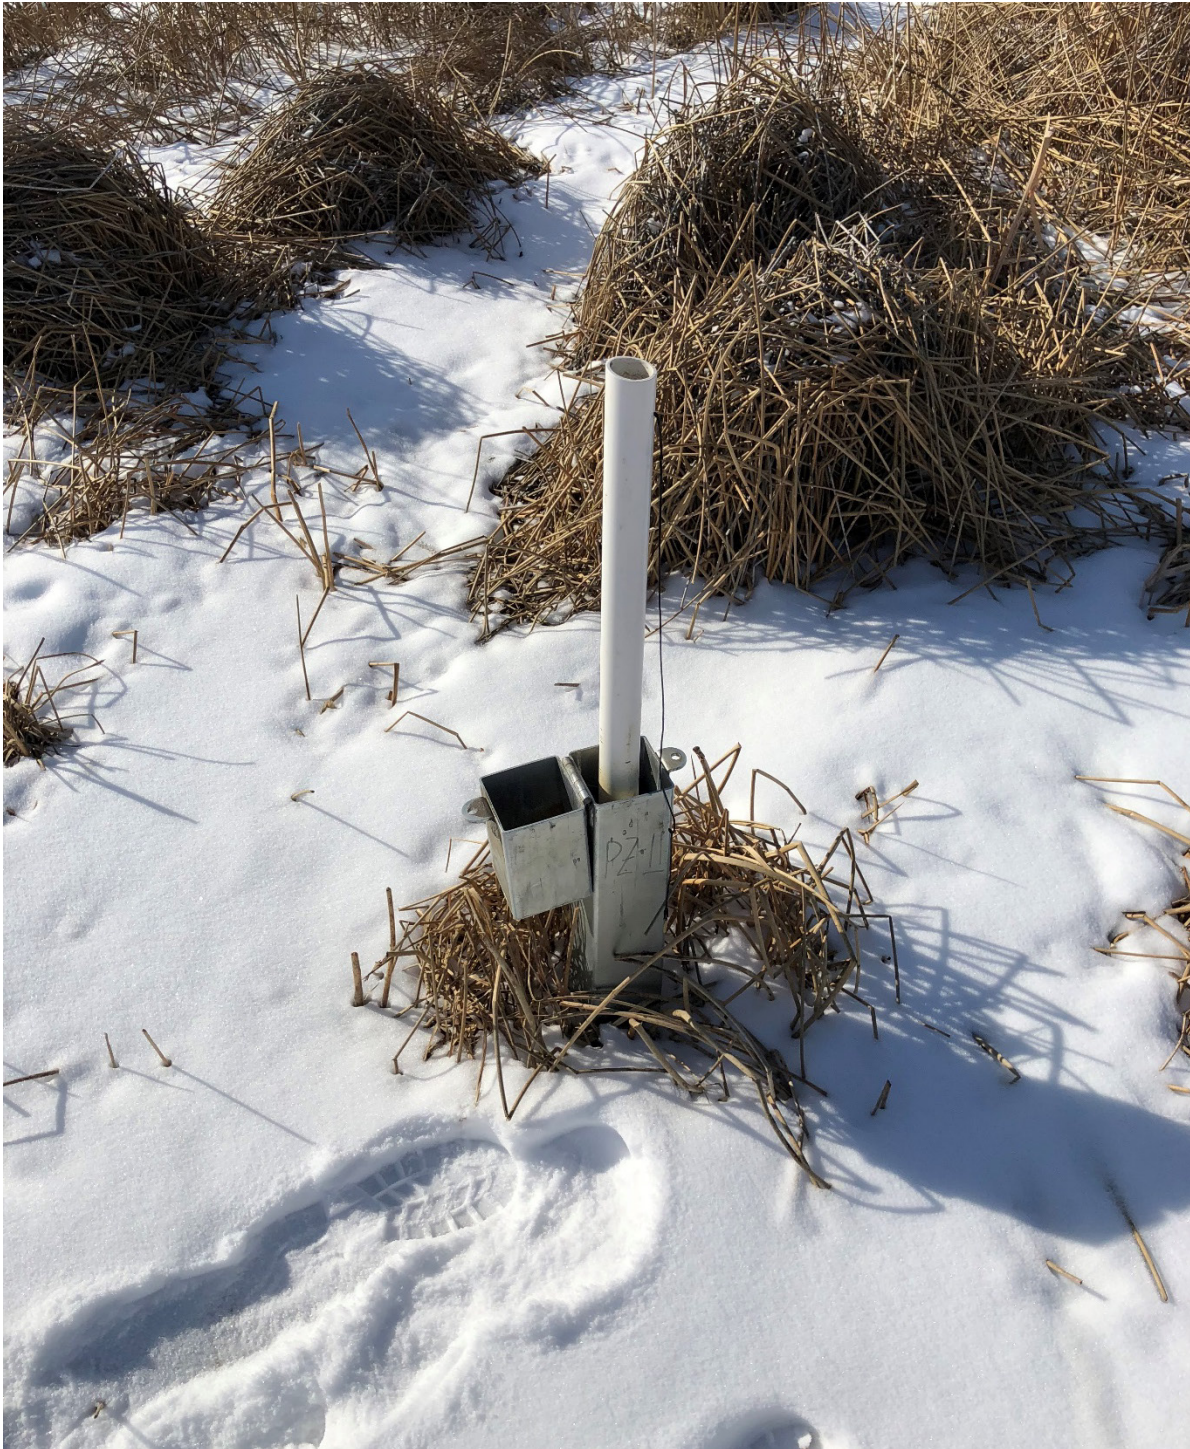
repaired and re-routed over the culvert, and the outer steel casings on PZ-11 and PZ-12 were left open and allowed to settle into the soft ground. The outer steel casings on PZ-07, PZ-09, and PZ-10 were also damaged by cattle and/or frost-jacking during winter in the early months of 2018 and stilling well SW-02 was knocked over and the SonTek cable was again damaged in February 2018 as detailed in the following section.

The outer steel casing to piezometers PZ-07, PZ-09, and PZ-10 appeared to have settled and were resting on the inner PVC piezometer casing so the team could not access these locations. It should be noted that during spring and summer 2017, the outer steel casings on piezometers PZ-11, and PZ-12 had also settled and had to be pried open. They have been left open since (Photograph 3 and Photograph 4).

Photograph 3. PZ-11 Outer Steel Casing Settled into Ground

1. Continue downloading the 15-minute transducer data and recording manual DTW readings on a monthly basis at all locations until at least 1 full year after completion of the construction project.
2. Resurvey the measuring point (MP) elevations on all monitoring locations each spring after the ground has thawed (typically late March to early May timeframe) to account for any changes in elevations caused by frost jacking, cattle damage, or other issues and to ensure water levels are accurate.

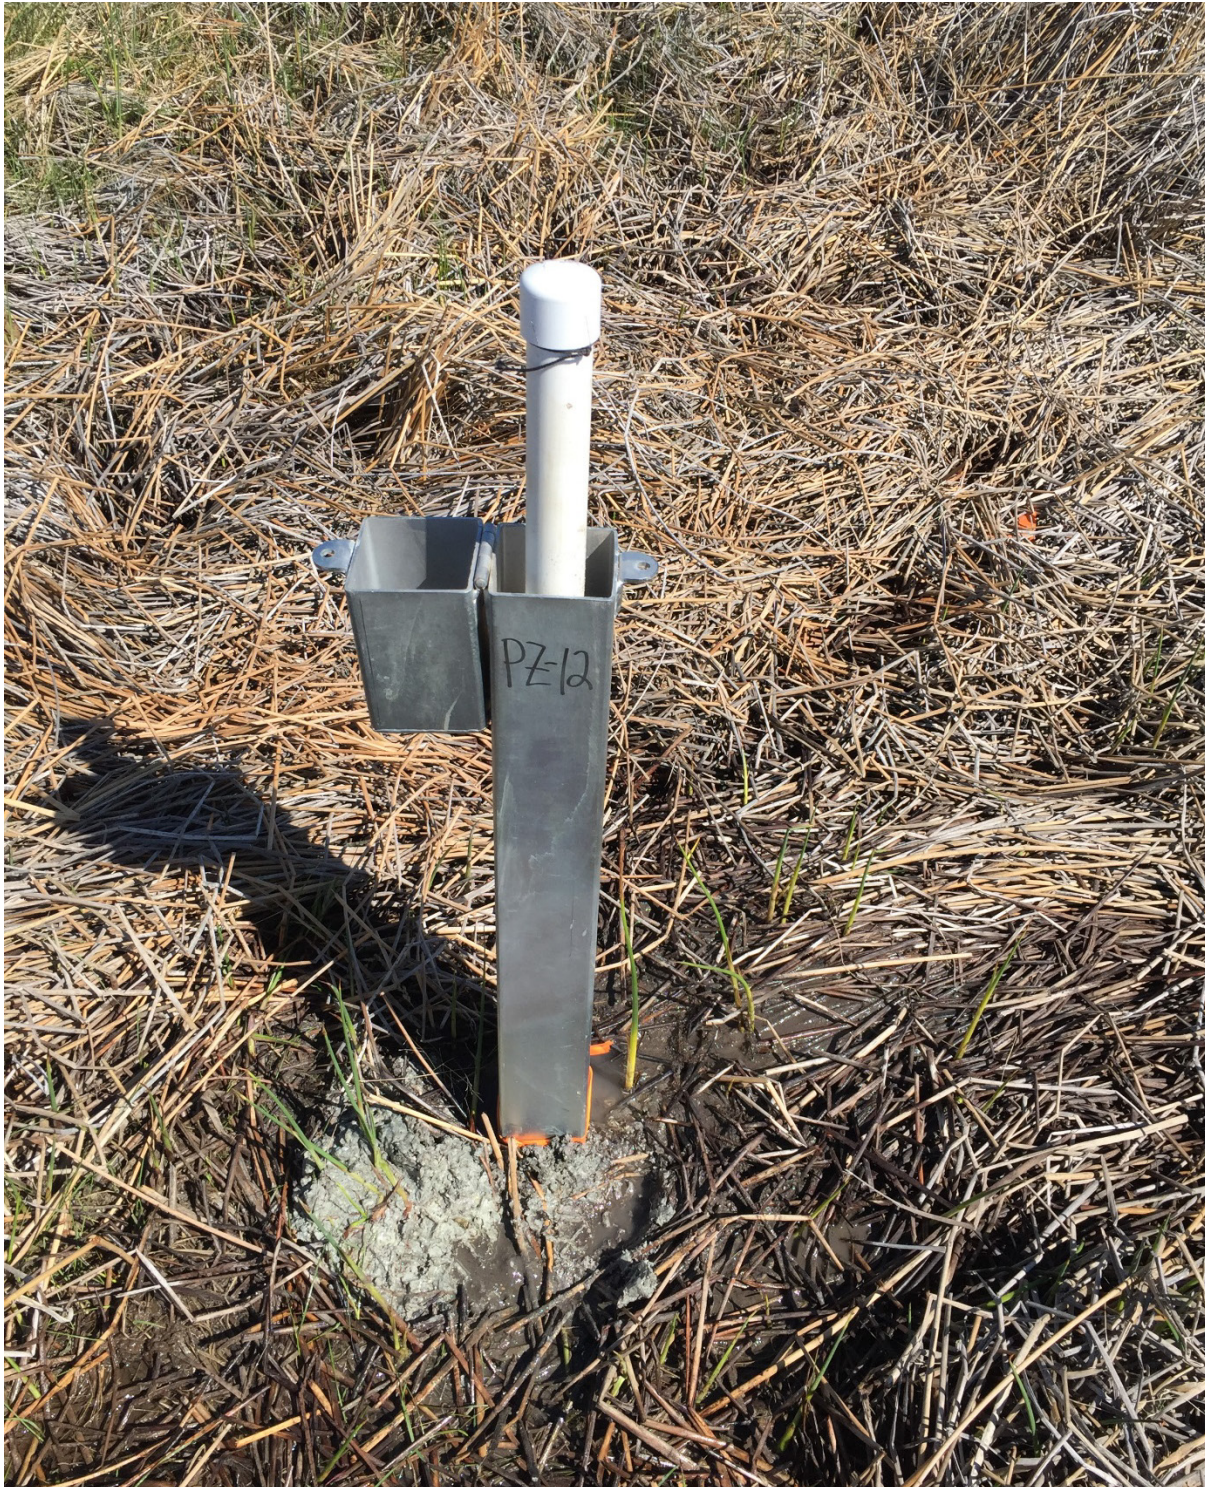
Photograph 4. PZ-12 Outer Steel Casing Settled into Ground

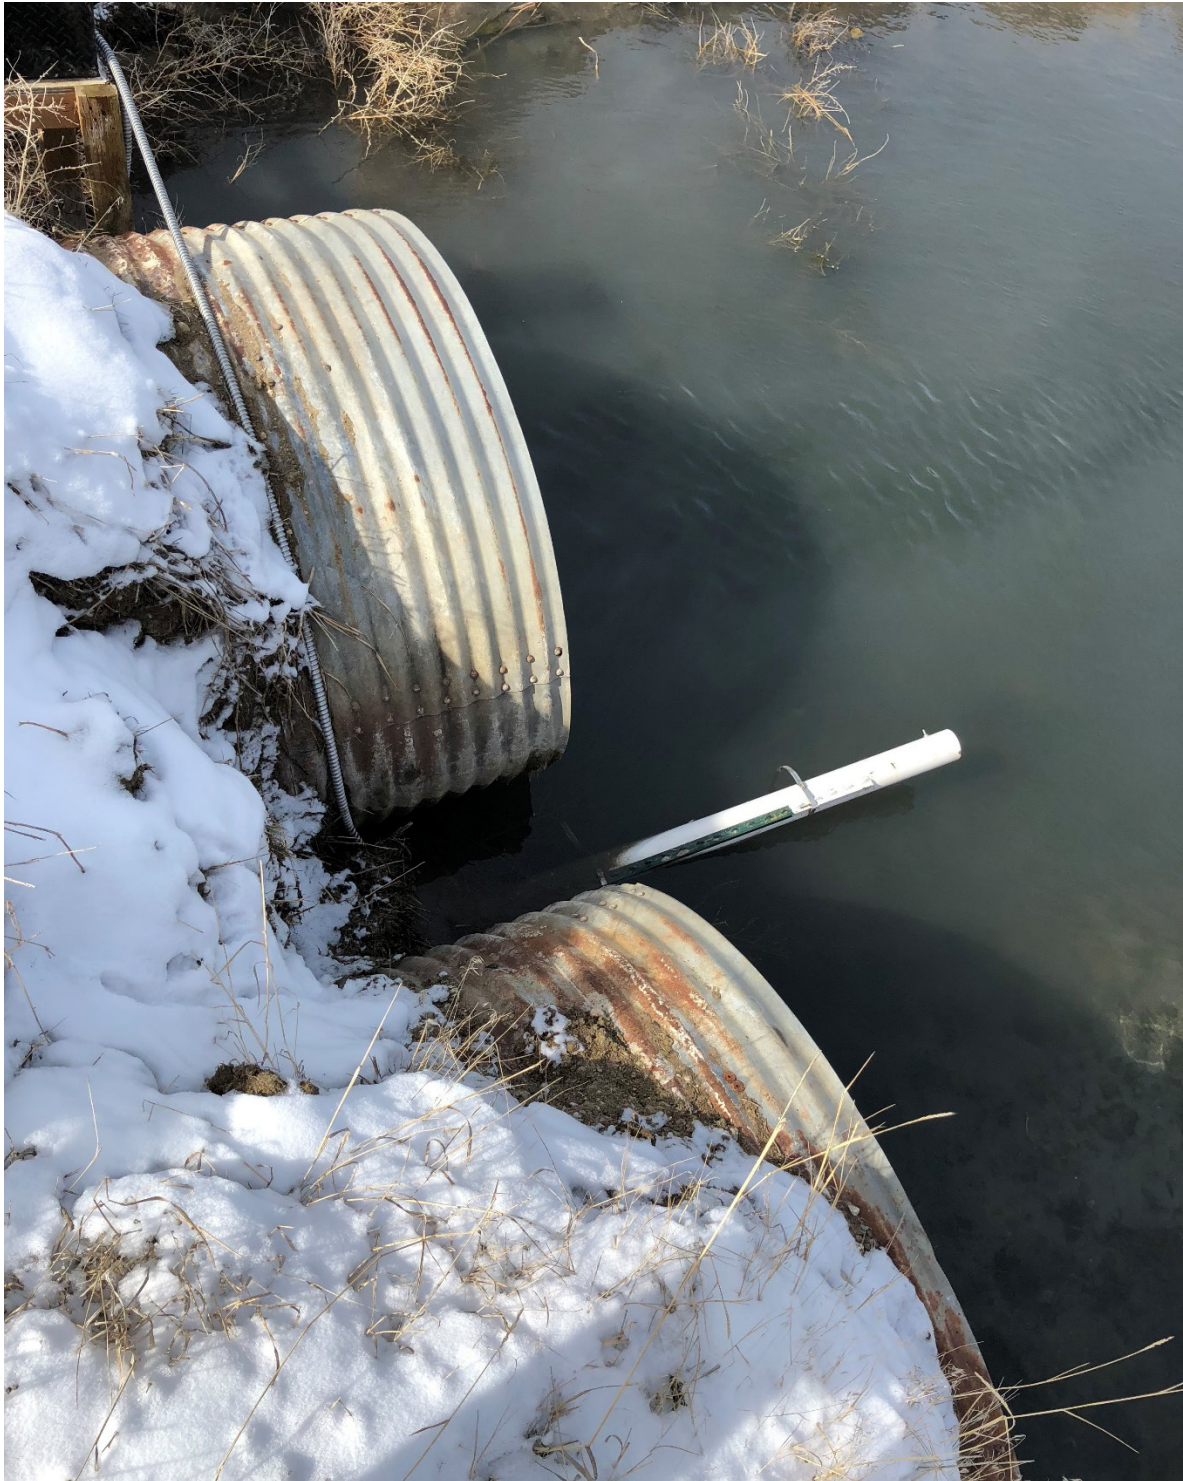
The inspection of the surface water monitoring site at the culverts showed that the stilling well (SW-02) had been knocked over, apparently by cattle (Photograph 5), and the cable to the right (east) of the SonTek-IQ Pipe was visibly damaged again (Photograph 6). The team was unable to connect to the right SonTek-IQ Pipe and were not equipped to enter the culvert and remove the instrument for repairs at that time. The stilling well SW-02 was reinstalled, but the measuring point elevation should be re-surveyed.

Photograph 5. Stilling Well SW-02 Damaged by Cattle

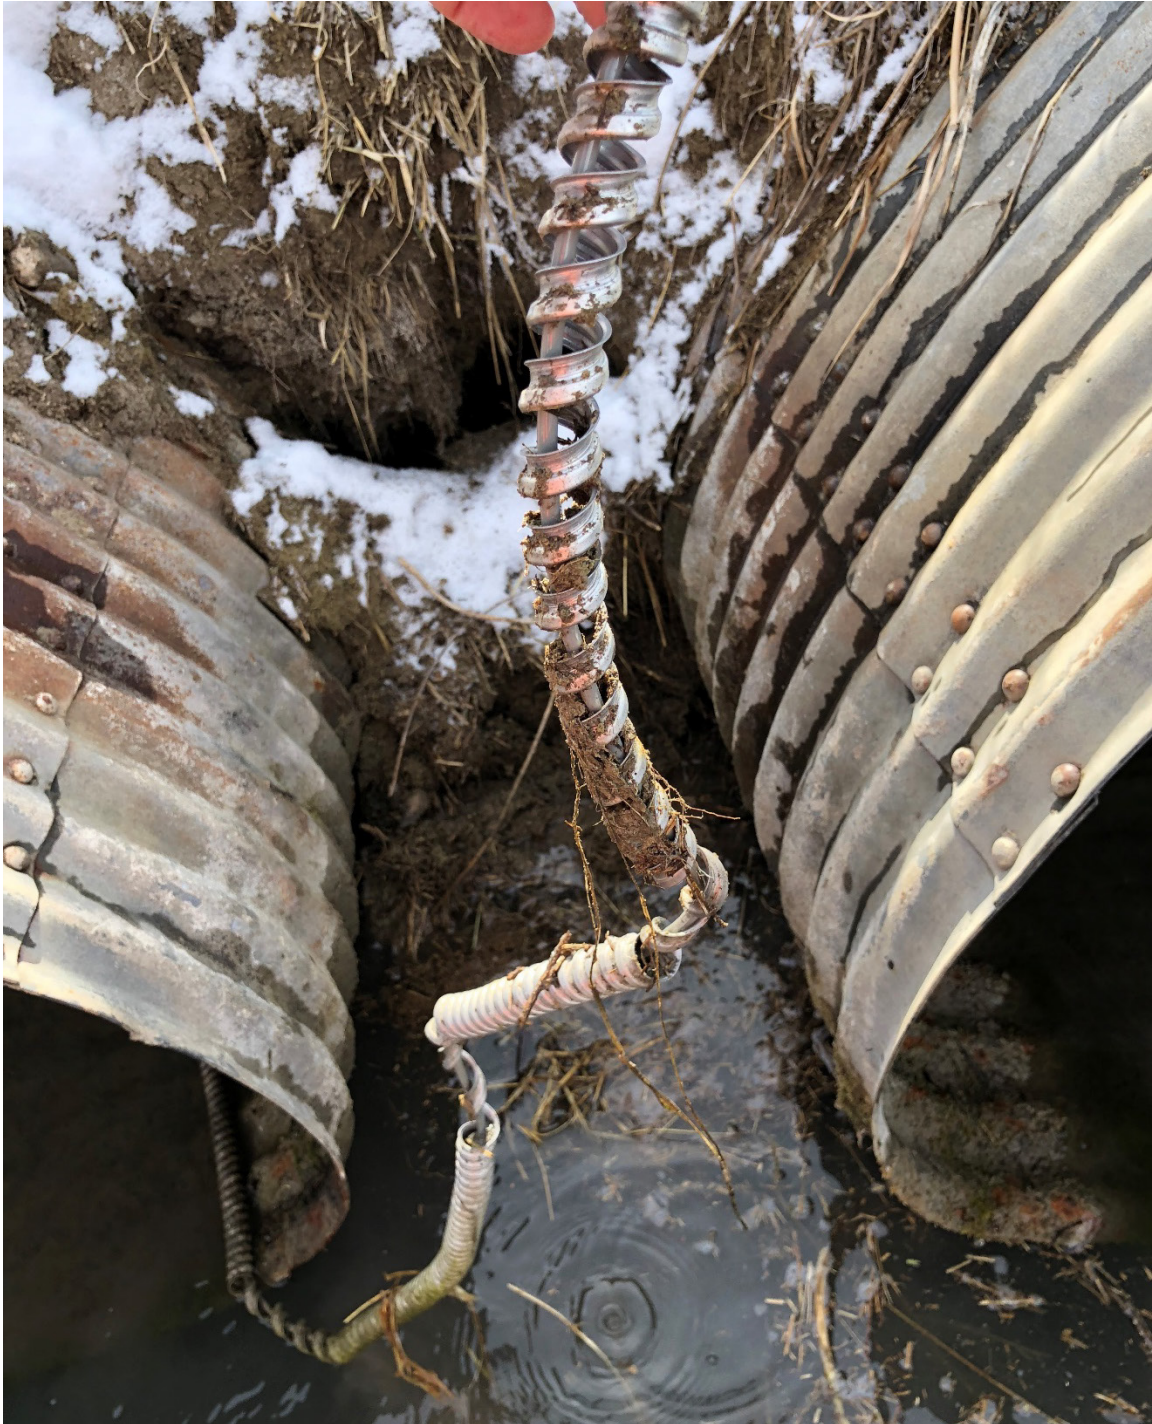
Additionally, cattle damaged the cable to one of the SonTek-IQ Pipe flow meters by apparently stepping on it and damaged some of the piezometers by rubbing on them and causing the outer steel casings to become loose and settle into the ground. The damaged SonTek cable was

Photograph 6. SonTek-IQ Pipe Cable Damaged by Cattle

After inspecting the SonTek-IQ Pipe flow meter and following discussions with MDT personnel, it was decided that the SonTek-IQ Pipes should be permanently removed at this time. Monthly flow measurements with the FlowTracker2 had been used to develop a good correlation with the
