Subject: Project Review – Billings District – Garryowens - South

CONSTRUCTION ENGINEERING SERVICES PROJECT REVIEW REPORT	
Project Number: IM 90-9(100)517	MDT District: Billings
Project Description: Garryowen - South	EPM: Timothy Ramaeker
Control Number: 5117	
Letting Date: Dec. 4, 2009	
Review Date: June 3, 2009	
Review Made By: John Huber	In Company With: NA
Project Description: Digouts, cold-in-place recycle, plant mix overlay, seal and cover and bridge approach rail improvements. The project is located on interstate 90 beginning south of Garryowen at RP 516.64 and extends approximately 11.9 km to RP 524.00. This project is located in Big Horn County and entirely within the Crow/Apsaalooke Nation Reservation.	
Review Type: (See attached sheet on review report types)	
<input checked="" type="checkbox"/> Oversight <input type="checkbox"/> Subject Specific- <input type="checkbox"/> Training <input type="checkbox"/> Investigatory <input type="checkbox"/> Constructibility <input type="checkbox"/> Post Construction

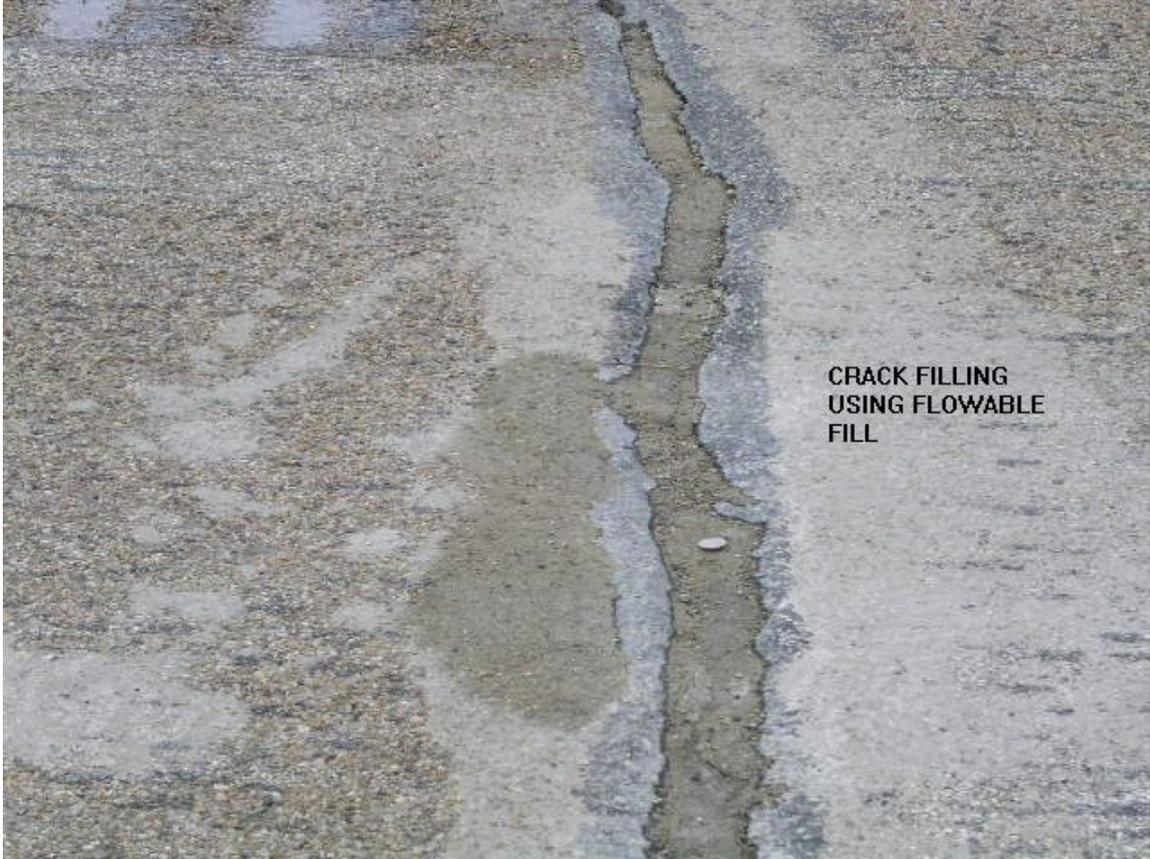
**CRACK FILLING
USING FLOWABLE
FILL**

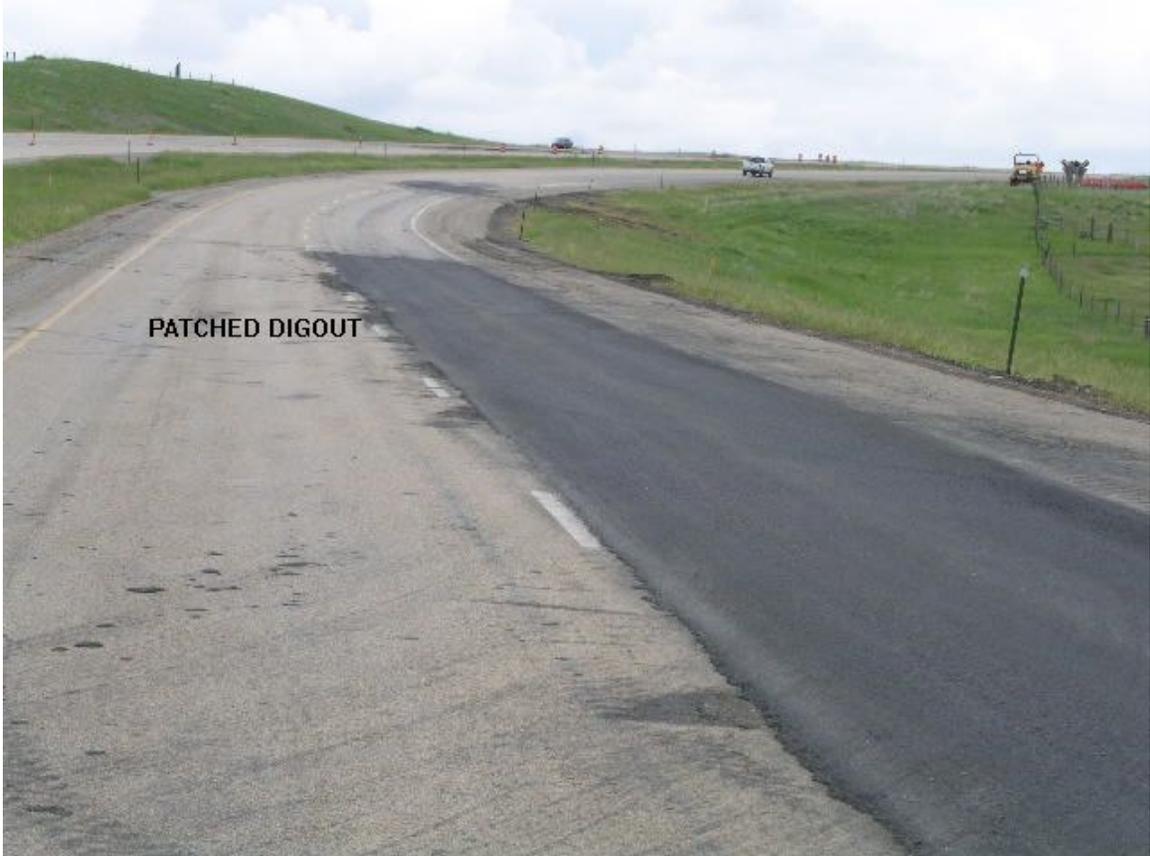
PATCHED DIGOUT

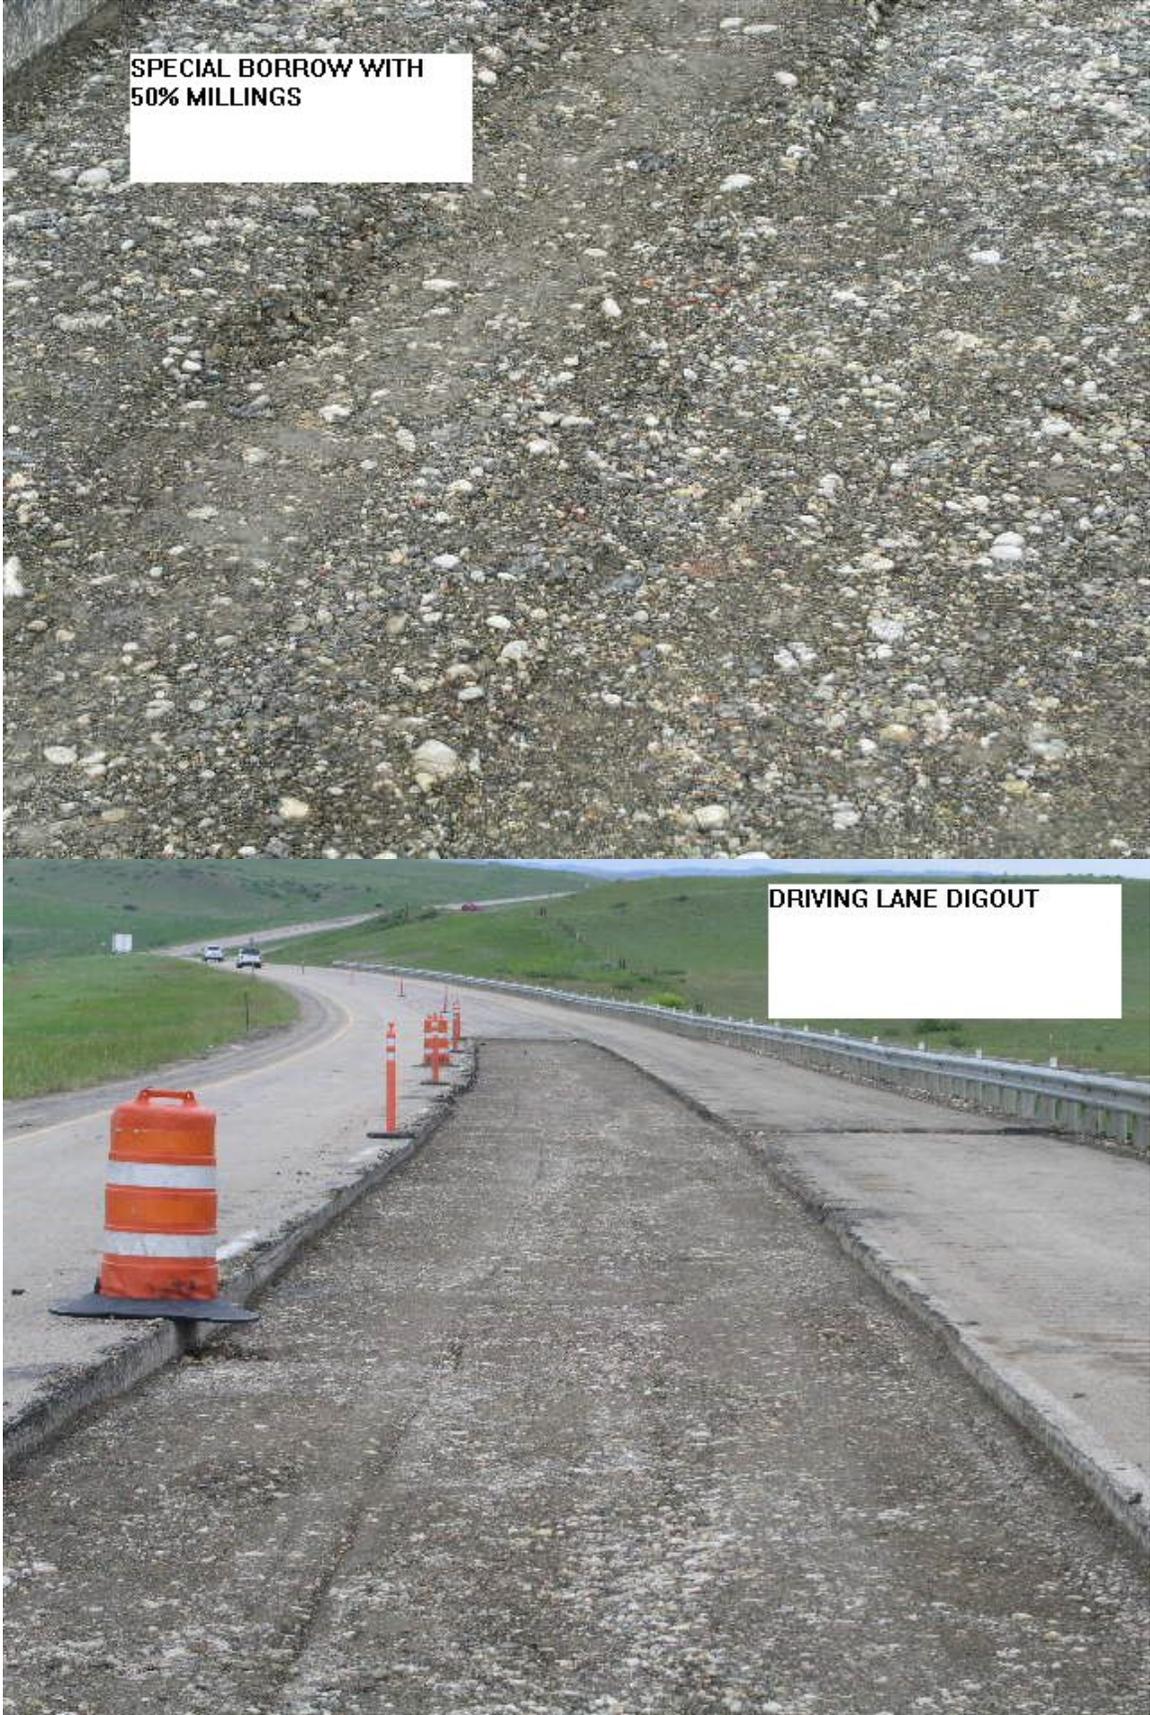
**SPECIAL BORROW WITH
50% MILLINGS**

DRIVING LANE DIGOUT
