# MONTANA DEPARTMENT OF TRANSPORTATION STREAM MITIGATION MONITORING REPORT

*Ashley Creek  
Flathead County, Montana*

**YEAR 2013**

MDT Project Number: NH-MT 5-3(59) FST  
Control Number: 2038

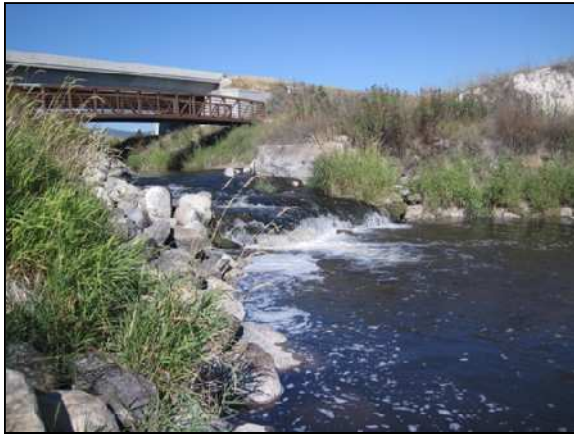
**Photo Point 1**

**Description:** View of grade control structure downstream of project area. **Compass:** 315 (Northwest)

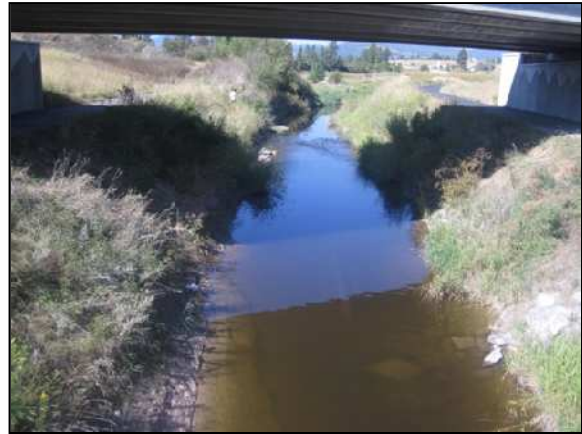
**Photo Point 2**

**Description:** View looking upstream from pedestrian bridge. **Compass:** 293 (West-Northwest)

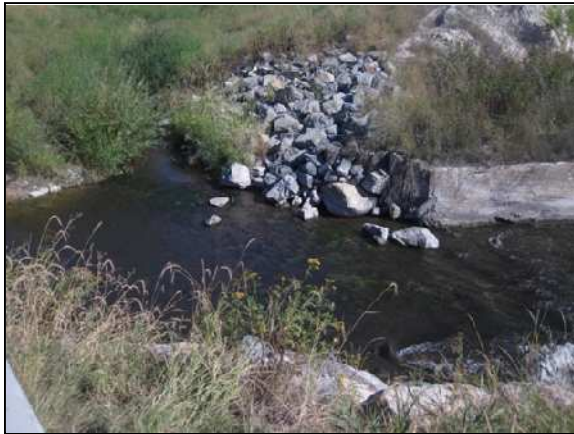
**Photo 5**

**Description:** View of Ashley/Spring Creek confluence.  
**Compass:** 0 (North)

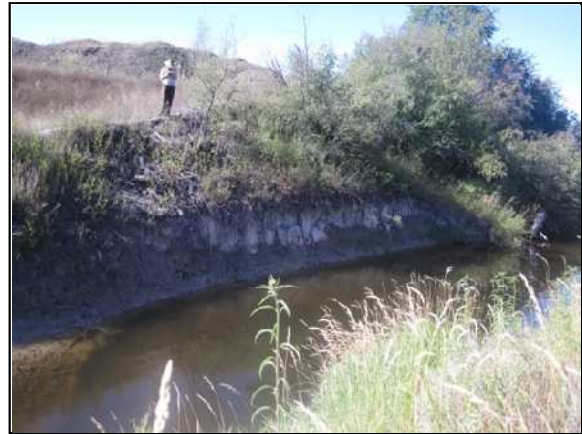
**Photo 6**

Two segments of eroding stream banks were observed along Ashley Creek, with bank erosion observations described in Table 5. Photos of each eroding bank are included in Appendix D of this report. Figure 2, Appendix A shows the GIS mapped location of eroding streambanks. Eroding streambank length totaled 85 feet, or 8% of the total project bank length of 1050 feet.

**Description:** View of eroding bank on south side of channel. **Compass:** 225 (South-Southwest)

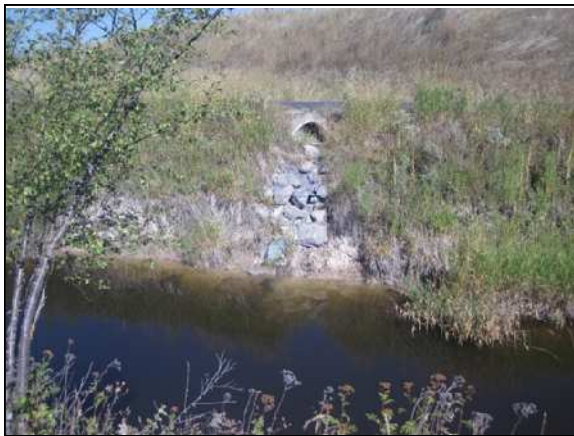
**Photo 7**

Stone materials placed along the toe of the bank beneath a culvert upstream from the new bridge have sloughed into the channel. These materials appear to be sloughing due to the steep bank angle (steeper than 1H:1V) and saturation of the bank when the culvert discharges water on the bank. Stone toe protection beneath this culvert may need to be replaced to maintain bank and culvert protection if additional material continues to slough.

**Description:** View of eroding bank beneath culvert outlet on north streambank upstream of bridge.  
**Compass:** 0 (North)
