# MONTANA DEPARTMENT OF TRANSPORTATION STREAM MITIGATION MONITORING REPORT

*Spring Creek  
Flathead County, Montana*

**YEAR 2013**

MDT Project Number: NH-MT 5-3(59) 109  
Control Number: 2038

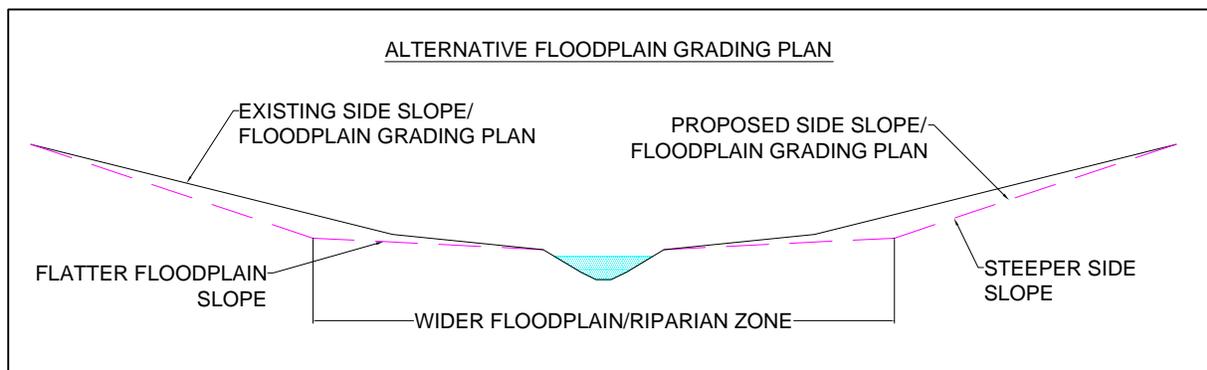
Figure 2. Alternative grading plan to increase floodplain and riparian areas.

The reconstructed channel segment is designed with upland side slopes that transition to a narrow, 17.5-foot wide floodplain bench. Perpendicular transect survey results (Appendix B) illustrate floodplain slopes down to the channel which reduces the area available for overbank flooding to a narrow zone adjacent to the channel. This design configuration results in a relatively limited riparian/floodplain zone width approximately three times wider than the active channel. Integrating a slightly steeper upland side slope design would provide for a wider, more functional floodplain and riparian zone by allowing the stream to access a larger, flat floodplain adjacent to the active channel (Figure 2). Constructing steeper side slopes and a wider floodplain area requires

additional excavation; therefore a cost/benefit analysis of creating additional floodplain and wetland features, and the associated mitigation credits, is potentially worth consideration for future stream and riparian mitigation designs.

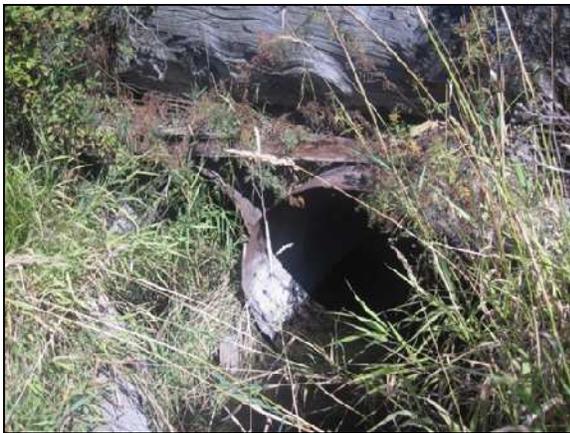
**Photo 1**  
**Description:** Culvert at upstream end of project area.  
**Compass:** 25 (North-Northeast)

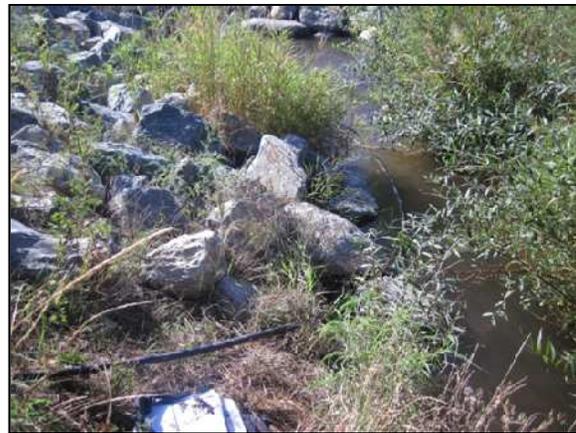
**Photo 2**  
**Description:** Hose in stream channel.  
**Compass:** 130 (Southeast)
