# MONTANA DEPARTMENT OF TRANSPORTATION STREAM MITIGATION MONITORING REPORT

*Sweathouse Creek  
Ravalli County, Montana*

**YEAR 2013**

MDT Project Number: NH 7-1(114)59  
Control Number: CN 201 5004

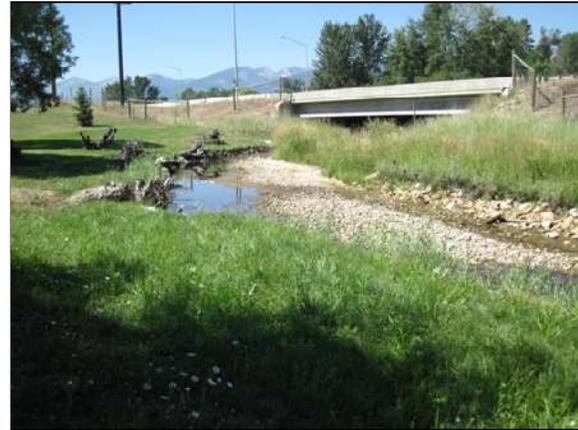
**Photo Point 3.1**  
**Description:** Looking upstream from downstream end of project reach. **Compass:** 225 (Southwest)

shown in Photos 1.2 and 3.1 in Appendix D. The point bar features developing on the north side of the channel are also illustrated on the left side of the perpendicular transect survey results for Transects #2 and #3 (Appendix B). Of note, the flood events in 2011 and 2013 have generated bar development within the channel; however, no active erosion was evident along banks across from these bar formations due to the bioengineered root wad and coir fabric bank treatments installed along the south/east bank.

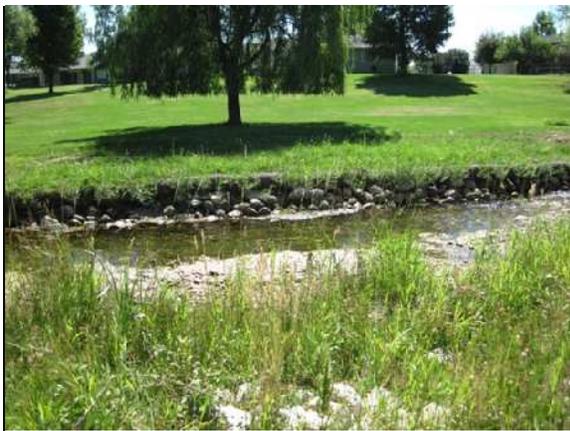
**Photo Point 6.2**

Monitoring observations noted the landowner to the south of the project reach is mowing all of the vegetation down to the stream bank (Photo Point 6.2). In order to maintain long term bank stability downstream of the bridge, it is important to maintain a healthy, un-mowed vegetative buffer between the lawn and the stream bank to promote root growth and soil stability between and downstream of the root wads. It is recommended that MDT establishes an agreement with the adjacent landowner to maintain a minimum buffer of 25' from the banks to encourage establishment of deep-rooted woody and herbaceous vegetation. In addition to erosion prevention, establishment of a riparian buffer would help protect water quality in Sweathouse Creek by filtering any adjacent herbicide or fertilizer applications.

**Description:** View of south bank looking across channel. **Compass:** 135 (Southeast)

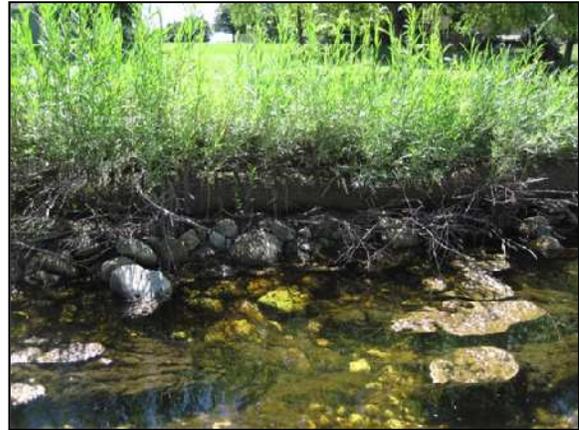
**Photo 4**

**Description:** View of willow cutting establishment on south bank. **Compass:** 90 (East)

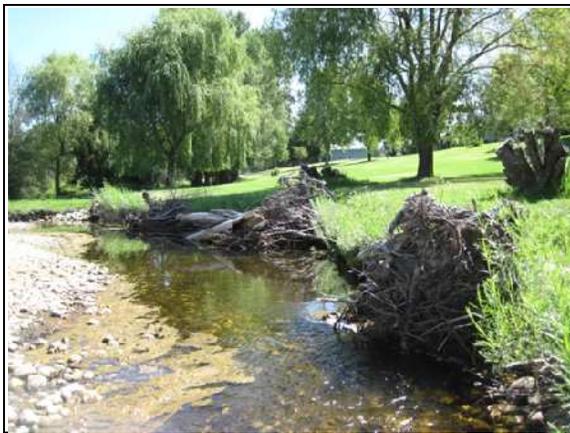
**Photo 2**

No stream bank erosion was noted within the Sweathouse Creek stream mitigation site. Root wads installed along the south bank appeared secure, with no evidence of undercutting or bank sloughing. The root wads provide structure for the development of pool scour features, as evidenced by results of Transects #2 and #3 in Appendix B. Results of transect surveys and their associated photos indicate gravel point bar development on the inside of the meander bend, and generation of scour pools against the root wads. These banks offer good fish habitat and cover, as evidenced by observations of several trout utilizing the root wad structures. Based on the observations and transect data, the bioengineered banks are successfully providing pool habitat features while maintaining bank integrity throughout the project reach.

**Description:** Root wads along south streambank. **Compass:** 45 (Northeast)

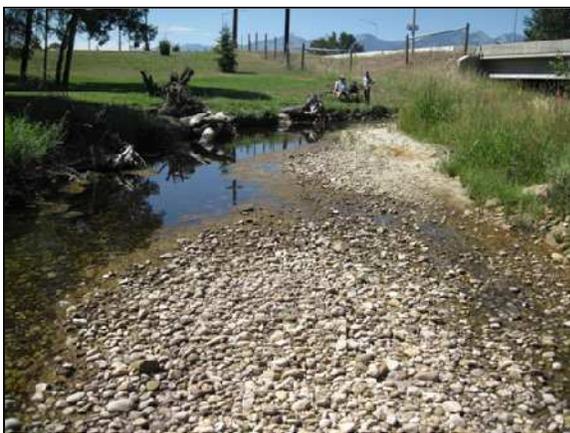
**Photo 3**

**Description:** Point bar formation on north side of channel. **Compass:** 250 (West-Southwest)

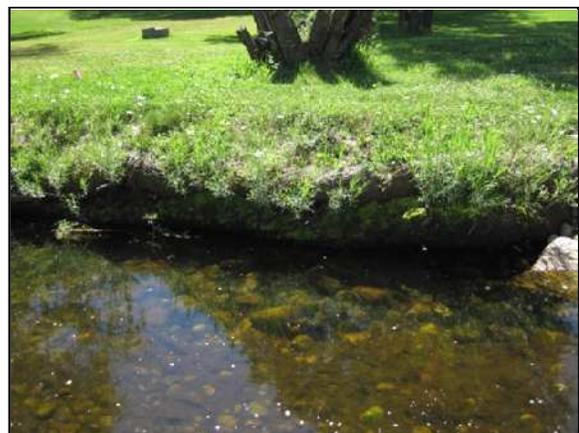
**Photo 6**

Field examination documented no eroding stream banks within the project area. The toe of the treated banks are stable (no erosion) and willow stems are growing well on the right bank between the coir material layers. Willow stems are also establishing on upper and lower parts of the left bank. A potential coir log failure was noted on the upstream right bank (Photo Point 2.1, Appendix D) where the coir was not keyed sufficiently into the bank. Maintenance of this section is noted in Section 6 of this report. Although Sweathouse Creek does not have an active stream gage, inspection of gage data from the Bitterroot River suggest tributary streams were subject to overbank flows in 2011 and near bankfull flows in 2013. These flood events deposited debris, sand, and twigs on the floodplain adjacent to the reconstructed segment of Sweathouse Creek. A point bar is forming on the left stream bank, as noted by gravel deposits

**Description:** Willow growth from coir along south streambank. **Compass:** 90 (East)
