# MONTANA DEPARTMENT OF TRANSPORTATION STREAM MITIGATION MONITORING REPORT

*Little Rock Creek at Judith Slide Repair  
Fergus County, Montana*

*Project Completed: 2013  
Monitoring Report #1: December, 2014*

MDT Project Number: STPS 426-2(12) 15  
Control Number: 7726000

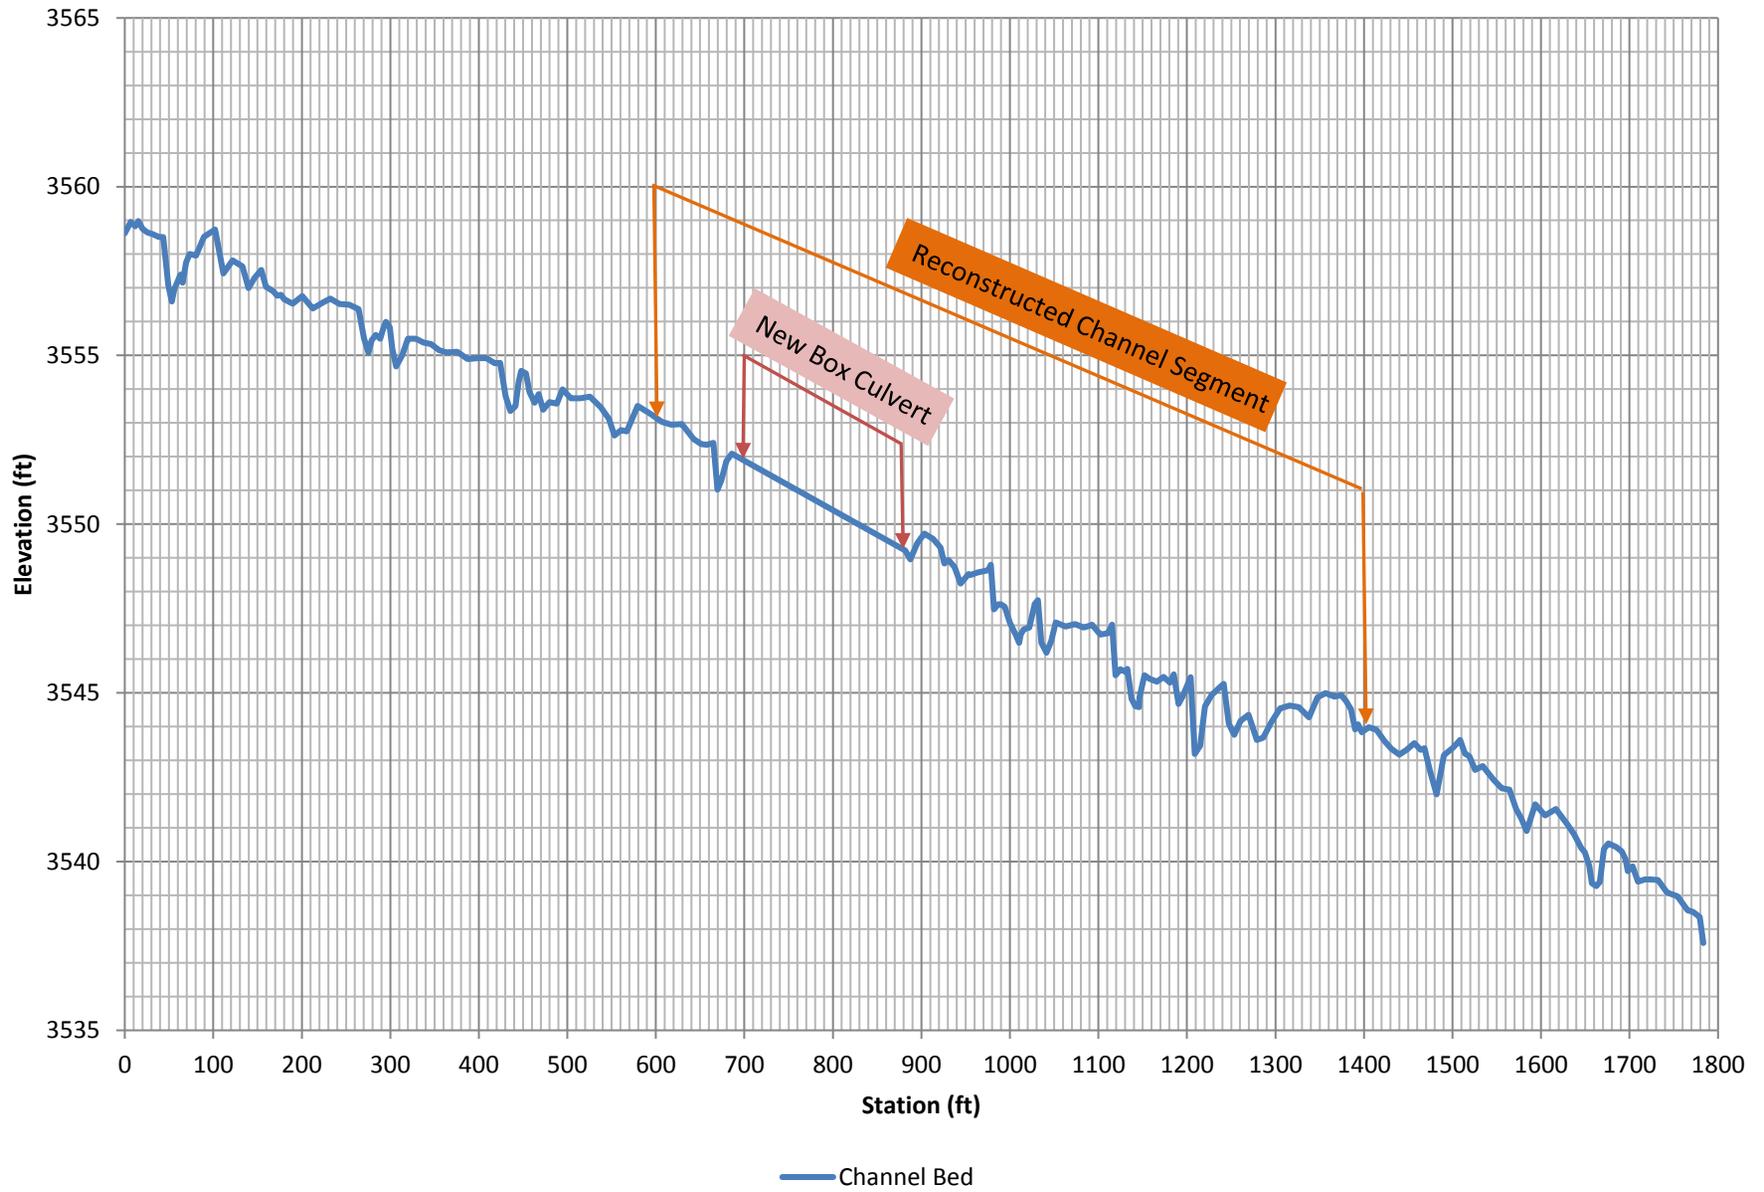
# Little Rock Creek Longitudinal Profile

The longitudinal profile of the channel thalweg reveals the presence of several pool features within the reconstructed channel segment, which are forming by a) scour against the outside meander bends, and b) plunging over rock weirs constructed across the channel width. The weir drop immediately downstream of the culvert appears to have filled in with a mix of gravel, sand, and silts following the most recent high flow event. Sediment deposition along the channel fringes immediately downstream of the culvert has also narrowed the channel to a width more closely matching the designed channel.

8. Although no observations of significant grade adjustments or head cuts were observed at the transition to the new channel, inspection of the longitudinal profile (Appendix B) indicates the reconstructed channel segment between STA 1250 and 1380 (at the downstream end of the reconstructed channel) is flatter than the overall grade of the surveyed channel segment. Gravel deposits were observed at the transition point between the reconstructed and original channel, which may be as a result of the flatter bed slope in this area. Photo point 5.3 on Page 3 of Appendix C shows these gravel deposits.

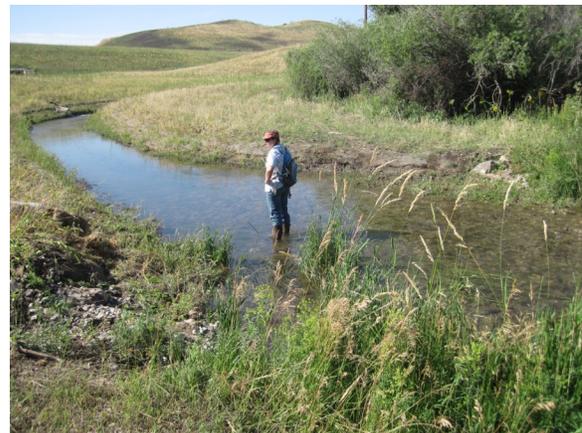
**Photo Point 5.2—2014**  
**Description:** Downstream end of project, looking at cattle crossing.  
**Compass:** 225 (Southwest)

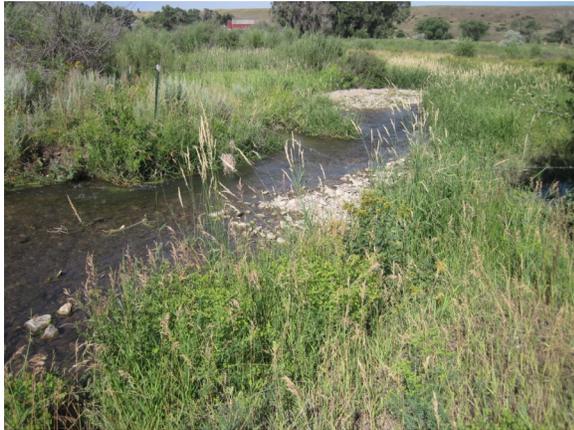
**Photo Point 5.3—2014**  
**Description:** Downstream end of project looking downstream.  
**Compass:** 270 (West)

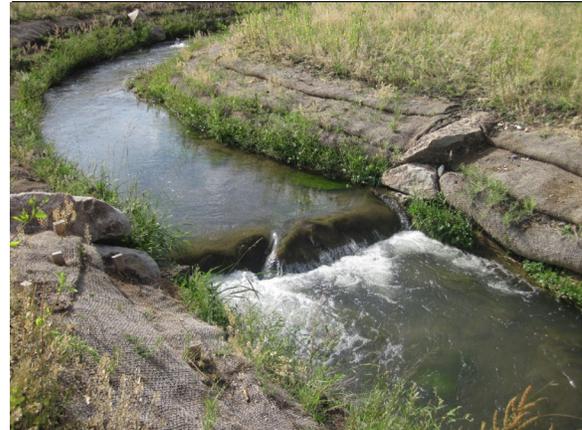
**Photo 1**  
**Description:** Rock weir 2, below culvert.

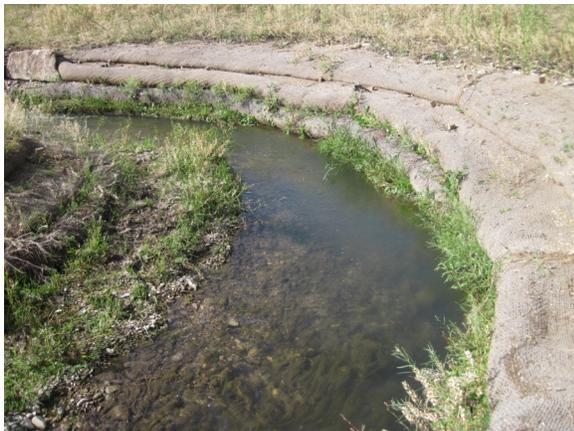
3. All coir lifts appeared to be built using a single layer of fabric, with installation of a coir log along the leading edge of the lower two lifts. The relatively large mesh size of the coir fabric may allow for finer sized fill material (silt, clay, sand, fine gravel) to wash out from within the soil lift. Although the removal of materials from within the coir lifts was not observed along this project site, it has been observed in other projects, and is cause for banks to slump, sag, and drop in elevation.

**Photo 2**  
**Description:** Undercut bank with some sagging in coir lift. Gravel deposit on right point bar.

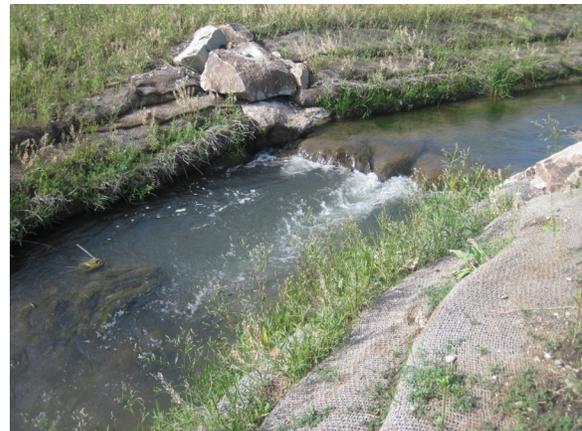
**Photo 3**  
**Description:** Rock weir 4, below culvert.

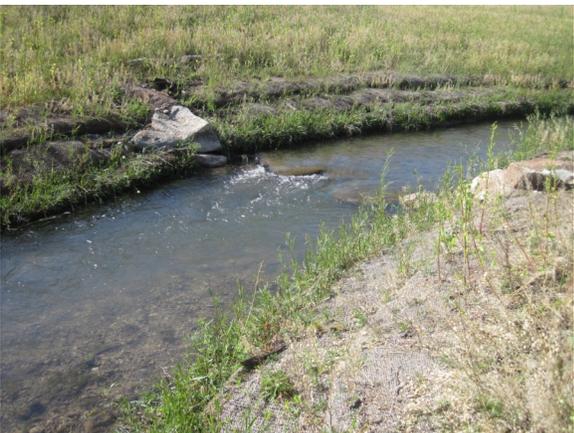
**Photo 4**  
**Description:** Rock weir 5, below culvert.
