# MONTANA DEPARTMENT OF TRANSPORTATION STREAM MITIGATION MONITORING REPORT

*Foy's Bend Fisheries Conservation Area  
Flathead County, Montana*

*Project Completed: 2013  
Monitoring Report #3: December 2015*

MDT Project Number: NH-MT 5-3(50) 109F  
Control Number: 20380013

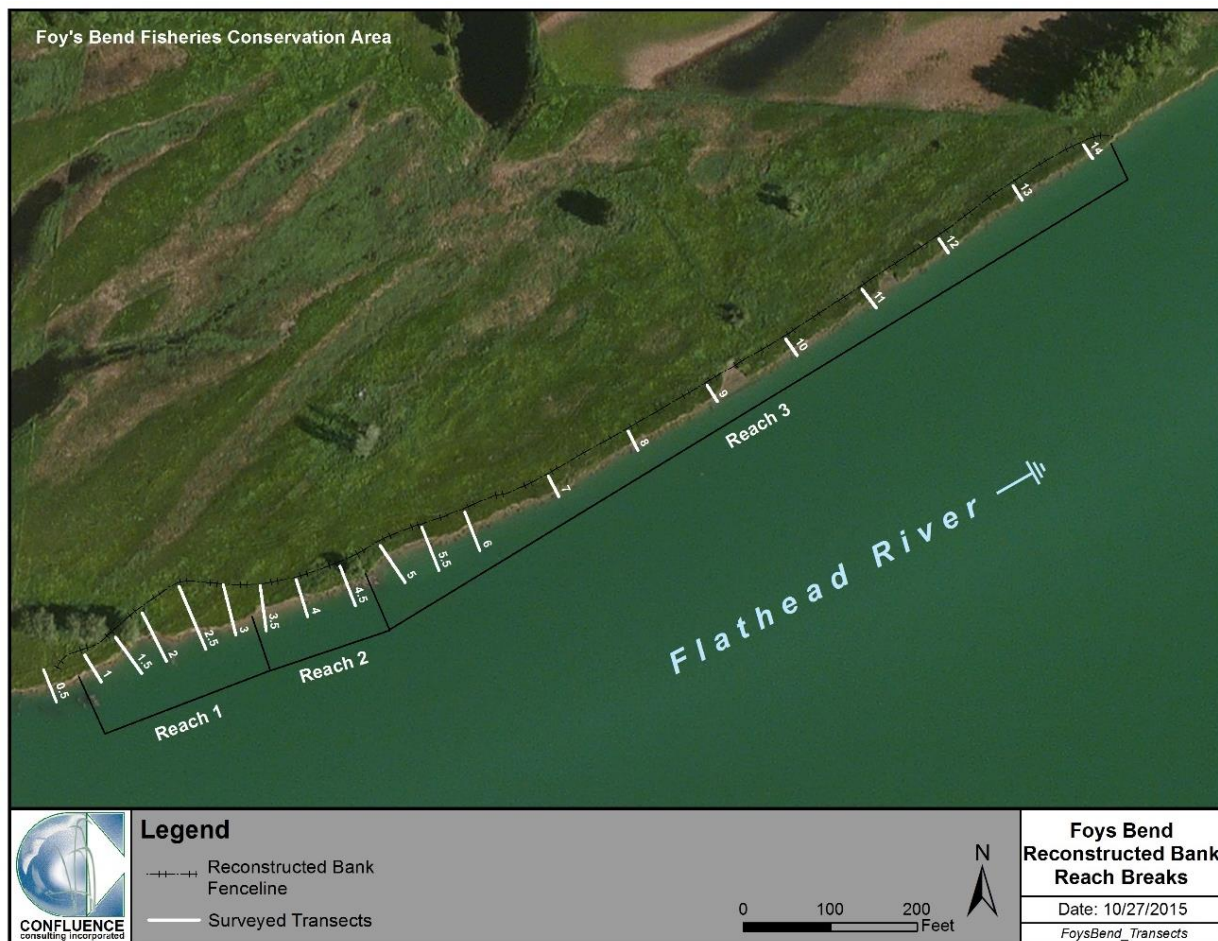
Figure 3. Reach breaks and surveyed transects along Foy's Bend reconstructed bank segment.

For the purposes of describing the reconstructed bank segment, it has been divided into three reaches based on conditions observed and surveys conducted during the April, 2015 site visit (Figure 3). The following sections describe monitoring data documented within each of the three reaches as well as immediately upstream of the reconstructed bank. Supporting data includes plotted survey transect data (Appendix B) and photo documentation of the river bank (Appendix C). Perpendicular bank transects plotted at each of the locations shown in Figure 3 also includes the elevation at the top of the fascine during the August, 2015 survey event.

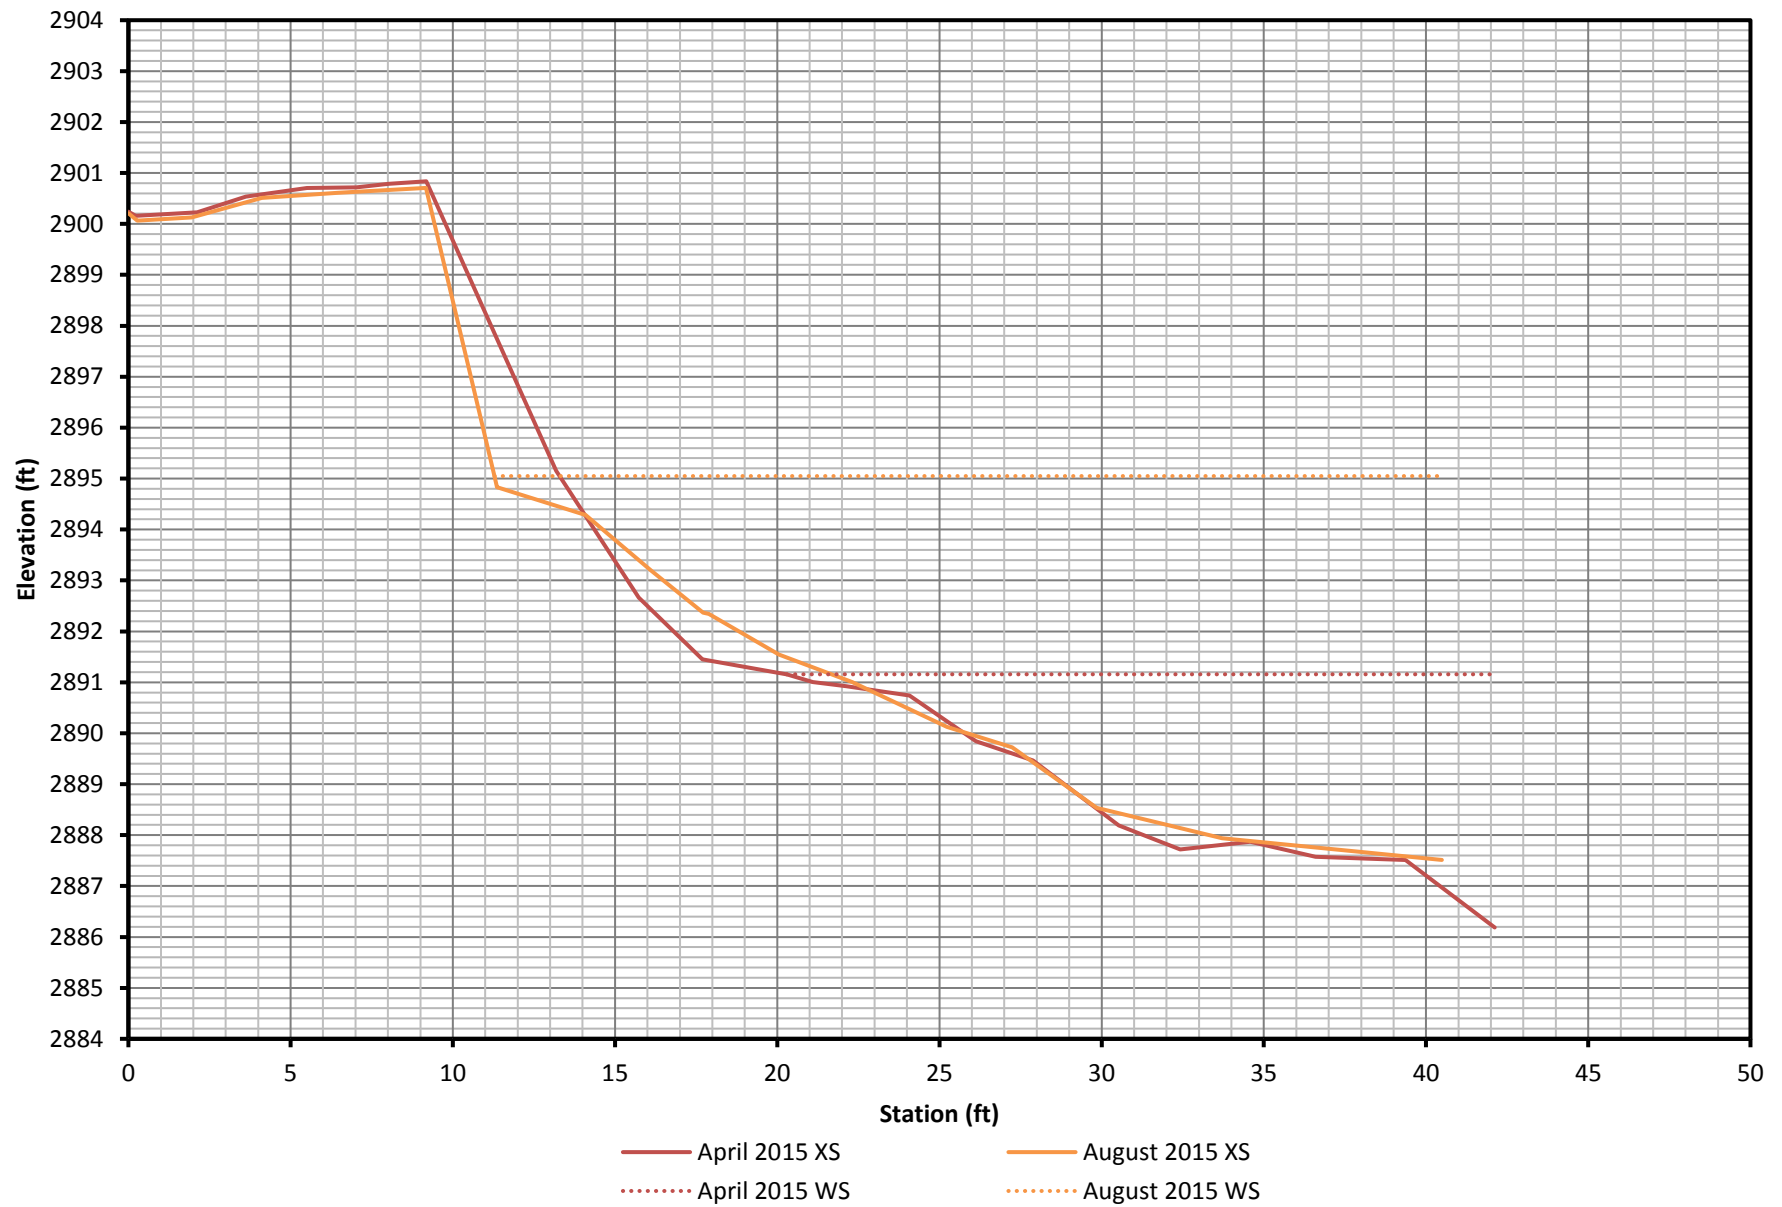
## Foy's Bend Bank Transect #0.5

Monitoring of the bank upstream of the stabilization project has included photo-documentation and surveying of perpendicular bank transect #0.5. The following points summarize conditions immediately upstream of the reconstructed bank segment:

northward, with evidence provided by wooden fence posts formerly at the top of the bank that have since fallen in the river. Given the bank retreat observed over the past two years and documented by survey transect #0.5 during the past year, erosion severity along this bank is considered severe. The erosion occurring along this bank segment has yet to affect the reconstructed bank area other than calving of the bank where fence posts were installed to establish the upstream extent of an enclosure. However, continued erosion of the river bank upstream of the stabilized reach may threaten the MDT project area if the erosion begins to flank the coir wrapped banks.

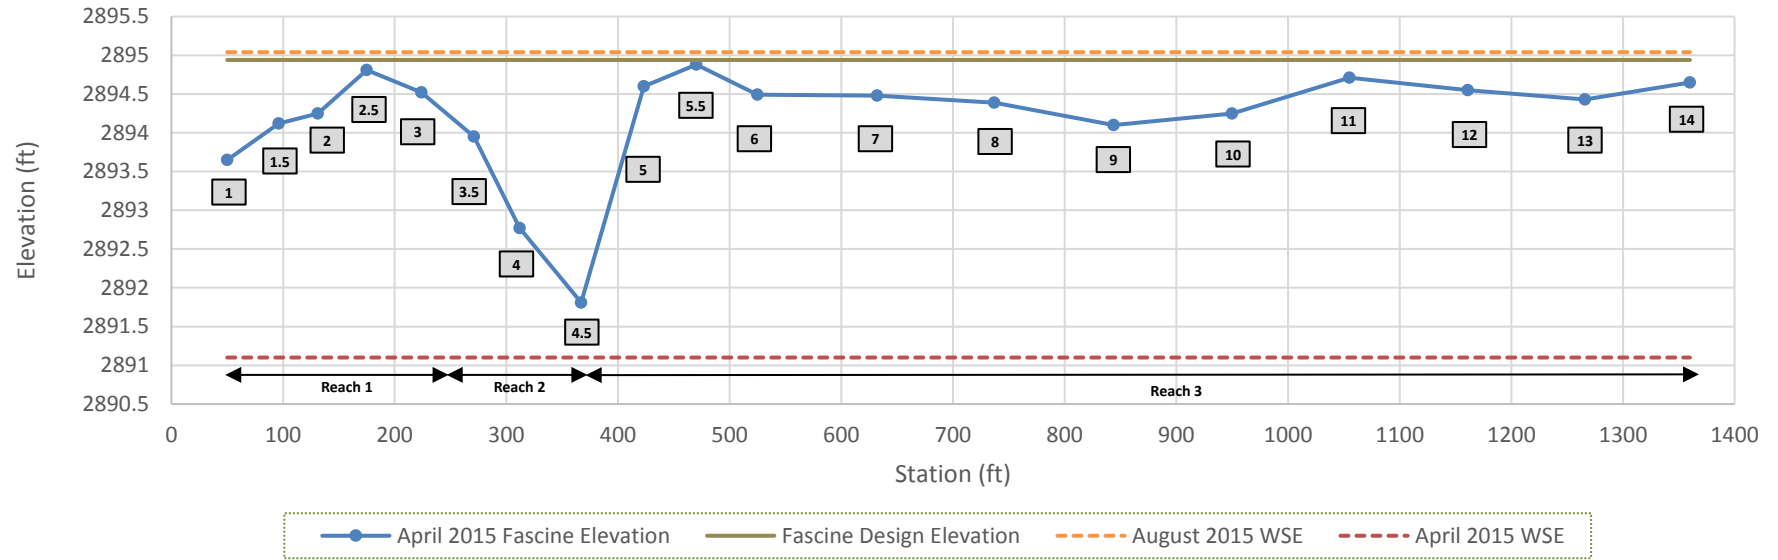
## Foy's Bend Fascine Profile

- Visual observations in March 2015 noted additional soil loss from beneath the bioengineered bank treatment as evidenced by the coir fascine and soil lift slumping into the river at low water (see fascine profile in Appendix B and Additional Photos 9 and 10 on page C-6 of Appendix C).

None of the fascines appear to be unravelling along the length of the reconstructed bank. As noted in the sections above describing Reaches 1-3, segments of the fascines have dropped in elevation by up to 3.1 feet below the design elevation due to a loss of bank material beneath them; however, they remain intact. All of the fascines are completely submerged during high water and all of the willow cuttings installed between the fascines and the coir wrapped soil lift have perished as a result of being submerged throughout the growing season.

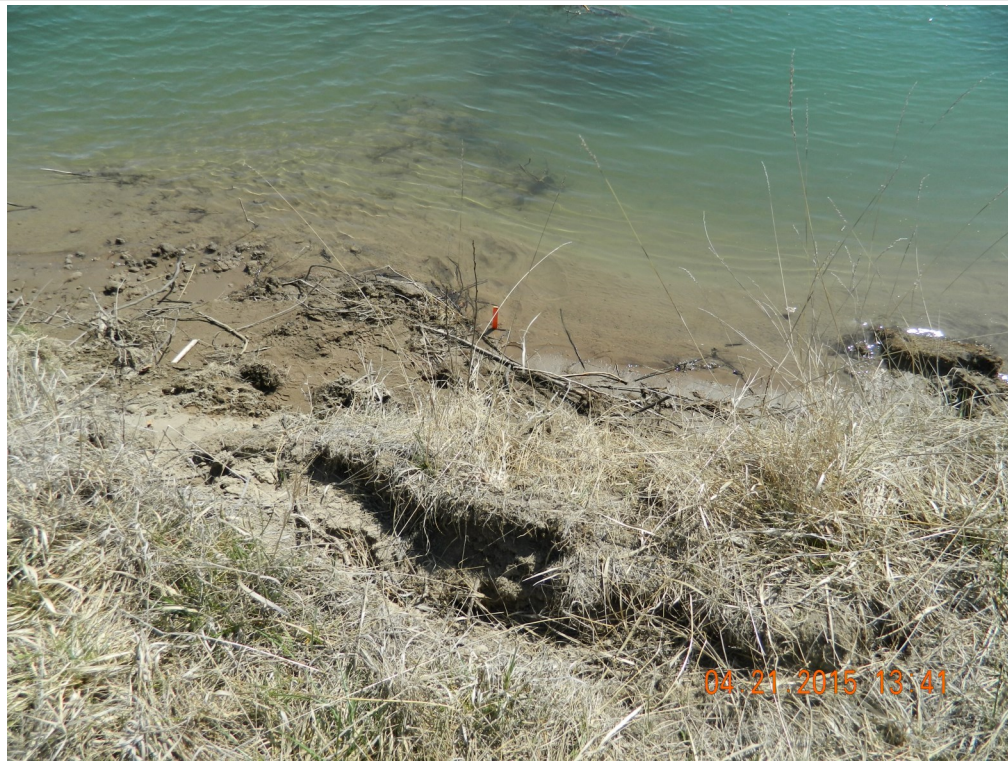
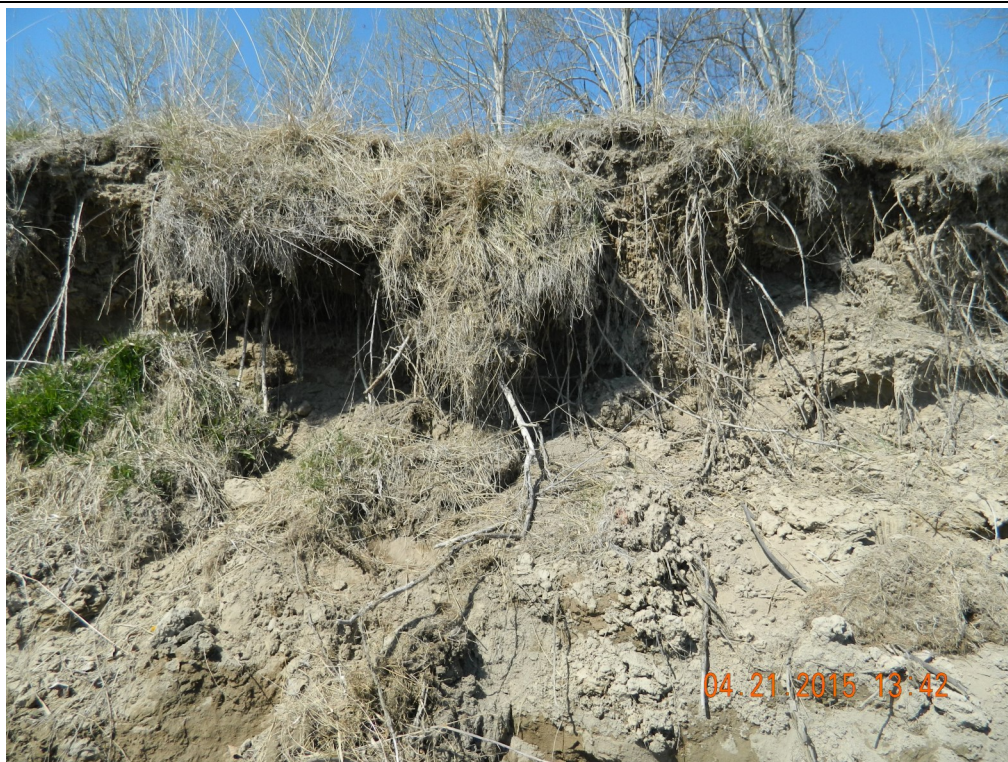
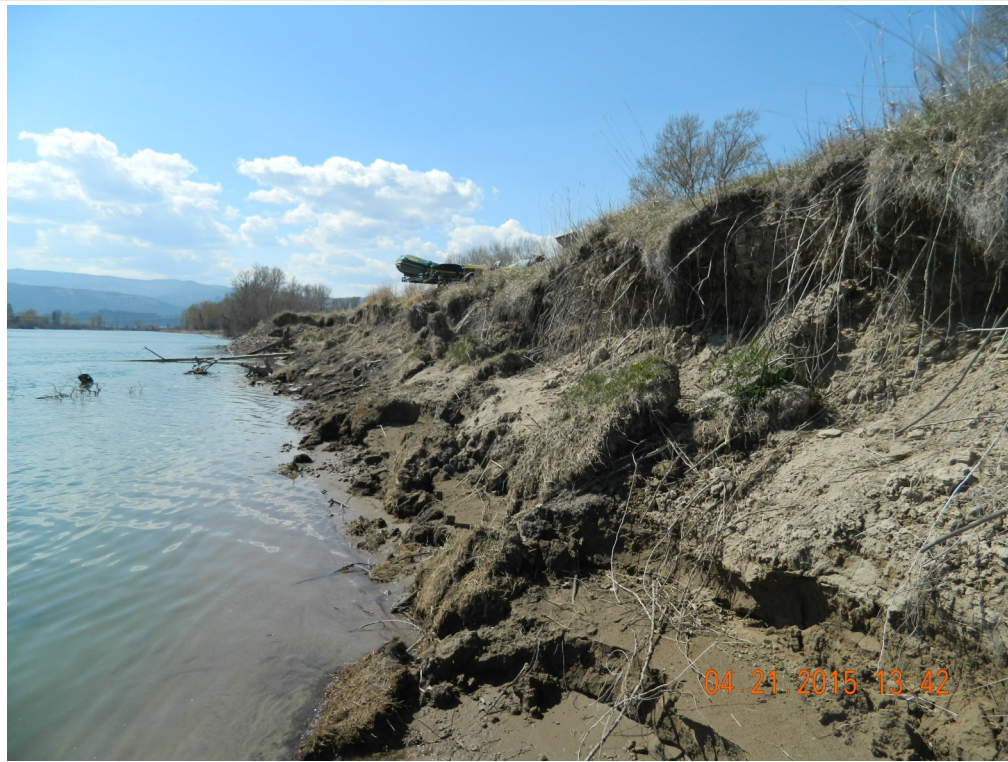
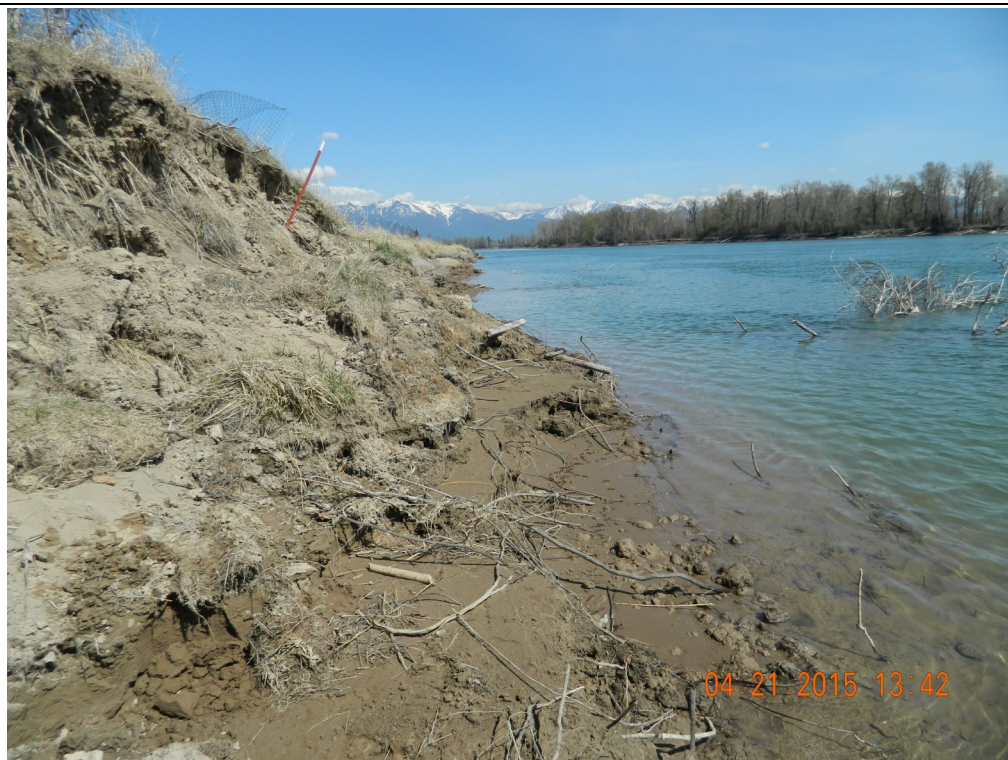
T 0.5: Looking South

T 0.5: Looking North

T 0.5: Looking West up stream

T 0.5: Looking East down stream
