MONTANA DEPARTMENT OF TRANSPORTATION STREAM MITIGATION MONITORING REPORT

*North Fork Bear Creek
Ravalli County, Montana*

*Year Project Completed: 2011
Monitoring Report #3: Submitted December, 2015*

MDT Project Number: NH-7-1(114)56
Control Number: 2015 003

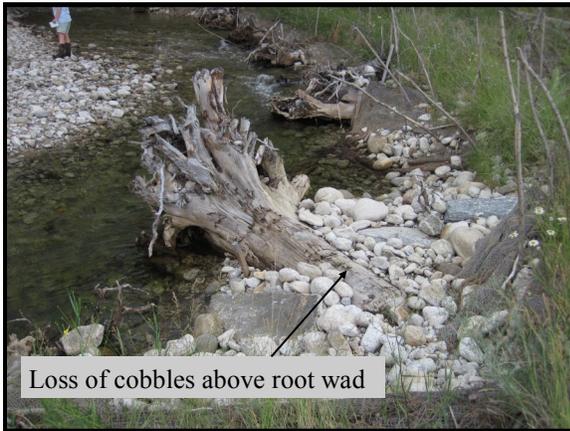
Additional Photo 1—2014

During the 2014 monitoring event, the trunk of one root wad installed upstream of Highway 93 appeared more exposed than the year prior (see Photo 1 in Appendix B). The following is an excerpt from the 2013 monitoring report from this site (CCI, 2014):

The exposure of this trunk appeared as a result of the loss of cobble material placed on the upper six inches of the bank during high flows in 2014. Cobble materials placed over this root wad were covered with a layer of topsoil and coir fabric during construction; however, the fabric has peeled back from the top of the bank and is no longer providing protection of the upper bank. If additional cobbles adjacent to this root wad mobilize during subsequent high flows, the root ball may create a scouring hydraulic against the bank, reducing the ability of the root wad to provide bank protection. Although the bank is not currently considered eroding due to the lack of lateral channel movement, continued monitoring is highly recommended to determine whether this segment of the project reach becomes more susceptible to erosion.

Loss of cobbles above root wad

Description: Root wads upstream of bridge.

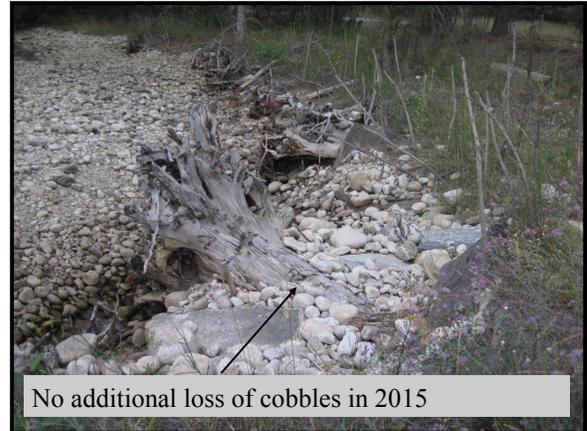
Additional Photo 1—2015

The 2015 monitoring event did not reveal any additional loss of cobbles or other bank materials in the vicinity of this root wad and tree trunk. Furthermore, no evidence of high water debris deposits or drift lines was noted, indicating the North Fork of Bear Creek likely did not experience an out of bank flow event during spring runoff. This evidence is supported by below average snowpack documented in the Bitterroot Mountains (NRCS, 2015). The channel had no flowing water during the monitoring site visit in 2015, which occurred during mid-summer during a drought conditions. Standing water was observed in residual pools formed by scour against the rootwads installed as part of the project, but otherwise no other water was observed in the channel. No water was observed in the North Fork Bear Creek mitigation site during the 2013 monitoring event as well, indicating this segment of the channel may experience frequent dewatering.

No additional loss of cobbles in 2015

Description: Root wads upstream of bridge.

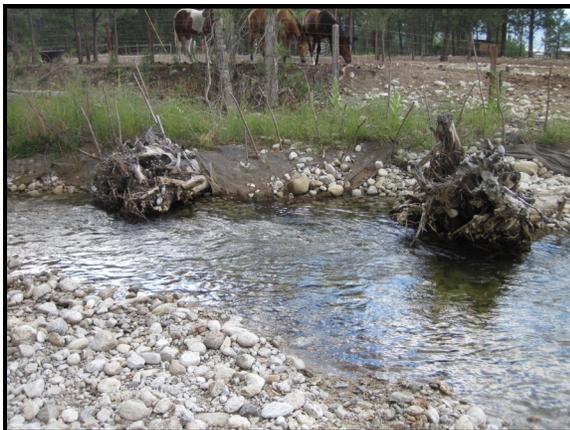
Additional Photo 2—2014

Description: Root wad upstream of bridge showing scour.

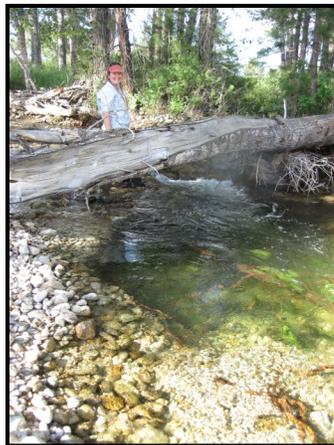
Additional Photo 3—2014

Description: Large hole downstream of project site.

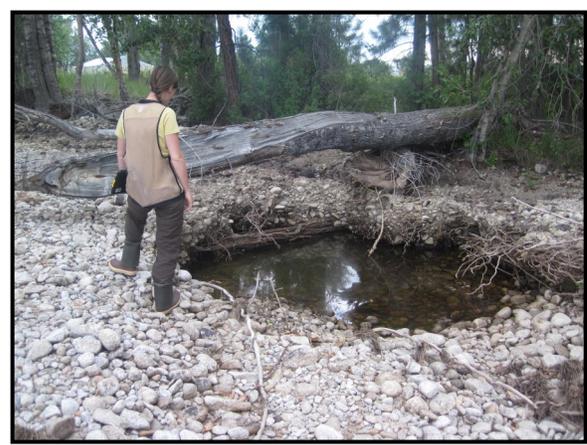
Additional Photo 3—2015

Description: Large hole downstream of project site.

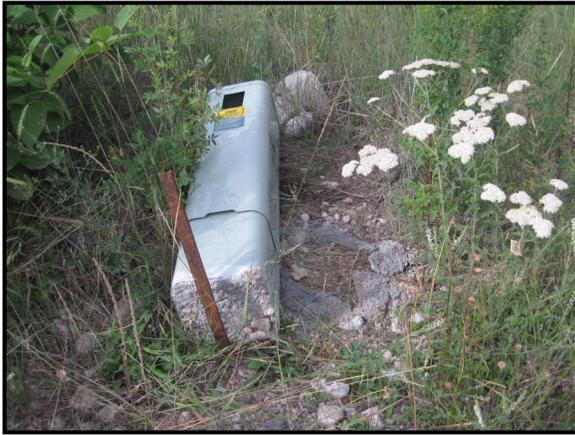
During the monitoring site visit, the remote camera stationed positioned to the west of the Highway 93 Bridge was found knocked off of its foundation and the camera removed. The monitoring crew contacted MDT and the researcher conducting wildlife use studies beneath Highway 93 Bridges to inform them of the damaged camera station.

Additional Photo 4 - 2015
Description: Downed camera station.
Taken in 2015

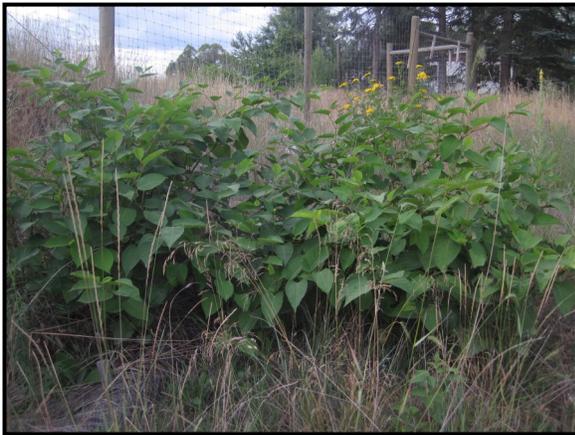
Three new noxious weed species were identified during the 2015 monitoring event, including *Berteroa incana* (Hoary False-Alyssum), *Hypericum perforatum* (Common St. John's-Wort), and *Potentilla recta* (Sulphur Cinquefoil). Noxious weeds were observed along both banks of the project reach. Although each individual weed infestation is relatively small in extent, the area of all infestations combined warrants concern and must be addressed to achieve the success criterion for riparian cover.

Additional Photo 6 - 2015
Description: Knotweed complex
Taken in 2015

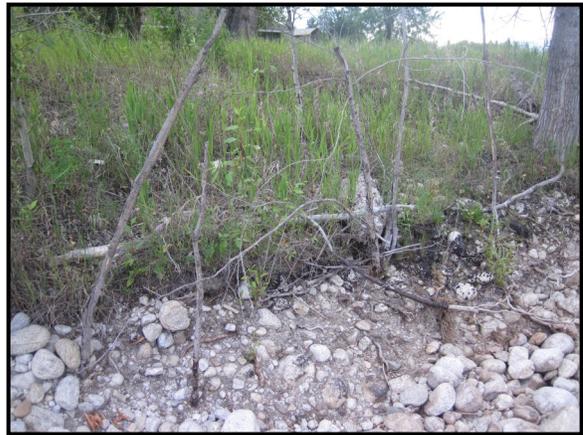
Attempts at establishing woody riparian vegetation within the project reach included installing cuttings along the banks upstream and downstream of the Highway 93 Bridge. Cottonwood and willow cuttings installed along the banks were unsuccessful. No cuttings were found alive during 2013, 2014, or 2015 field observations (see photo points 2.1 and 2.2, Appendix B). Upon inspection, all cuttings were installed to a depth of approximately one foot, with 4 to 5 feet of the stem extending above ground. Mortality of these cuttings can be attributed to the shallow planting depth and inability of the cuttings to extend roots to the low water table elevation.

Percent cover of woody vegetation has increased from 27% in 2013, to 30% in 2014, to 32% in 2015. The majority of woody plants include shrubs and trees that existed prior to relocating the channel and volunteer species that are colonizing the site. None of the woody cuttings planted along the left (north) bank survived due to inappropriate planting techniques.

Additional Photo 7 - 2015
Description: Failed woody cuttings
Taken in 2015
