MONTANA DEPARTMENT OF TRANSPORTATION STREAM MITIGATION MONITORING REPORT

*Bowser Creek
Flathead County, Montana*

*Project Completed: 2010
Monitoring Report #4: December, 2016*

MDT Project Number: NH 15(93)
Control Number: 2038-011

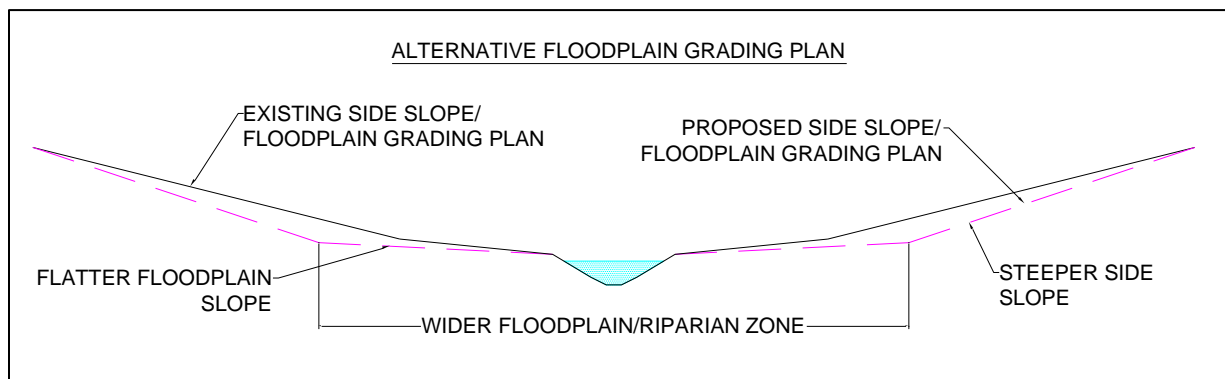
Figure 2. Alternative grading plan to increase floodplain and riparian areas.

Designed side slope dimensions along Bowser Creek provide room for a very narrow, 14-foot wide riparian and floodplain zone. Perpendicular transect survey results (Appendix B) illustrate a narrow bankfull bench adjacent to the creek has been constructed for flood inundation and wetland/riparian vegetation establishment. Integrating a slightly steeper upland side slope design would provide for a wider, more functional floodplain and riparian zone by allowing the stream to access a larger flat zone adjacent to the active channel (Figure 2). Constructing steeper side slopes and a wider floodplain area requires additional excavation; therefore, a cost/benefit analysis of creating additional floodplain and wetland features, and the associated mitigation credits, is potentially worth consideration for future stream and riparian mitigation designs. Design of steeper side slopes along floodplains adjacent to highways must also take into account traffic and safety considerations, and allow for vehicles to exit the roadway safely.

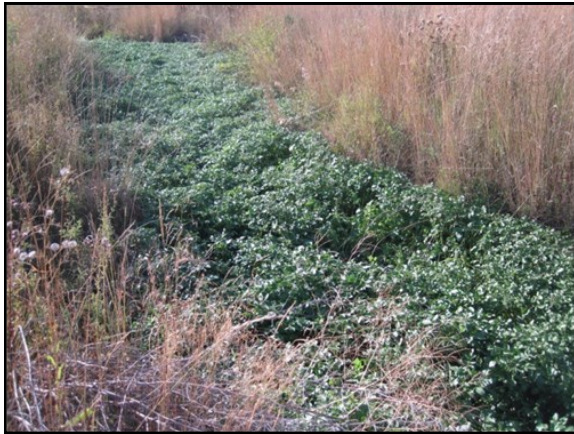
Additional Photo 1: August 2013

Description: Dense Watercress growth in Bowser Creek. **Compass:** 90 (East)

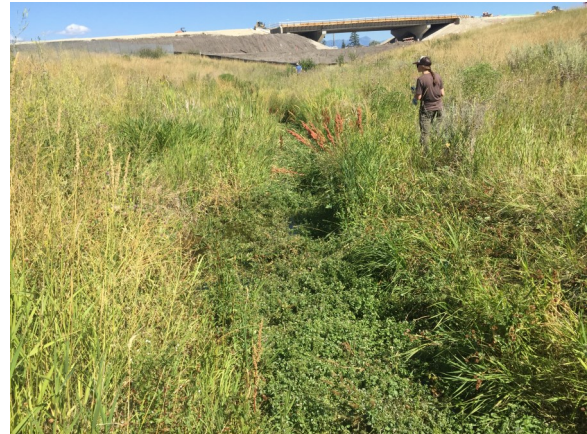
Additional Photo 1: August, 2016

Vegetation community Type 3 – *Nasturtium officinale* was identified within the channel. Watercress (*Nasturtium officinale*) dominated this community type with more than 50% cover growing in the channel bed. This community has been consistently observed in dense stands along the stream bed during the growing season.

Description: Dense watercress growth in Bowser Creek. **Compass:** 90 (East)

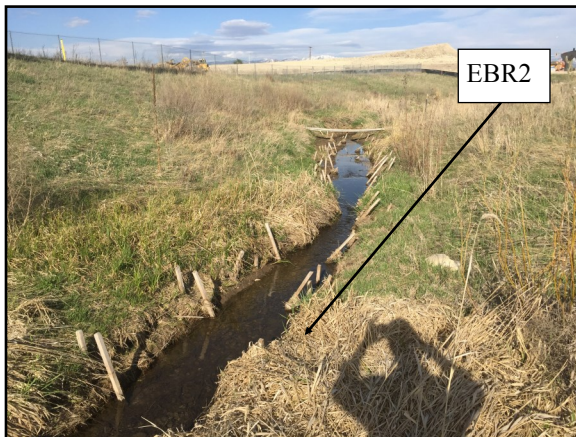
Additional Photo 2: April, 2016

Description: Eroding bank EBR2 (not eroding)
Compass: 90 (East)

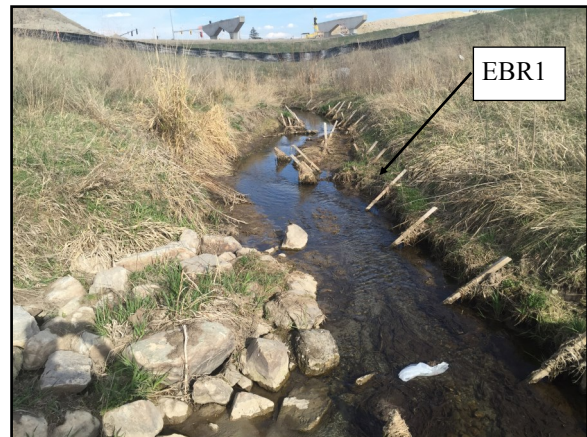
Additional Photo 3: April, 2016

Description: Eroding bank EBR1 (not eroding)
Compass: 90 (East)

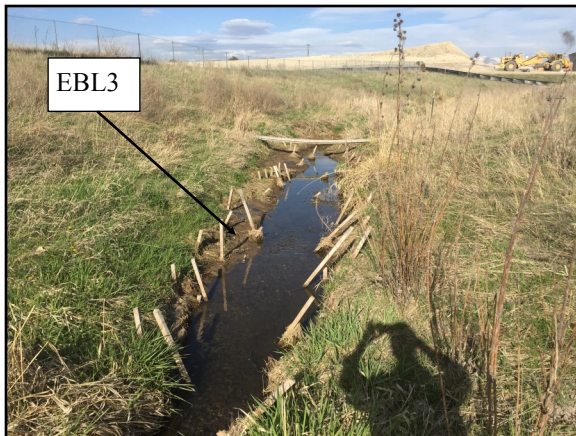
Additional Photo 4: April 2016

Eroding bank EBL3 was identified in 2015 as a newly eroding bank segment. Erosion along this bank is evident from the wood stakes that were used to construct the outside edge of the bank, which are now 2 to 3 feet away from the edge of the bank. The channel is approximately 12 feet wide at this location, which is 6.5 feet wider than the design width of 5.5 feet. As noted above, erosion along EBL3 is associated with bank saturation and seeps entering Bowser Creek caused by the adjacent retention pond. Vegetation along this bank is dominated by Canada thistle, bull thistle, and smooth brome. The majority of the bank does not appear to be actively eroding; however, a significant seep observed near the downstream end of EBL3 is causing bank calving and sediment inputs to the channel (see Additional Photo 5 in Appendix C). As a result of these factors, bank erosion along EBL3 is considered moderate.

Description: View downstream of eroding bank EBL3. Compass 90

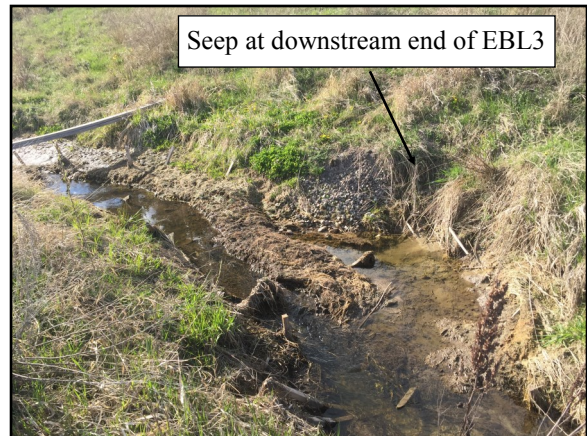
Additional Photo 5: April, 2016

Description: View of seep causing saturation and bank failure at downstream end of EBL3.

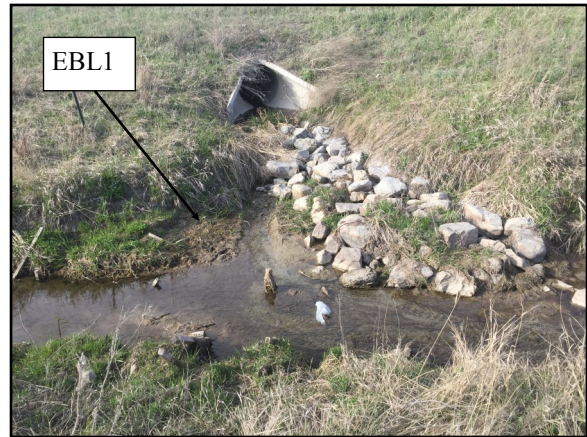
Eroding stream bank EBL1 is located immediately upstream of a culvert entering Bowser Creek from the north. Erosion at EBL1 was noted during the first monitoring event; however, the bank does not appear to have retreated any further in the past four years (see Additional Photo 7 in Appendix C). Vegetation has established along the length of the bank and bare ground is no longer exposed. Previous monitoring reports assigned a low erosion severity rating along the bank based on the lack of active erosion occurring. As a result of the factors described above, EBL1 has been removed from the list of eroding banks along Bowser Creek and no longer is included on Figure 3 in Appendix A.

Additional Photo 7: April 2016
Description: View looking across channel at EBL1
Compass: 0 (North)

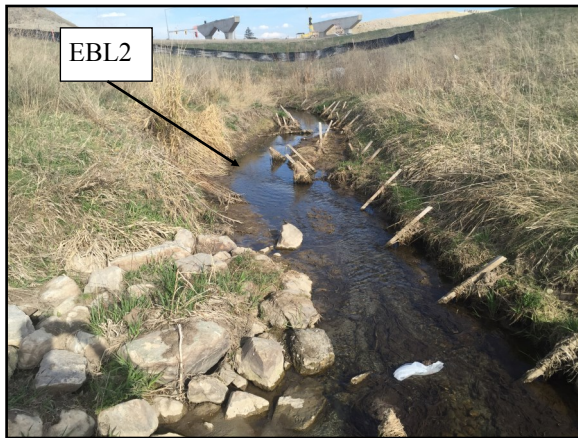
Eroding bank EBL2 is located just downstream of the culvert noted above. Inspection of the creek during the April, 2016 site visit revealed the channel has widened from its assumed constructed width of 5.5 feet to over 13 feet (see Additional Photo 8 in Appendix C). Survey transect #2 runs through this eroding bank, and repeated surveys through this transect indicate the left bank initially retreated approximately 1.5 feet from 2013 to 2014 and has since remained relatively stable. Based on these survey results, this segment of reconstructed channel likely widened between the time it was

constructed in 2010 and the first monitoring event in 2013. No further erosion was noted during the 2015 or 2016 monitoring events. As a result of the lack of recent erosion noted, erosion severity is considered low at EBL2.

Additional Photo 8: April 2016
Description: View downstream of EBL2.
Compass: 90 (East)
