MONTANA DEPARTMENT OF TRANSPORTATION STREAM MITIGATION MONITORING REPORT

*Foy's Bend Fisheries Conservation Area
Flathead County, Montana*

*Project Completed: 2013
Monitoring Report #4: December 2016*

MDT Project Number: NH-MT 5-3(50) 109F
Control Number: 20380013

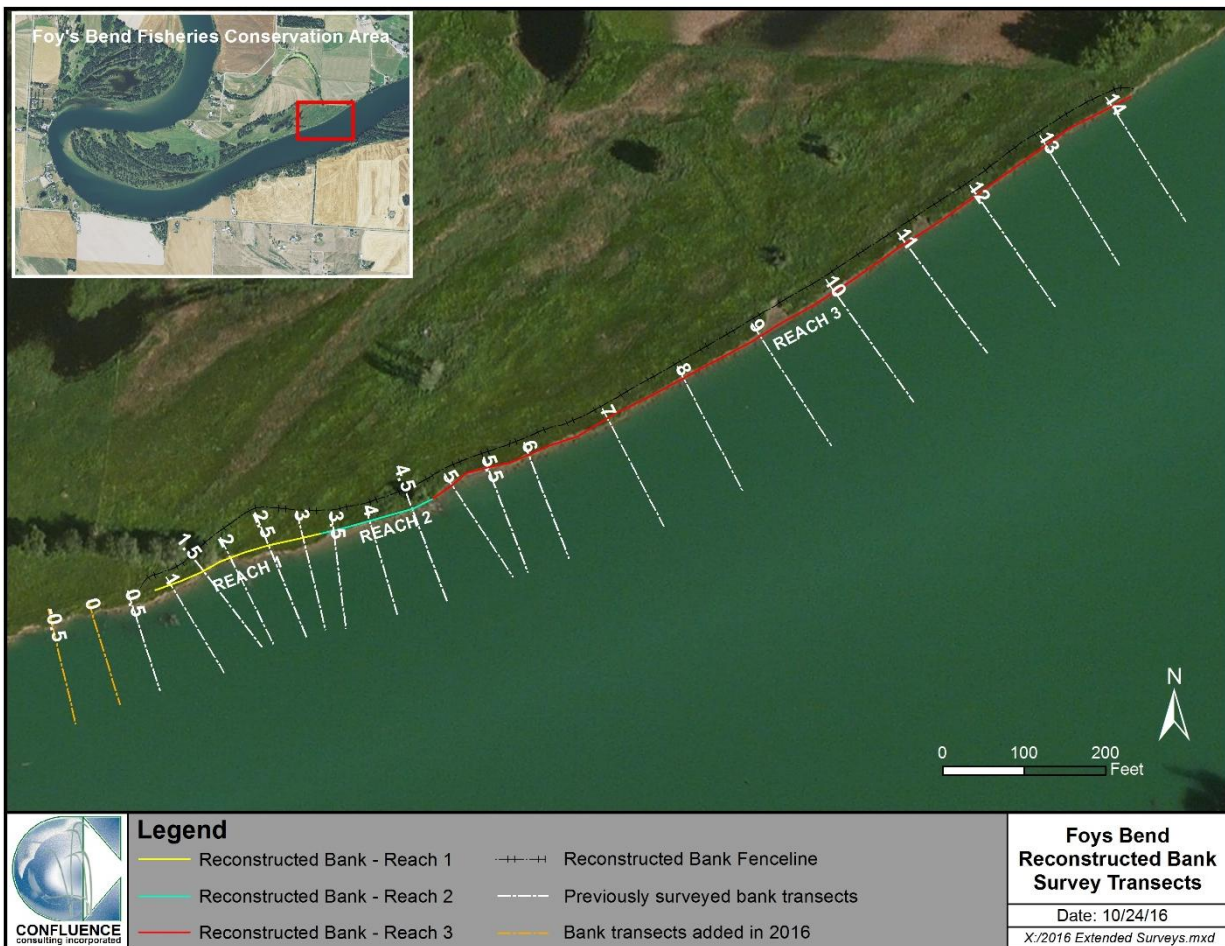
Figure 3. Reach breaks and surveyed transects along Foy's Bend reconstructed bank segment.

For the purposes of describing the reconstructed bank segment, it has been divided into three reaches based on conditions observed and surveys conducted during the monitoring site visits (Figure 3). The following sections describe monitoring data documented within each of the three reaches as well as immediately upstream of the reconstructed bank. Supporting data includes plotted survey transect data (Appendix B) and photo documentation of the river bank (Appendix C). Perpendicular bank transects plotted at each of the locations shown in Figure 3 also includes the elevation at the top of the fascine during the most recent survey event.

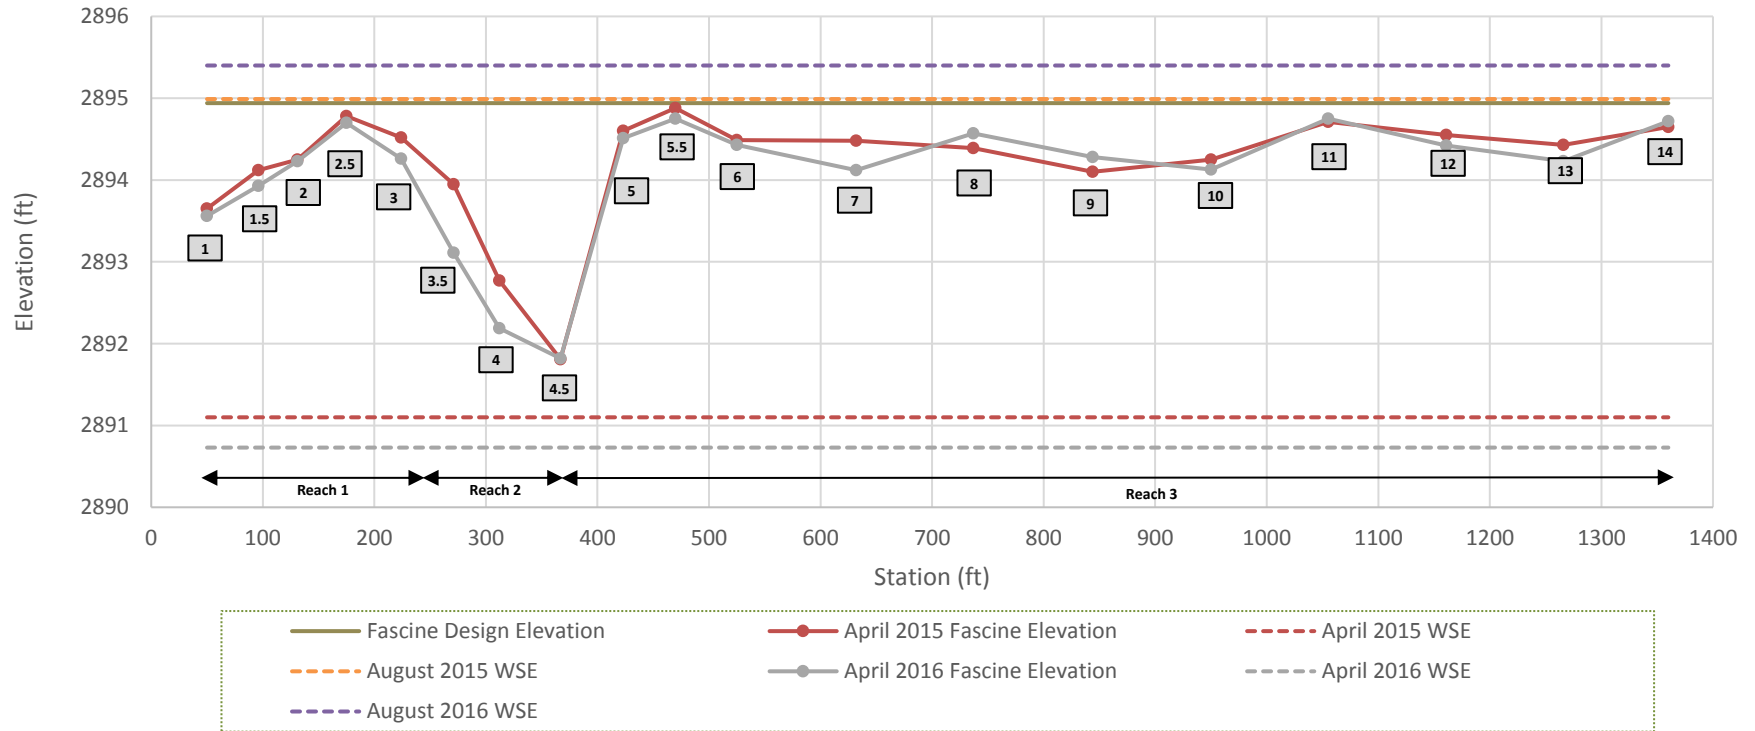
Foy's Bend Fascine Profile

- The woody fascine below the soil lift is lower than the design elevation (and assumed construction elevation) by up to 1.3 feet within Reach 1 (@ transect #1), but did not drop further in the past year. The lowering of the fascine may be a result of compaction or decomposition of the fascine and/or slope failure beneath the fascine (see profile of fascine surveyed in August, 2015 on page 21

of Appendix B and Additional photo 5 on page C-5 of Appendix C). Slope failure below the fascines is likely the main contributing factor to the drop in fascine elevation.

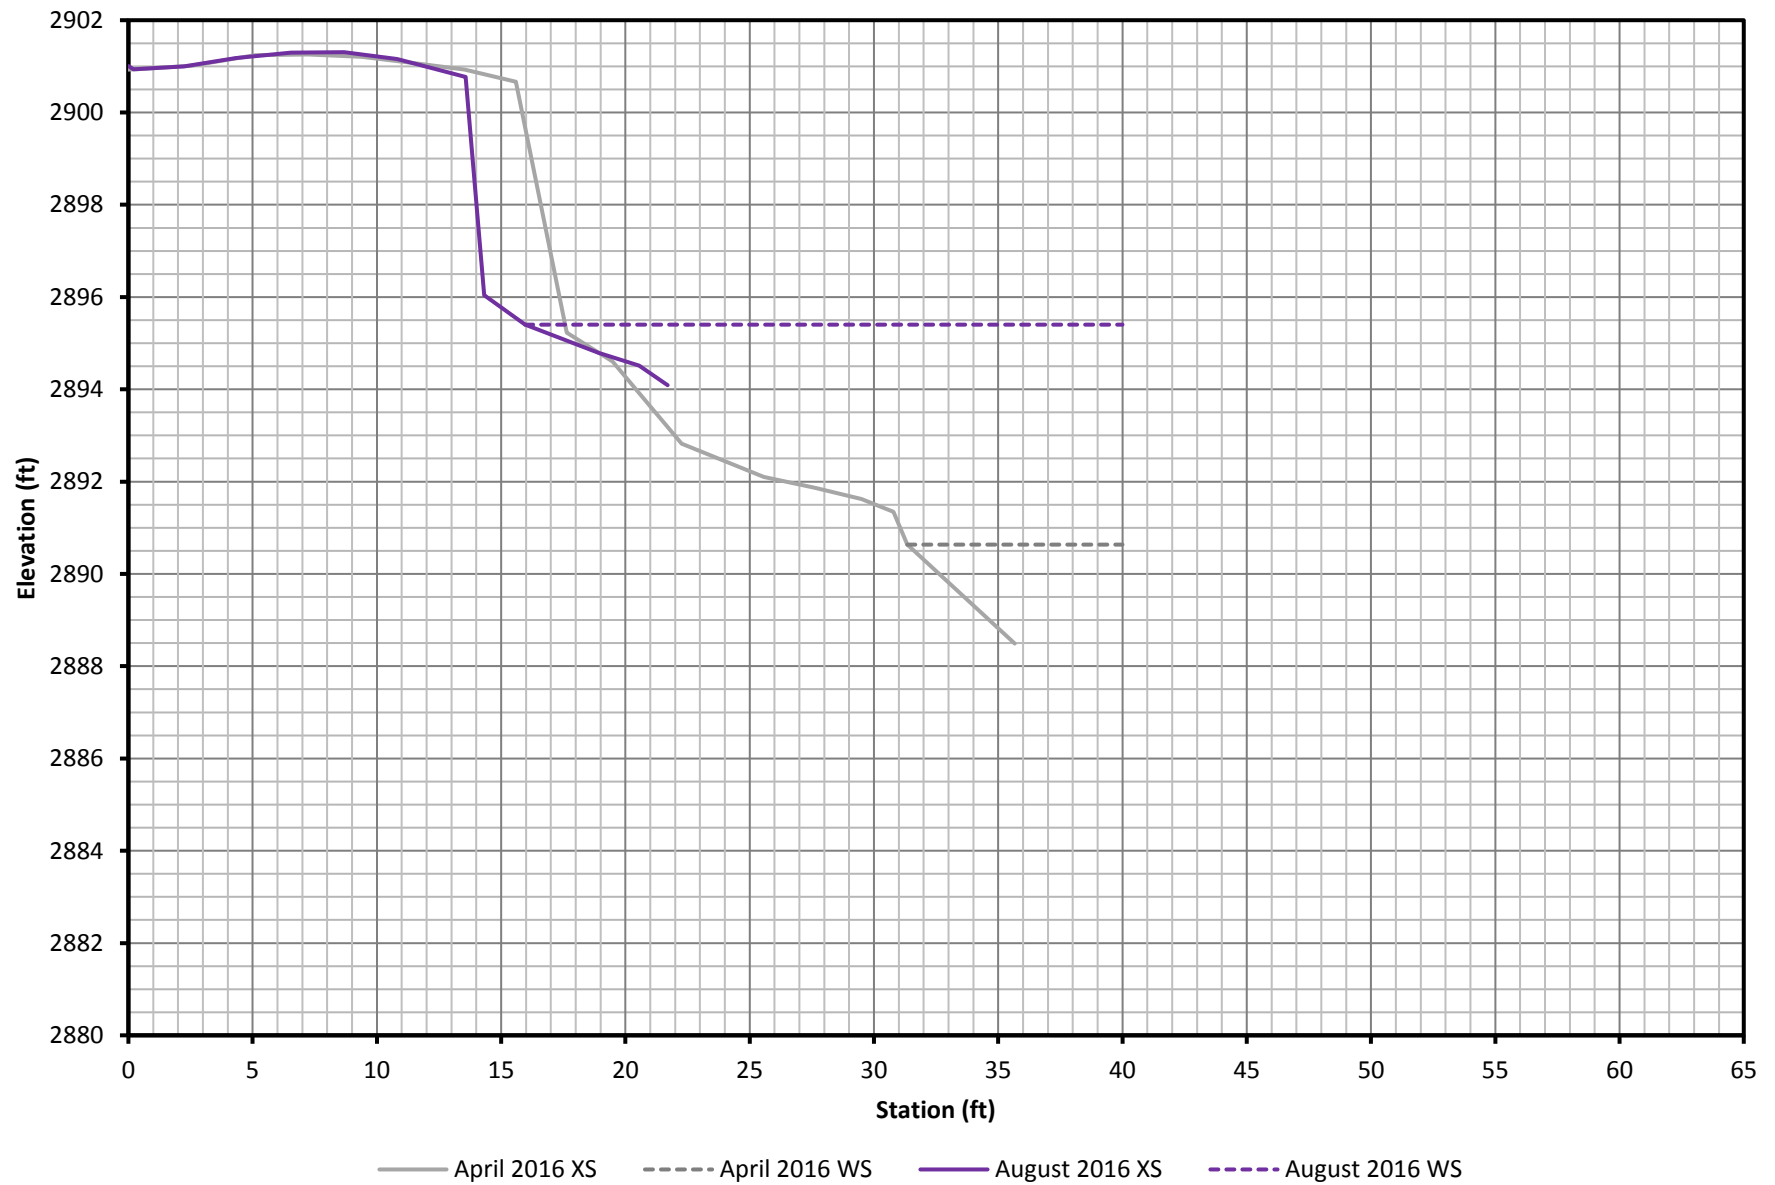
Foy's Bend Upper Bank Transect # -0.5

- Given the upper bank retreat observed over the past three years, erosion along this bank is considered severe. The erosion occurring along this bank segment has yet to affect the reconstructed bank area other than calving of the bank where fence posts were installed at the upstream extent of the restored stream bank enclosure. Continued erosion of the river bank upstream of the stabilized reach is threatening to extend into the MDT project area.

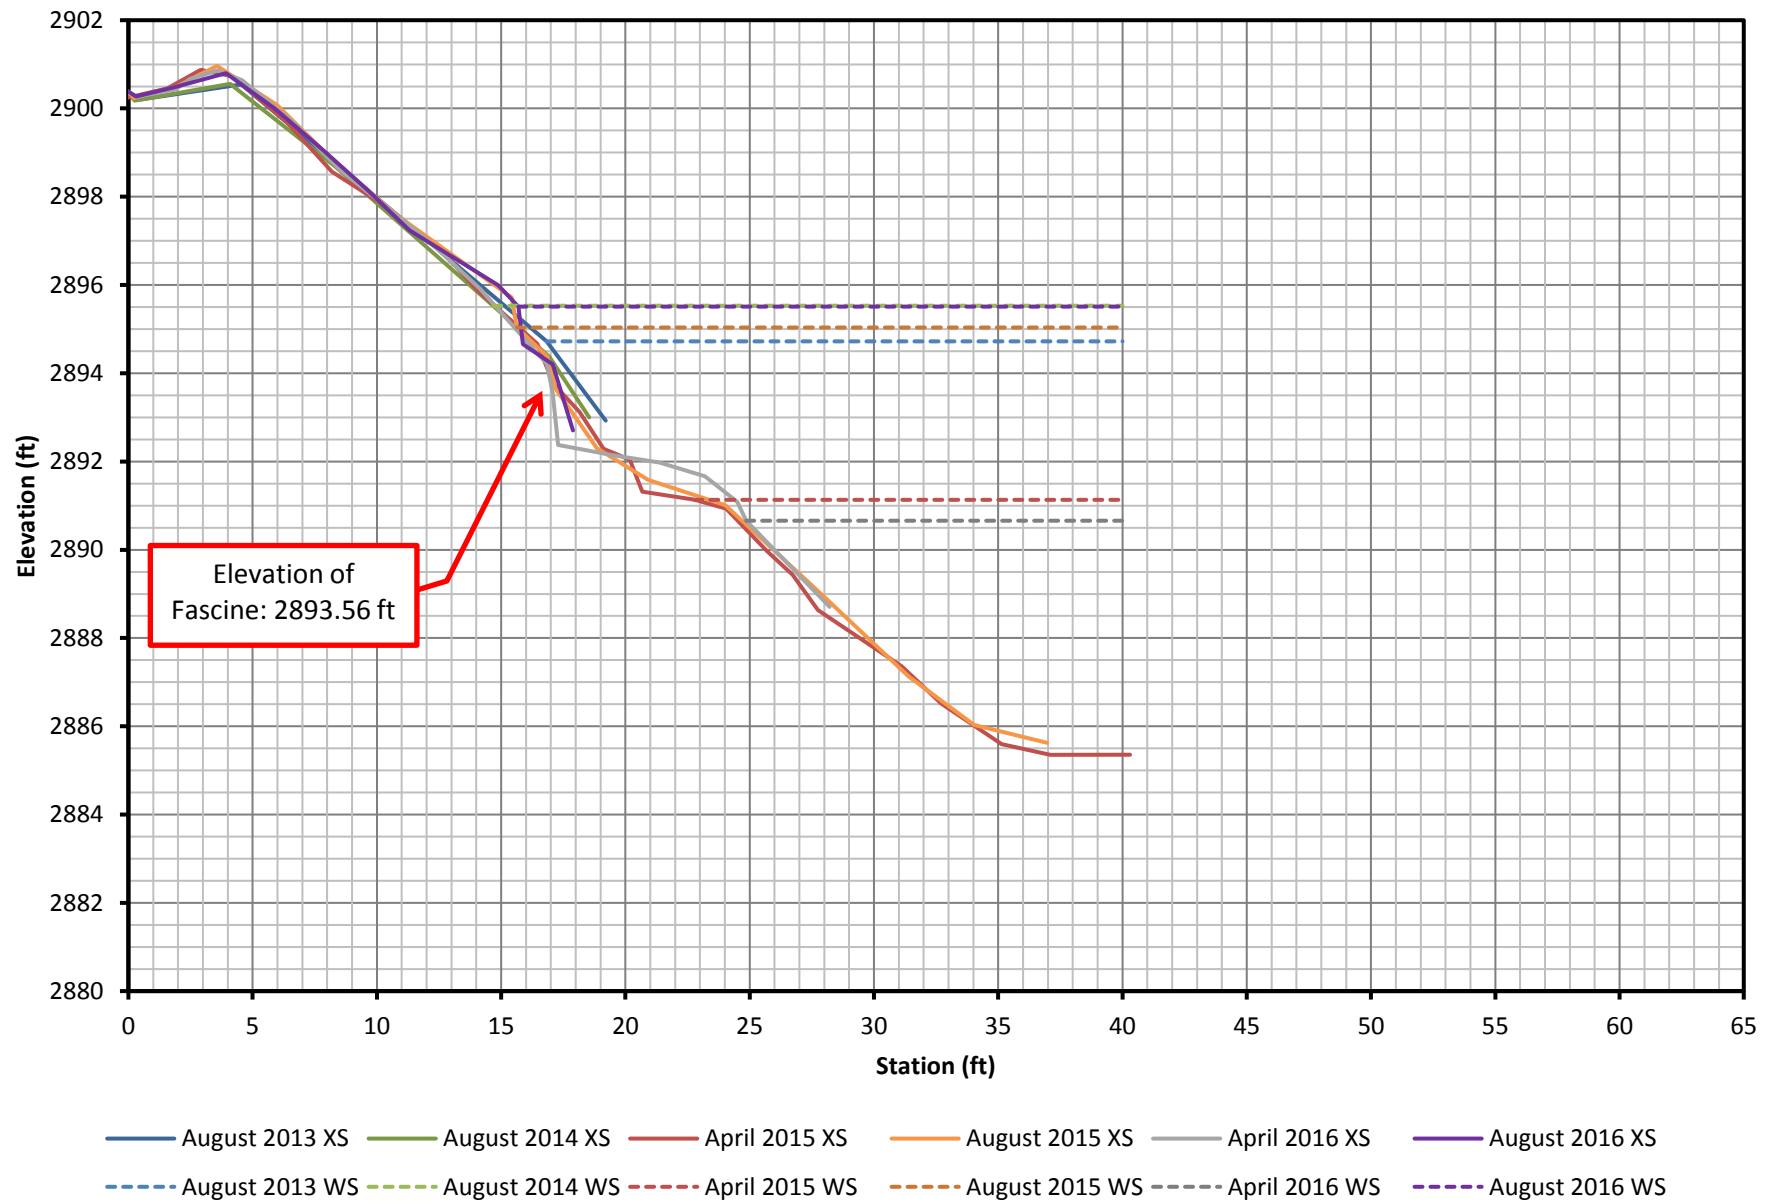
Foy's Bend Bank Transect #1

- The upper, re-sloped portion of the reconstructed bank above the bioengineered treatment appears stable with no indication of lateral erosion between bank transects 1 through 3 (see Photo Point 5.2 on page C-3 of Appendix C). This rate of erosion is well below the rate considered “functional” in the performance standards and is less than that observed at transects #-0.5 to #0.5 just upstream.

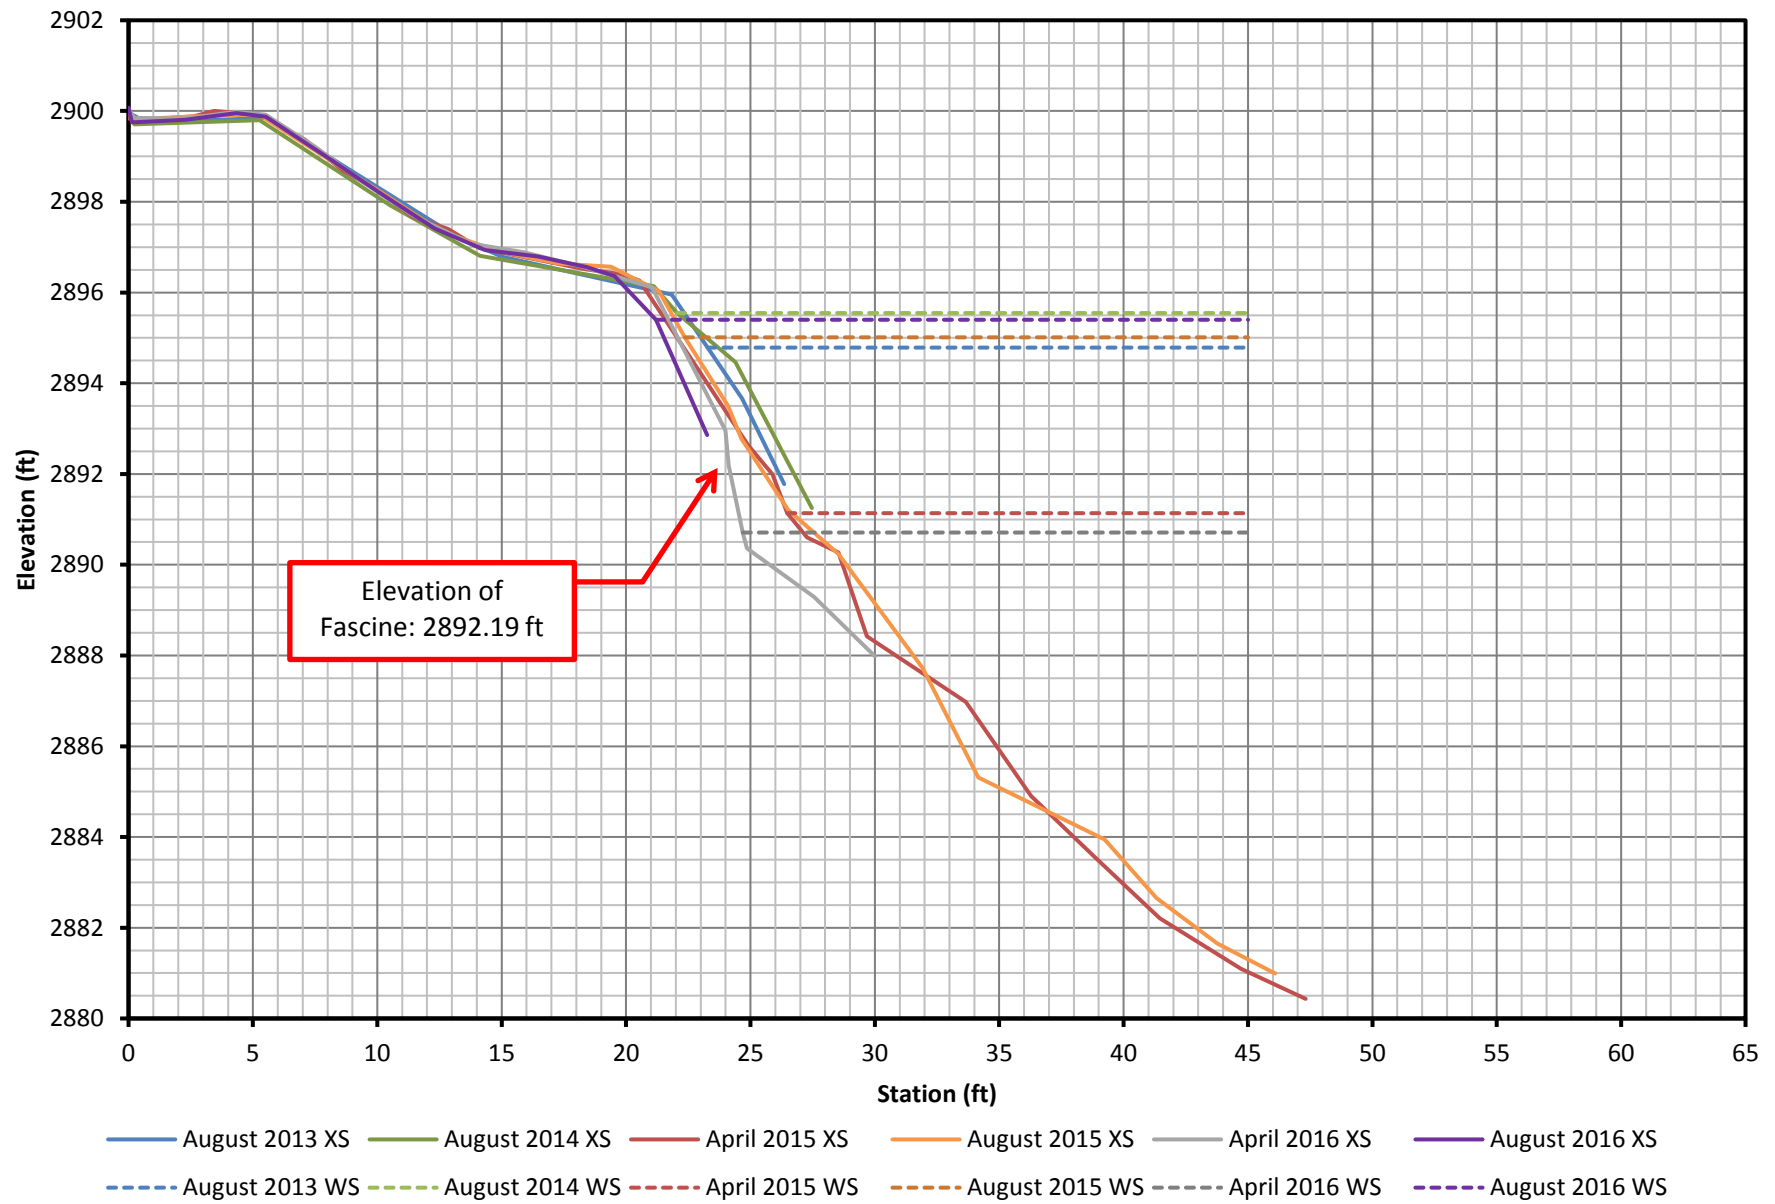
Foy's Bend Bank Transect #4

- Undercutting of the stabilized bank has caused a 20-foot segment of woody fascine to separate from the bank near transect #4. Additional fracturing of the woody fascine from beneath the bank is expected as the lower bank continues to recede northward (see Additional Photo 8 on page C-6 of Appendix C).
