MONTANA DEPARTMENT OF TRANSPORTATION STREAM MONITORING REPORT

*Little Rock Creek at Judith Slide Repair
Fergus County, Montana*

*Project Completed: 2013
Monitoring Report #3: December, 2016*

MDT Project Number: STPS 426-2(12) 15
Control Number: 7726000

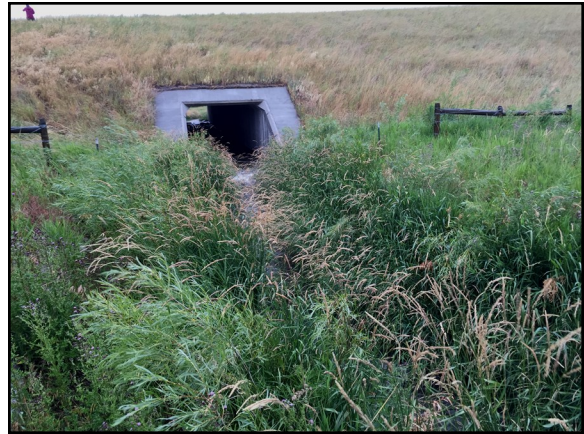
Photo Point 1—2016

Table 2 summarizes the areal percent cover of total vegetation, woody vegetation, and noxious weeds observed along each riparian and stream bank transect during the 2014 through 2016 monitoring events. Both riparian vegetation transects were located downstream of the box culvert, and are representative of the reconstructed channel and associated riparian zones below the culvert outlet. Total percent cover of vegetation increased from 83% in 2015 to 88% in 2016. Total percent woody cover increased from 14% in 2015 to 17% in 2016. Percent cover of Montana State-listed noxious weeds increased from 3% in 2015 to 4% in 2016 (See Section 4.3). Vegetation upstream and downstream of the culvert is establishing well, with a diversity of stream bank and riparian vegetation developing on both sides of the channel (See Photo Point 1 and Additional Photo #1 in Appendix A).

Description: Upstream end of project looking downstream. **Compass:** 0 (North)

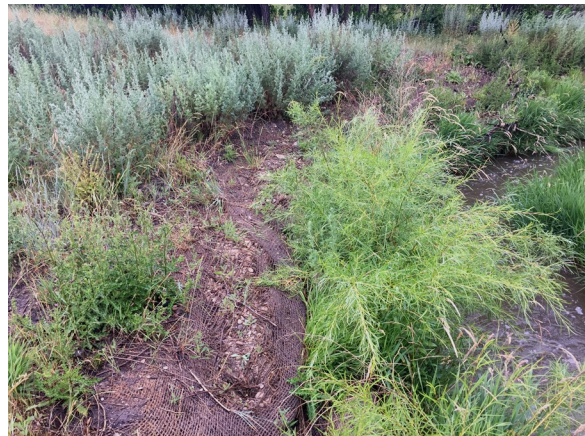
Additional Photo 2

Description: Coir fabric stretching over short segment of eroding bank.

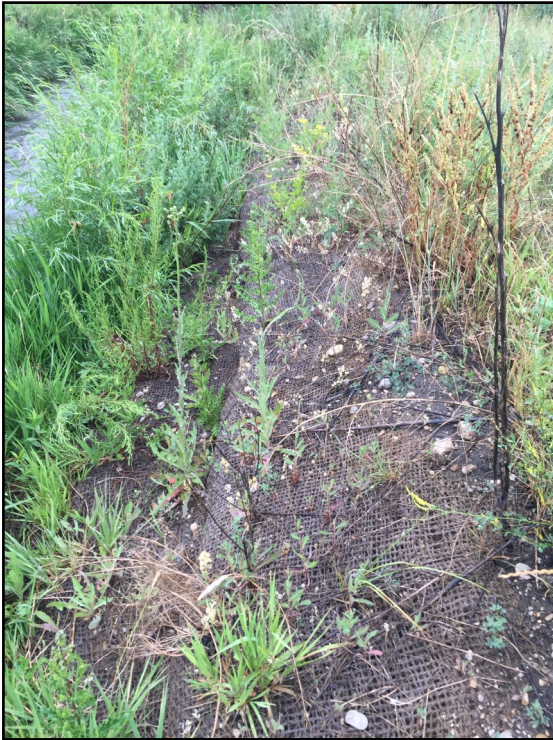
4. As noted in previous monitoring reports, vegetation establishment along the upper coir fabric lifts remains relatively limited. Much of the coir fabric surfaces remain bare or have been colonized by undesirable and weedy species (See additional Photos 5-6 in Appendix C). Potential causes include 1) below average precipitation in 2015, 2) an improper seed mix, or 3) no seeding applied to this area. The design calls for seeding the area above the uppermost lift with a wetland seed mix, which may have been inappropriate for such a dry zone. The design does not call for seeding of native fill material placed within the second highest coir lift layer. Precipitation data from a nearby weather station indicated average precipitation for the 2016 water year up to the time of the monitoring event, indicating this is not likely a limiting factor in vegetation establishment (WRCC 2016).

Additional Photo 5
Description: Unvegetated upper soil lift
Taken in 2016 @ STA 11+00

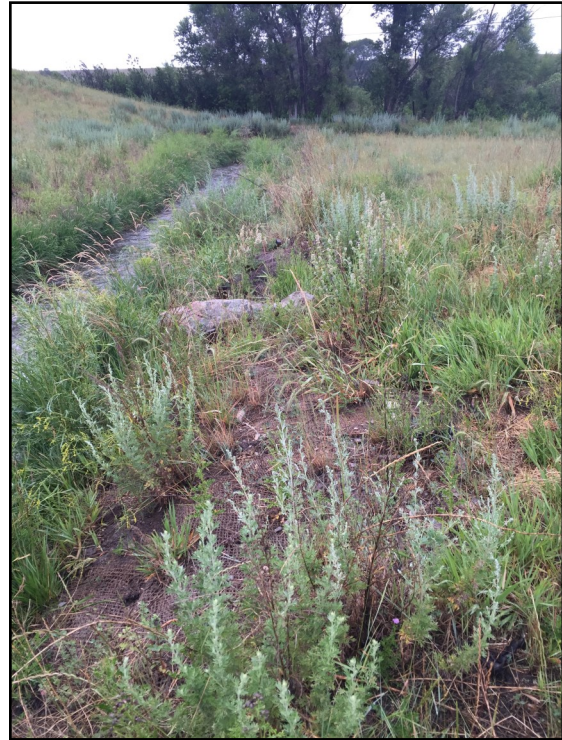
Additional Photo 6
Description: Unvegetated upper soil lift
Taken in 2015 looking downstream @ STA 11+00

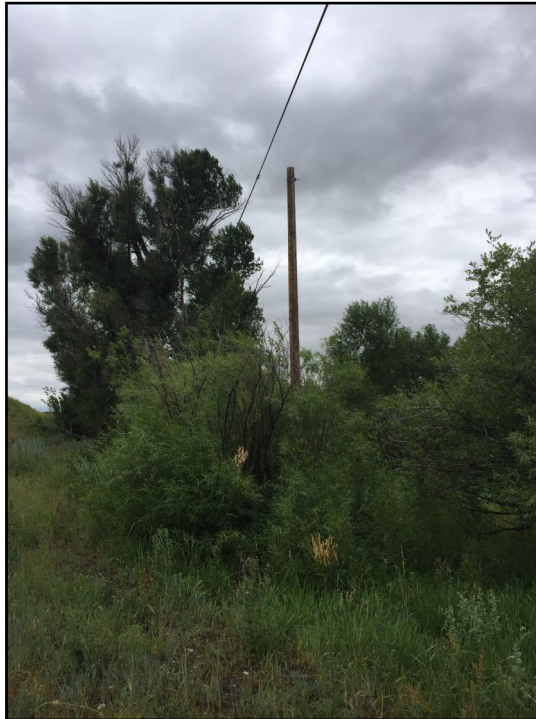
9. Sometime prior to the 2016 monitoring event, telephone line spanning the new channel alignment became separated from the support pole located just west of the creek (see Additional Photo #7 in Appendix C). This issue was reported to MDT immediately after the July 2016 monitoring event and has subsequently been repaired.

Additional Photo 7
Power / phone line separated from support pole
spanning project reach
