MONTANA DEPARTMENT OF TRANSPORTATION STREAM MITIGATION MONITORING REPORT

*Sweathouse Creek
Ravalli County, Montana*

*Year Project Completed: 2011
Monitoring Report #4: December, 2016*

MDT Project Number: NH 7-1(114)59
Control Number: CN 2015004

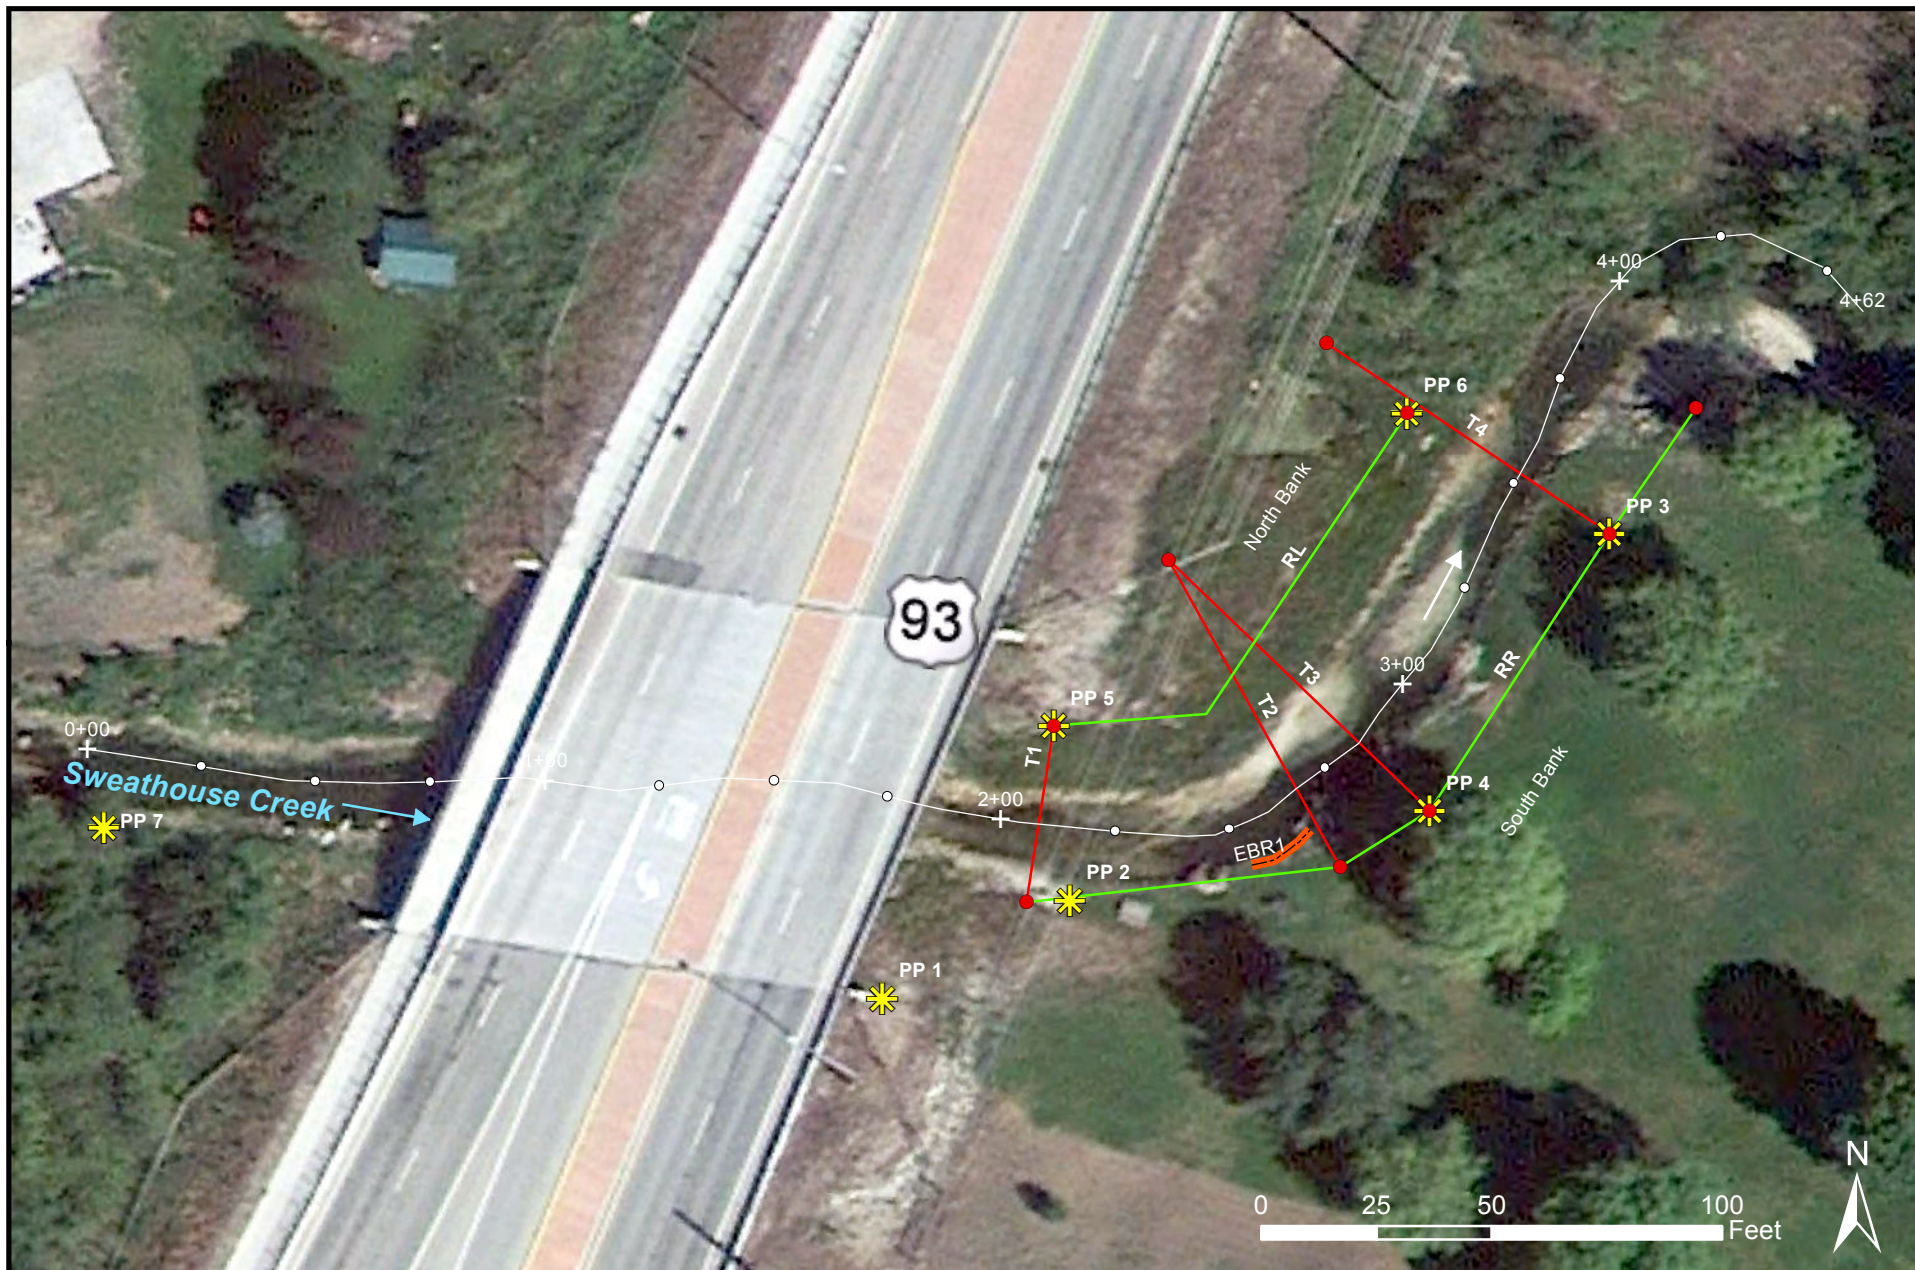
Figure 2

2016 Monitoring Features Sweathouse Creek

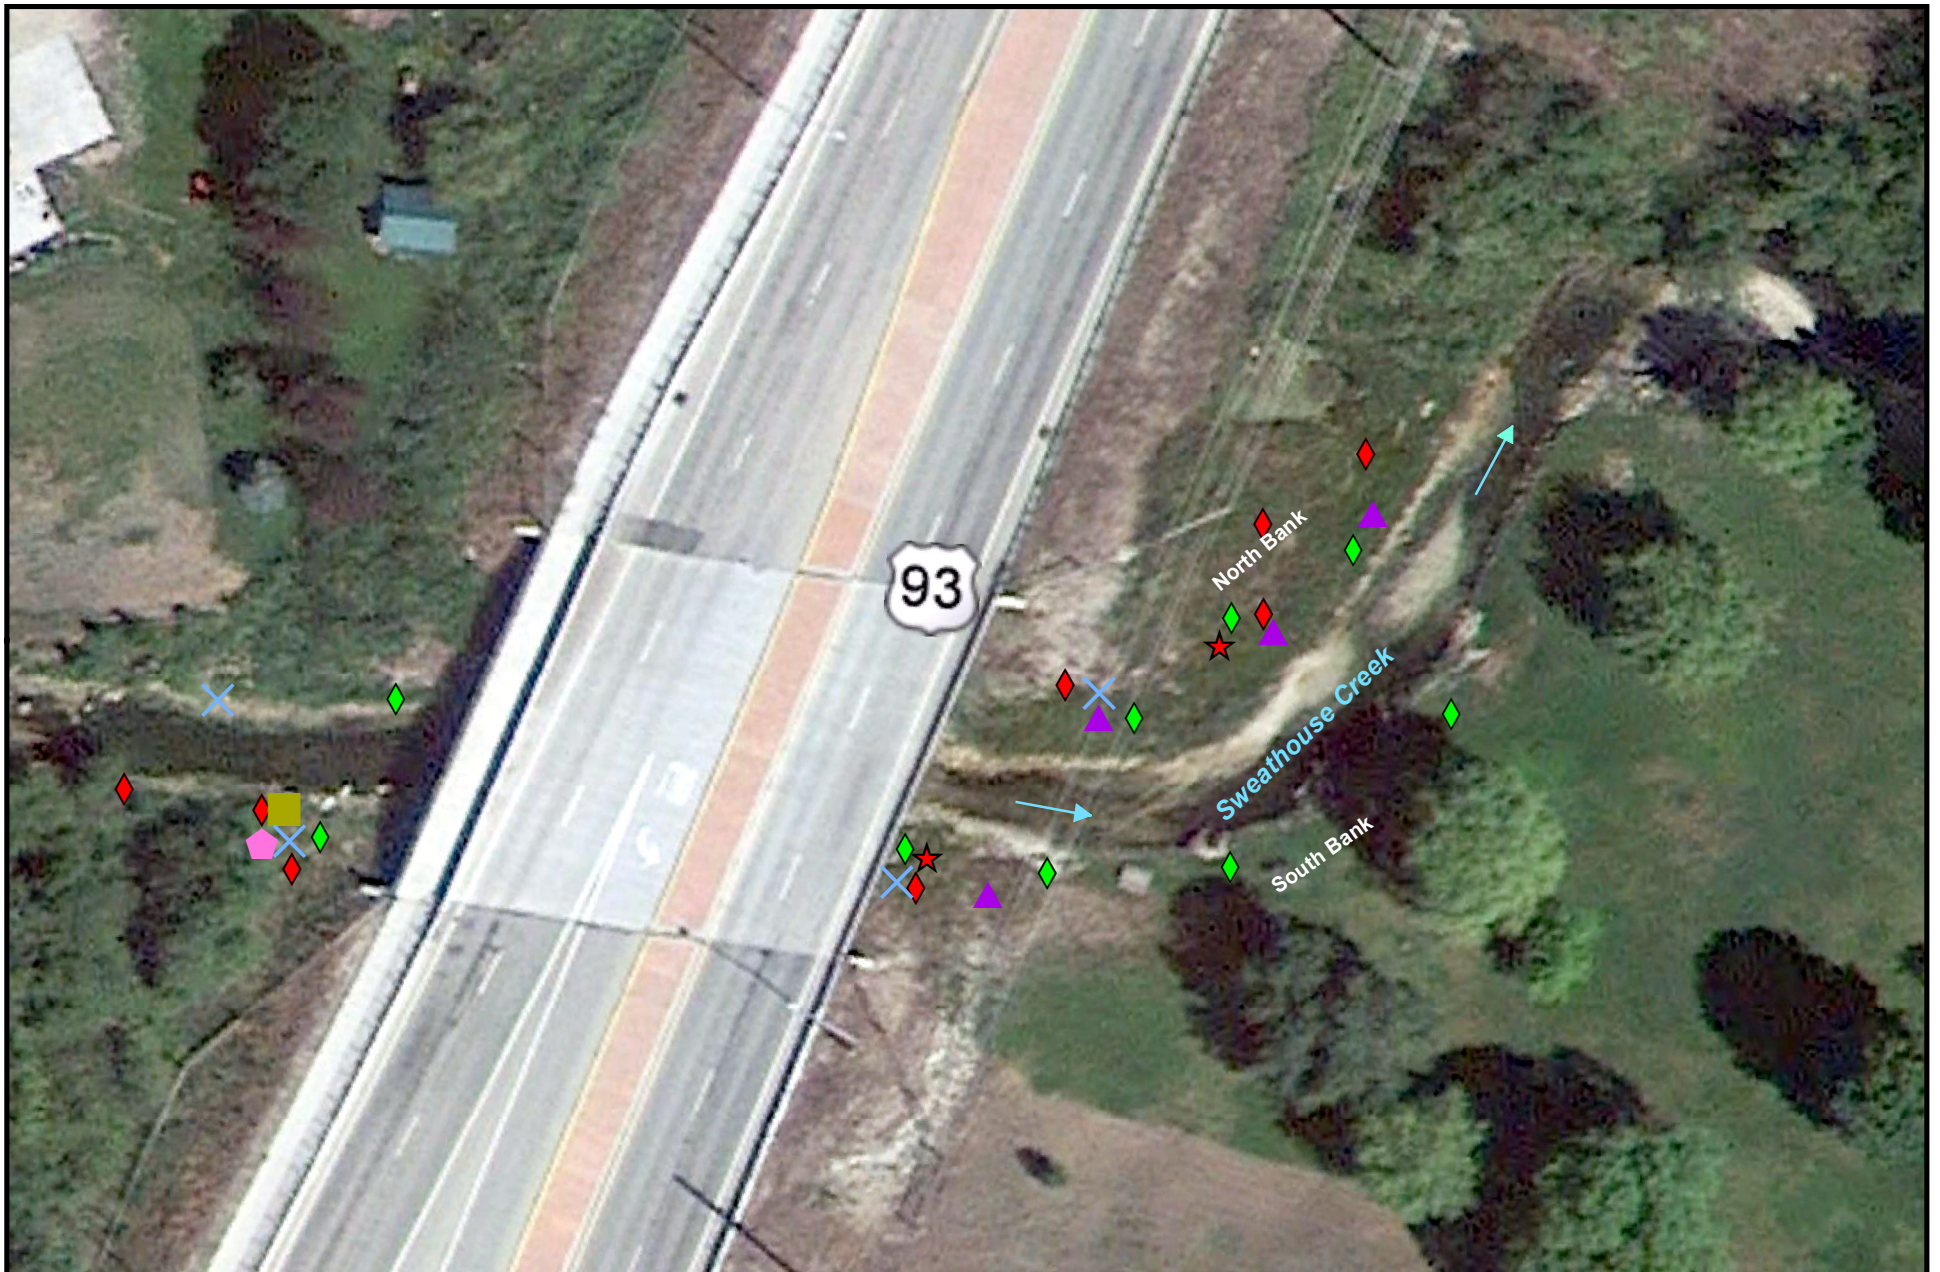
Each noxious weed occurrence was identified in areas less than 0.1 acre in size with cover classes ranging from trace (less than 1 percent) to low (1 to 5 percent). The extent of noxious weed coverage has increased at the site, with 23 new infestations mapped since 2014. An estimated 8% of the project area has been colonized by noxious weeds. Weeds were observed on both stream banks upstream and downstream of the Highway 93 Bridge with specific infestation locations provided in Figure 3, Appendix A.

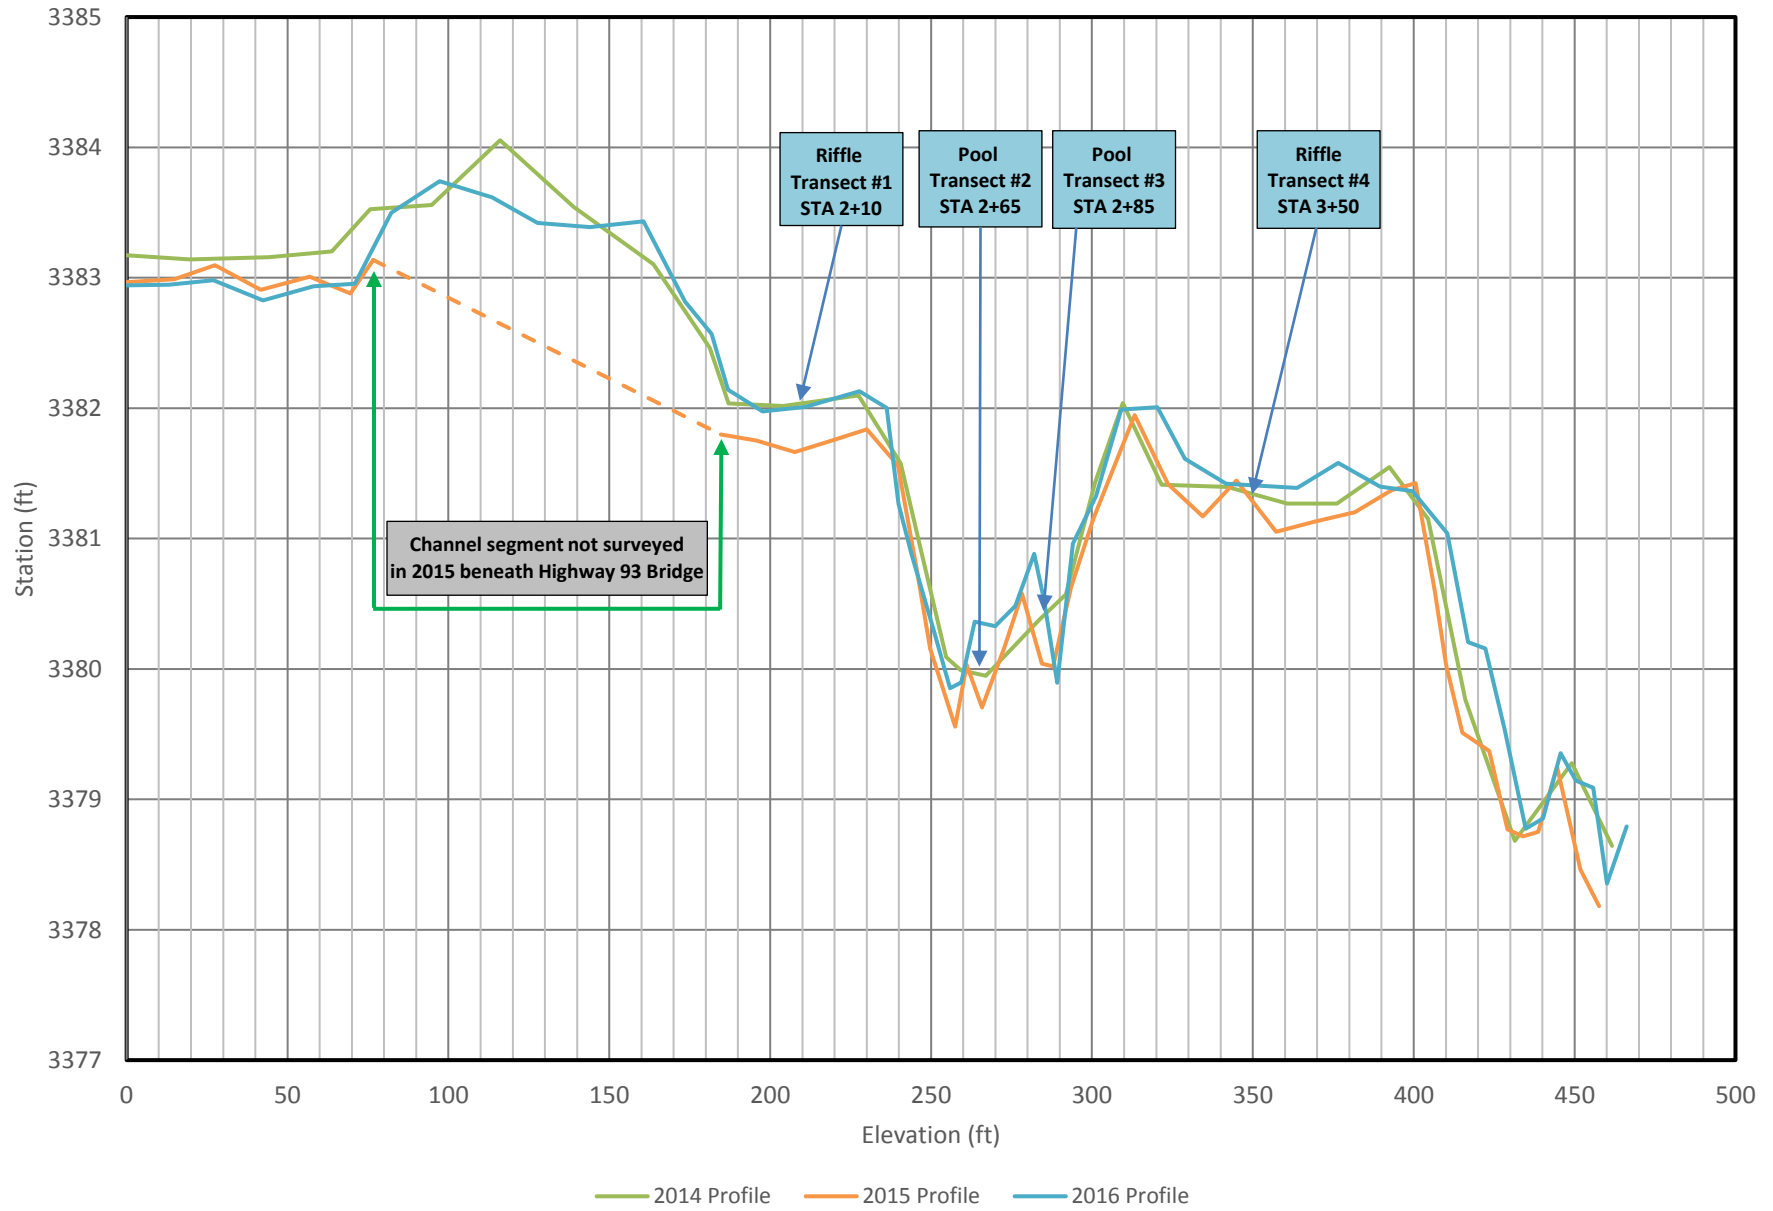
Sweathouse Creek Longitudinal Profiles: 2014 - 2016

A longitudinal profile surveyed down the length of the channel thalweg was repeated in 2016 (see profile in Appendix B). The thalweg elevation has remained relatively consistent throughout the project reach, with minor bed adjustments noticeable over the past three years. A riffle crest beneath the bridge has become lower by approximately 0.4 feet since 2014, which is likely due to settling of materials placed following construction. All other riffle crest elevations have remained consistent throughout the remainder of the project reach. Slight adjustments to bed elevation along the profile, such as those observed at the pools developing between STA 2+50 and 3+00 are most likely due to natural scour and depositional processes at play in a meandering channel, and are not attributed to channel instability within the project reach. The profile indicates the pool features along the right bank have maintained depth while the riffles have maintained a consistent channel slope. The channel planform is straight between STA 3+10 and 4+00, which is resulting in the extension of the riffle feature originally constructed at this location. Overall, the channel appears to be maintaining capacity and slope throughout the length of the project.

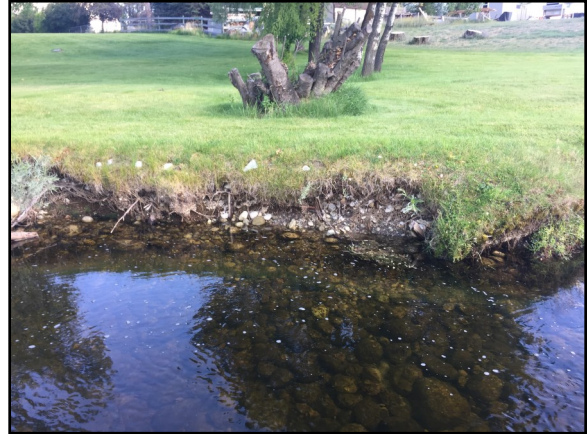
Additional Photo 4 - 2016

An erosion inventory conducted along both stream banks revealed no new erosion in 2016. In 2014, erosion was noted along a short segment of the right (south) bank where one of the coir logs separated from the bank and washed downstream. Monitoring of the site during the past two years has indicated no further bank erosion at this location (see Additional Photos 4 and 5 in Appendix C).

The 15-foot section of eroding bank along Sweathouse Creek identified in 2014 did not continue to erode in 2015 or 2016 and is not currently jeopardizing any woody structures installed along the south bank. This moderately eroding bank occurs between two root wads installed to protect the bank from lateral erosion. One of the coir logs placed to protect the upper bank washed out, exposing the upper bank to active flows. Vegetation along this bank has been consistently mowed, and woody vegetation

planted during the project's construction has only sparsely established along the bank toe. It does not appear corrective actions will be necessary to stabilize this bank unless future monitoring efforts indicate accelerated erosion.

Description: Eroding bank EBR1 along right (south bank). **Compass:** 90 (East)

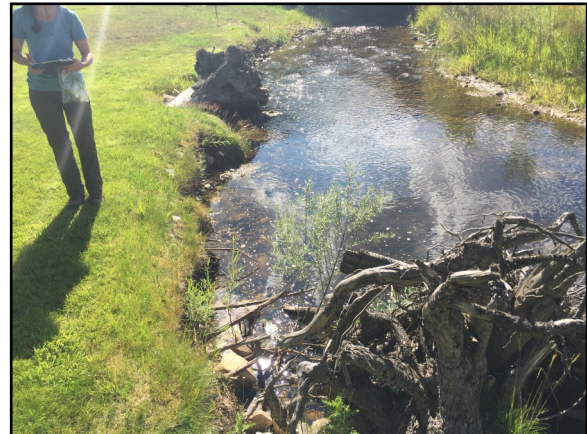
Additional Photo 5: Eroding Bank EBR1 - 2016

Description: Looking upstream toward Highway 93 bridge from south bank.
