MONTANA DEPARTMENT OF TRANSPORTATION STREAM MITIGATION MONITORING REPORT

*Mill Creek
Ravalli County, Montana*

*Project Constructed: 2011
Monitoring Report #5: December, 2017*

MDT Project Number: NH7-(114)59
Control Number: 2015004

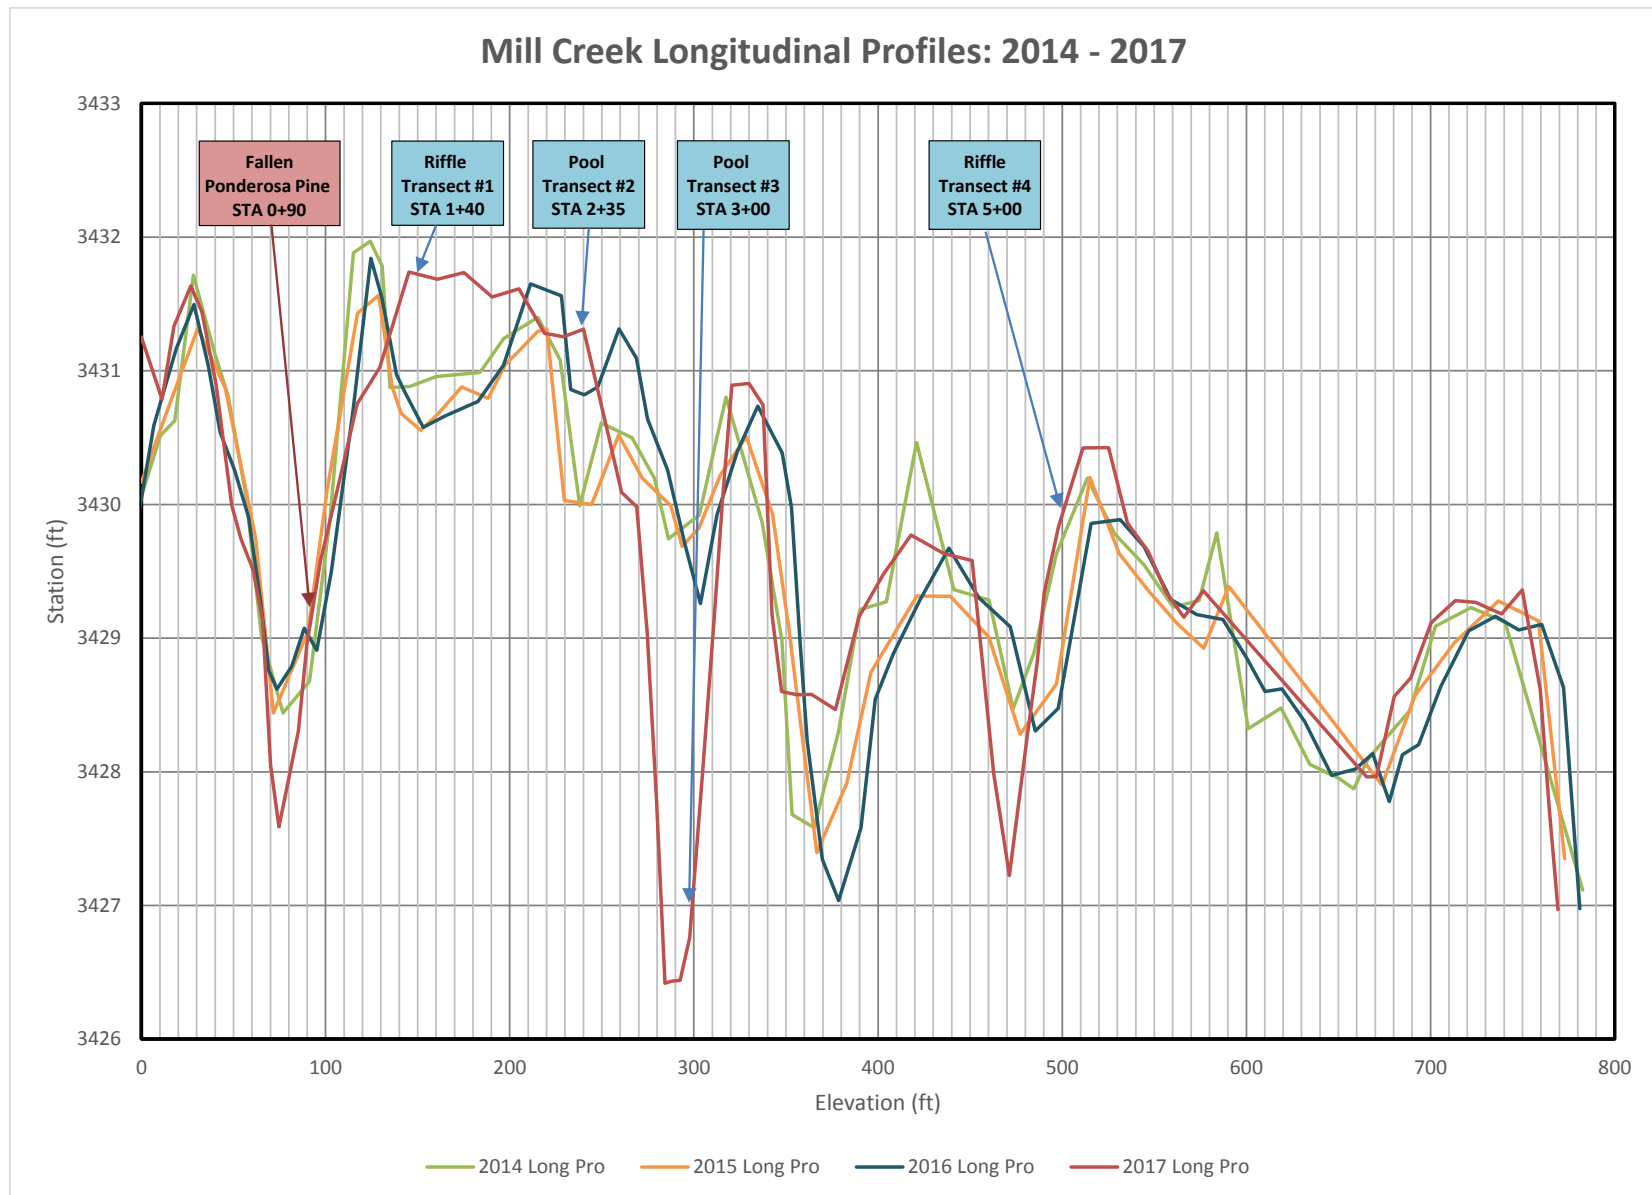
Figure 2. Thalweg longitudinal profile along Mill Creek, 2014 – 2017.

Inspection of the stream bed longitudinal profile and cross sections at each of the four monitoring transects over the past five years reveal stream bed adjustments are occurring along the length of the relocated channel. Adjustments to the bed and banks of a stream channel like Mill Creek can be attributed to natural erosion and depositional processes that can be affected by woody debris recruitment, point and mid-channel bar formation, and lateral channel adjustments. This reach of Mill Creek, as well as a lengthy segment of channel observed upstream, exhibits many gravel and cobble point bars and islands, which are indicative of a watershed with a large supply of bedload. Observations of the stream banks along the project reach indicates gravel and cobble material is also generated during lateral bank migrations. As a result of the high bedload composition of Mill Creek, the stream bed forms vary from year to year, with scour and depositional processes influenced by evolving meander patterns and woody debris complexes. Creeks transporting a large supply of cobble and gravel tend to laterally migrate more rapidly as bars develop and woody debris is recruited to the channel. The Mill Creek monitoring reach includes several large trees and woody debris complexes, which generate bedform complexity and aquatic habitat variability. As a result of these factors, continued channel adjustments and bank erosion are likely to naturally occur within the monitoring reach, which should be considered a healthy response of the channel to natural alluvial processes. As a result, corrective actions to halt natural bank erosion and bedform diversity in the restored channel segment are unwarranted and the channel should be allowed to naturally develop.

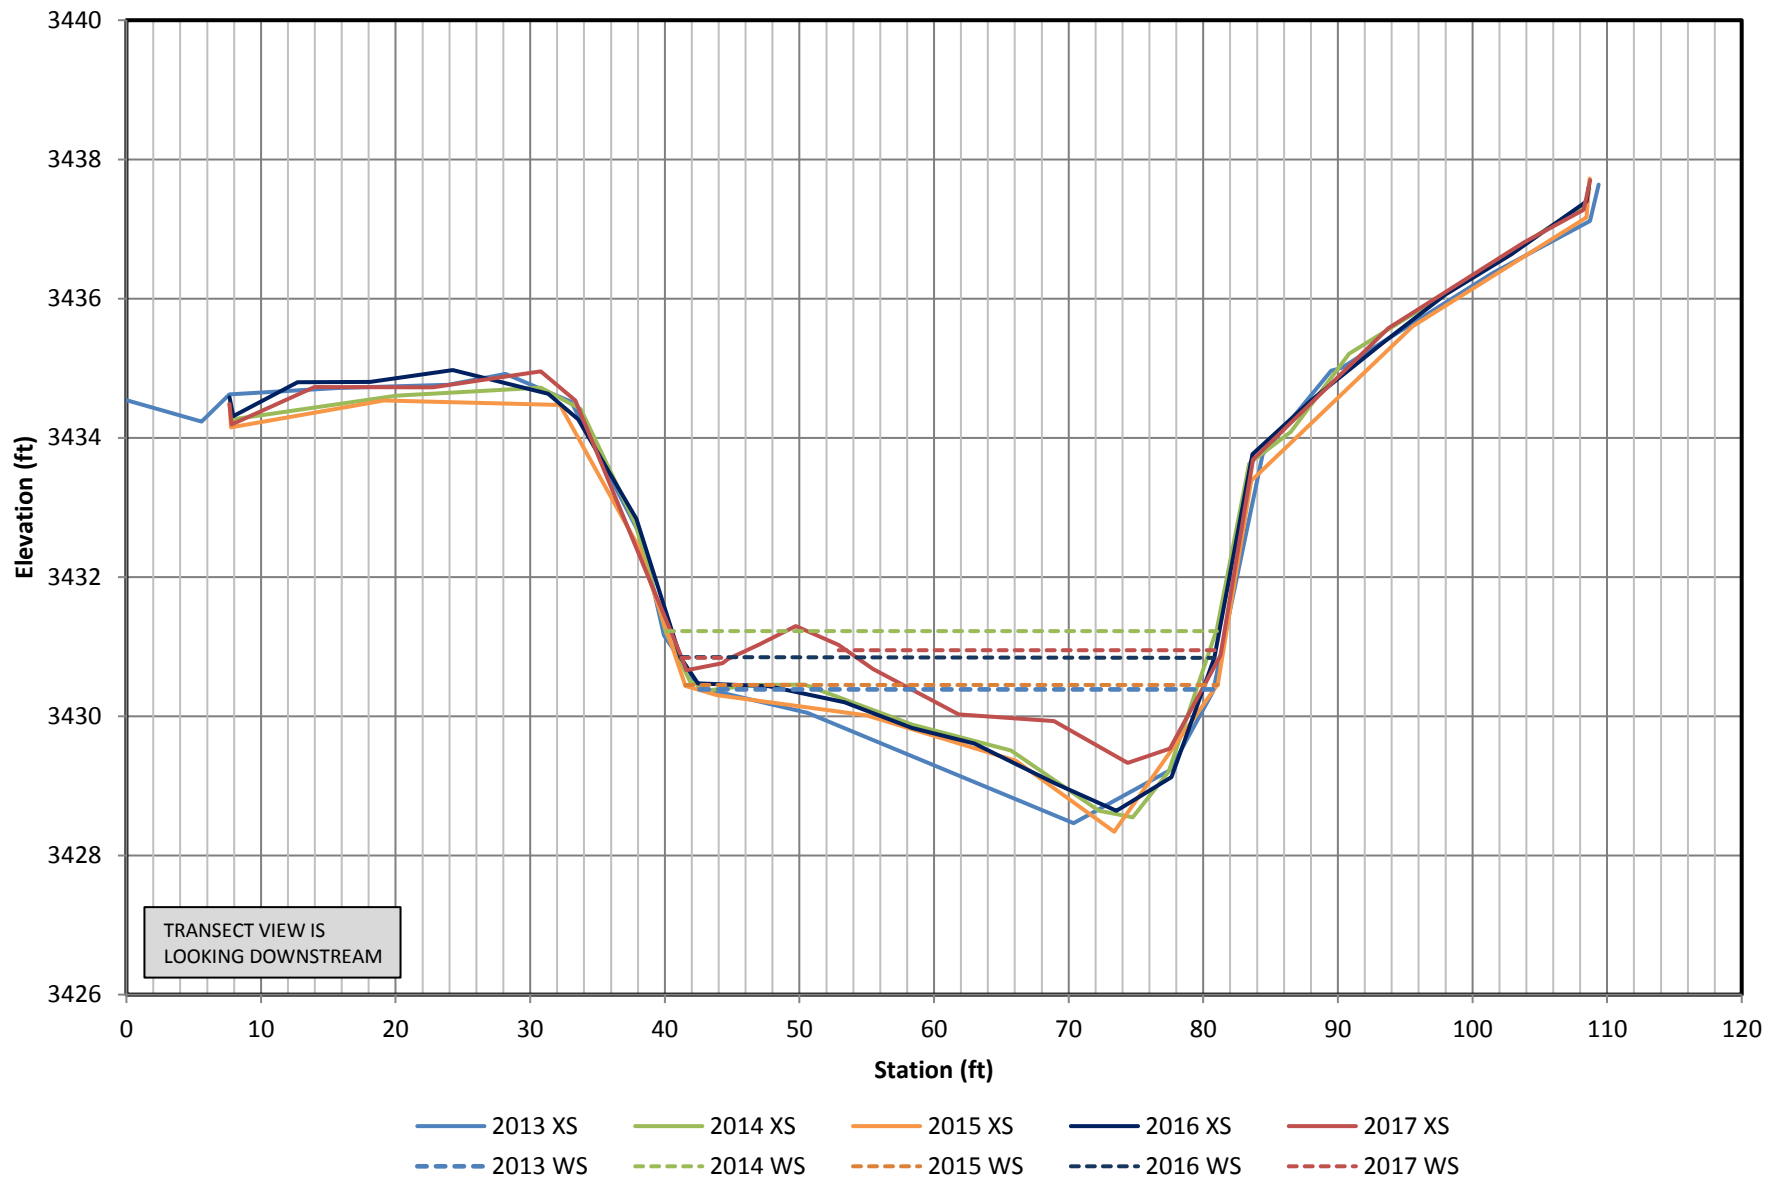
Mill Creek Transect #4 - Riffle

Transect #4 occurs at a riffle just above the last meander bend upstream of the U.S. Highway 93 Bridge. Repeated surveys at this transect between 2013 and 2017 reveal little adjustment to the stream bed and banks, although the bed appears to have aggraded by 3-4" in the past year. Although gravel has deposited across the width of the channel since 2016, inspection of the longitudinal profile does not indicate widespread aggradation along the downstream extent of the project reach. The deposit across transect #4 is more likely due to the deep pool scour that occurred immediately upstream of the transect. Gravel that scoured from this pool has since deposited in the next riffle downstream, and is likely to continue moving downstream during subsequent flood events.

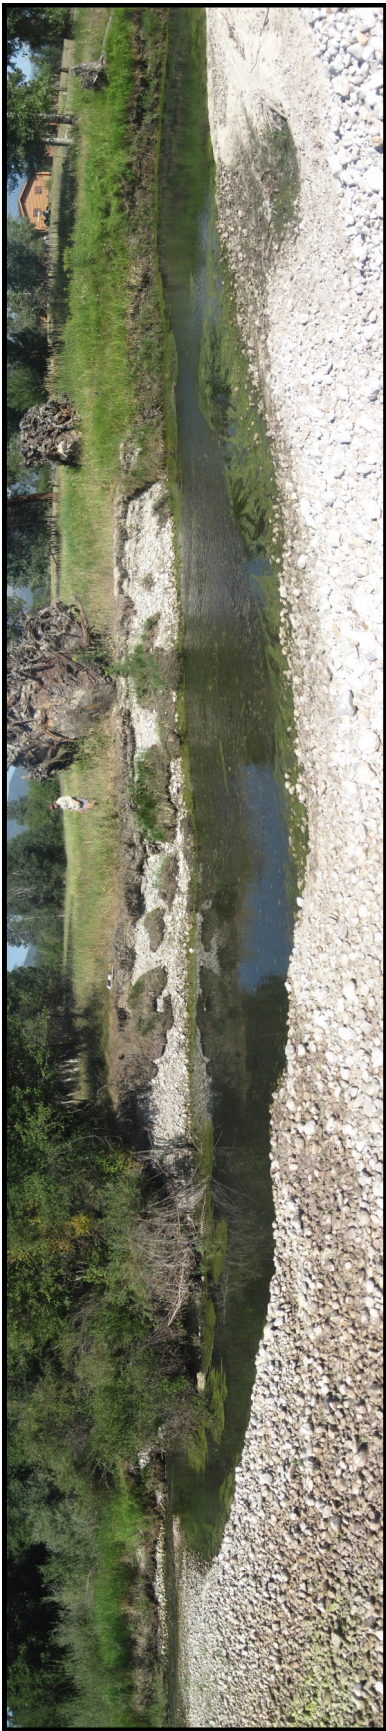
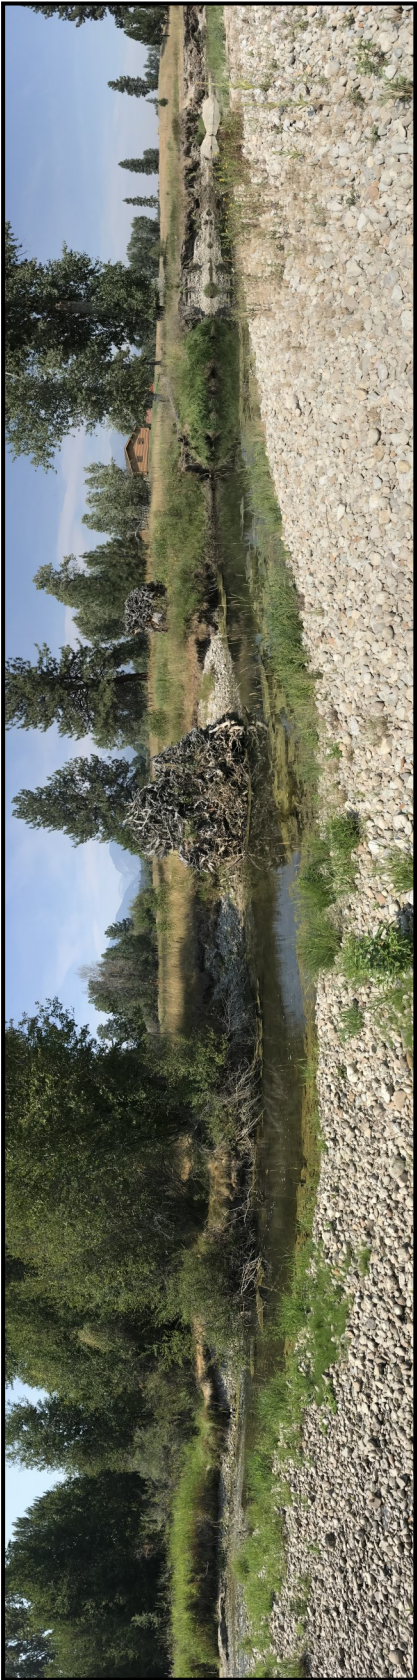
Banks EBL1 and EBL2 were originally documented as two separate eroding bank segments that combined into one long, 247-foot eroding bank in 2014 (herein referred to as EBL1-2). These eroding bank areas occur on private land upstream of the project reach, but has been documented in previous monitoring reports due to the potential of this bank affecting the project reach. The upper 150 feet of EBL1-2 has shown relatively little change over the past four monitoring years, has migrated northward approximately one foot since 2014 (see Additional Photo 1 in Appendix C). The lower 100 feet of the bank has migrated northward at a more rapid pace than the upper bank segment since 2014, especially in the vicinity of a large ponderosa pine tree that fell into the channel in 2016. The bank has migrated northward approximately six feet in the past year adjacent to the exposed root ball of this tree (see Additional Photo 2 and 8 in Appendix C).

Bank erosion at EBL1-2 is due to adjacent point bar formation forcing the channel against a relatively high, herbaceous vegetated stream bank along a relatively sharp meander bend. Root wads and large rocks placed on, but not keyed into the toe of the banks are causing increased scour against the bank toe. Bank erosion on sharp meander bends is commonly observed in naturally migrating streams with high bedload such as Mill Creek. The vegetation community along these banks include speckled alder, Kentucky bluegrass, smooth brome, sedges, common yarrow, western-wheat grass, Canadian goldenrod, and ox-eye daisy, most of which are upland species less capable of withstanding erosive forces. The bank retreated between 3 and 7 feet from 2013 to 2014 an additional 2-5 feet from 2014 to 2015 and approximately 3-5 feet

further since 2016. Based on the combination of eroding factors, severity of erosion along EBL1-2 is considered high. Although this bank has consistently retreated, its effect on the restored channel segment below it does not appear to be consequential. Rather, the eroding bank has resulted in the recruitment of large woody debris to the channel, which is beneficial toward the development of diverse aquatic habitat. The alignment of the channel along EBL1-2 has not induced additional erosion further downstream, and as a result of these factors, corrective actions are not warranted.

Additional Photo 1:EUpper end of eroding Bank EBL1 -2

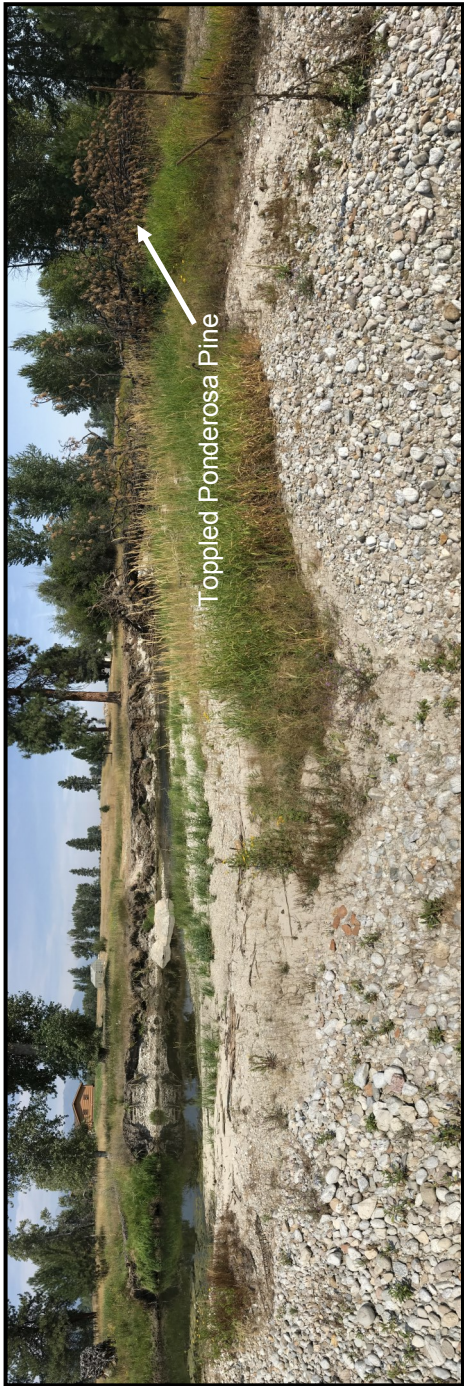
Additional Photo 2: Lower end of eroding Bank EBL1-2

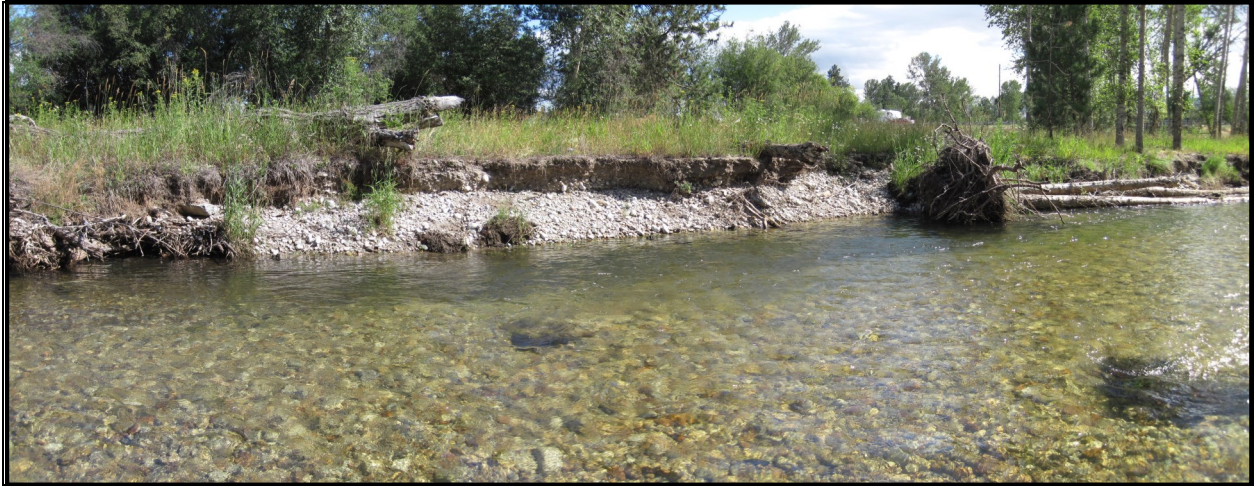
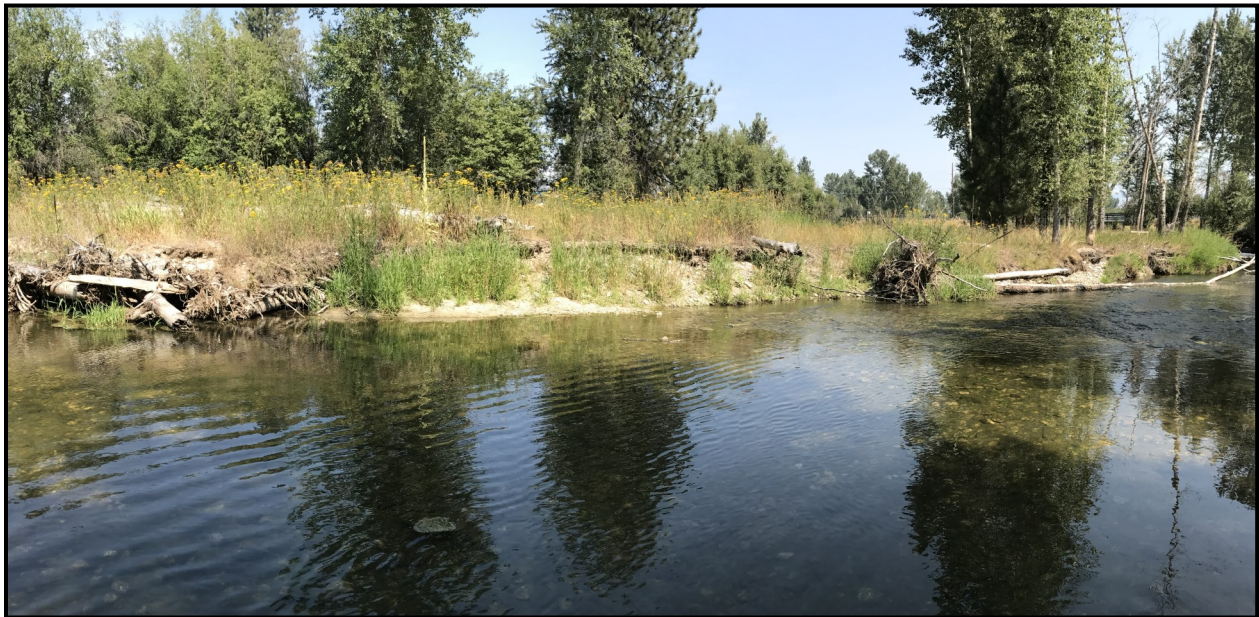
Signs of active erosion at EBL3 were originally observed in 2014 at the head of the former channel alignment which is now backfilled with gravel, cobble, and soil. Erosion was observed along approximately 90 feet between the upstream extent of the backfill and the root ball of a fallen tree. The vegetation community along this bank consists of short-awn meadow foxtail, white and red clover, Kentucky bluegrass, common tansy, and ox-eye daisy. Erosion along this bank has not advanced in length or continued lateral movement in the past three years (see Additional Photo 3 and 4 in Appendix C). Based on the lack of continued lateral erosion noted since 2014, bank EBL3 has been removed from the list of actively eroding banks and is no longer featured on Figure 3 of Appendix A

Additional Photo 3: Upper section of Eroding Streambank EBL3

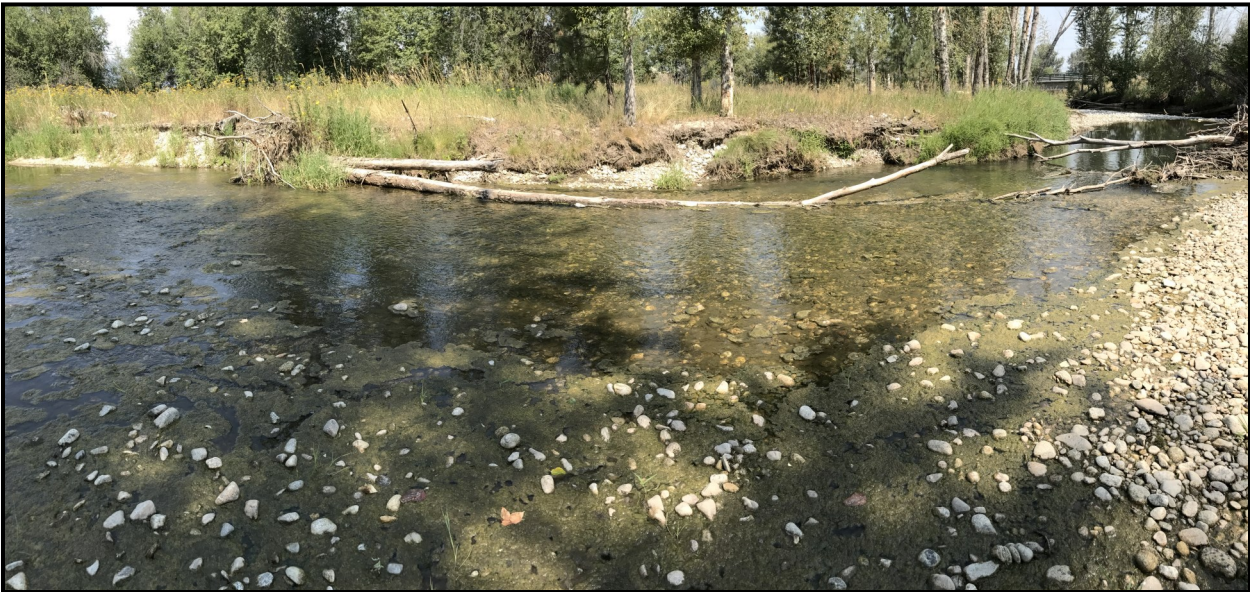
Additional Photo 4: Lower section of Eroding Streambank EBL3

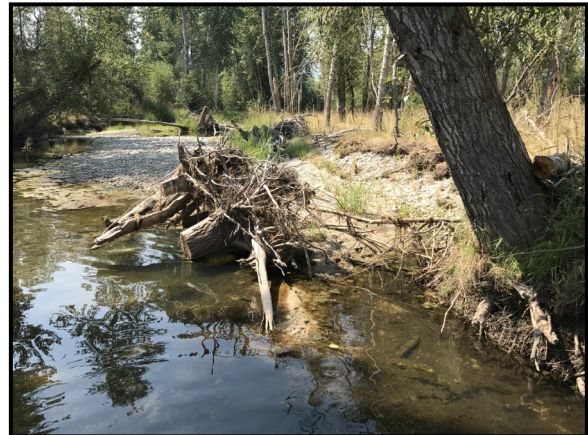
Lateral erosion at bank EBL4 appears to have continued over the past two years, as evidenced by the adjacent root balls detaching from the bank (see Additional Photo 5 in Appendix C). The bank has retreated approximately 6-8 feet since 2013, although the eroding bank length of 64 feet has not increased. Bank instability at this location was potentially caused by removal of the trees for use in log revetment construction, or from natural channel adjustments following construction. The dominant vegetation along the bank includes reed canary grass and smooth brome, the former of which offers dense roots capable of withstanding erosion more effectively than most species. Erosion severity along this bank is considered low, as it does not jeopardize any infrastructure elements or the newly installed bridge downstream. As a result of the erosion occurring likely as a result of natural channel adjustments, no corrective actions are warranted at this location.

Additional Photo 5: Eroding streambank EBL4

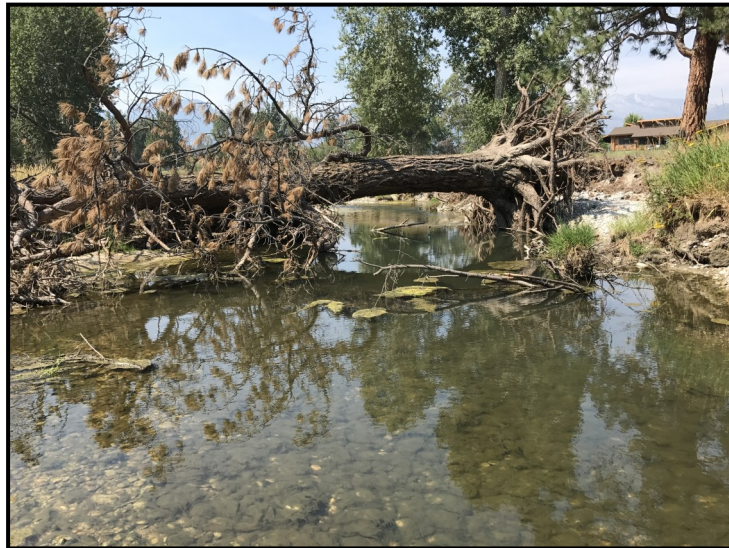
Erosion at EBR2 was originally noted in 2014 along 65 feet of the channel across from the head of the deactivated stream channel. Erosion at this location was tied to channel adjustments and scour along the outside of a meander. No additional erosion along this bank segment has been noted over the past three years (see Additional Photo 7 in Appendix C), and as such, it has been removed from the list of actively eroding banks.

Additional Photo 8: Ponderosa pine in channel near downstream end of EBR2
